**NYC Department of Education**  
**Building Condition Assessment Survey 2023 - 2024**

Architectural Inspection

**K274**

**Asset:** P.S. 274 - BROOKLYN, 800 BUSHWICK AVENUE, New York, 11221

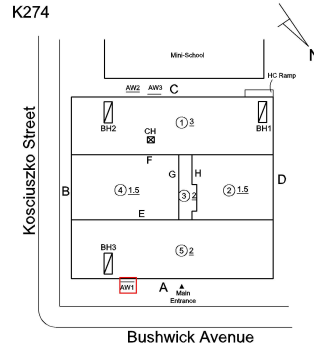
Question	Response
<b>Architectural</b>	
<b>EXTERIOR</b>	Inspected
<b>AREAWAY</b>	Inspected
Instance on AW1-AW3	Inspected
Instance Condition	3 - Fair
Instance Quantity	3
Instance Quantity Uom	EACH
Deficiency	AREAWAY GRATINGS: MAJOR RUSTING AND / OR BROKEN SUPPORTS

20  
L.F.  
REPLACE  
PRIORITY 4  
LEVEL 2

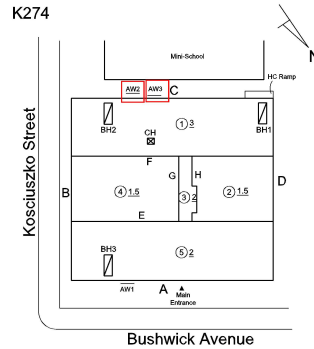
**AREAWAY GRATINGS: MAJOR RUSTING / OR BROKEN**

80  
S.F.  
REPLACE  
PRIORITY 4  
LEVEL 2

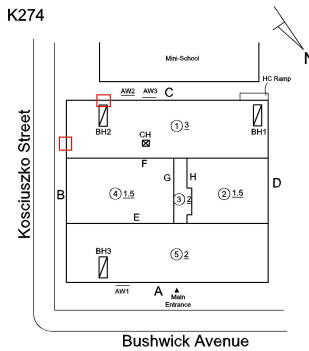
METAL CLAD: DETERIORATED DOOR AND FRAME - MAJOR DETERIORATION

4  
EACH  
REPLACE  
PRIORITY 4  
LEVEL 2

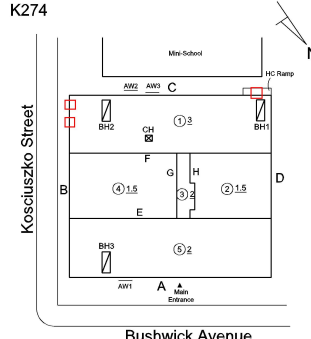
Question	Response
<b>EXTERIOR</b>	
<b>DOORS</b>	
<b>DOORS AND FRAMES</b>	
Violations	Facade B - Exit 3 No violations recorded.
Deficiency	METAL CLAD: DETERIORATED DOOR - MAJOR DETERIORATION
Roof Plan reference	K274

Deficiency Quantity	4
Quantity Uom	EACH
Potential Action	REPLACE
Urgency of Action	PRIORITY 4
Purpose of Action	LEVEL 2
Deficiency Photo1

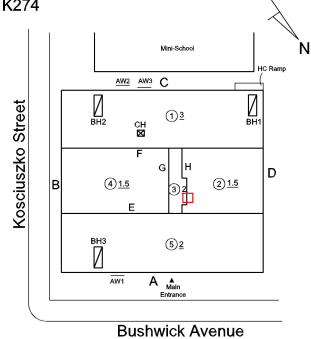
Question	Response
<b>EXTERIOR</b>	
<b>EXTERIOR SOFFITS</b>	Inspected
Condition	2 - Between Good and Fair
Deficiency	No deficiencies recorded
<b>LOADING DOCK</b>	Does not Exist
<b>LOUVER</b>	Inspected
Condition	3 - Fair
Deficiency	MISSING/DAMAGED SCREEN
Roof Plan reference	K274
Elevation

Deficiency Quantity	20
Quantity Uom	S.F.
Potential Action	REPLACE
Urgency of Action	PRIORITY 4
Purpose of Action	LEVEL 2
Deficiency Photo1

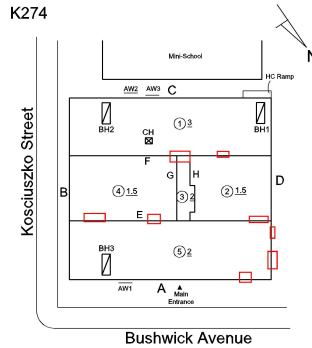
RAILINGS/PANELS: DETERIORATED, MAJOR RUSTING

REPLACE

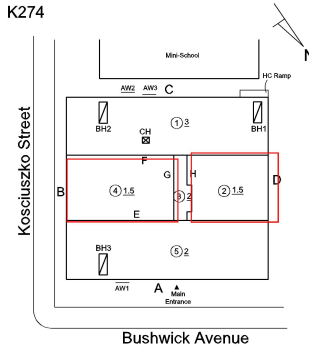
Deficiency	<b>BUILT-UP: ROOFING: LOSS OF GRAVEL</b>
Roof Plan reference	K274

Deficiency Quantity	500
Quantity Uom	S.F.
Potential Action	INSTALL NEW GRAVEL
Urgency of Action	PRIORITY 3
Purpose of Action	LEVEL 2
Deficiency Photo 1

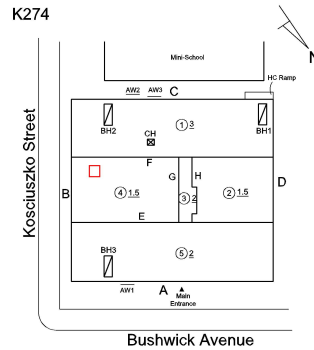
**ROOFING DRAINS**

1  
 EACH  
 REPLACE  
 PRIORITY 4  
 LEVEL 2

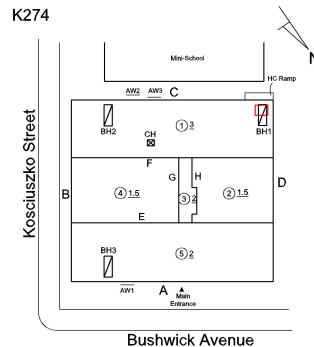
BULKHEAD/PENTHOUSE WALLS/INTERIOR: PLASTER  
 CRACKS/SPALLING

10  
 S.F.  
 REPLACE  
 PRIORITY 4  
 LEVEL 2

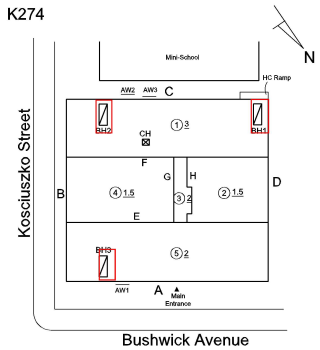
Violations	BH1 No violations recorded.
Deficiency	BULKHEAD/PENTHOUSE WALLS/EXTERIOR: DETERIORATED JOINTS
Roof Plan reference	K274

Deficiency Quantity	300
Quantity Uom	S.F.
Potential Action	REPOINT
Urgency of Action	PRIORITY 3
Purpose of Action	LEVEL 2
Deficiency Photo1

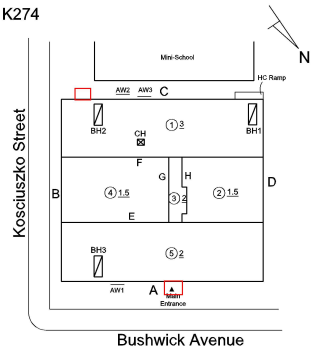
Question	Response
<b>EXTERIOR</b>	
<b>STAIRS/RAMPS: EXTERIOR</b>	
<b>BUILDING CHEEK/FLANK WALLS</b>	Inspected
Condition	2 - Between Good and Fair
Deficiency	No deficiencies recorded
<b>RAILINGS</b>	Inspected
Condition	2 - Between Good and Fair
Deficiency	No deficiencies recorded
<b>STAIRS/RAMPS</b>	Inspected
Condition	3 - Fair
Deficiency	<b>CONCRETE: CRACKS/SPALLING - MINOR</b>
Roof Plan reference	K274

Deficiency Quantity	20
Quantity Uom	S.F.
Potential Action	REPAIR
Urgency of Action	PRIORITY 3
Purpose of Action	LEVEL 2
Deficiency Photo1

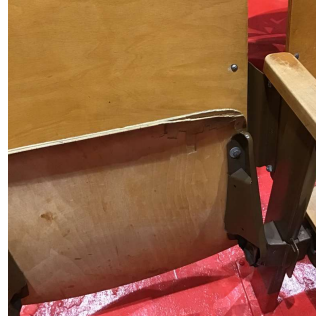
Seat A/103

DAMAGED/BROKEN/INOPERABLE

REPLACE

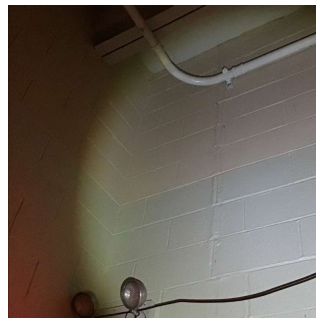
Deficiency MASONRY: CRACKS/SPALLING

Deficiency Location/Instance Rear Stage Left

Potential Action REPLACE

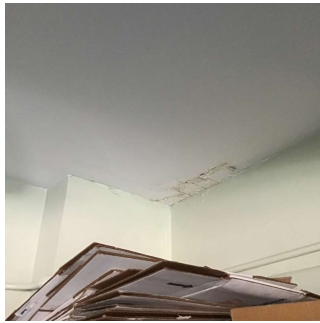
Violations	Columns at Center No violations recorded.
<b>Window Curtains/Shades/Blinds</b>	
Instance on 1st Floor	Does not Exist
<b>CLASSROOMS/CORRIDORS/ADMIN SPACES</b>	
<b>Ceiling</b>	
Condition	2 - Between Good and Fair
Deficiency	PLASTER: CRACKS/SPALLING
Deficiency Location/Instance	Room 227
Deficiency Quantity	10
Quantity Uom	S.F.
Potential Action	REPLACE
Urgency of Action	PRIORITY 3
Purpose of Action	LEVEL 2
Deficiency Photo1

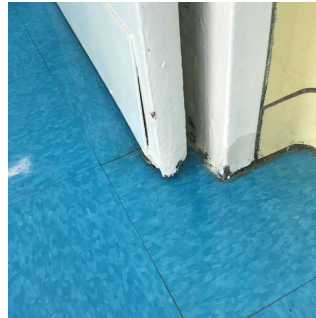
Corridor near Room 252

METAL: DETERIORATED DOOR

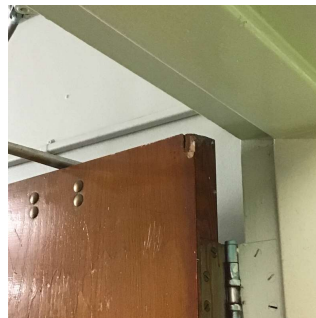
WOOD: DETERIORATED DOOR

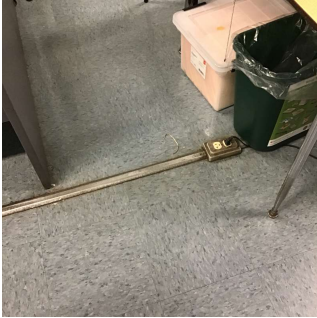
Question	Response
<b>INTERIOR</b>	
<b>CLASSROOMS/CORRIDORS/ADMIN SPACES</b>	
<b>Door(s)</b>	Inspected
	Room 302
Violations	No violations recorded.
<b>Floor Finish</b>	Inspected
Condition	2 - Between Good and Fair
Deficiency	VINYL TILES: TRIPPING HAZARD - ELECTRICAL OUTLET
Deficiency Location/Instance	Rooms 143, 328
Deficiency Quantity	10
Quantity Uom	S.F.
Potential Action	REMOVE
Urgency of Action	PRIORITY 5
Purpose of Action	LEVEL 6
Deficiency Photo1

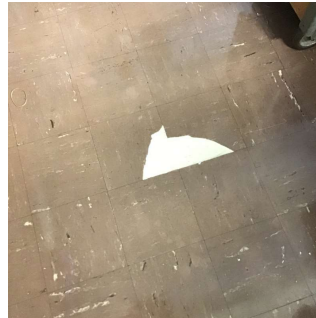
Room 328

VINYL TILES: BROKEN/DETERIORATED/MISSING TILES

REPLACE

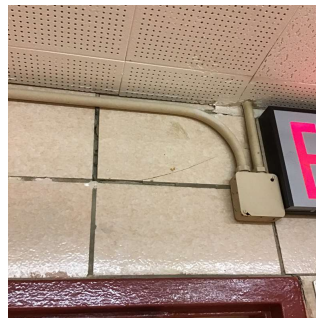
GLAZED BLOCK: CRACKS/SPALLING

REPLACE

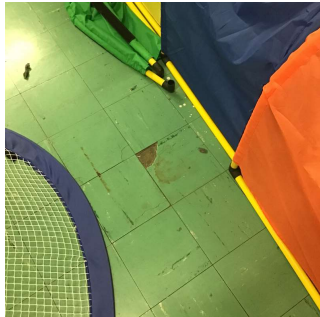
Violations	Center No violations recorded.
Deficiency	VINYL TILES: BROKEN/DETERIORATED/MISSING TILES
Deficiency Location/Instance	Office
Deficiency Quantity	20
Quantity Uom	S.F.
Potential Action	REPLACE
Urgency of Action	PRIORITY 3
Purpose of Action	LEVEL 2
Deficiency Photo1

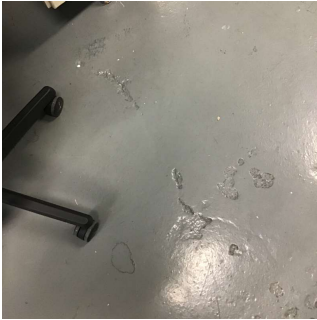
Violations	Exit 5 Vestibule No violations recorded.
<b>Floor Finish</b>	
Instance on 1st Floor	Inspected
Condition	3 - Fair
Deficiency	CONCRETE: CRACKS
Deficiency Location/Instance	Store Room
Deficiency Quantity	10
Quantity Uom	S.F.
Potential Action	REPLACE
Urgency of Action	PRIORITY 3
Purpose of Action	LEVEL 2
Deficiency Photo1

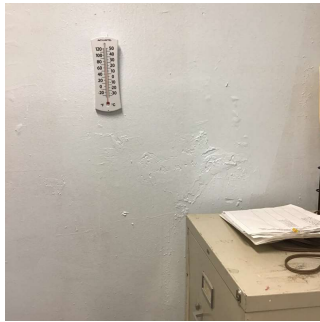
Violations	Serving Area No violations recorded.
<b>Walls</b>	
Instance on 1st Floor	Inspected
Condition	2 - Between Good and Fair
Deficiency	PLASTER: CRACKS/SPALLING
Deficiency Location/Instance	Store Room, Locker Room
Deficiency Quantity	20
Quantity Uom	S.F.
Potential Action	REPLACE
Urgency of Action	PRIORITY 3
Purpose of Action	LEVEL 2
Deficiency Photo1

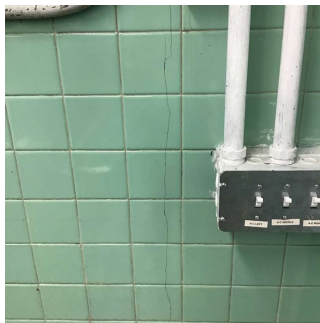
Violations	Store Room No violations recorded.
Deficiency	CERAMIC TILE: BROKEN/ MISSING
Deficiency Location/Instance	Serving Area, Rear
Deficiency Quantity	25
Quantity Uom	S.F.
Potential Action	REPLACE
Urgency of Action	PRIORITY 3
Purpose of Action	LEVEL 2

Question	Response
<b>INTERIOR</b>	
<b>KITCHEN</b>	Inspected
<b>Walls</b>	
Deficiency Photo1

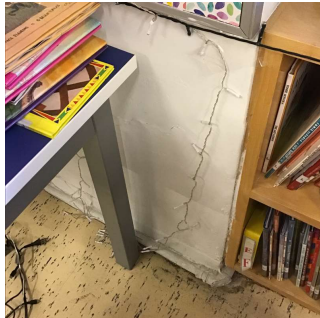
Violations	Serving Area No violations recorded.
<b>LIBRARY</b>	Inspected
Instance on 2nd Floor	Inspected
<b>Built-in Furnishing</b>	
Instance on 2nd Floor	Does not Exist
<b>Ceiling</b>	
Instance on 2nd Floor	Inspected
Condition	2 - Between Good and Fair
Deficiency	No deficiencies recorded
<b>Door(s)</b>	
Instance on 2nd Floor	Inspected
Condition	2 - Between Good and Fair
Deficiency	No deficiencies recorded
<b>Floor Finish</b>	
Instance on 2nd Floor	Inspected
Condition	2 - Between Good and Fair
Deficiency	No deficiencies recorded
<b>Walls</b>	
Instance on 2nd Floor	Inspected
Condition	2 - Between Good and Fair
Deficiency	PLASTER: CRACKS/SPALLING
Deficiency Location/Instance	Left Side Near Windows
Deficiency Quantity	10
Quantity Uom	S.F.
Potential Action	REPLACE
Urgency of Action	PRIORITY 4
Purpose of Action	LEVEL 4
Deficiency Photo1

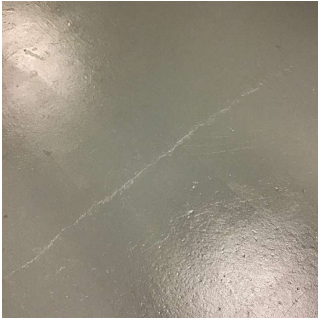
Question	Response
<b>INTERIOR</b>	
<b>LIBRARY</b>	Inspected
<b>Walls</b>	
Violations	35553934L
<b>LOCKER ROOM</b>	Inspected
Instance on Basement - Boys (100 Lockers)	Inaccessible
Instance on Basement - Girls (50 Lockers)	Inspected
Alternative use	Yes
<b>Ceiling</b>	
Instance on Basement - Girls (50 Lockers)	Inspected
Condition	2 - Between Good and Fair
Deficiency	No deficiencies recorded
<b>Door(s)</b>	
Instance on Basement - Girls (50 Lockers)	Inspected
Condition	3 - Fair
Deficiency	WOOD: DETERIORATED DOOR
Deficiency Location/Instance	Entrance
Deficiency Quantity	1
Quantity Uom	EACH
Potential Action	MAINTENANCE
Urgency of Action	PRIORITY 3
Purpose of Action	LEVEL 2
Deficiency Photo1	No photo recorded
Violations	No violations recorded.
<b>Floor Finish</b>	
Instance on Basement - Girls (50 Lockers)	Inspected
Condition	3 - Fair
Deficiency	CONCRETE: CRACKS
Deficiency Location/Instance	Center
Deficiency Quantity	50
Quantity Uom	S.F.

Potential Action	REPLACE
Urgency of Action	PRIORITY 3
Purpose of Action	LEVEL 2
Deficiency Photo1

Center
Violations	No violations recorded.
<b>Locker Room Lockers</b>	
Instance on Basement - Girls (50 Lockers)	Inspected
Condition	2 - Between Good and Fair
Deficiency	No deficiencies recorded
<b>Walls</b>

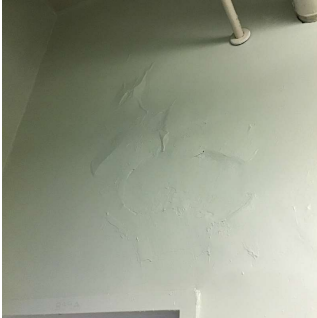
Question	Response
<b>INTERIOR</b>	
<b>LOCKER ROOM</b>	Inspected
<b>Walls</b>	
Instance on Basement - Girls (50 Lockers)	Inspected
Condition	2 - Between Good and Fair
Deficiency	PLASTER: CRACKS/SPALLING
Deficiency Location/Instance	Near Toilet Room
Deficiency Quantity	20
Quantity Uom	S.F.
Potential Action	REPLACE
Urgency of Action	PRIORITY 3
Purpose of Action	LEVEL 2
Deficiency Photo1

Violations	Near Toilet Room No violations recorded.
<b>MULTI-PURPOSE ROOM</b>	Does not Exist
<b>SCIENCE DEMO ROOM</b>	Does not Exist
<b>SCIENCE LAB</b>	Does not Exist
<b>SCIENCE PREP ROOM</b>	Does not Exist
<b>SHOWER ROOM</b>	Inspected
Instance on Basement - Boys	Inaccessible
Instance on Basement - Girls	Inaccessible
<b>STAIRS/RAMPS: INTERIOR</b>	Inspected
Do Letter Stair Signs Exist?	Yes
<b>Ceiling</b>	Inspected
Condition	2 - Between Good and Fair
Deficiency	No deficiencies recorded
<b>Door(s)</b>	Inspected
Condition	3 - Fair
Deficiency	METAL: DETERIORATED DOOR AND FRAME

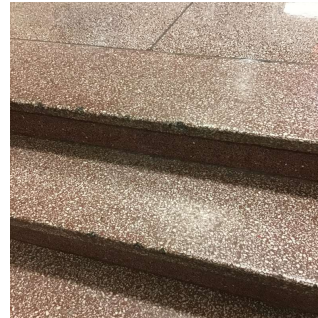
Main Entrance Lobby

**TERRAZZO: CRACKS**

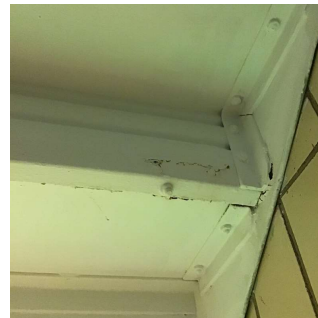
Stair EF/Basement

**METAL: RUST - MAJOR**

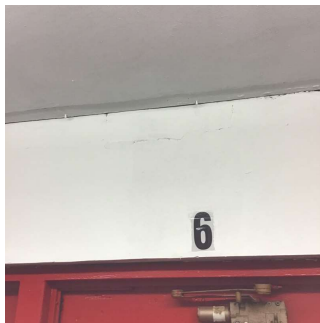
Question	Response
<b>INTERIOR</b>	
<b>STAIRS/RAMPS: INTERIOR</b>	
<b>Walls</b>	
Deficiency Photo1

Violations	Stair GH/1 Vestibule No violations recorded.
Deficiency	GLAZED BLOCK: CRACKS/SPALLING
Deficiency Location/Instance	Stair BC/Basement, 1
Deficiency Quantity	20
Quantity Uom	S.F.
Potential Action	REPLACE
Urgency of Action	PRIORITY 3
Purpose of Action	LEVEL 2
Deficiency Photo1

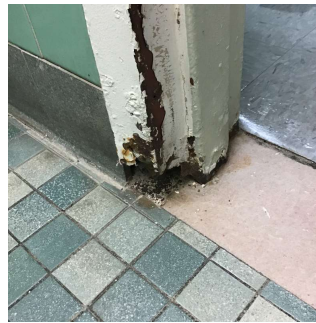
In Room 157

**Door(s)**

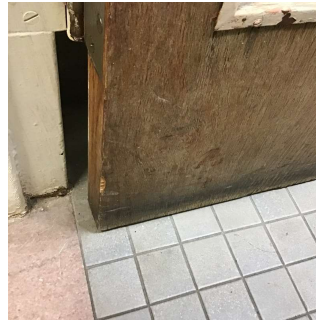
Kitchen

WOOD: DETERIORATED DOOR

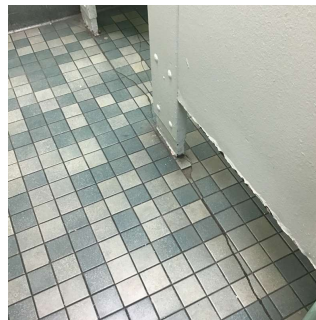
CERAMIC TILE: DETERIORATED SUBSTRATE

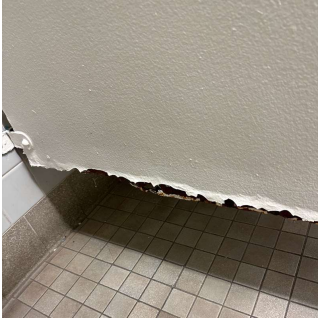
Question	Response
<b>INTERIOR</b>	
<b>TOILET ROOMS - STAFF</b>	
<b>Floor Finish</b>	Inspected
	Room 203
Violations	No violations recorded.
<b>Stalls</b>	Inspected
Condition	5 - Poor
Deficiency	RUST - MAJOR
Deficiency Location/Instance	Rooms 146, 203, 303, Old Girls Locker Room, Gymnasium Office, and others
Deficiency Quantity	7
Quantity Uom	EACH
Potential Action	REPLACE
Urgency of Action	PRIORITY 3
Purpose of Action	LEVEL 2
Deficiency Photo1

Room 146
Violations	No violations recorded.
<b>Walls</b>	Inspected
Condition	2 - Between Good and Fair
Deficiency	CERAMIC TILE: BROKEN/ MISSING
Deficiency Location/Instance	Kitchen, Room 154, Old Girls Locker Room, Gymnasium Office
Deficiency Quantity	30
Quantity Uom	S.F.
Potential Action	REPLACE
Urgency of Action	PRIORITY 3
Purpose of Action	LEVEL 2
Deficiency Photo1

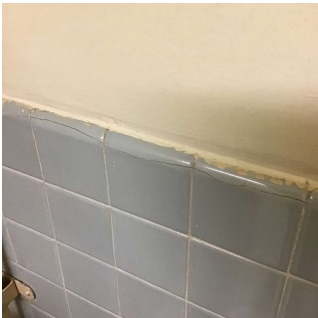
Kitchen
Violations	No violations recorded.
<b>TOILET ROOMS - STUDENTS</b>	
	Inspected
<b>Ceiling</b>	Inspected

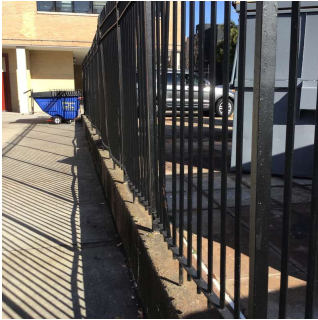
Question	Response
<b>SITE</b>	
<b>FENCES</b>	Inspected
Violations	No violations recorded.
Deficiency	WROUGHT IRON: DAMAGED/DETERIORATED
Deficiency Location/Instance	Near Kosciuszko Street
Deficiency Quantity	320
Quantity Uom	S.F.
Potential Action	REPLACE
Urgency of Action	PRIORITY 3
Purpose of Action	LEVEL 2
Deficiency Photo1

Violations	Near Kosciuszko Street No violations recorded.
Deficiency	CHAIN LINK: DAMAGED POST/RAIL
Deficiency Location/Instance	Schoolyard
Deficiency Quantity	15
Quantity Uom	L.F.
Potential Action	REPLACE
Urgency of Action	PRIORITY 3
Purpose of Action	LEVEL 2
Deficiency Photo1

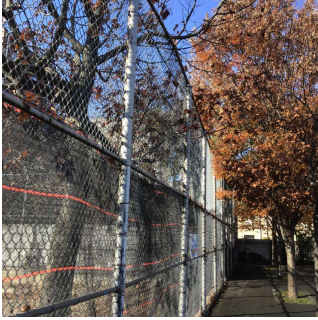
Violations	Schoolyard No violations recorded.
Deficiency	CHAIN LINK: DAMAGED/DETERIORATED
Deficiency Location/Instance	Schoolyard
Deficiency Quantity	100
Quantity Uom	S.F.
Potential Action	REPLACE
Urgency of Action	PRIORITY 3
Purpose of Action	LEVEL 2

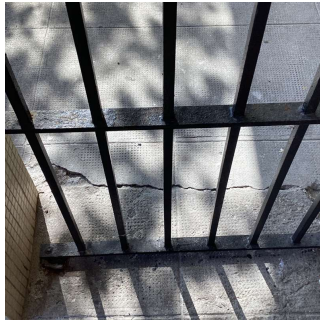
Violations	Schoolyard No violations recorded.
<b>IRRIGATION SYSTEM</b>	Does not Exist
<b>PAVING</b>	Inspected
<b>Student Non-Use</b>	Inspected
Gravel Exists?	No
<b>Asphalt</b>	Does not Exist
<b>Concrete</b>	Inspected
Condition	2 - Between Good and Fair
Deficiency	CRACKS - MAJOR
Deficiency Location/Instance	Near Exit 2
Deficiency Quantity	10
Quantity Uom	S.F.
Potential Action	REPLACE
Urgency of Action	PRIORITY 3
Purpose of Action	LEVEL 2
Deficiency Photo1

Violations	Near Exit 2 No violations recorded.
<b>Pavers</b>	Does not Exist
<b>Student Use</b>	Inspected
Gravel Exists?	No
<b>Asphalt</b>	Inspected
Condition	4 - Between Fair and Poor
Deficiency	CRACKS - MAJOR
Deficiency Location/Instance	Schoolyard
Deficiency Quantity	500
Quantity Uom	S.F.
Potential Action	REPLACE
Urgency of Action	PRIORITY 3

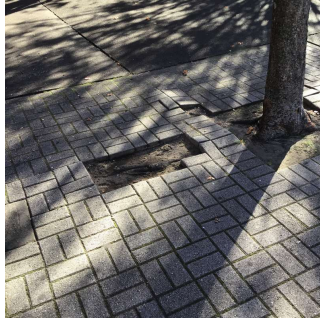
Question	Response
<b>SITE</b>	
<b>PAVING</b>	
<b>Student Use</b>	
<b>Pavers</b>	
Deficiency Photo1

Violations	Schoolyard No violations recorded.
Deficiency	HEAVING
Deficiency Location/Instance	Schoolyard
Deficiency Quantity	75
Quantity Uom	S.F.
Potential Action	REPLACE
Urgency of Action	PRIORITY 3
Purpose of Action	LEVEL 2
Deficiency Photo1

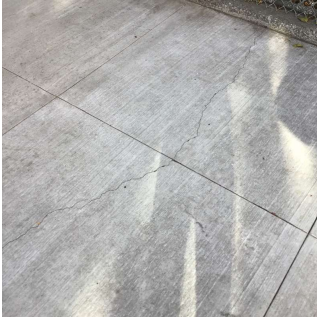
Violations	Schoolyard No violations recorded.
<b>Site Sidewalks &amp; Walkways</b>	Inspected
<b>Asphalt</b>	Does not Exist
<b>Concrete</b>	Inspected
Condition	4 - Between Fair and Poor
Deficiency	DAMAGED/DETERIORATED/MISSING SECTIONS
Deficiency Location/Instance	Near Mini School, Near Exit 5, Near Kosciuszko Street
Deficiency Quantity	500
Quantity Uom	S.F.
Potential Action	REPLACE
Urgency of Action	PRIORITY 3
Purpose of Action	LEVEL 2

Violations	Near Mini School No violations recorded.
<b>Pavers</b>	Does not Exist
<b>DOT Sidewalk</b>	Inspected
<b>Asphalt</b>	Does not Exist
<b>Concrete</b>	Inspected
Condition	4 - Between Fair and Poor
Deficiency	DAMAGED CURBS
Deficiency Location/Instance	Kosciuszko Street, Bushwick Avenue
Deficiency Quantity	110
Quantity Uom	L.F.
Potential Action	REPLACE
Urgency of Action	PRIORITY 3
Purpose of Action	LEVEL 2
Deficiency Photo1

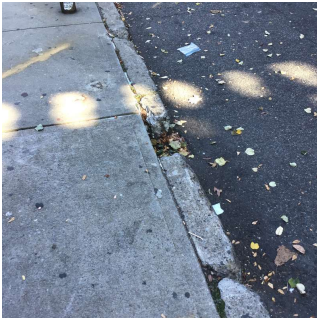
Violations	Kosciuszko Street No violations recorded.
Deficiency	DAMAGED/DETERIORATED/MISSING SECTIONS
Deficiency Location/Instance	Broadway, Kosciuszko Street, Bushwick Avenue
Deficiency Quantity	850
Quantity Uom	S.F.
Potential Action	REPLACE
Urgency of Action	PRIORITY 3
Purpose of Action	LEVEL 2

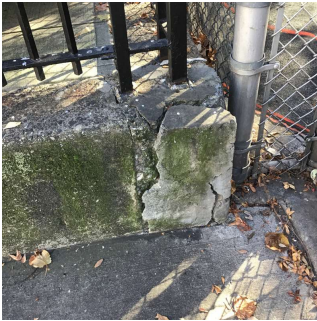
Violations	Broadway No violations recorded.
<b>Pavers</b>	Does not Exist
<b>PLAYGROUNDS</b>	Inspected
Instance on Schoolyard	Under Construction
<b>PLAYING SURFACE</b>	Inspected
<b>Playing Field</b>	Inspected
Instance on Schoolyard	Inspected
Instance Condition	1 - Good
Deficiency	No deficiencies recorded
<b>Running Track</b>	Does not Exist
<b>RETAINING WALLS</b>	Inspected
Are there any Retaining Walls 6' OR higher facing public street/sidewalk?	No
Condition	2 - Between Good and Fair
Deficiency	CAST IN PLACE CONCRETE: CRACKS/SPALLING - MAJOR
Deficiency Location/Instance	Near Kosciuszko Street
Deficiency Quantity	20
Quantity Uom	S.F.
Potential Action	REPLACE
Urgency of Action	PRIORITY 3
Purpose of Action	LEVEL 2
Deficiency Photo1

Violations	Near Kosciuszko Street No violations recorded.
<b>SEATING</b>	Inspected
