NYC Department of Education
Building Condition Assessment Survey 2023 - 2024

Architectural Inspection

Asset: **I.S. 281 - BROOKLYN, 8787 24 AVENUE, New York, 11214**

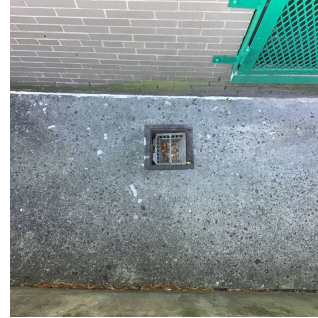
AW3

AREAWAY DRAINS: DETERIORATED

REPLACE
 PRIORITY 4
 LEVEL 2

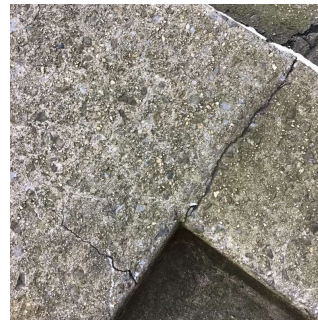
AW2

AREAWAY WALLS: CRACKS AND SPALLING

60
 S.F.
 REPLACE
 PRIORITY 4
 LEVEL 2

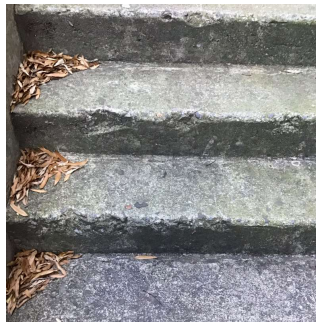
AW2
No violations recorded.

AREAWAY STAIRS: DETERIORATED TREADS/RISERS/NOSINGS

20
S.F.
REPLACE
PRIORITY 4
LEVEL 2

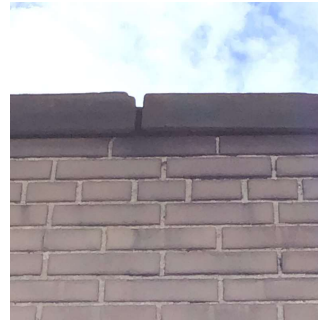
CHI

3 - Fair
BRICK: DETERIORATED CAP

10
L.F.
REPLACE
PRIORITY 4
LEVEL 2

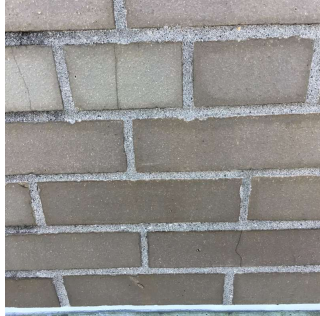
BRICK: MINOR CRACKS AND SPALLING

Question	Response
EXTERIOR	
CHIMNEY	
Potential Action	RESTITCH
Urgency of Action	PRIORITY 3
Purpose of Action	LEVEL 2
Deficiency Photo1

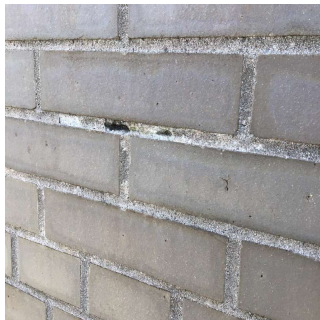
Violations	CH1 No violations recorded.
Deficiency	BRICK: DETERIORATED JOINTS
Roof Plan reference	K281

Deficiency Quantity	50
Quantity Uom	S.F.
Potential Action	REPOINT
Urgency of Action	PRIORITY 3
Purpose of Action	LEVEL 2
Deficiency Photo1

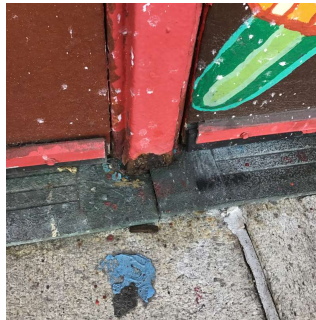
Facade A

Violations	CH1 No violations recorded.
COPING	Does not Exist
CORNICE	Does not Exist
DOORS	Inspected
DOORS AND FRAMES	Inspected
Condition	5 - Poor
Deficiency	METAL: DETERIORATED DOOR AND FRAME - MAJOR DETERIORATION

12
EACH
REPLACE
PRIORITY 4
LEVEL 2

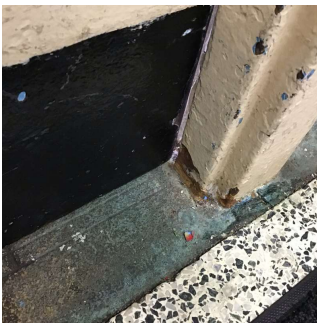
METAL: DETERIORATED DOOR AND FRAME - MINOR DETERIORATION

9
EACH
MAINTENANCE
PRIORITY 3
LEVEL 2

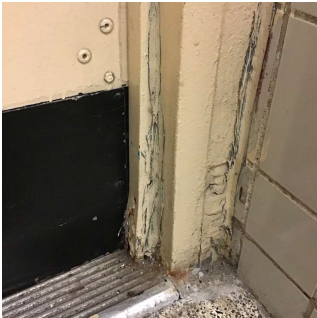
Violations	Facade A No violations recorded.
Deficiency	METAL CLAD: DETERIORATED DOOR AND FRAME - MAJOR DETERIORATION
Roof Plan reference	K281

Deficiency Quantity	2
Quantity Uom	EACH
Potential Action	REPLACE
Urgency of Action	PRIORITY 4
Purpose of Action	LEVEL 2
Deficiency Photo1

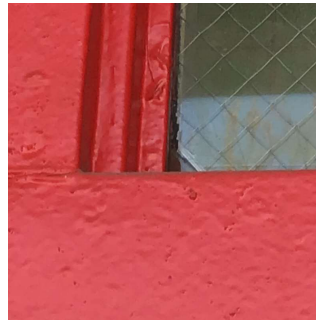
Facade A
No violations recorded.

Violations	Facade F No violations recorded.
DOOR HARDWARE	Inspected
Condition	3 - Fair
Deficiency	No deficiencies recorded
LINTELS	Inspected
Condition	2 - Between Good and Fair
Deficiency	No deficiencies recorded
TRANSOM/SIDE LIGHT	Inspected
Condition	3 - Fair
Deficiency	METAL: BROKEN GLASS

90
S.F.
MAINTENANCE
PRIORITY 3
LEVEL 2

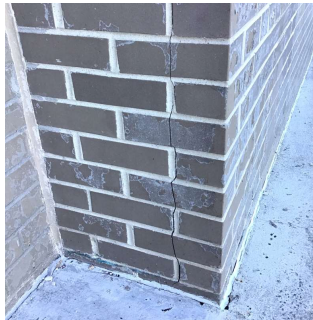
Facade B

BRICK: MAJOR / THRU CRACKS
K281

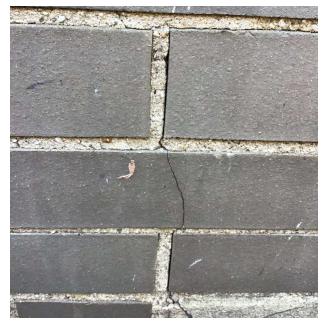
Facade H

BRICK: MINOR CRACKS AND SPALLING

PRIORITY 3

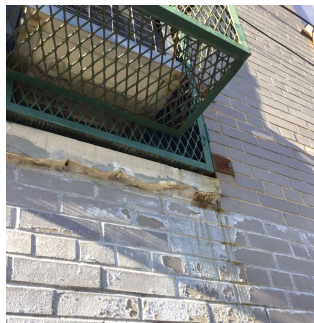
Facade C

BRICK: DETERIORATED MASONRY SILLS - MAJOR

REMOVE AND REPLACE

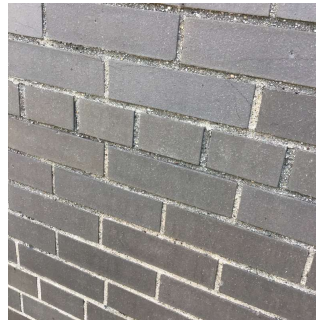
Facade A

BRICK: DETERIORATED JOINTS

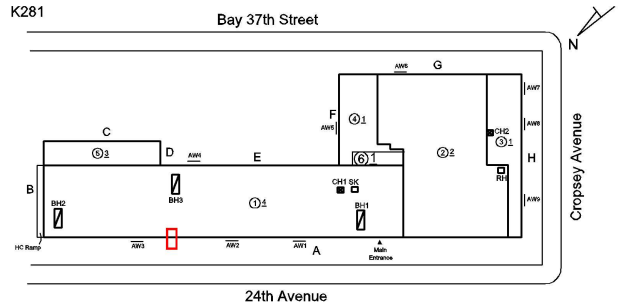
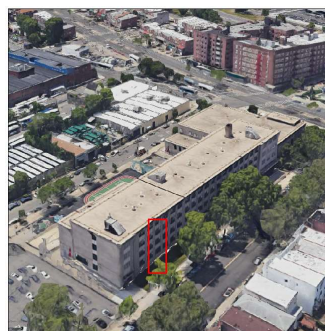
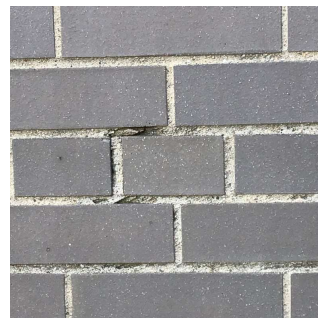
Facade A

BRICK: DETERIORATED CONTROL/EXPANSION JOINTS

20

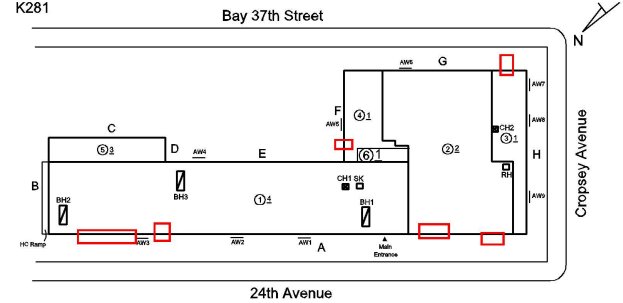
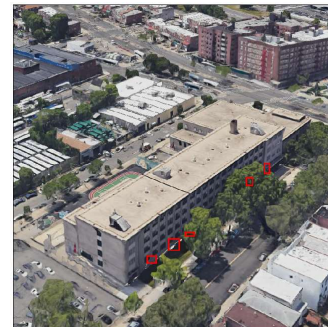
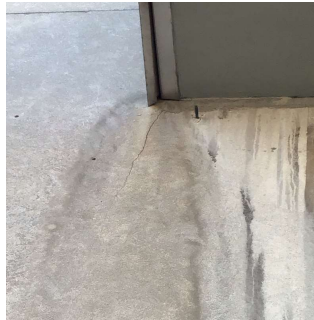
Facade A

BRICK: DETERIORATED JOINTS

200

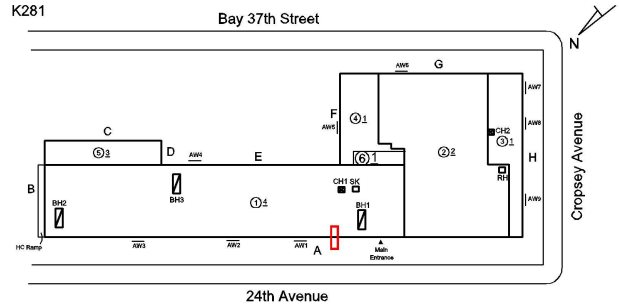
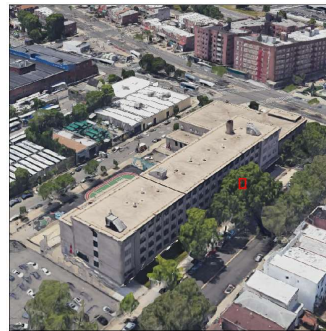
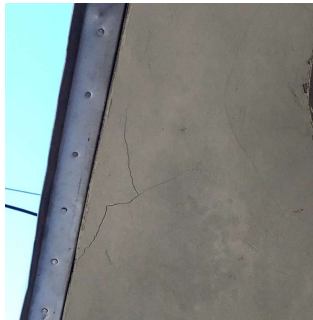
Facade A

STONE: CHIPPED/SPALLED/BROKEN PIECES - MINOR

10

REPAIR

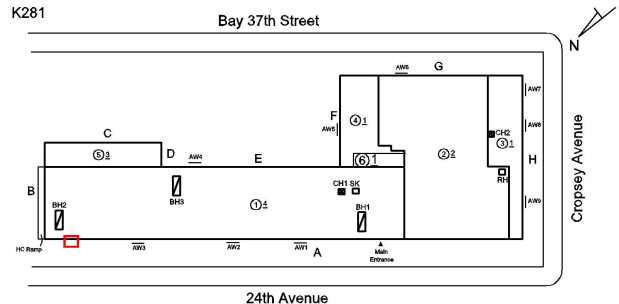
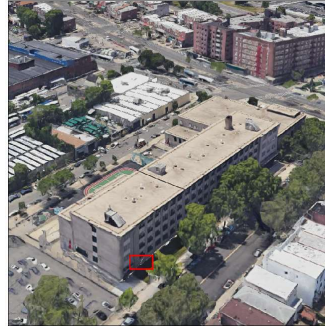
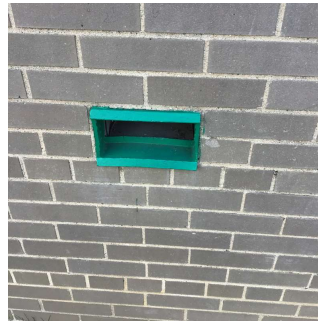
Facade A

CONCRETE: DETERIORATED

10

REPLACE

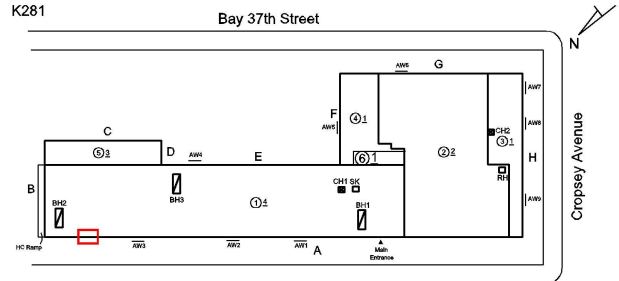
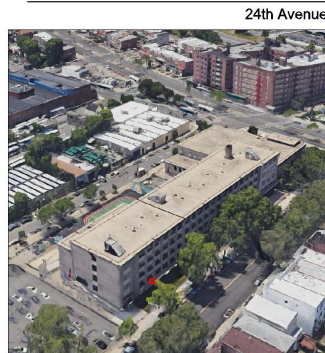
MISSING/DAMAGED SCREEN

10

S.F.
REPLACE
PRIORITY 4
LEVEL 2

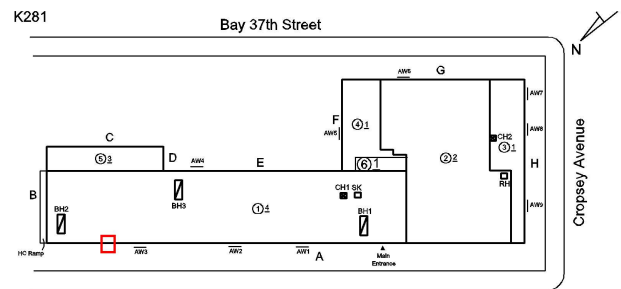
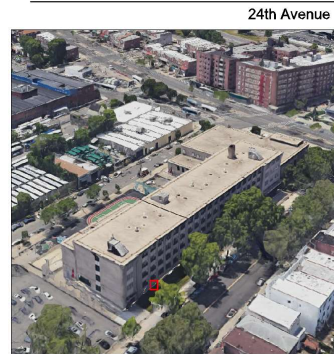
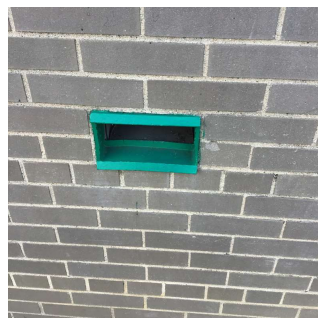
BROKEN/ DENTED BLADES

10
S.F.
REPLACE
PRIORITY 4
LEVEL 2

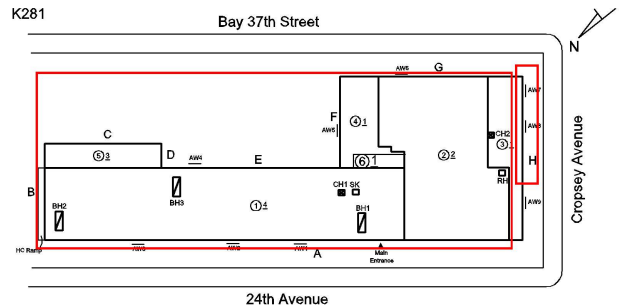
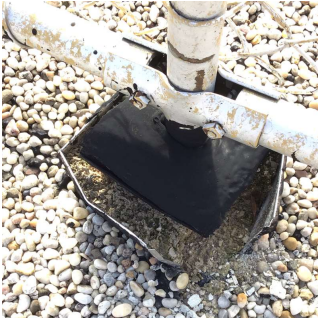
Deficiency	BUILT-UP: FLASHING: PITCH POCKET DETERIORATED - MAJOR
Roof Plan reference

Deficiency Quantity	170
---------------------	-----

Question	Response
EXTERIOR	
ROOF	
Roofing	
ROOFING	
Quantity Uom	EACH
Potential Action	REPLACE
Urgency of Action	PRIORITY 4
Purpose of Action	LEVEL 2
Deficiency Photo1

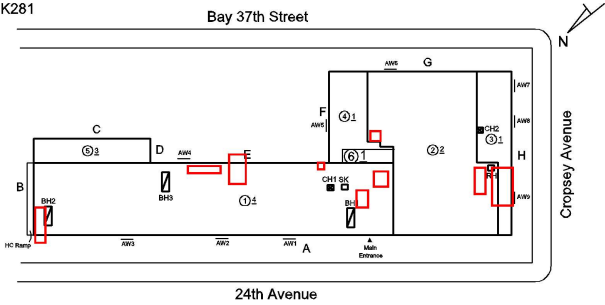
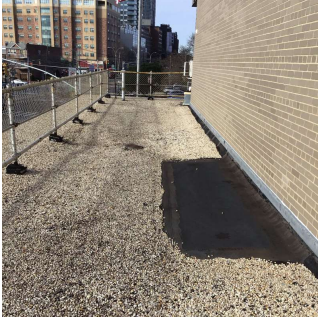
Violations	Roof 3 No violations recorded.
Deficiency	BUILT-UP: ROOFING: LOSS OF GRAVEL
Roof Plan reference	K281

Bay 37th Street 24th Avenue Cropsey Avenue
Deficiency Quantity	100
Quantity Uom	S.F.
Potential Action	INSTALL NEW GRAVEL
Urgency of Action	PRIORITY 3
Purpose of Action	LEVEL 2
Deficiency Photo1

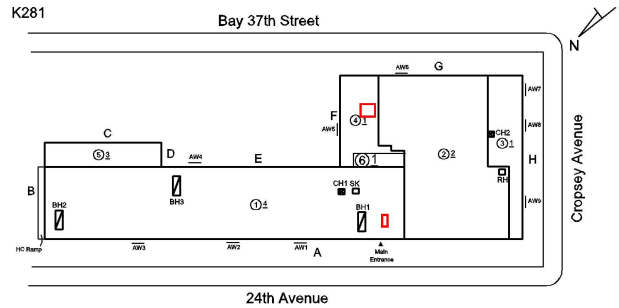
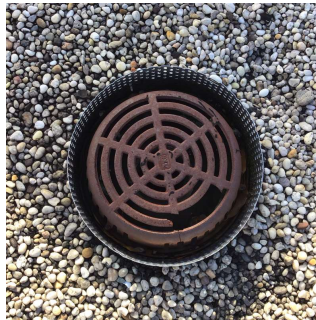
Roof 1
 No violations recorded.

Violations	Roof 3 No violations recorded.
ROOFING DRAINS	
Condition	Inspected 4 - Between Fair and Poor
Deficiency	DETERIORATED

2
 EACH
 REPLACE
 PRIORITY 4
 LEVEL 2

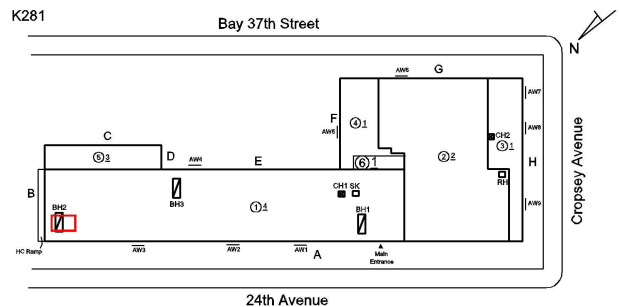
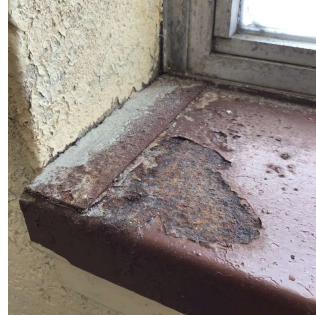
BH2

BULKHEAD/PENTHOUSE WINDOWS: AIR/WATER INFILTRATION WITH DAMAGED TRIM OR SILLS

30
 L.F.
 MAINTENANCE
 PRIORITY 3
 LEVEL 2

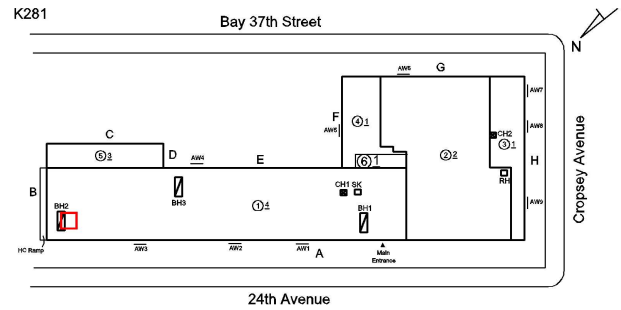
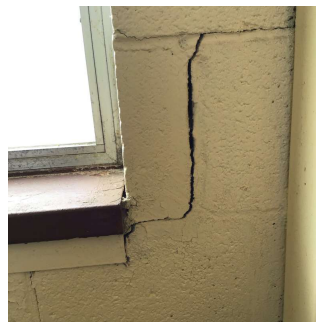
BH2

**BULKHEAD/PENTHOUSE WALLS/INTERIOR: CMU
CRACKS/SPALLING**

10

REPLACE

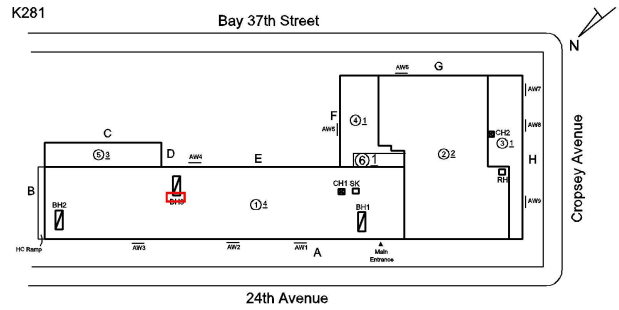
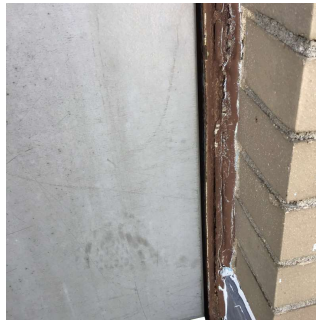
BH3
No violations recorded.

**BULKHEAD/PENTHOUSE DOORS: DETERIORATED DOOR
AND FRAME**

1
EACH
REPLACE DOOR AND FRAME
PRIORITY 4
LEVEL 2

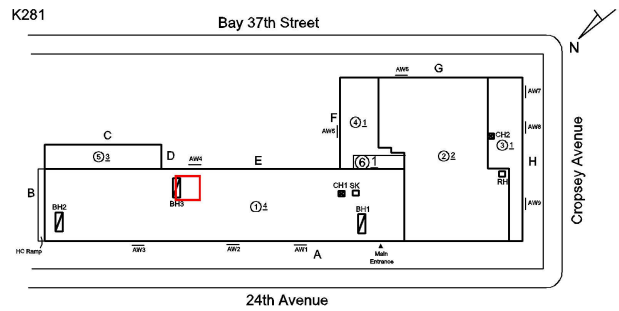
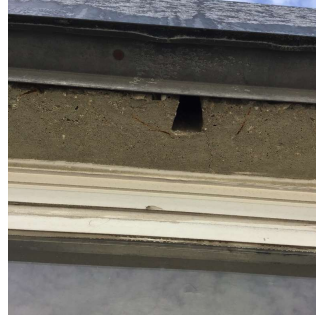
BH3

BULKHEAD/PENTHOUSE ROOF: DETERIORATED

10
S.F.
REPLACE
PRIORITY 4
LEVEL 2

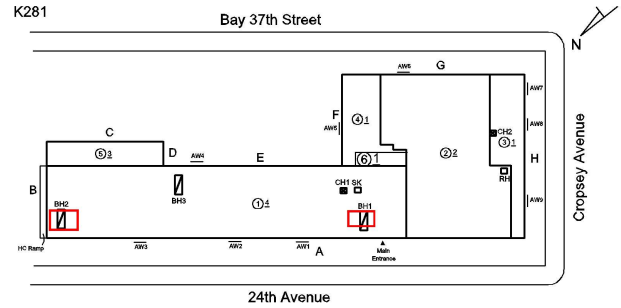
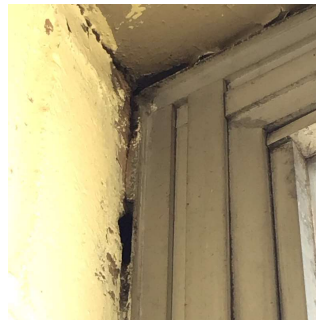
BH1

BULKHEAD/PENTHOUSE WINDOWS: AIR/WATER INFILTRATION WITH DAMAGED CAULKING

120

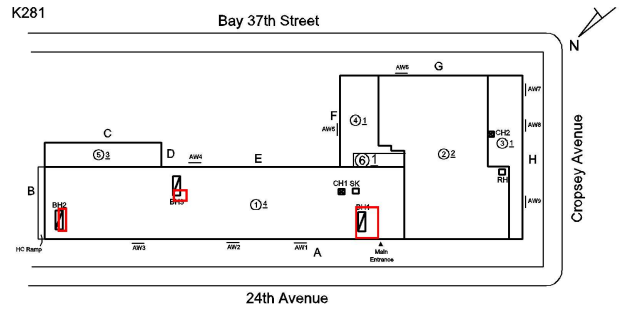
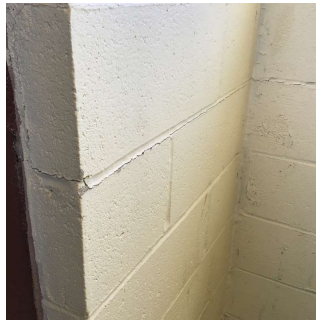
BH1

BULKHEAD/PENTHOUSE WALLS/INTERIOR: CMU DETERIORATED JOINTS

30
S.F.
REPOINT
PRIORITY 3
LEVEL 2

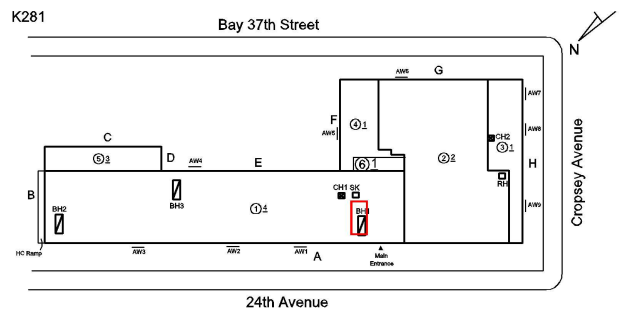
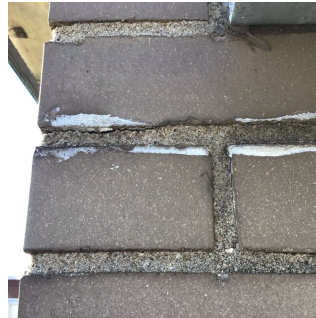
BH1

BULKHEAD/PENTHOUSE WALLS/EXTERIOR: DETERIORATED JOINTS

30
S.F.
REPOINT
PRIORITY 4
LEVEL 2

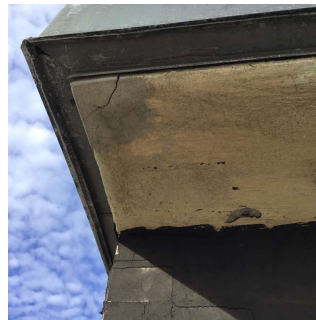
BH2

BULKHEAD/PENTHOUSE ROOF: DETERIORATED

REPAIR

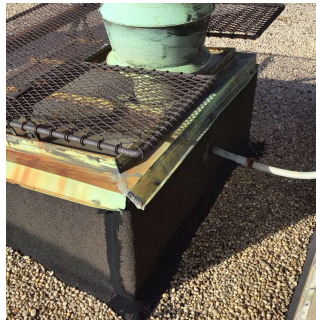
SK
 No violations recorded.

BROKEN FRAMING

SKYLIGHT/ROOF VENT

10
 L.F.
 MAINTENANCE
 PRIORITY 3
 LEVEL 2

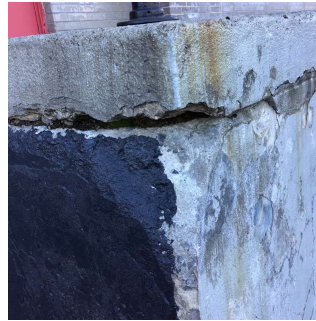
Facade B

CAST IN PLACE CONCRETE: CRACKS/SPALLING - MAJOR

10
 S.F.
 REPLACE
 PRIORITY 4
 LEVEL 2

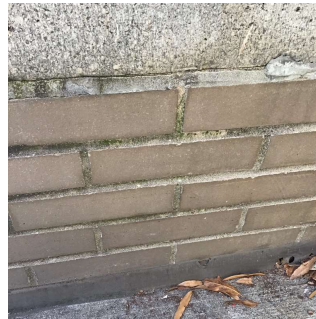
Facade G

BRICK: DETERIORATED JOINTS

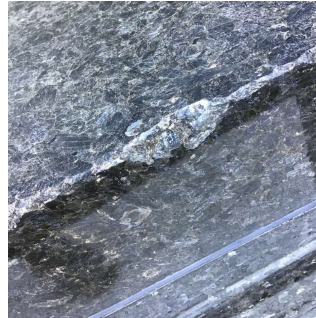
Facade A

STONE: CRACKS/SPALLING - MINOR

Quantity Uom	S.F.
Potential Action	REPAIR
Urgency of Action	PRIORITY 3
Purpose of Action	LEVEL 2
Deficiency Photo1

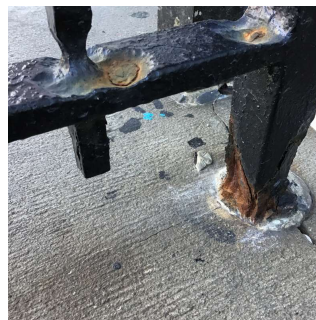
Facade A

RUST - MAJOR

REPLACE

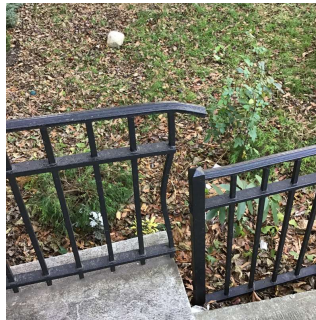
DAMAGED

RAILINGS

Facade A
No violations recorded.

20
L.F.
REPLACE
PRIORITY 4
LEVEL 2

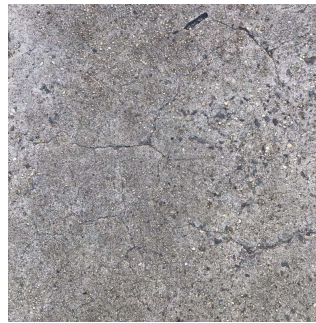
Facade H

CONCRETE: CRACKS/SPALLING - MINOR

20
S.F.
REPAIR
PRIORITY 3
LEVEL 2

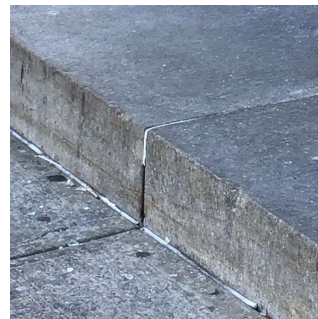
Facade A

STONE: DETERIORATED JOINTS

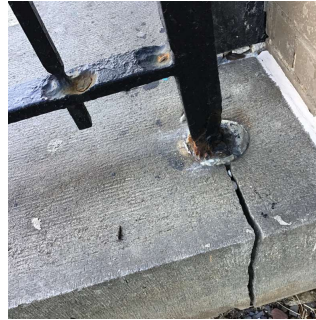
Facade A

STONE: CRACKS/SPALLING - MAJOR

S.F.
REPLACE
PRIORITY 4
LEVEL 2

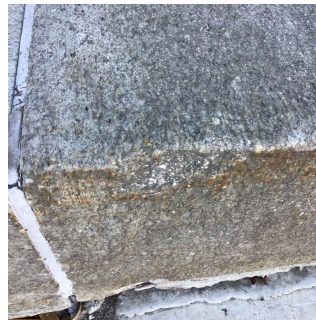
Facade A

STONE: CRACKS/SPALLING - MINOR

S.F.
REPAIR
PRIORITY 3
LEVEL 2

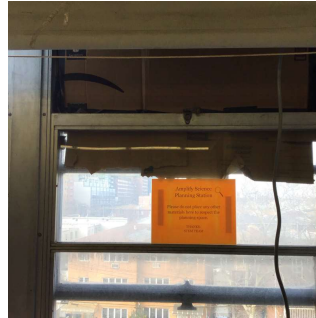
Facade A, Room 441

ALUMINUM - DOUBLE HUNG: BROKEN PANE

60
S.F.
MAINTENANCE
PRIORITY 3
LEVEL 2

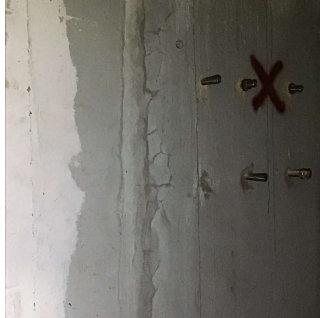
2nd Floor - Fan Room 2
Violations	No violations recorded.
VAULTS-BUNKERS	
	Inspected
Foundation Walls	Inspected
Condition	3 - Fair
Deficiency	CRACKS, SPALLING
Deficiency Location/Instance	Basement - Vault
Deficiency Quantity	10
Quantity Uom	S.F.
Potential Action	REPAIR
Urgency of Action	PRIORITY 4
Purpose of Action	LEVEL 5

Violations	Basement - Vault No violations recorded.
Slab Structure	Inspected
Condition	2 - Between Good and Fair
Deficiency	No deficiencies recorded
Vault/Ash Hoist Doors and Framing	Does not Exist
AUDITORIUM	
Instance on 1st Floor (616 Seats)	Inspected
Ceiling	
Instance on 1st Floor (616 Seats)	Inspected
Condition	1 - Good
Deficiency	No deficiencies recorded
Door(s)	
Instance on 1st Floor (616 Seats)	Inspected
Condition	2 - Between Good and Fair
Deficiency	No deficiencies recorded
Fixed H/C Lift	
Instance on 1st Floor (616 Seats)	Does not Exist
Fixed Seating	
Instance on 1st Floor (616 Seats)	Inspected
Condition	1 - Good
Deficiency	No deficiencies recorded
Floor Finish	
Instance on 1st Floor (616 Seats)	Inspected
Condition	2 - Between Good and Fair
Deficiency	VINYL TILES: BROKEN/DETERIORATED/MISSING TILES
Deficiency Location/Instance	Left Side Backstage Room

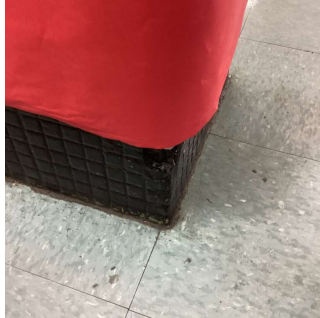
Question	Response
INTERIOR	
CAFETERIA	
Floor Finish	
Quantity Uom	S.F.
Potential Action	REPLACE
Urgency of Action	PRIORITY 3
Purpose of Action	LEVEL 2
Deficiency Photo1	 
	Near Kitchen
Violations	No violations recorded.
Deficiency	CERAMIC TILE: BROKEN/MISSING TILES
Deficiency Location/Instance	Near fridges
Deficiency Quantity	10
Quantity Uom	S.F.
Potential Action	REPLACE
Urgency of Action	PRIORITY 3
Purpose of Action	LEVEL 2
Deficiency Photo1	 
	Near fridges
Violations	No violations recorded.
Sliding-folding Partition	
Instance on Basement - Staff (1000 SF)	Does not Exist
Instance on Basement - Students	Does not Exist
Stage	
Instance on Basement - Students	Does not Exist
Instance on Basement - Staff (1000 SF)	Does not Exist
Walls	
Instance on Basement - Students	Inspected
Condition	2 - Between Good and Fair
Deficiency	CERAMIC TILE: BROKEN/ MISSING
Deficiency Location/Instance	Columns
Deficiency Quantity	30
Quantity Uom	S.F.

Violations	Column No violations recorded.
Deficiency	MASONRY: CRACKS/SPALLING
Deficiency Location/Instance	Near Stair G/Basement, by Windows
Deficiency Quantity	20
Quantity Uom	S.F.
Potential Action	REPLACE
Urgency of Action	PRIORITY 3
Purpose of Action	LEVEL 2
Deficiency Photo1

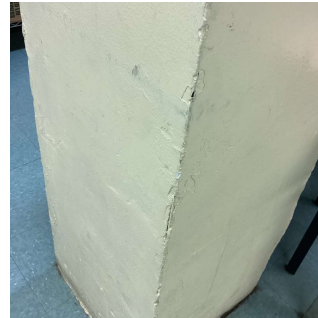
Column

PLASTER: CRACKS/SPALLING

REPLACE

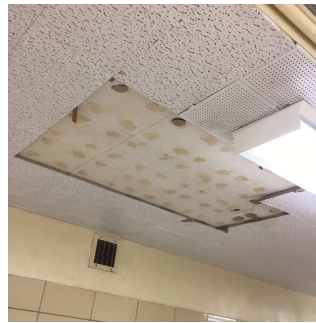
Corridor near Cafeteria

ACOUSTIC TILES ON PLASTER: DAMAGED/MISSING

REPLACE

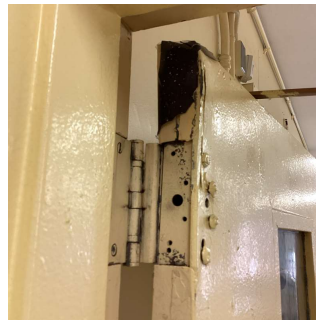
Room 309

METAL: DETERIORATED DOOR

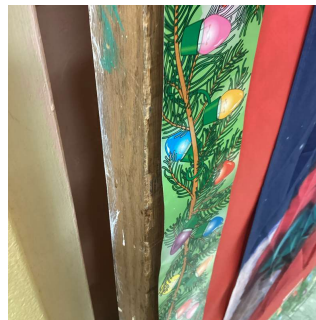
Deficiency

WOOD: DETERIORATED DOOR

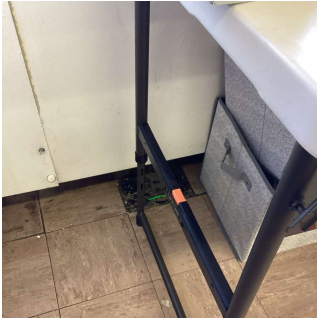
Room 441
Violations	No violations recorded.
Deficiency	TERRAZZO: CRACKS
Deficiency Location/Instance	Corridor near Room 152
Deficiency Quantity	10
Quantity Uom	S.F.
Potential Action	REPLACE
Urgency of Action	PRIORITY 3
Purpose of Action	LEVEL 2
Deficiency Photo1

Question	Response
INTERIOR	
CLASSROOMS/CORRIDORS/ADMIN SPACES	
Door(s)	Inspected
	Room 140
Violations	No violations recorded.
Floor Finish	Inspected
Condition	2 - Between Good and Fair
Deficiency	VINYL TILES: BROKEN/DETERIORATED/MISSING TILES
Deficiency Location/Instance	Rooms 441,317,209,109,111 and others
Deficiency Quantity	60
Quantity Uom	S.F.
Potential Action	REPLACE
Urgency of Action	PRIORITY 3
Purpose of Action	LEVEL 2
Deficiency Photo1

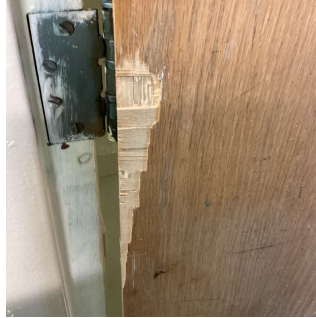
Room 154

Question	Response
INTERIOR	
CLASSROOMS/CORRIDORS/ADMIN SPACES	
Walls	
Potential Action	REPLACE
Urgency of Action	PRIORITY 3
Purpose of Action	LEVEL 2
Deficiency Photo1	 
	Corridor near Stair H/Basement
Violations	No violations recorded.
Deficiency	GLAZED BLOCK: CRACKS/SPALLING
Deficiency Location/Instance	Corridor near Stairs C/4, E/1, by Gymnasium
Deficiency Quantity	30
Quantity Uom	S.F.
Potential Action	REPLACE
Urgency of Action	PRIORITY 3
Purpose of Action	LEVEL 2
Deficiency Photo1	 
	Corridor near Stair E/1
Violations	No violations recorded.
Specialties	Does not Exist
GYMNASIUM	Inspected
Instance on 1st Floor	Inspected
Ceiling	
Instance on 1st Floor	Inspected
Condition	2 - Between Good and Fair
Deficiency	No deficiencies recorded
Door(s)	
Instance on 1st Floor	Inspected
Condition	5 - Poor
Deficiency	WOOD: DETERIORATED DOOR
Deficiency Location/Instance	Rooms 170,156,154, Main Entrance, Storage Room
Deficiency Quantity	6

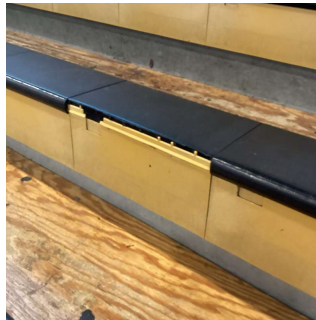
Inspected
3 - Fair
DAMAGED BLEACHERS
Near Windows
220
S.F.
REPLACE
PRIORITY 3
LEVEL 2

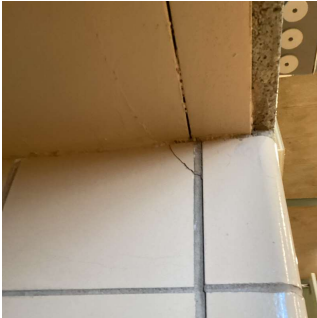
Question	Response
INTERIOR	
GYMNASIUM	
Stage	
Instance on 1st Floor	Does not Exist
Walls	
Instance on 1st Floor	Inspected
Condition	2 - Between Good and Fair
Deficiency	GLAZED BLOCK: CRACKS/SPALLING
Deficiency Location/Instance	Near Girls Locker Room
Deficiency Quantity	10
Quantity Uom	S.F.
Potential Action	REPLACE
Urgency of Action	PRIORITY 3
Purpose of Action	LEVEL 2
Deficiency Photo1

Near Girls Locker Room
Violations	No violations recorded.
Deficiency	MASONRY: CRACKS/SPALLING
Deficiency Location/Instance	Room 170, near Windows
Deficiency Quantity	20
Quantity Uom	S.F.
Potential Action	REPLACE
Urgency of Action	PRIORITY 3
Purpose of Action	LEVEL 2
Deficiency Photo1

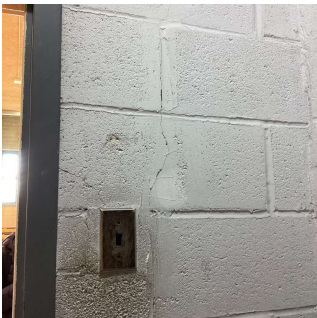
Room 170
Violations	No violations recorded.
Window Curtains/Shades/Blinds	
Instance on 1st Floor	Does not Exist
INTERIOR DOOR HARDWARE	
Instance on 1st Floor	Inspected
Condition	3 - Fair
Deficiency	No deficiencies recorded
INTERIOR GUARDS	
Instance on 1st Floor	Inspected

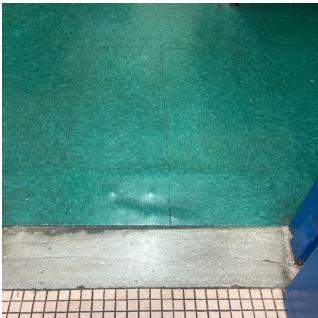
Violations	Left Side Served area No violations recorded.
Floor Finish	
Instance on Basement	Inspected
Condition	3 - Fair
Deficiency	VINYL TILES: DETERIORATED SUBSTRATE
Deficiency Location/Instance	Office Room
Deficiency Quantity	10
Quantity Uom	S.F.
Potential Action	REPLACE
Urgency of Action	PRIORITY 3
Purpose of Action	LEVEL 2

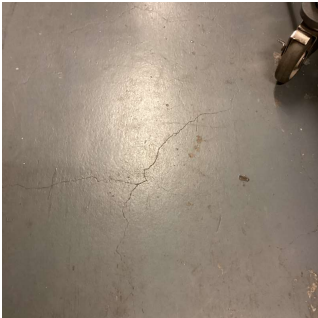
Question	Response
INTERIOR	
KITCHEN	Inspected
Floor Finish	
Violations	No violations recorded.
Deficiency	CONCRETE: CRACKS
Deficiency Location/Instance	Storage Room
Deficiency Quantity	10
Quantity Uom	S.F.
Potential Action	REPLACE
Urgency of Action	PRIORITY 3
Purpose of Action	LEVEL 2
Deficiency Photo1

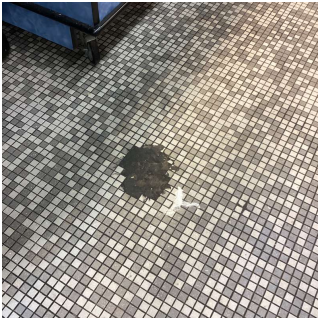
Violations	No violations recorded.
Deficiency	CERAMIC TILE: BROKEN/MISSING TILES
Deficiency Location/Instance	Servery, Left Side Servery area, near Exit - Vestibule
Deficiency Quantity	40
Quantity Uom	S.F.
Potential Action	REPLACE
Urgency of Action	PRIORITY 3
Purpose of Action	LEVEL 2
Deficiency Photo1

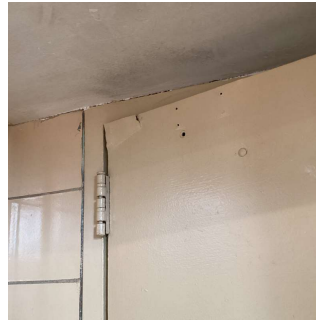
Office Room
Violations	No violations recorded.
Floor Finish	
Instance on Room 234	Inspected
Condition	2 - Between Good and Fair
Deficiency	No deficiencies recorded
Walls	
Instance on Room 234	Inspected
Condition	2 - Between Good and Fair
Deficiency	No deficiencies recorded
LOCKER ROOM	
	Inspected
Instance on 1st Floor - Boys (152 Lockers)	Inspected
Alternative use	No
Instance on 1st Floor - Girls (154 Lockers)	Inspected
Alternative use	No
Ceiling	
Instance on 1st Floor - Boys (152 Lockers)	Inspected
Condition	2 - Between Good and Fair
Deficiency	No deficiencies recorded
Instance on 1st Floor - Girls (154 Lockers)	Inspected
Condition	2 - Between Good and Fair
Deficiency	No deficiencies recorded
Door(s)	
Instance on 1st Floor - Boys (152 Lockers)	Inspected
Condition	3 - Fair
Deficiency	METAL: DETERIORATED DOOR

Deficiency Location/Instance	Main Entrance
Deficiency Quantity	1
Quantity Uom	EACH
Potential Action	MAINTENANCE
Urgency of Action	PRIORITY 3
Purpose of Action	LEVEL 2

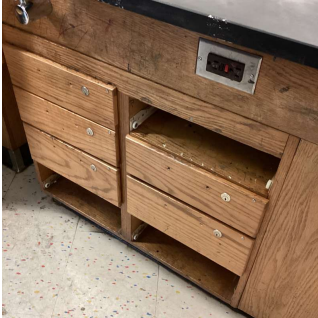
Question	Response
INTERIOR	
SCIENCE LAB	
Fixed Equipment	
Instance on Rooms 214,113,109	Inspected
Condition	3 - Fair
Deficiency	CABINETS: MISSING/DAMAGED
Deficiency Location/Instance	Rooms 214,113,109
Deficiency Quantity	46
Quantity Uom	L.F.
Potential Action	REPLACE
Urgency of Action	PRIORITY 3
Purpose of Action	LEVEL 2
Deficiency Photo1

Violations	Room 214 No violations recorded.
SCIENCE PREP ROOM	
Instance on Room 111	Inspected
Alternative use	No
Fixed Equipment	
Instance on Room 111	Inspected
Condition	2 - Between Good and Fair
Deficiency	No deficiencies recorded
SHOWER ROOM	
Instance on 1st Floor - Boys	Inaccessible
Instance on 1st Floor - Girls	Inaccessible
STAIRS/RAMPS: INTERIOR	
Do Letter Stair Signs Exist?	Yes
Ceiling	
Condition	2 - Between Good and Fair
Deficiency	PLASTER: CRACKS/SPALLING
Deficiency Location/Instance	Stair D/4
Deficiency Quantity	10
Quantity Uom	S.F.
Potential Action	REPLACE
Urgency of Action	PRIORITY 3

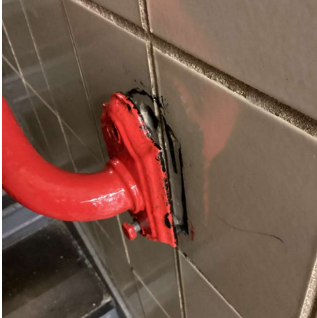
Question	Response
INTERIOR	
STAIRS/RAMPS: INTERIOR	
Door(s)	Inspected
	Stair E/Basement
Violations	No violations recorded.
Partition	Does not Exist
Railings	Inspected
Condition	3 - Fair
Deficiency	METAL: BROKEN BRACKET
Deficiency Location/Instance	Stair E/Basement
Deficiency Quantity	1
Quantity Uom	EACH
Potential Action	REPLACE
Urgency of Action	PRIORITY 3
Purpose of Action	LEVEL 2
Deficiency Photo1

Stair E/Basement
Violations	No violations recorded.
Stairs and Landings	Inspected
Condition	3 - Fair
Deficiency	STONE: WORN-OUT TREAD/NOSINGS
Deficiency Location/Instance	Stairs E/Basement,1
Deficiency Quantity	140
Quantity Uom	S.F.
Potential Action	REPLACE
Urgency of Action	PRIORITY 3
Purpose of Action	LEVEL 2
Deficiency Photo1

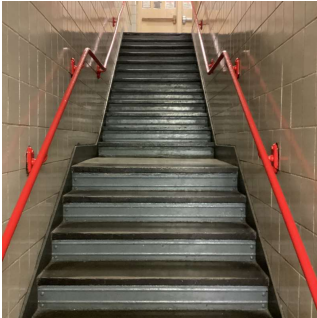
Stair E/Basement
Violations	No violations recorded.
Deficiency	VINYL TILES: BROKEN/DETERIORATED/MISSING TILES
Deficiency Location/Instance	Stairs B/2, C/4,3, D/2, Left side Auditorium Stair and others

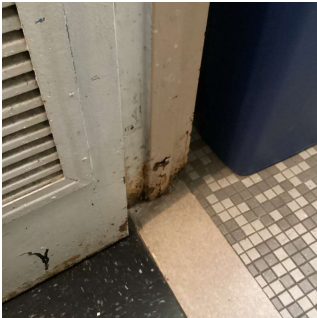
Violations	Room 241 No violations recorded.
Deficiency	METAL: DETERIORATED DOOR AND FRAME

Deficiency Location/Instance	In Kitchen Locker Room

Question	Response
INTERIOR	
TOILET ROOMS - STAFF	
Door(s)	
Deficiency Quantity	1
Quantity Uom	EACH
Potential Action	MAINTENANCE
Urgency of Action	PRIORITY 3
Purpose of Action	LEVEL 2
Deficiency Photo1

In Kitchen Locker Room
Violations	No violations recorded.
Floor Finish	Inspected
Condition	2 - Between Good and Fair
Deficiency	No deficiencies recorded
Stalls	Inspected
Condition	5 - Poor
Deficiency	RUST - MAJOR
Deficiency Location/Instance	In Kitchen Locker Room, Rooms 345,310,242,241
Deficiency Quantity	5
Quantity Uom	EACH
Potential Action	REPLACE
Urgency of Action	PRIORITY 3
Purpose of Action	LEVEL 2
Deficiency Photo1

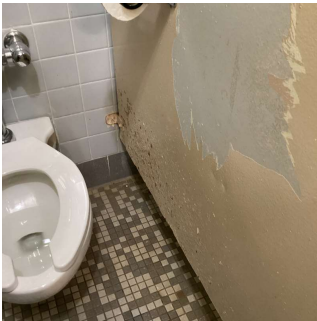
In Kitchen Locker Room
Violations	No violations recorded.
Walls	Inspected
Condition	2 - Between Good and Fair
Deficiency	PLASTER: CRACKS/SPALLING
Deficiency Location/Instance	In Kitchen Locker Room, Room 345, In Auditorium Right Side Backstage Room
Deficiency Quantity	30
Quantity Uom	S.F.
Potential Action	REPLACE

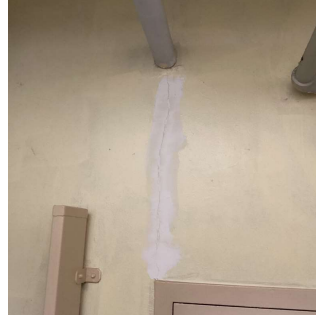
In Kitchen Locker Room
No violations recorded.

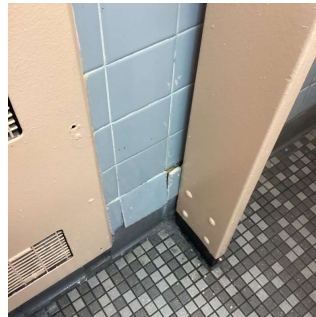
Room 345
No violations recorded.

Deficiency	CERAMIC TILE: BROKEN/ MISSING
Deficiency Location/Instance	Rooms 345,310,242, In Auditorium Right and Left Side Backstage Rooms
Deficiency Quantity	50
Quantity Uom	S.F.
Potential Action	REPLACE
Urgency of Action	PRIORITY 3
Purpose of Action	LEVEL 2
Deficiency Photo1

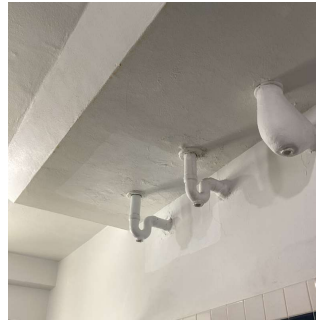
Deficiency	PLASTER: CRACKS/SPALLING
Deficiency Location/Instance	Room 118
Deficiency Quantity	10
Quantity Uom	S.F.
Potential Action	REPLACE
Urgency of Action	PRIORITY 3
Purpose of Action	LEVEL 2

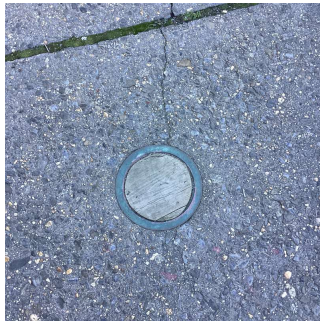
Girls Toilet Room - Basement
Violations	No violations recorded.
LIFE SAFETY	Inspected
F.D. HOLDING AREA	Does not Exist
STEEL STAIRS	Does not Exist
SITE	Inspected
CONTAINERIZATION	Does not Exist
Drainage System for Asphalt	Inspected
Catch Basins/Manhole - Surrounded by asphalt	Inspected
Condition	2 - Between Good and Fair
Deficiency	No deficiencies recorded
Culverts - Asphalt Covering	Does not Exist
Drainage System for Concrete	Inspected
Catch Basins/Manhole - Surrounded by concrete	Inspected
Condition	3 - Fair
Deficiency	DAMAGED COVER
Deficiency Location/Instance	24th Avenue
Deficiency Quantity	1
Quantity Uom	EACH
Potential Action	REPLACE
Urgency of Action	PRIORITY 3
Purpose of Action	LEVEL 2
Deficiency Photo1

24th Avenue
Violations	No violations recorded.
Culverts - Concrete Covering	Does not Exist
Drainage System for Soil	Does not Exist

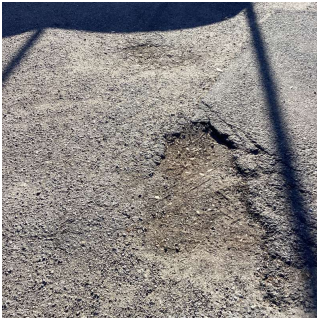
Question	Response
SITE	
IRRIGATION SYSTEM	Does not Exist
PAVING	Inspected
Student Non-Use	Inspected
Gravel Exists?	No
Asphalt	Inspected
Condition	4 - Between Fair and Poor
Deficiency	POTHOLES
Deficiency Location/Instance	37th Street, near Exit 9
Deficiency Quantity	30
Quantity Uom	S.F.
Potential Action	REPAIR
Urgency of Action	PRIORITY 3
Purpose of Action	LEVEL 2
Deficiency Photo1

37th Street	
Violations	No violations recorded.
Deficiency	CRACKS - MAJOR
Deficiency Location/Instance	37th Street
Deficiency Quantity	2,500
Quantity Uom	S.F.
Potential Action	REPLACE
Urgency of Action	PRIORITY 3
Purpose of Action	LEVEL 2
Deficiency Photo1

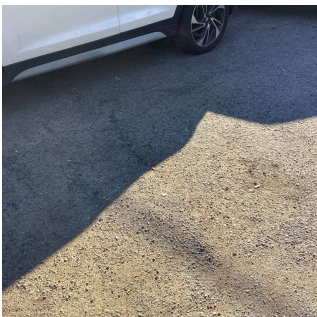
37th Street	
Violations	No violations recorded.
Concrete	Inspected
Condition	3 - Fair
Deficiency	DAMAGED/DETERIORATED/MISSING SECTIONS
Deficiency Location/Instance	Parking Lot
Deficiency Quantity	100
Quantity Uom	S.F.
Potential Action	REPLACE

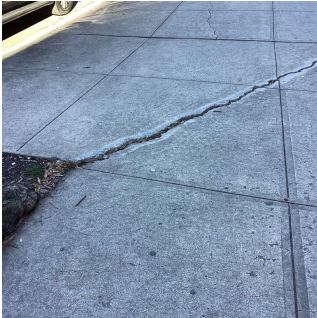
Question	Response
SITE	
PAVING	
DOT Sidewalk	
Concrete	
Deficiency Location/Instance	24th Avenue
Deficiency Quantity	100
Quantity Uom	S.F.
Potential Action	REPLACE
Urgency of Action	PRIORITY 5
Purpose of Action	LEVEL 6
Deficiency Photo1

Violations	24th Avenue No violations recorded.
Deficiency	DAMAGED CURBS
Deficiency Location/Instance	Cropsey Avenue
Deficiency Quantity	50
Quantity Uom	L.F.
Potential Action	REPLACE
Urgency of Action	PRIORITY 3
Purpose of Action	LEVEL 2
Deficiency Photo1

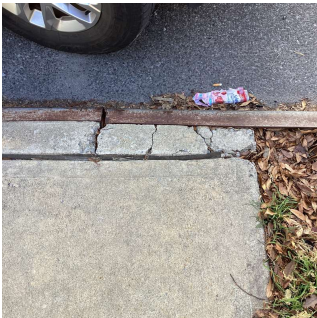
Violations	Cropsey Avenue No violations recorded.
Deficiency	HEAVING
Deficiency Location/Instance	24th Avenue, Bay 37th Street
Deficiency Quantity	150
Quantity Uom	S.F.
Potential Action	REPLACE
Urgency of Action	PRIORITY 3
Purpose of Action	LEVEL 2

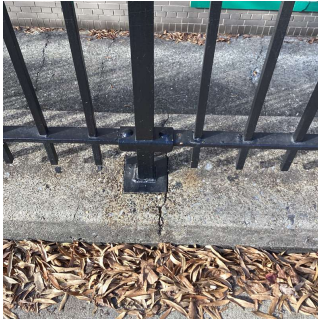
Question	Response
SITE	
RETAINING WALLS	
Deficiency Photo1

Violations	Bay 37th Street No violations recorded.
SEATING	Does not Exist
SITE WALLS (NOT RETAINING WALLS)	Does not Exist
STAIRS/RAMPS: EXTERIOR	Does not Exist
ARTWORK	Does not Exist
