NYC Department of Education
Building Condition Assessment Survey 2023 - 2024

Architectural Inspection

Asset: P.S. 282 - BROOKLYN, 180 6TH AVENUE, New York, 11217

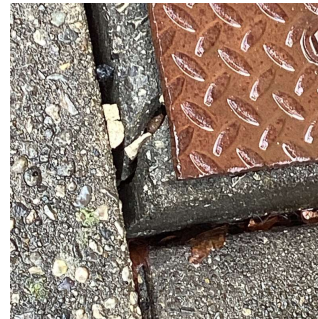
AW1

AREAWAY WALLS: CRACKS AND SPALLING

REPAIR

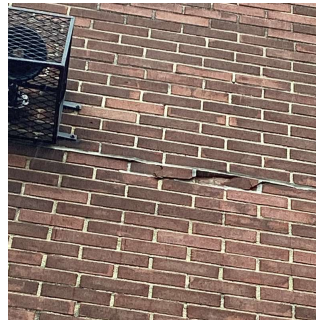
Facade H

BRICK: MAJOR / THRU CRACKS

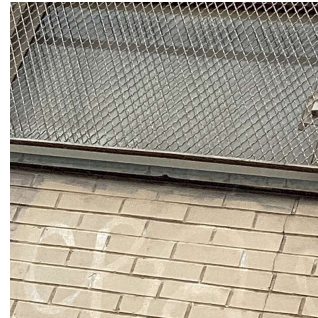
Facade E - Near HC Entrance

BRICK: DETERIORATED MASONRY SILLS - MINOR

REPAIR

PRIORITY 3
LEVEL 2

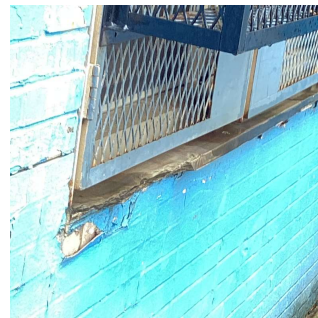
Facade D

BRICK: DETERIORATED MASONRY SILLS - MAJOR

REMOVE AND REPLACE

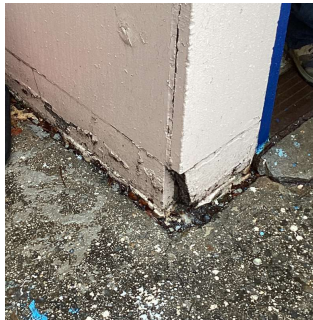
Facade A - Main Entrance

STONE: CHIPPED/SPALLED/BROKEN PIECES - MAJOR

REPLACE

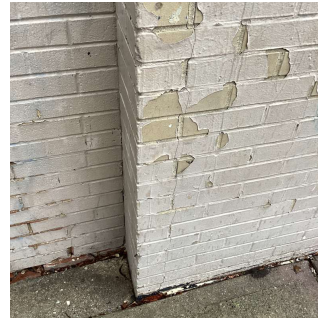
Facade B

BRICK: MINOR CRACKS AND SPALLING

PRIORITY 3
LEVEL 2

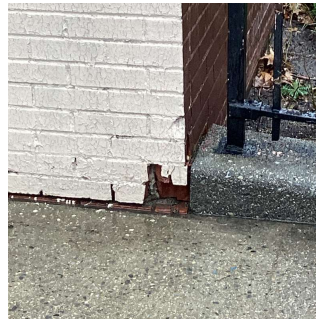
Corner of Facade H and Facade J

BRICK: CRACKS/DISPLACED/SPALLED BRICK AT BUILDING CORNERS

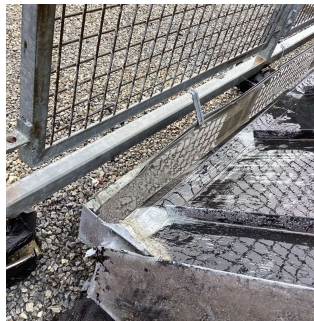
Roof 1 - BH3

Deficiency	DAMAGED/MISSING
------------	-----------------

REPLACE

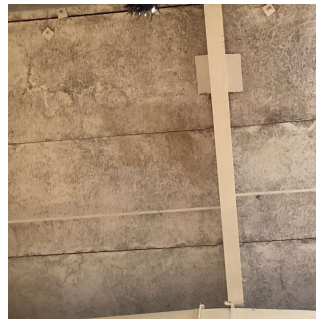
Roof 2 - Gymnasium (shown), Auditorium (similar)
No violations recorded.

Violations	Roof 1 - Near BH2 No violations recorded.
Deficiency	BUILT-UP: ROOFING: MAJOR ACTIVE ROOF LEAKS IN INSTRUCTIONAL SPACE

200
S.F.
REPLACE ROOFING WITHOUT MAJOR EQUIPMENT
REMOVAL
PRIORITY 5
LEVEL 2

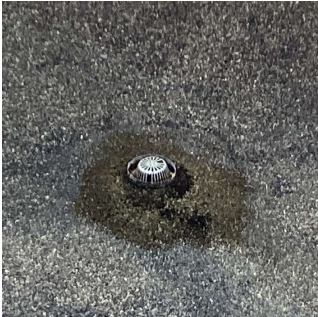
Question	Response
EXTERIOR	
ROOF	
Roofing	
ROOFING DRAINS	
Deficiency Photo1

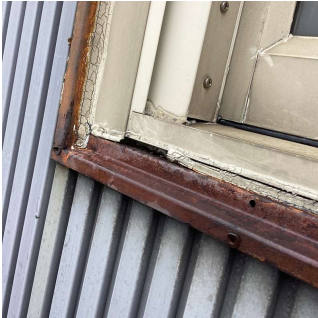
Violations	Roof 1 - BH2 No violations recorded.
Deficiency	BULKHEAD/PENTHOUSE WALLS/EXTERIOR: CRACKS/SPALLING - MINOR

Violations	Roof 3 No violations recorded.
Specialties	Inspected
BULKHEAD/PENTHOUSE	Inspected
Condition	3 - Fair
Deficiency	BULKHEAD/PENTHOUSE WINDOWS: AIR/WATER INFILTRATION WITH DAMAGED CAULKING
Roof Plan reference

Deficiency Quantity	30
Quantity Uom	L.F.
Potential Action	MAINTENANCE
Urgency of Action	PRIORITY 3
Purpose of Action	LEVEL 2
Deficiency Photo1

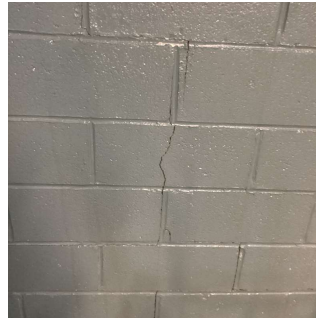
Roof 1 - BH2

Deficiency **BULKHEAD/PENTHOUSE WALLS/INTERIOR: CMU CRACKS/SPALLING**

40
S.F.
REPLACE
PRIORITY 4
LEVEL 2

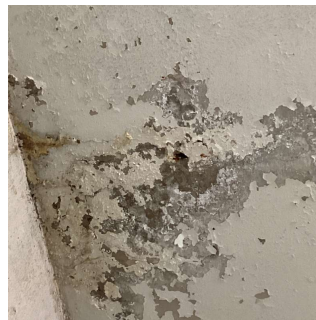
Roof 1 - BH1

BULKHEAD/PENTHOUSE CEILING: PLASTER DAMAGED/DETERIORATED

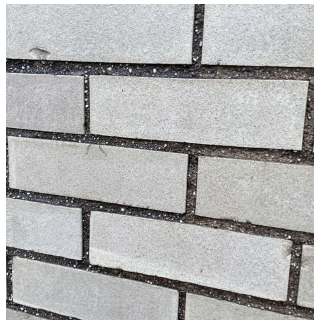
Roof 1 - BH3
No violations recorded.

BULKHEAD/PENTHOUSE WALLS/EXTERIOR: DETERIORATED JOINTS

100
S.F.
REPOINT
PRIORITY 3
LEVEL 2

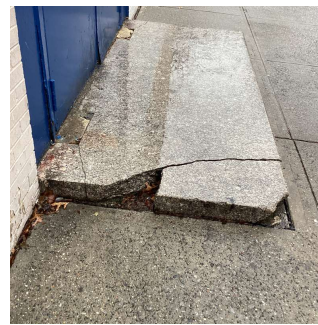
Facade B - Exit 3
 No violations recorded.

STONE: CRACKS/SPALLING - MAJOR

30
 S.F.
 REPLACE
 PRIORITY 5
 LEVEL 6

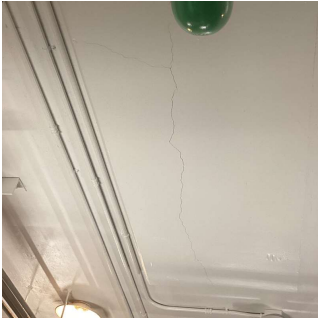
Basement - Oil Tank Room
Violations	No violations recorded.
Deficiency	CONCRETE SLAB ON GRADE: THRU CRACKS
Deficiency Location/Instance	Basement - Electrical Room
Deficiency Quantity	20
Quantity Uom	S.F.
Potential Action	REPAIR
Urgency of Action	PRIORITY 3
Purpose of Action	LEVEL 5
Deficiency Photo1

Question	Response
INTERIOR	
STRUCTURAL	Inspected
COLUMNS/BEAMS/BEARING WALLS	Inspected
Condition	2 - Between Good and Fair
Deficiency	No deficiencies recorded
FLOOR STRUCTURE	Inspected
Condition	3 - Fair
Deficiency	CONCRETE: CRACKS/SPALLED/REINFORCEMENT EXPOSED
Deficiency Location/Instance	Basement - Oil Tank Room
Deficiency Quantity	10
Quantity Uom	S.F.
Potential Action	REPAIR
Urgency of Action	PRIORITY 3
Purpose of Action	LEVEL 5
Deficiency Photo1

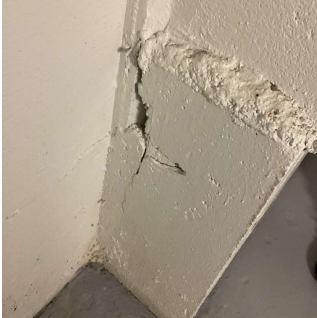
Basement - Electrical Room
Violations	No violations recorded.
FOUNDATION WALLS	Inspected
Material Type(s)	Concrete
Condition	4 - Between Fair and Poor
Deficiency	CONCRETE: CRACKED/SPALLED/REINFORCEMENT EXPOSED

Deficiency Location/Instance	Basement - Oil Tank Room
Deficiency Quantity	10

Question	Response
INTERIOR	
STRUCTURAL	
FOUNDATION WALLS	
Quantity Uom	S.F.
Potential Action	REPAIR
Urgency of Action	PRIORITY 4
Purpose of Action	LEVEL 5
Deficiency Photo1

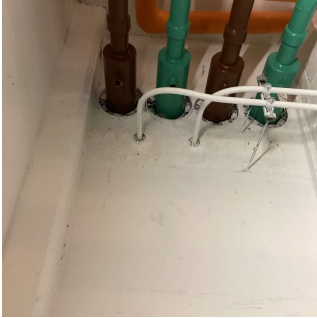
Violations	Basement - Oil Tank Room No violations recorded.
Deficiency	CONCRETE: WATER INFILTRATION IN NON- INSTRUCTIONAL SPACE
Deficiency Location/Instance	Basement - Oil Tank Room, Boiler Room
Deficiency Quantity	200
Quantity Uom	S.F.
Potential Action	INSTALL WATERPROOFING
Urgency of Action	PRIORITY 5
Purpose of Action	LEVEL 5
Deficiency Photo1

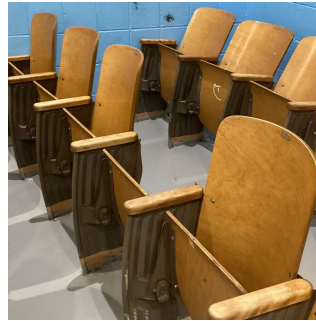
Seat M/8

DAMAGED/BROKEN/INOPERABLE

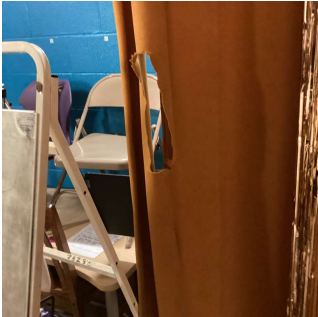
Violations	Right side No violations recorded.

Instance on 1st Floor (400 Seats)	Inspected
Condition	4 - Between Fair and Poor
Deficiency	WORN/DETERIORATED
Deficiency Location/Instance	Right side, left side
Deficiency Quantity	300
Quantity Uom	S.F.
Potential Action	REPLACE
Urgency of Action	PRIORITY 3
Purpose of Action	LEVEL 2
Deficiency Photo1

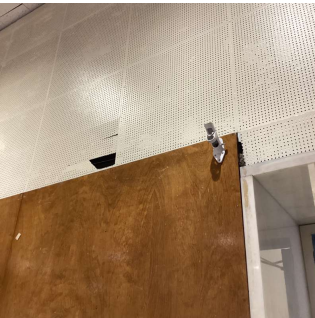
Question	Response
INTERIOR	
AUDITORIUM	
Walls	
Deficiency Photo1 Violations	  Stafe No violations recorded.
Deficiency Deficiency Location/Instance Deficiency Quantity Quantity Uom Potential Action Urgency of Action Purpose of Action Deficiency Photo1 Violations	METAL CLADDING: DETERIORATED Near Entrance 10 S.F. REPLACE PRIORITY 3 LEVEL 2

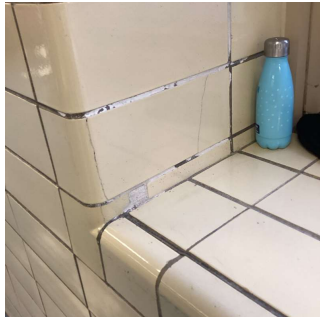
Condition	2 - Between Good and Fair
Deficiency	GLAZED BLOCK: CRACKS/SPALLING
Deficiency Location/Instance	Near Windows
Deficiency Quantity	10
Quantity Uom	S.F.
Potential Action	REPLACE
Urgency of Action	PRIORITY 3

Question	Response
INTERIOR	
CAFETERIA	Inspected
Walls	
Purpose of Action	LEVEL 2
Deficiency Photo1

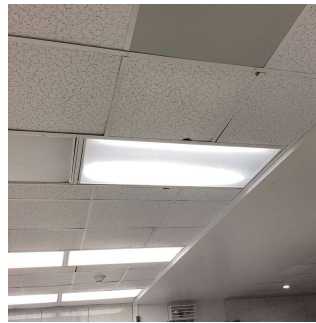
Main Entrance Lobby

Violations	Room 322 No violations recorded.
Deficiency	ACOUSTIC TILES: DAMAGED/MISSING
Deficiency Location/Instance	Main Entrance Lobby, Corridor near Room 011, 024, Cafeteria, and others
Deficiency Quantity	100
Quantity Uom	S.F.
Potential Action	REPLACE
Urgency of Action	PRIORITY 3
Purpose of Action	LEVEL 2

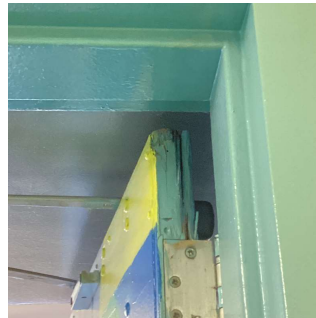
Room 322

WOOD: DETERIORATED DOOR

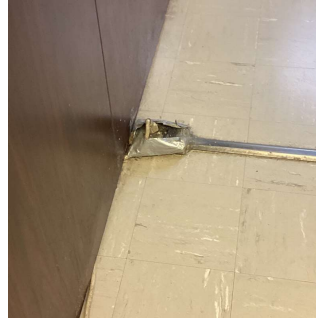
Room 133

VINYL TILES: TRIPPING HAZARD - ELECTRICAL OUTLET

Potential Action	REMOVE
Urgency of Action	PRIORITY 5
Purpose of Action	LEVEL 6
Deficiency Photo1

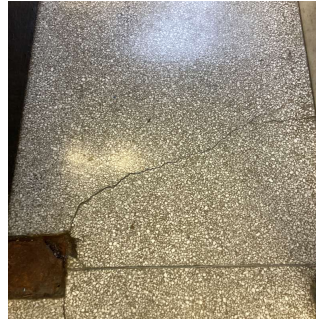
Main Entrance Vestibule

Deficiency	TERRAZZO: CRACKS
Deficiency Location/Instance	Main Entrance Vestibule, Exit 1, Exit G
Deficiency Quantity	40
Quantity Uom	S.F.
Potential Action	REPLACE
Urgency of Action	PRIORITY 3
Purpose of Action	LEVEL 2
Deficiency Photo1

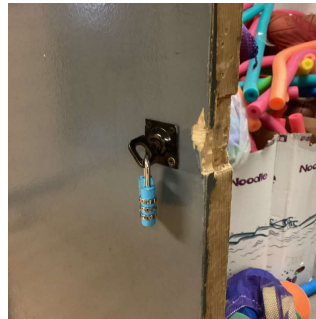
Storage

Instance on 1st Floor	Inspected
Condition	5 - Poor
Deficiency	WOOD: DETERIORATED DOOR
Deficiency Location/Instance	Storage, Entrance
Deficiency Quantity	4
Quantity Uom	EACH
Potential Action	MAINTENANCE
Urgency of Action	PRIORITY 3
Purpose of Action	LEVEL 2
Deficiency Photo1

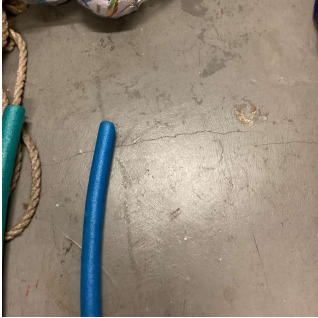
Storage
No violations recorded.

Instance on 1st Floor	Inspected
Condition	2 - Between Good and Fair
Deficiency	CONCRETE: CRACKS
Deficiency Location/Instance	Storage
Deficiency Quantity	10
Quantity Uom	S.F.
Potential Action	REPLACE
Urgency of Action	PRIORITY 3
Purpose of Action	LEVEL 2
Deficiency Photo1

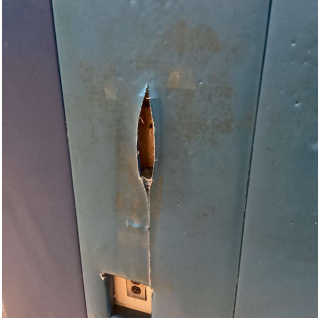
Instance on 1st Floor	Inspected
Condition	3 - Fair
Deficiency	WALL PADDING: DETERIORATED
Deficiency Location/Instance	Near center, Entrance
Deficiency Quantity	200
Quantity Uom	S.F.
Potential Action	REPLACE
Urgency of Action	PRIORITY 3
Purpose of Action	LEVEL 2
Deficiency Photo1

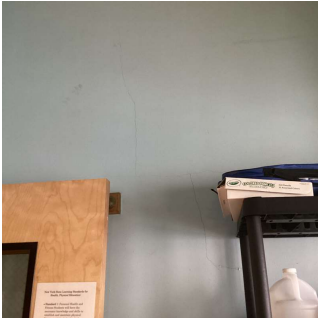
Question	Response
INTERIOR	
GYMNASIUM	
Walls	
Violations	Near Entrance No violations recorded.
Deficiency	PLASTER: CRACKS/SPALLING
Deficiency Location/Instance	Office
Deficiency Quantity	15
Quantity Uom	S.F.
Potential Action	REPLACE
Urgency of Action	PRIORITY 3
Purpose of Action	LEVEL 2
Deficiency Photo1

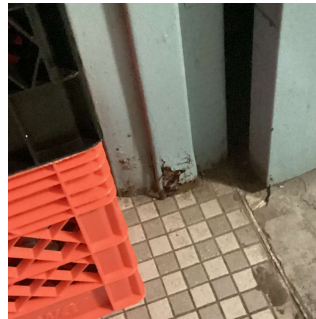
Instance on Basement	Inspected
Condition	3 - Fair
Deficiency	METAL: DETERIORATED DOOR AND FRAME
Deficiency Location/Instance	Storage
Deficiency Quantity	1
Quantity Uom	EACH
Potential Action	MAINTENANCE
Urgency of Action	PRIORITY 3
Purpose of Action	LEVEL 2
Deficiency Photo1

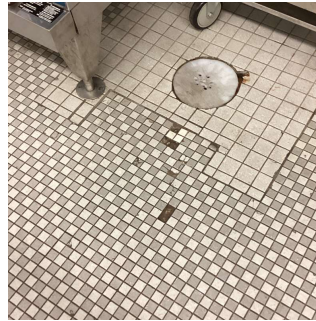
Near Windows

Instance on Basement	Inspected
Condition	2 - Between Good and Fair
Deficiency	CERAMIC TILE: BROKEN/MISSING TILES
Deficiency Location/Instance	Near center, windows, exit
Deficiency Quantity	20
Quantity Uom	S.F.
Potential Action	REPLACE
Urgency of Action	PRIORITY 3
Purpose of Action	LEVEL 2

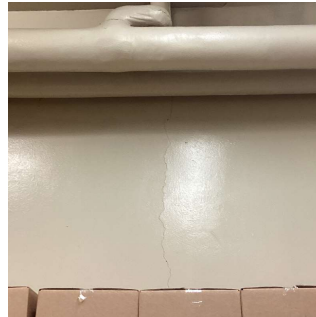
Storage

PLASTER: CRACKS/SPALLING

REPLACE

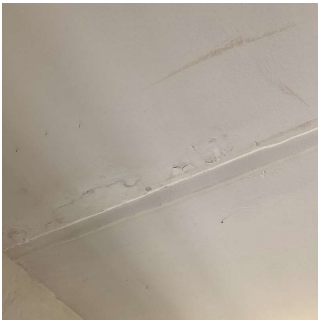
Question	Response
INTERIOR	
LIBRARY	
Walls	
Instance on Room 220	Inspected
Condition	2 - Between Good and Fair
Deficiency	No deficiencies recorded
LOCKER ROOM	
Does not Exist	
MULTI-PURPOSE ROOM	
Does not Exist	
SCIENCE DEMO ROOM	
Does not Exist	
SCIENCE LAB	
Inspected	
Instance on Room 305	Inspected
Alternative use	No
Fixed Equipment	
Instance on Room 305	Inspected
Condition	2 - Between Good and Fair
Deficiency	No deficiencies recorded
SCIENCE PREP ROOM	
Inspected	
Instance on Room 303	Inspected
Alternative use	No
Fixed Equipment	
Instance on Room 303	Inspected
Condition	2 - Between Good and Fair
Deficiency	No deficiencies recorded
SHOWER ROOM	
Does not Exist	
STAIRS/RAMPS: INTERIOR	
Inspected	
Do Letter Stair Signs Exist?	Partially
Ceiling	
Inspected	
Condition	2 - Between Good and Fair
Deficiency	PLASTER: CRACKS/SPALLING
Deficiency Location/Instance	Stair DE/1
Deficiency Quantity	10
Quantity Uom	S.F.
Potential Action	REPLACE
Urgency of Action	PRIORITY 3

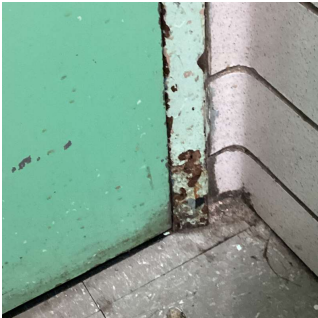
Violations	Stair DE/1 No violations recorded.
Door(s)	
Inspected	
Condition	2 - Between Good and Fair
Deficiency	METAL: DETERIORATED DOOR AND FRAME
Deficiency Location/Instance	Stair C/Basement

Question	Response
INTERIOR	
STAIRS/RAMPS: INTERIOR	
Door(s)	
Deficiency Quantity	1
Quantity Uom	EACH
Potential Action	MAINTENANCE
Urgency of Action	PRIORITY 3
Purpose of Action	LEVEL 2
Deficiency Photo1

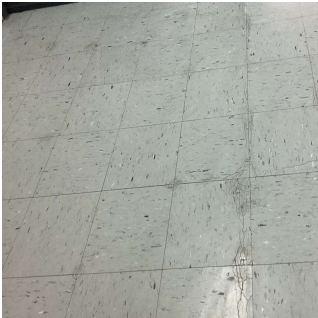
Stair C/Basement
Violations	No violations recorded.
Partition	Does not Exist
Railings	Inspected
Condition	2 - Between Good and Fair
Deficiency	No deficiencies recorded
Stairs and Landings	Inspected
Condition	3 - Fair
Deficiency	VINYL TILES: DETERIORATED SUBSTRATE
Deficiency Location/Instance	Stair C/Basement, DE/Basement, F/1
Deficiency Quantity	120
Quantity Uom	S.F.
Potential Action	REPLACE
Urgency of Action	PRIORITY 3
Purpose of Action	LEVEL 2
Deficiency Photo1

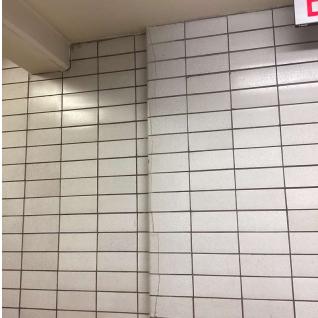
Question	Response
INTERIOR	
STAIRS/RAMPS: INTERIOR	
Walls	Inspected
Condition	2 - Between Good and Fair
Deficiency	GLAZED BLOCK: CRACKS/SPALLING
Deficiency Location/Instance	Stair C/1, DE/1, F/1, Basement, H/1
Deficiency Quantity	50
Quantity Uom	S.F.
Potential Action	REPLACE
Urgency of Action	PRIORITY 3
Purpose of Action	LEVEL 2
Deficiency Photo1

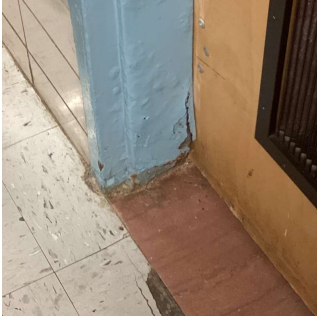
Violations	Stair H/1 No violations recorded.
Deficiency	PLASTER: CRACKS/SPALLING
Deficiency Location/Instance	Stair F/2, 1, H/1
Deficiency Quantity	30
Quantity Uom	S.F.
Potential Action	REPLACE
Urgency of Action	PRIORITY 3
Purpose of Action	LEVEL 2
Deficiency Photo1	 
Violations	Stair F/1 No violations recorded.
TOILET ROOMS - STAFF	
Ceiling	Inspected
Condition	2 - Between Good and Fair
Deficiency	No deficiencies recorded
Door(s)	Inspected
Condition	5 - Poor
Deficiency	WOOD: DETERIORATED DOOR AND FRAME
Deficiency Location/Instance	Room 014
Deficiency Quantity	1
Quantity Uom	EACH

Question	Response
INTERIOR	
TOILET ROOMS - STAFF	
Door(s)	
Potential Action	MAINTENANCE
Urgency of Action	PRIORITY 3
Purpose of Action	LEVEL 2
Deficiency Photo1

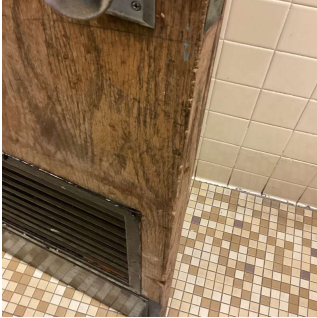
Room 014
Violations	No violations recorded.
Deficiency	WOOD: DETERIORATED DOOR
Deficiency Location/Instance	Room 161
Deficiency Quantity	1
Quantity Uom	EACH
Potential Action	MAINTENANCE
Urgency of Action	PRIORITY 3
Purpose of Action	LEVEL 2
Deficiency Photo1

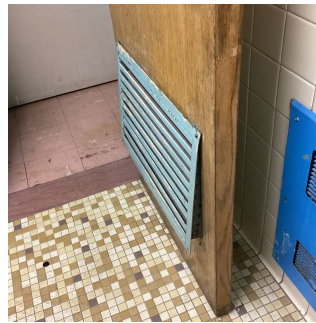
Room 161
Violations	No violations recorded.
Deficiency	WOOD: DAMAGED LOUVER
Deficiency Location/Instance	Gymnasium Staff Toilet
Deficiency Quantity	1
Quantity Uom	EACH
Potential Action	MAINTENANCE
Urgency of Action	PRIORITY 3
Purpose of Action	LEVEL 2

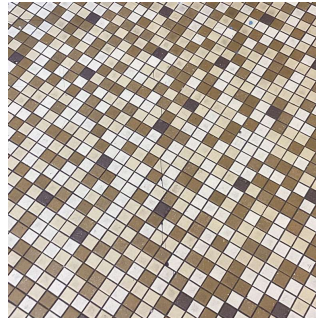
Room 221

CERAMIC TILE: BROKEN/MISSING TILES

REPLACE

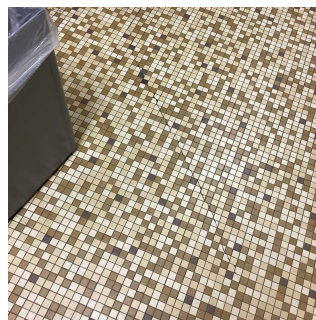
CERAMIC TILE: DETERIORATED SUBSTRATE

REPLACE

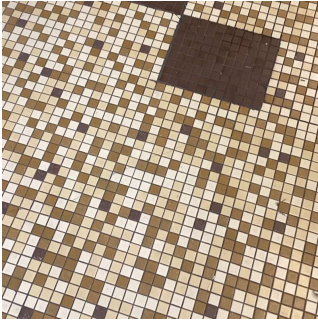
Violations	Room 118 No violations recorded.
Deficiency	CERAMIC TILE: BROKEN/MISSING TILES
Deficiency Location/Instance	Room 318, 316, 218, 112
Deficiency Quantity	40
Quantity Uom	S.F.
Potential Action	REPLACE
Urgency of Action	PRIORITY 3
Purpose of Action	LEVEL 2
Deficiency Photo1

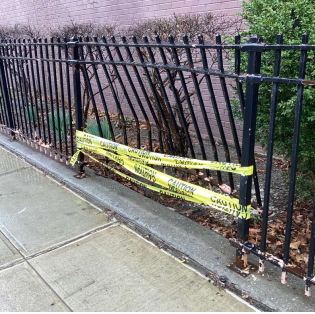
Violations	<p>Along 6th Avenue No violations recorded.</p>
Deficiency	WROUGHT IRON: DAMAGED/DETERIORATED
Deficiency Location/Instance	Along 6th Avenue, Lincoln Place
Deficiency Quantity	320
Quantity Uom	S.F.
Potential Action	REPLACE
Urgency of Action	PRIORITY 3
Purpose of Action	LEVEL 2
Deficiency Photo1

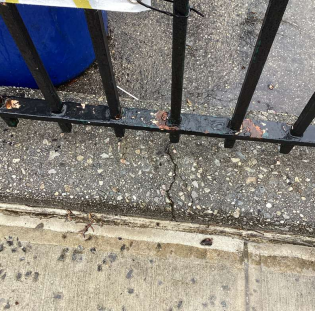
Violations	<p>Along 6th Avenue No violations recorded.</p>
Deficiency	CONCRETE CURB: DAMAGED/DETERIORATED
Deficiency Location/Instance	Along 6th Avenue, Berkeley Place
Deficiency Quantity	40
Quantity Uom	S.F.
Potential Action	REPLACE
Urgency of Action	PRIORITY 3
Purpose of Action	LEVEL 2
Deficiency Photo1

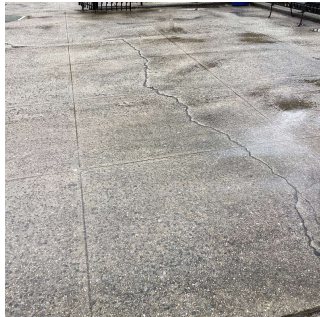
Near Main Entrance
Violations	35663329K
Deficiency	DAMAGED/DETERIORATED/MISSING SECTIONS
Deficiency Location/Instance	Near Main Entrance
Deficiency Quantity	650
Quantity Uom	S.F.
Potential Action	REPLACE
Urgency of Action	PRIORITY 4
Purpose of Action	LEVEL 4
Deficiency Photo1

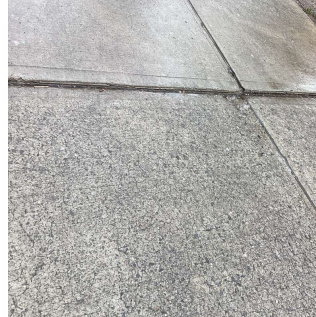
Near Main Entrance
Violations	35663329K
Pavers	Does not Exist
DOT Sidewalk	Inspected
Asphalt	Does not Exist
Concrete	Inspected
Condition	4 - Between Fair and Poor
Deficiency	HEAVING
Deficiency Location/Instance	Along Berkeley Place
Deficiency Quantity	200
Quantity Uom	S.F.
Potential Action	REPLACE
Urgency of Action	PRIORITY 3
Purpose of Action	LEVEL 2

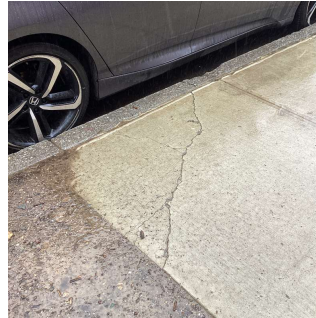
Along 6th Avenue

DAMAGED/DETERIORATED/MISSING SECTIONS

REPLACE

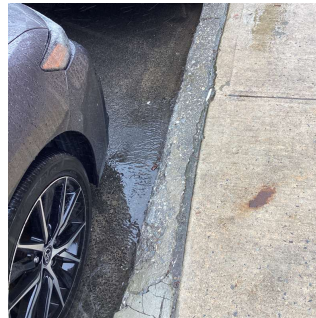
Along 6th Avenue

DAMAGED CURBS

REPLACE

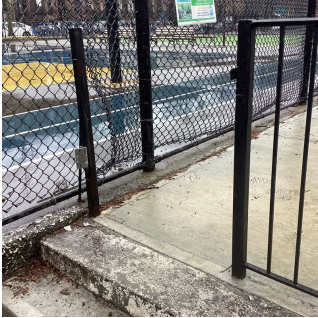
Question	Response
SITE	
PAVING	Inspected
DOT Sidewalk	
Concrete	Inspected
Violations	No violations recorded.
Pavers	Does not Exist
PLAYGROUNDS	Inspected
Instance on South side of Building	Inspected
Benches	
Instance on South side of Building	Inspected
Condition	2 - Between Good and Fair
Deficiency	No deficiencies recorded
Fence	
Instance on South side of Building	Inspected
Condition	2 - Between Good and Fair
Deficiency	ALUMINUM: MISSING SECTIONS
Deficiency Location/Instance	Schoolyard
Deficiency Quantity	40
Quantity Uom	S.F.
Potential Action	REPLACE
Urgency of Action	PRIORITY 3
Purpose of Action	LEVEL 2
Deficiency Photo1

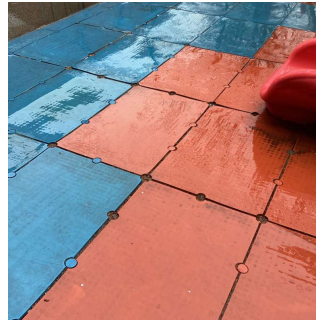
Question	Response
SITE	
PLAYGROUNDS	Inspected
Pavement	
Deficiency Photo1	 
Violations	Schoolyard No violations recorded.
Deficiency	ASPHALT: CRACKS - MAJOR
Deficiency Location/Instance	Schoolyard
Deficiency Quantity	50
Quantity Uom	S.F.
Potential Action	REPLACE
Urgency of Action	PRIORITY 3
Purpose of Action	LEVEL 2
Deficiency Photo1	 
Violations	Schoolyard No violations recorded.
Play Equipment	
Instance on South side of Building	Inspected
Condition	2 - Between Good and Fair
Deficiency	No deficiencies recorded
Safety Surfacing	
Instance on South side of Building	Inspected
Condition	2 - Between Good and Fair
Deficiency	DETERIORATED/MISSING
Deficiency Location/Instance	Schoolyard
Deficiency Quantity	10
Quantity Uom	S.F.
Potential Action	MAINTENANCE
Urgency of Action	PRIORITY 3
Purpose of Action	LEVEL 2

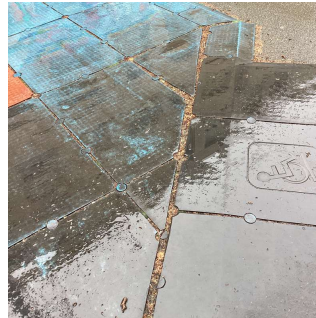
Deficiency	DETERIORATED/MISSING
Deficiency Location/Instance	Schoolyard
Deficiency Quantity	10
Quantity Uom	S.F.
Potential Action	REPLACE
Urgency of Action	PRIORITY 5
Purpose of Action	LEVEL 6
Deficiency Photo1
