NYC Department of Education
Building Condition Assessment Survey 2023 - 2024

Architectural Inspection

Asset: P.S. 288 - BROOKLYN, 2950 WEST 25 STREET, New York, 11224

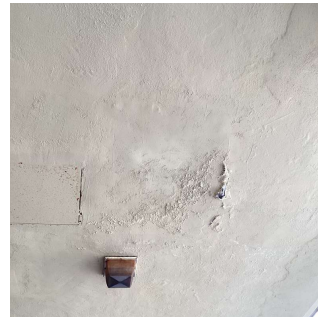
Facade C

Deficiency

REPLACE

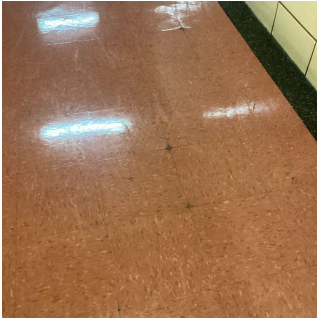
Question	Response
INTERIOR	
CLASSROOMS/CORRIDORS/ADMIN SPACES	
Door(s)	Inspected
	Room 333
Violations	No violations recorded.
Floor Finish	Inspected
Condition	2 - Between Good and Fair
Deficiency	VINYL TILES: BROKEN/DETERIORATED/MISSING TILES
Deficiency Location/Instance	Corridor near Room 349
Deficiency Quantity	20
Quantity Uom	S.F.
Potential Action	REPLACE
Urgency of Action	PRIORITY 3
Purpose of Action	LEVEL 2
Deficiency Photo1

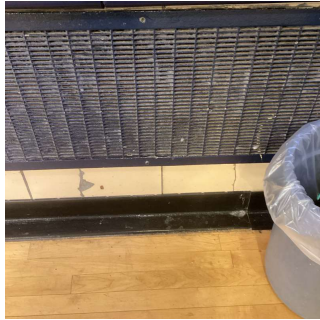
Violations	Right Side No violations recorded.
Deficiency	GLAZED BLOCK: CRACKS/SPALLING
Deficiency Location/Instance	Near Main Entrance
Deficiency Quantity	10
Quantity Uom	S.F.
Potential Action	REPLACE
Urgency of Action	PRIORITY 3
Purpose of Action	LEVEL 2
Deficiency Photo1

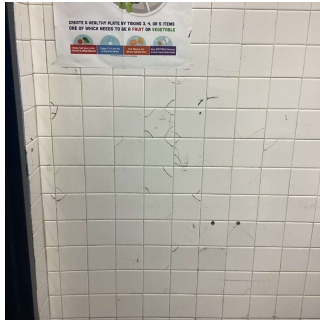
Violations	Severy No violations recorded.
Walls	
Instance on 1st Floor	Inspected
Condition	2 - Between Good and Fair
Deficiency	CERAMIC TILE: BROKEN/ MISSING
Deficiency Location/Instance	Severy, by Sink
Deficiency Quantity	20
Quantity Uom	S.F.
Potential Action	REPLACE
Urgency of Action	PRIORITY 3
Purpose of Action	LEVEL 2
Deficiency Photo1

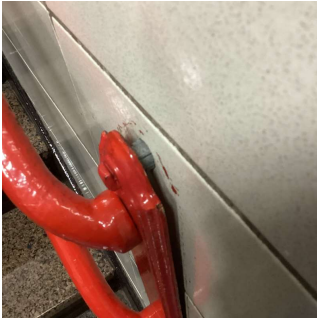
Question	Response
INTERIOR	
STAIRS/RAMPS: INTERIOR	
Ceiling	
Deficiency Photo1	 
Violations	Stair D/3 No violations recorded.
Door(s)	Inspected
Condition	2 - Between Good and Fair
Deficiency	No deficiencies recorded
Partition	Does not Exist
Railings	Inspected
Condition	3 - Fair
Deficiency	METAL: BROKEN BRACKET
Deficiency Location/Instance	Stair B/1
Deficiency Quantity	1
Quantity Uom	EACH
Potential Action	REPLACE
Urgency of Action	PRIORITY 3
Purpose of Action	LEVEL 2
Deficiency Photo1

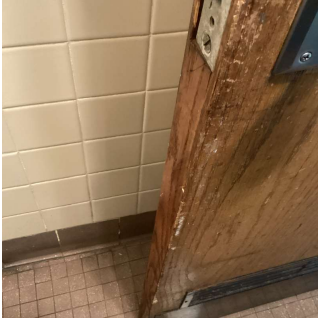
Violations	In Women Kitchen Locker Room No violations recorded.
Deficiency	WOOD: DETERIORATED DOOR
Deficiency Location/Instance	Room 202
Deficiency Quantity	1
Quantity Uom	EACH
Potential Action	MAINTENANCE
Urgency of Action	PRIORITY 3
Purpose of Action	LEVEL 2
Deficiency Photo1

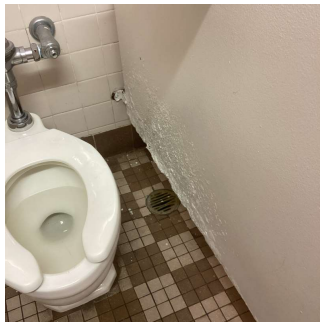
Violations	Room 135 No violations recorded.
Stalls	Inspected
Condition	5 - Poor
Deficiency	RUST - MAJOR
Deficiency Location/Instance	Rooms 340, 302, 244, 135, In Women Kitchen Locker Room and others
Deficiency Quantity	7
Quantity Uom	EACH
Potential Action	REPLACE
Urgency of Action	PRIORITY 3
Purpose of Action	LEVEL 2
Deficiency Photo1

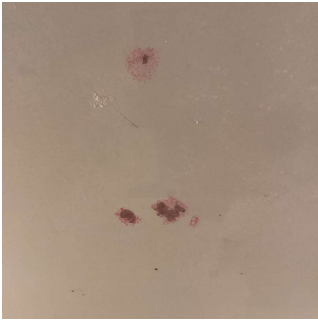
Violations	In Gymnasium Office Room No violations recorded.
TOILET ROOMS - STUDENTS	
Ceiling	Inspected
Condition	2 - Between Good and Fair
Deficiency	PLASTER: CRACKS/SPALLING
Deficiency Location/Instance	Room 241
Deficiency Quantity	10
Quantity Uom	S.F.
Potential Action	REPLACE
Urgency of Action	PRIORITY 3
Purpose of Action	LEVEL 2
Deficiency Photo1

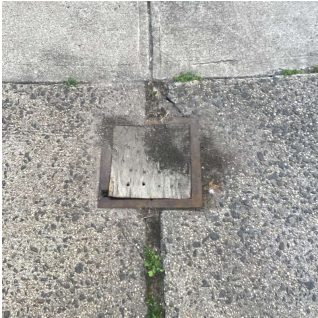
Question	Response
INTERIOR	Inspected
TOILET ROOMS - STUDENTS	Inspected
Walls	
Violations	Room 243 No violations recorded.
LIFE SAFETY	Inspected
F.D. HOLDING AREA	Does not Exist
STEEL STAIRS	Does not Exist
SITE	Inspected
CONTAINERIZATION	Inspected
Condition	1 - Good
Deficiency	No deficiencies recorded
Drainage System for Asphalt	Inspected
Catch Basins/Manhole - Surrounded by asphalt	Inspected
Condition	2 - Between Good and Fair
Deficiency	No deficiencies recorded
Culverts - Asphalt Covering	Does not Exist
Drainage System for Concrete	Inspected
Catch Basins/Manhole - Surrounded by concrete	Inspected
Condition	4 - Between Fair and Poor
Deficiency	DAMAGED COVER
Deficiency Location/Instance	Near Exits 6, 5
Deficiency Quantity	2
Quantity Uom	EACH
Potential Action	REPLACE
Urgency of Action	PRIORITY 3
Purpose of Action	LEVEL 2
Deficiency Photo1

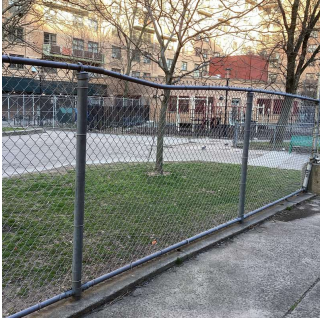
Question	Response
SITE	
FENCES	
Deficiency	CHAIN LINK: DAMAGED POST/RAIL
Deficiency Location/Instance	West 27th Street
Deficiency Quantity	60
Quantity Uom	L.F.
Potential Action	REPLACE
Urgency of Action	PRIORITY 3
Purpose of Action	LEVEL 2
Deficiency Photo1

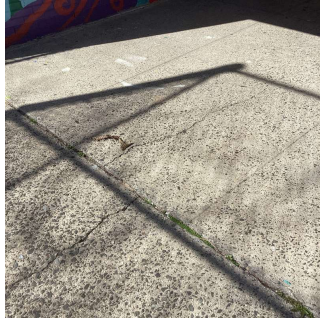
Near Exit 2
Violations	No violations recorded.
Deficiency	HEAVING
Deficiency Location/Instance	Near Exits 2, 5, 6, West 27th Street
Deficiency Quantity	325
Quantity Uom	S.F.
Potential Action	REPLACE
Urgency of Action	PRIORITY 3
Purpose of Action	LEVEL 2
Deficiency Photo1

Question	Response
SITE	
PAVING	
Site Sidewalks & Walkways	
Asphalt	Does not Exist
Concrete	Inspected
Condition	4 - Between Fair and Poor
Deficiency	DAMAGED/DETERIORATED/MISSING SECTIONS
Deficiency Location/Instance	Near Exit 2, West 26th Street, West 27th Street
Deficiency Quantity	825
Quantity Uom	S.F.
Potential Action	REPLACE
Urgency of Action	PRIORITY 3
Purpose of Action	LEVEL 2
Deficiency Photo1

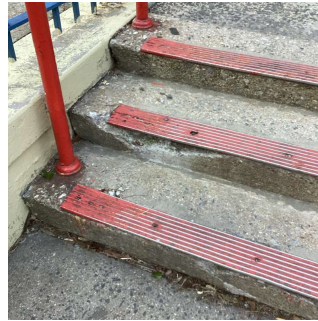
West 25th Street

Stairs/ramps
