NYC Department of Education
Building Condition Assessment Survey 2023 - 2024

Architectural Inspection

Asset: P.S. 290 - BROOKLYN, 135 SCHENCK AVENUE, New York, 11207

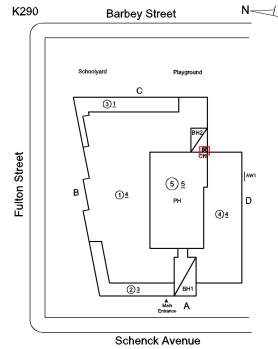
Question	Response
Architectural	
EXTERIOR	Inspected
AREAWAY	Inspected
Instance on AW1	Inspected
Instance Condition	2 - Between Good and Fair
Instance Quantity	1
Instance Quantity Uom	EACH
Deficiency	No deficiencies recorded
AWNINGS AND CANOPIES	Does not Exist
CHIMNEY	Inspected
Material Type(s)	Masonry
Condition	3 - Fair
Deficiency	BRICK: DETERIORATED JOINTS

20
S.F.
REPOINT
PRIORITY 4
LEVEL 2

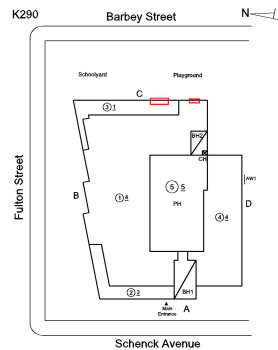
METAL: DETERIORATED DOOR AND FRAME - MAJOR DETERIORATION

4
EACH
REPLACE
PRIORITY 4

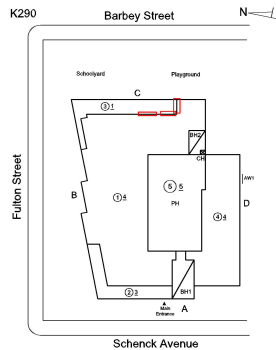
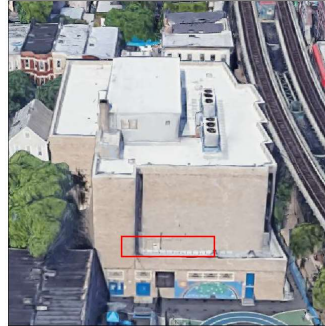
BRICK: WATER INFILTRATION IN INSTRUCTIONAL SPACE

REPAIR

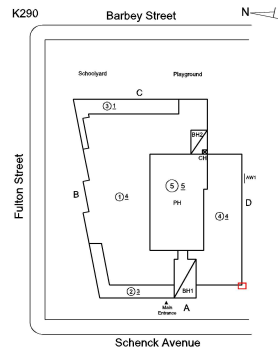
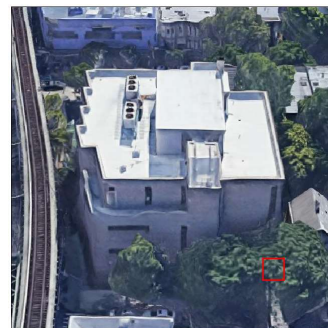
BRICK: CRACKS/DISPLACED/SPALLED BRICK AT BUILDING CORNERS

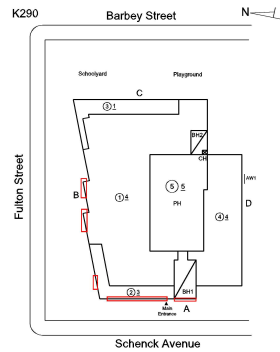
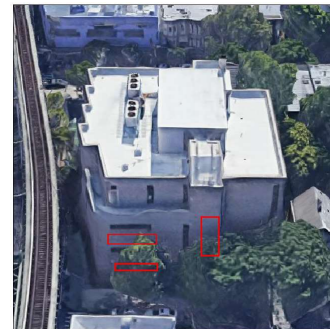
BRICK: DETERIORATED JOINTS

100
S.F.
REPOINT
PRIORITY 3
LEVEL 2

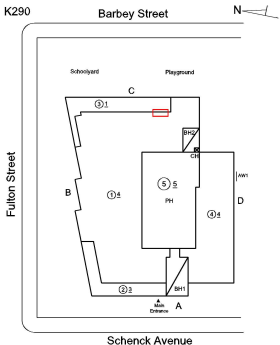
Facade A
Violations	No violations recorded.
EXTERIOR SOFFITS	Inspected
Condition	2 - Between Good and Fair
Deficiency	No deficiencies recorded
LOADING DOCK	Does not Exist
LOUVER	Inspected
Condition	2 - Between Good and Fair
Deficiency	No deficiencies recorded
PARAPETS	Inspected
Material Type(s)	Masonry
Replacement Quantity	6,000
Replacement Uom	C.F.
Instance on All Roofs	Inspected
Instance Condition	3 - Fair
Instance Quantity	6,000
Instance Quantity Uom	C.F.
Deficiency	BRICK: OUT OF PLUMB
Roof Plan reference

Deficiency Quantity	40
Quantity Uom	C.F.
Potential Action	REMOVE AND REBUILD
Urgency of Action	PRIORITY 4
Purpose of Action	LEVEL 2

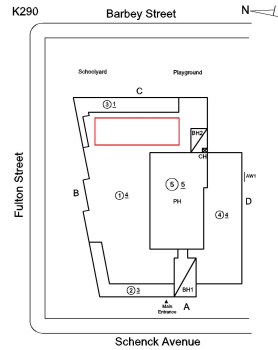
Installation Year	2021
Source of Installation	Custodial Staff
Deficiency	MODIFIED BITUMEN: ROOFING: DELAMINATION

100
S.F.
REPLACE ROOFING WITHOUT MAJOR EQUIPMENT
REMOVAL
PRIORITY 4
LEVEL 2

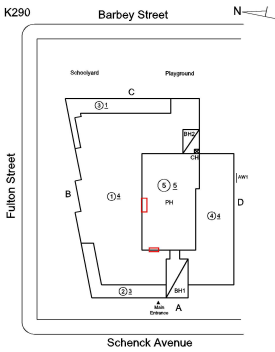
BH2
Violations	No violations recorded.
Deficiency	BULKHEAD/PENTHOUSE WALLS/EXTERIOR: DAMAGED METAL SIDING
Roof Plan reference

Deficiency Quantity	20
Quantity Uom	S.F.
Potential Action	REPLACE
Urgency of Action	PRIORITY 4
Purpose of Action	LEVEL 2
Deficiency Photo1

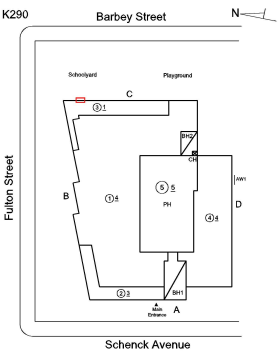
Question	Response
EXTERIOR	
ROOF	Inspected
Specialties	Inspected
DUNNAGE STEEL	Inspected
Deficiency	No deficiencies recorded
SKYLIGHT/ROOF VENT	Does not Exist
ROOF/GRAVITY TANK	Does not Exist
STAIRS/RAMPS: EXTERIOR	Inspected
BUILDING CHEEK/FLANK WALLS	Does not Exist
RAILINGS	Inspected
Condition	2 - Between Good and Fair
Deficiency	No deficiencies recorded
STAIRS/RAMPS	Inspected
Condition	4 - Between Fair and Poor
Deficiency	CONCRETE: WORN-OUT TREAD/RISER/NOSING
Roof Plan reference

Deficiency Quantity	10
Quantity Uom	S.F.
Potential Action	REPLACE
Urgency of Action	PRIORITY 4
Purpose of Action	LEVEL 2
Deficiency Photo1

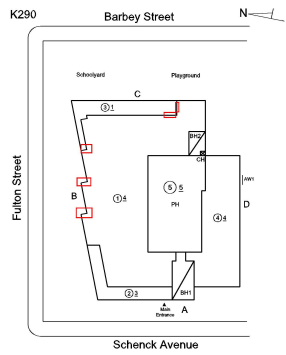
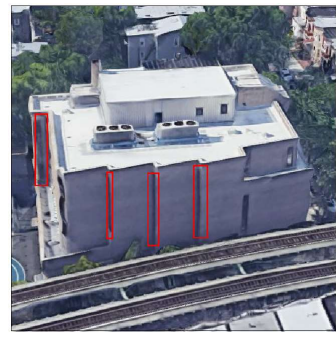
Question	Response
EXTERIOR	
STAIRS/RAMPS: EXTERIOR	Inspected
STAIRS/RAMPS	
Roof Plan reference	
Deficiency Quantity	10
Quantity Uom	S.F.
Potential Action	REPLACE
Urgency of Action	PRIORITY 4
Purpose of Action	LEVEL 2
Deficiency Photo1	
Violations	Facade C No violations recorded.
WINDOWS	Inspected
Replacement Quantity	3,400
Replacement Uom	S.F.
EXTERIOR GUARDS	Inspected
Condition	2 - Between Good and Fair
Deficiency	No deficiencies recorded
LINTELS	Inspected
Condition	1 - Good
Deficiency	No deficiencies recorded
WINDOWS	Inspected
Material Type(s)	Aluminum
Instance on Aluminum - Other: All Facades	Inspected
Instance Condition	3 - Fair
Instance Quantity	3,400
Instance Quantity Uom	S.F.
Are these windows insulated	Yes
Installation Year	2021
Source of Installation	Custodial Staff
Deficiency	ALUMINUM - OTHER: AIR/WATER INFILTRATION

Deficiency Quantity	120
Quantity Uom	L.F.
Potential Action	REPLACE TRIM, SILLS OR WEATHERSTRIPPING
Urgency of Action	PRIORITY 5
Purpose of Action	LEVEL 2
Deficiency Photo1

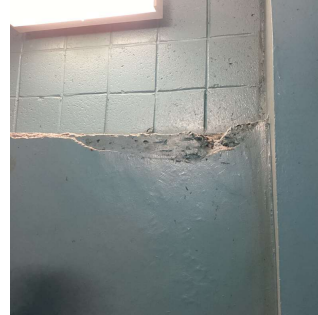
Violations	Facade B - Room 401 (Facade B - Rooms 305, 403, Stair B/3, Stair B/4, Facade C - Room 400 similar) No violations recorded.
INTERIOR	
Inspected	
POOLS	
Does not Exist	
STRUCTURAL	
Inspected	
COLUMNS/BEAMS/BEARING WALLS	
Inspected	
Condition	3 - Fair
Deficiency	CONCRETE COLUMNS/BEAMS: CRACKED/SPALLED/REINFORCEMENT EXPOSED
Deficiency Location/Instance	BH1
Deficiency Quantity	10
Quantity Uom	S.F.
Potential Action	REPAIR

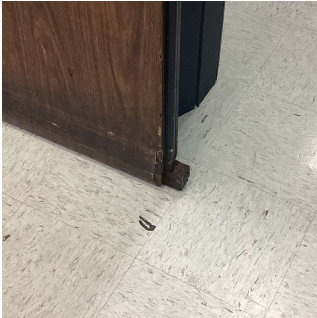
Question	Response
INTERIOR	
GYMNASIUM	
Seating	
Instance on 1st Floor	Does not Exist
Sliding-folding Partition	
Instance on 1st Floor	Inspected
Condition	3 - Fair
Deficiency	MOVABLE PANELS: DAMAGED
Deficiency Location/Instance	Center
Deficiency Quantity	80
Quantity Uom	S.F.
Potential Action	REPLACE
Urgency of Action	PRIORITY 3
Purpose of Action	LEVEL 2
Deficiency Photo1

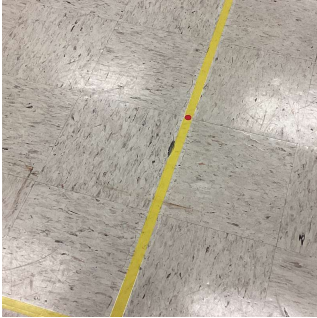
Center
Violations	No violations recorded.
Stage	
Instance on 1st Floor	Inspected
Stage	
Instance on 1st Floor	Inspected
Condition	2 - Between Good and Fair
Deficiency	DAMAGED FLOOR
Deficiency Location/Instance	Left Side
Deficiency Quantity	10
Quantity Uom	S.F.
Potential Action	REPLACE
Urgency of Action	PRIORITY 3
Purpose of Action	LEVEL 2
Deficiency Photo1

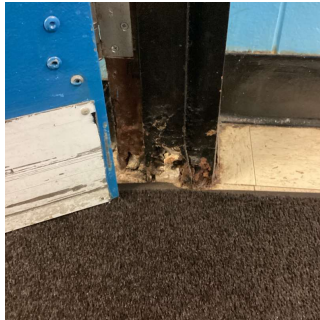
Violations	Stair B/2 No violations recorded.
Door(s)	Inspected
Condition	4 - Between Fair and Poor
Deficiency	METAL: DETERIORATED DOOR AND FRAME
Deficiency Location/Instance	Stair B/1 Vestibule
Deficiency Quantity	2
Quantity Uom	EACH
Potential Action	MAINTENANCE
Urgency of Action	PRIORITY 3
Purpose of Action	LEVEL 2
Deficiency Photo1

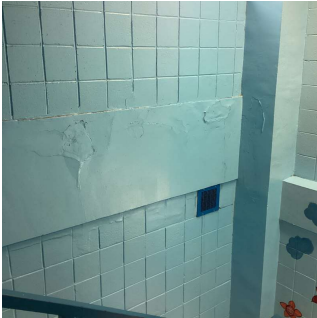
Question	Response
INTERIOR	
STAIRS/RAMPS: INTERIOR	
Stairs and Landings	Inspected
	Stair A/3
Violations	No violations recorded.
Walls	Inspected
Condition	2 - Between Good and Fair
Deficiency	PLASTER: CRACKS/SPALLING - ACTIVE LEAK
Deficiency Location/Instance	Stair B/2
Deficiency Quantity	50
Quantity Uom	S.F.
Potential Action	REPLACE
Urgency of Action	PRIORITY 5
Purpose of Action	LEVEL 2
Deficiency Photo1

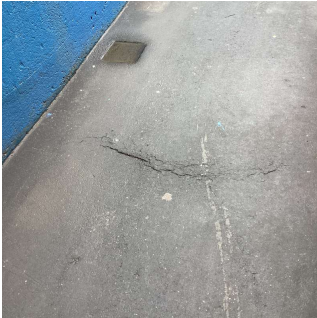
Violations	Schoolyard No violations recorded.
Concrete	Does not Exist
Pavers	Does not Exist
Site Sidewalks & Walkways	Inspected
Asphalt	Inspected
Condition	2 - Between Good and Fair
Deficiency	HEAVING
Deficiency Location/Instance	Near Exit 3
Deficiency Quantity	10
Quantity Uom	S.F.
Potential Action	REPLACE
Urgency of Action	PRIORITY 3
Purpose of Action	LEVEL 2
Deficiency Photo1

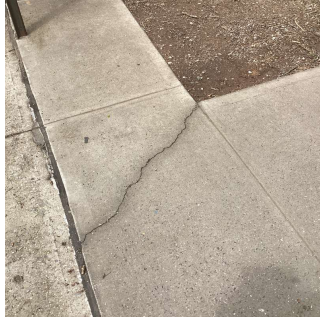
Violations	Barbey Street No violations recorded.
Deficiency	DAMAGED/DETERIORATED/MISSING SECTIONS
Deficiency Location/Instance	Schenck Avenue, Fulton Street, Barbey Street
Deficiency Quantity	250
Quantity Uom	S.F.
Potential Action	REPLACE
Urgency of Action	PRIORITY 3
