NYC Department of Education
Building Condition Assessment Survey 2023 - 2024

Architectural Inspection

Asset: P.S. 297 - BROOKLYN, 700 PARK AVENUE, New York, 11206

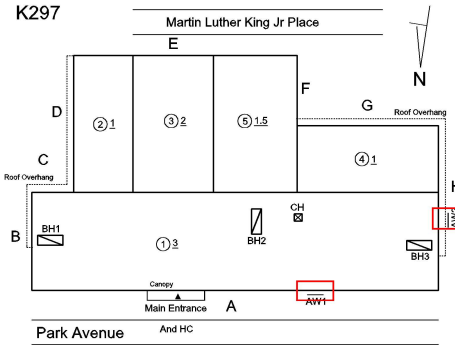
Question	Response
Architectural	
EXTERIOR	Inspected
AREAWAY	Inspected
Instance on AW1-AW2	Inspected
Instance Condition	3 - Fair
Instance Quantity	2
Instance Quantity Uom	EACH
Deficiency	AREAWAY WALLS: CRACKS AND SPALLING

AREAWAY

20
 S.F.
 REPAIR
 PRIORITY 3
 LEVEL 2
 No photo recorded
 No violations recorded.

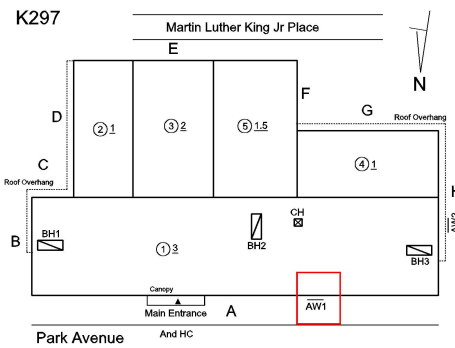
AREAWAY SLAB: CRACKS AND SPALLING

30
 S.F.
 REPAIR
 PRIORITY 3
 LEVEL 2
 No photo recorded
 No violations recorded.

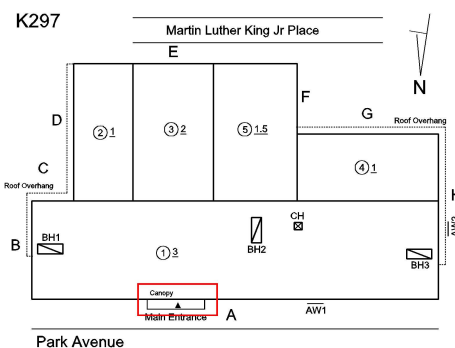
Main Entrance Canopy
 No violations recorded.

CONCRETE: MAJOR CRACKS/SPALLING

Quantity Uom	S.F.
Potential Action	REPAIR
Urgency of Action	PRIORITY 4
Purpose of Action	LEVEL 2
Deficiency Photo1

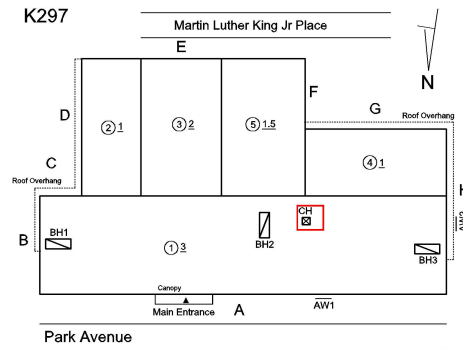
Roof 1
 No violations recorded.

BRICK: DETERIORATED JOINTS

Deficiency Quantity	200
Quantity Uom	S.F.
Potential Action	REPOINT
Urgency of Action	PRIORITY 3
Purpose of Action	LEVEL 2
Deficiency Photo1

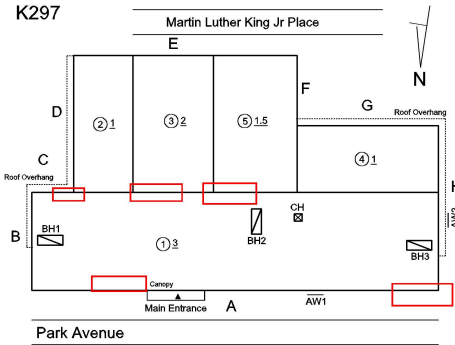
CAST STONE: DETERIORATED BED JOINT

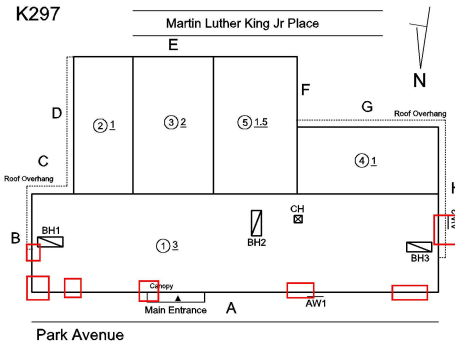
CAST STONE: DETERIORATED TRANSVERSE JOINTS

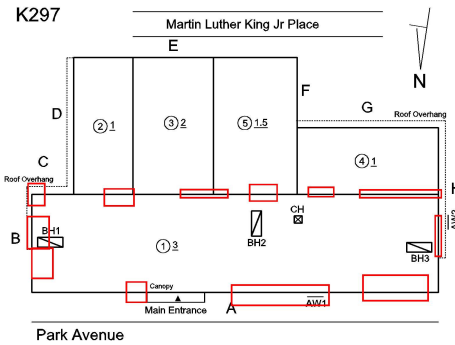
CAST STONE: CRACKED/BROKEN PIECES

REPLACE-IN-KIND

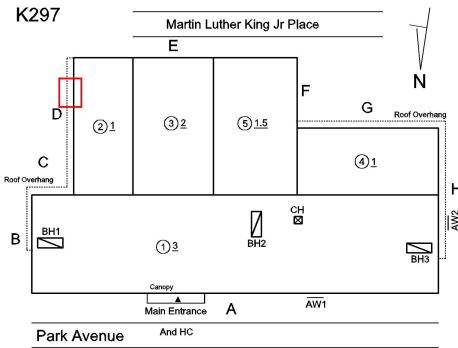
Facade D frame only
No violations recorded.

METAL: DETERIORATED DOOR AND FRAME - MAJOR DETERIORATION

2
EACH
REPLACE
PRIORITY 4
LEVEL 2

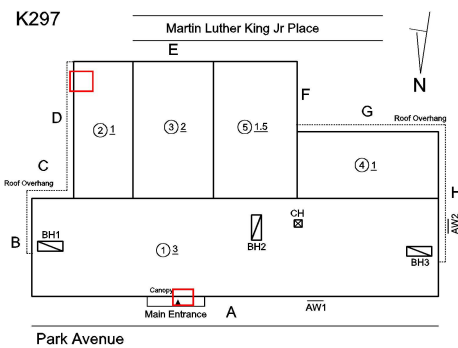
METAL: DETERIORATED DOOR - MINOR DETERIORATION

2
EACH
MAINTENANCE
PRIORITY 3
LEVEL 2
No photo recorded
No violations recorded.

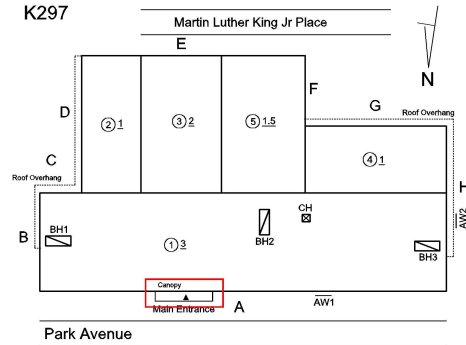
Deficiency	CLOGGED
Roof Plan reference	K297

Deficiency Quantity	1
Quantity Uom	EACH
Potential Action	MAINTENANCE
Urgency of Action	PRIORITY 5
Purpose of Action	LEVEL 2
Deficiency Photo1	No photo recorded
Violations	No violations recorded.

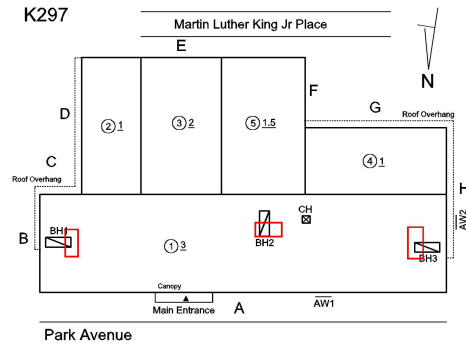
Deficiency	BULKHEAD/PENTHOUSE ROOF: DETERIORATED
Roof Plan reference	K297

Deficiency Quantity	20
Quantity Uom	S.F.
Potential Action	REPAIR
Urgency of Action	PRIORITY 3
Purpose of Action	LEVEL 2

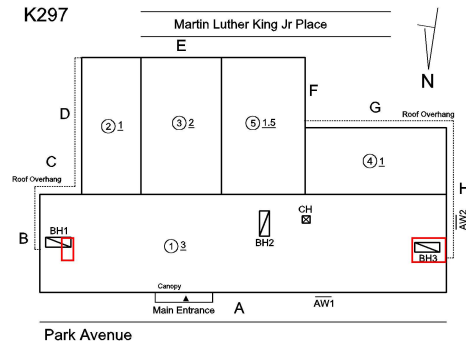
**BULKHEAD/PENTHOUSE WALLS/INTERIOR: CMU
 CRACKS/SPALLING**

REPLACE

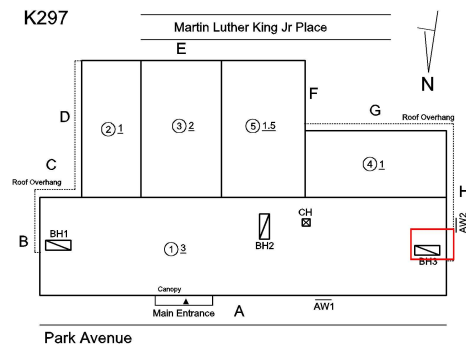
**BULKHEAD/PENTHOUSE CEILING: PLASTER
 DAMAGED/DETERIORATED**

REPLACE

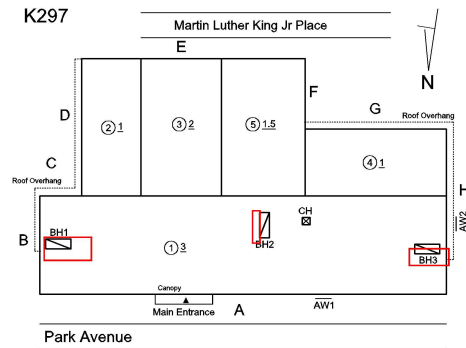
**BULKHEAD/PENTHOUSE WALLS/EXTERIOR:
CRACKS/SPALLING - MAJOR**

REPLACE

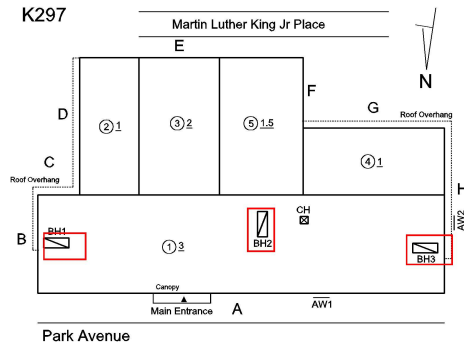
Bulkhead 3
No violations recorded.

**BULKHEAD/PENTHOUSE WALLS/EXTERIOR: DETERIORATED
JOINTS**

300
S.F.
REPOINT
PRIORITY 3
LEVEL 2

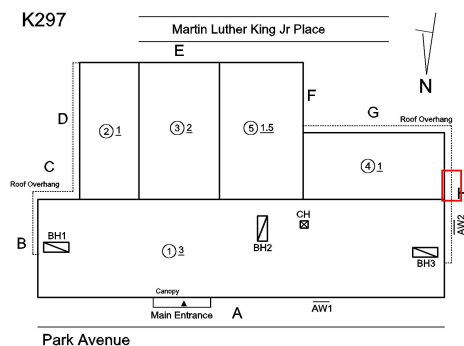
MISSING RAILING

Question	Response
EXTERIOR	
STAIRS/RAMPS: EXTERIOR	
RAILINGS	
Deficiency Quantity	10
Quantity Uom	L.F.
Potential Action	REPLACE
Urgency of Action	PRIORITY 5
Purpose of Action	LEVEL 6
Deficiency Photo1

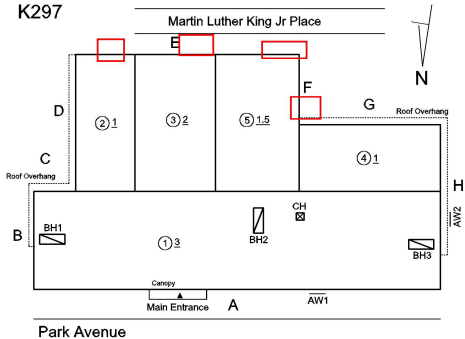
Exit 8
Violations	No violations recorded.
STAIRS/RAMPS	
Condition	Inspected
Deficiency	5 - Poor
Roof Plan reference	<p>CONCRETE: CRACKS/SPALLING - MAJOR</p>

<p>K297 Martin Luther King Jr Place Park Avenue</p>
Deficiency Quantity	30
Quantity Uom	S.F.
Potential Action	REPLACE
Urgency of Action	PRIORITY 4
Purpose of Action	LEVEL 2
Deficiency Photo1

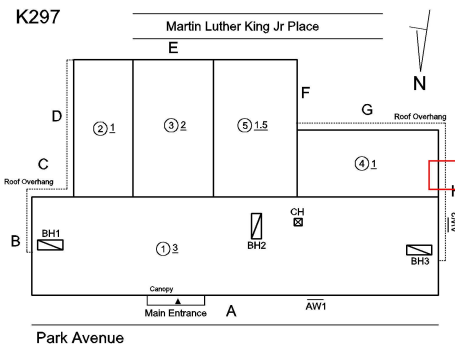
Exit 8
No violations recorded.

Exit 9
Violations	No violations recorded.
Deficiency	STONE: DETERIORATED JOINTS

10
L.F.
REPOINT
PRIORITY 3
LEVEL 2

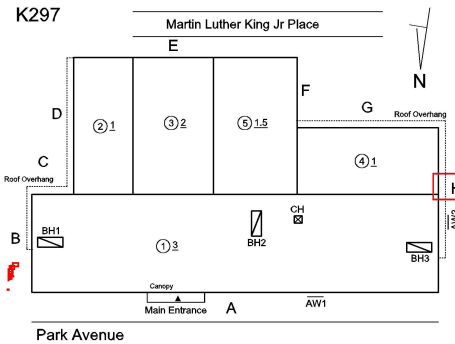
STONE: CRACKS/SPALLING - MAJOR

10
S.F.
REPLACE
PRIORITY 4
LEVEL 2

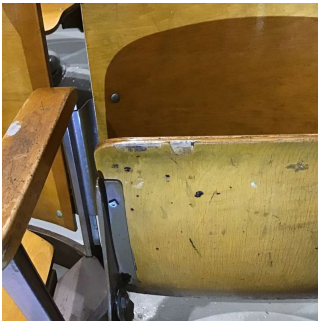
Violations	Boiler Room Pit No violations recorded.
FOUNDATION WALLS	
Material Type(s)	Inspected Concrete
Condition	2 - Between Good and Fair
Deficiency	No deficiencies recorded
ROOF STRUCTURE	
Condition	Inspected 2 - Between Good and Fair
Deficiency	No deficiencies recorded
VAULTS-BUNKERS	
	Does not Exist
AUDITORIUM	
Instance on 1st Floor (414 Seats)	Inspected Inspected
Ceiling	
Instance on 1st Floor (414 Seats)	Inspected
Condition	2 - Between Good and Fair
Deficiency	No deficiencies recorded
Door(s)	
Instance on 1st Floor (414 Seats)	Inspected
Condition	2 - Between Good and Fair
Deficiency	No deficiencies recorded
Fixed H/C Lift	
Instance on 1st Floor (414 Seats)	Does not Exist
Fixed Seating	
Instance on 1st Floor (414 Seats)	Inspected
Condition	3 - Fair
Deficiency	DAMAGED/BROKEN/INOPERABLE
Deficiency Location/Instance	Seats A/2,4,9, B/6,112, and others

Seat A/9
Violations	No violations recorded.
Floor Finish	
Instance on 1st Floor (414 Seats)	Inspected
Condition	2 - Between Good and Fair
Deficiency	VINYL TILES: BROKEN/DETERIORATED/MISSING TILES
Deficiency Location/Instance	Right Aisle
Deficiency Quantity	10
Quantity Uom	S.F.
Potential Action	REPLACE
Urgency of Action	PRIORITY 3
Purpose of Action	LEVEL 2
Deficiency Photo1

Deficiency Quantity	13
Quantity Uom	EACH
Potential Action	REPLACE
Urgency of Action	PRIORITY 3
Purpose of Action	LEVEL 2

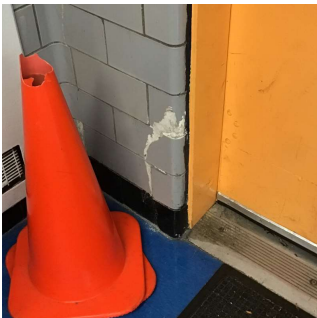
Exit 7
Violations	No violations recorded.
Deficiency	GLAZED BLOCK: CRACKS/SPALLING
Deficiency Location/Instance	Exit 7
Deficiency Quantity	10
Quantity Uom	S.F.
Potential Action	REPLACE
Urgency of Action	PRIORITY 3
Purpose of Action	LEVEL 2
Deficiency Photo1

Exit 7
Violations	No violations recorded.
Window Curtains/Shades/Blinds	
Instance on 1st Floor	Does not Exist
CLASSROOMS/CORRIDORS/ADMIN SPACES	
Ceiling	Inspected
Condition	2 - Between Good and Fair
Deficiency	PLASTER: CRACKS/SPALLING
Deficiency Location/Instance	Room 137
Deficiency Quantity	25
Quantity Uom	S.F.
Potential Action	REPLACE
Urgency of Action	PRIORITY 3
Purpose of Action	LEVEL 2

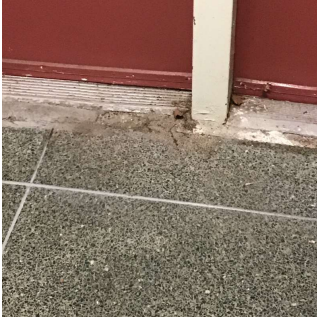
Question	Response
INTERIOR	
CLASSROOMS/CORRIDORS/ADMIN SPACES	
Door(s)	Inspected
	Room 137 Vestibule
Violations	No violations recorded.
Floor Finish	Inspected
Condition	2 - Between Good and Fair
Deficiency	TERRAZZO: CRACKS
Deficiency Location/Instance	Exit 4 Vestibule, Main Entrance Vestibule
Deficiency Quantity	20
Quantity Uom	S.F.
Potential Action	REPLACE
Urgency of Action	PRIORITY 3
Purpose of Action	LEVEL 2
Deficiency Photo1

Exit 4 Vestibule
Violations	No violations recorded.
Deficiency	VINYL TILES: BROKEN/DETERIORATED/MISSING TILES
Deficiency Location/Instance	Rooms 204, 205, 304, 308, 314, and others
Deficiency Quantity	100
Quantity Uom	S.F.
Potential Action	REPLACE
Urgency of Action	PRIORITY 3
Purpose of Action	LEVEL 2
Deficiency Photo1

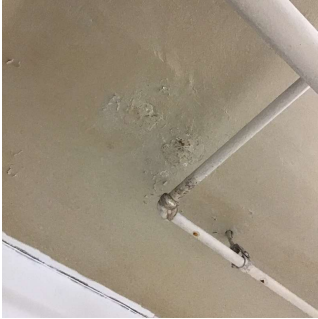
Question	Response
INTERIOR	
CLASSROOMS/CORRIDORS/ADMIN SPACES	Inspected
Walls	Inspected
Violations	Exit 4 Vestibule No violations recorded.
Specialties	Does not Exist
GYMNASIUM	Inspected
Instance on Basement	Inspected
Ceiling	
Instance on Basement	Inspected
Condition	2 - Between Good and Fair
Deficiency	PLASTER: CRACKS/SPALLING
Deficiency Location/Instance	Office
Deficiency Quantity	10
Quantity Uom	S.F.
Potential Action	REPLACE
Urgency of Action	PRIORITY 3
Purpose of Action	LEVEL 2
Deficiency Photo1

Violations	Office No violations recorded.
Door(s)	
Instance on Basement	Inspected
Condition	2 - Between Good and Fair
Deficiency	No deficiencies recorded
Fixed Equipment	
Instance on Basement	Inspected
Condition	2 - Between Good and Fair
Deficiency	No deficiencies recorded
Floor Finish	
Instance on Basement	Inspected
Condition	2 - Between Good and Fair
Deficiency	WOOD: DAMAGED/DETERIORATED
Deficiency Location/Instance	Entrance, Near Drinking Fountain, Near Exit 6

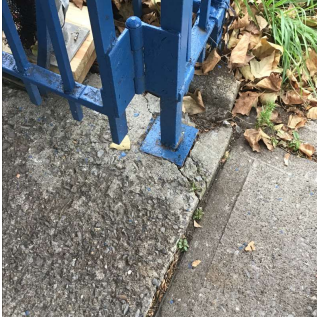
Question	Response
SITE	
PAVING	
Site Sidewalks & Walkways	
Asphalt	Does not Exist
Concrete	Inspected
Condition	3 - Fair
Deficiency	HEAVING
Deficiency Location/Instance	Near Exit 7
Deficiency Quantity	50
Quantity Uom	S.F.
Potential Action	REPLACE
Urgency of Action	PRIORITY 3
Purpose of Action	LEVEL 2
Deficiency Photo1	 
	Near Exit 7
Violations	No violations recorded.
Deficiency	DAMAGED/DETERIORATED/MISSING SECTIONS
Deficiency Location/Instance	Park Avenue, Martin Luther King Jr. Place
Deficiency Quantity	225
Quantity Uom	S.F.
Potential Action	REPLACE
Urgency of Action	PRIORITY 3
Purpose of Action	LEVEL 2
Deficiency Photo1

Park Avenue
Violations	No violations recorded.
Pavers	Does not Exist
DOT Sidewalk	Inspected
Asphalt	Does not Exist
Concrete	Inspected
Condition	4 - Between Fair and Poor
Deficiency	HEAVING
Deficiency Location/Instance	Park Avenue, Martin Luther King Jr. Place
Deficiency Quantity	225
