NYC Department of Education
Building Condition Assessment Survey 2023 - 2024

Architectural Inspection

Asset: P.S. 298 - BROOKLYN, 85 WATKINS STREET, New York, 11212

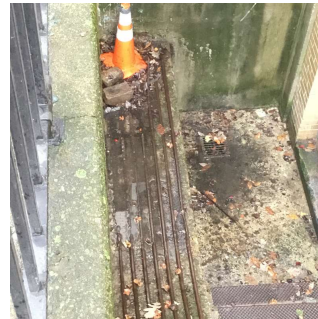
AW1

AREAWAY STAIRS: DETERIORATED MATERIAL SLIDE

Deficiency Quantity

40

REPLACE

LEVEL 2

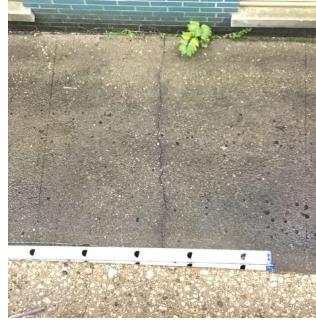
AW3
No violations recorded.

AREAWAY SLAB: CRACKS AND SPALLING

70
S.F.
REPAIR
PRIORITY 3
LEVEL 2

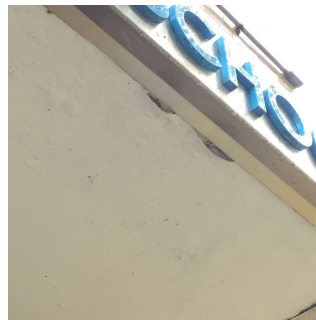
Facade D
No violations recorded.

METAL: DETERIORATION/DAMAGED/MISSING PIECES

Deficiency Quantity

10

REPAIR

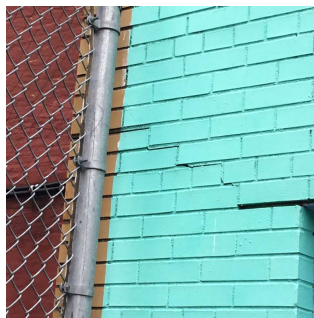
Deficiency
BRICK: CRACKS/DISPLACED/SPALLED BRICK AT BUILDING CORNERS

25
S.F.
REMOVE AND REBUILD
PRIORITY 4
LEVEL 2

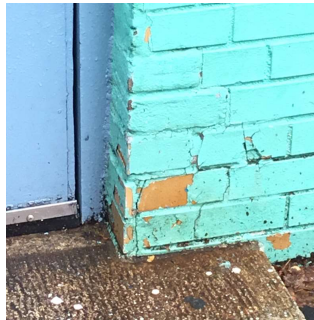
Facade E

BRICK: MAJOR / THRU CRACKS

Deficiency Quantity

10

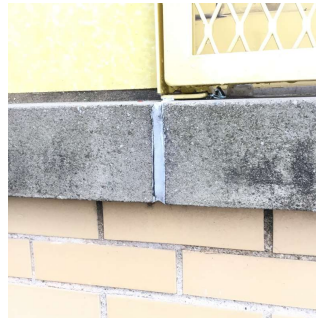
Facade C

BRICK: MASONRY SILLS - DETERIORATED JOINTS

Deficiency Quantity

50

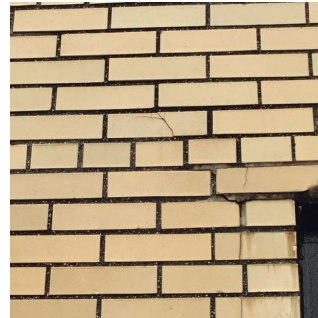
Facade B

BRICK: MINOR CRACKS AND SPALLING

Deficiency Quantity

400

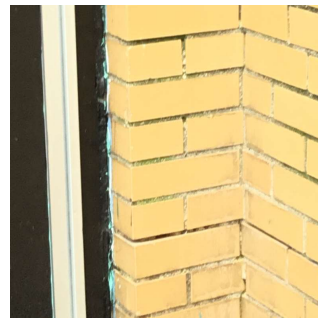
Facade B

BRICK: DETERIORATED JOINTS

Deficiency Quantity

25

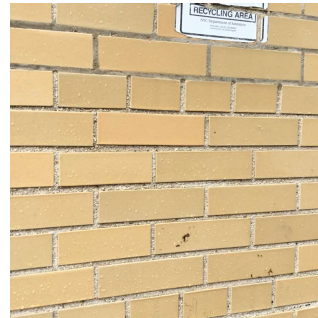
Facade A

BRICK: DETERIORATED JOINTS

Deficiency Quantity

1,200

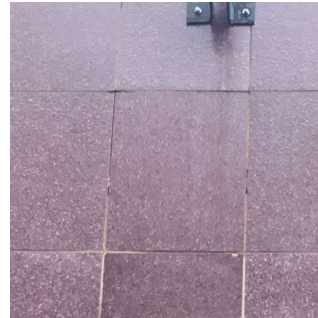
Facade F

CERAMIC TILE: DETERIORATED JOINTS

Deficiency Quantity

15

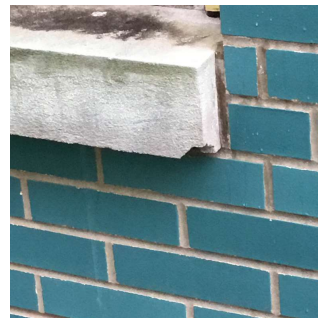
Courtyard

BRICK: DETERIORATED MASONRY SILLS - MINOR

REPAIR

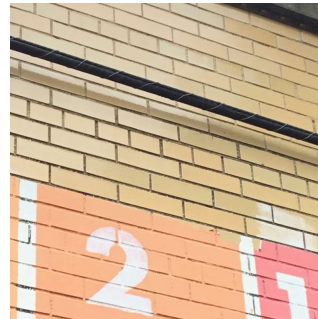
Facade E

BRICK: DETERIORATED JOINTS

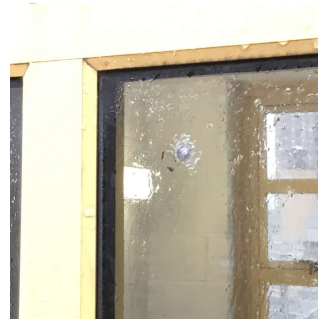
BH1

BULKHEAD/PENTHOUSE WINDOWS: DAMAGED, DETERIORATED WINDOWS

30
S.F.
REPLACE
PRIORITY 4
LEVEL 2

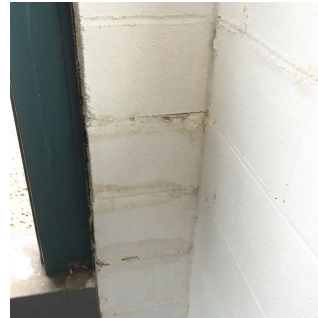
Roof 1

**BULKHEAD/PENTHOUSE WALLS/INTERIOR: CMU
CRACKS/SPALLING**

15
S.F.
REPLACE
PRIORITY 3
LEVEL 2

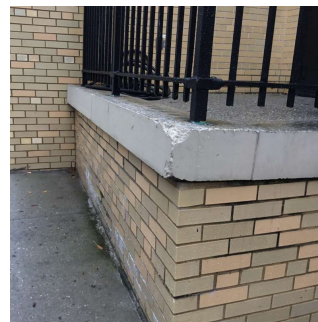
Facade B

BRICK: DETERIORATED COPING STONE

10
S.F.
REPLACE
PRIORITY 4
LEVEL 2

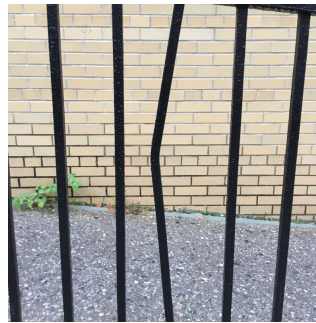
Facade B

DAMAGED

20
L.F.
REPLACE
PRIORITY 4
LEVEL 2

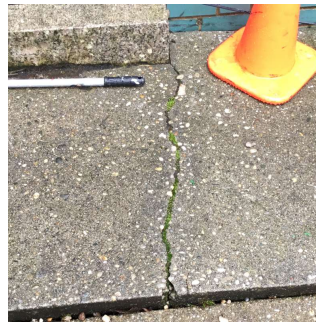
Courtyard

CONCRETE: CRACKS/SPALLING - MAJOR

20
S.F.
REPLACE
PRIORITY 4
LEVEL 2

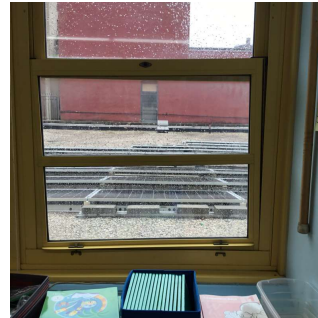
Facade D - Room 229

Violations	Facade B No violations recorded.
LINTELS	Inspected
Condition	2 - Between Good and Fair
Deficiency	No deficiencies recorded
WINDOWS	Inspected
Material Type(s)	Aluminum
Instance on Aluminum - Double Hung: All Facades	Inspected
Instance Condition	3 - Fair
Instance Quantity	12,000
Instance Quantity Uom	S.F.
Are these windows insulated	Yes
Installation Year	2010
Source of Installation	Custodial Staff
Deficiency	ALUMINUM - DOUBLE HUNG: INOPERABLE BALANCE
Roof Plan reference	K298

Deficiency Quantity	120
Quantity Uom	EACH
Potential Action	REPLACE BALANCES
Urgency of Action	PRIORITY 3

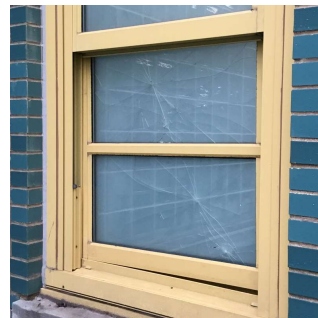
Courtyard (Facade G - Room 330 similar)

ALUMINUM - DOUBLE HUNG: BROKEN PANE

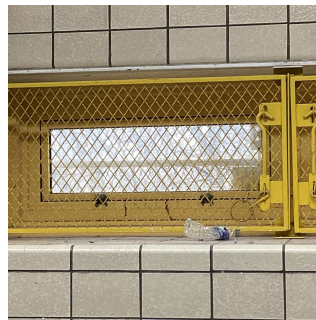
Facade D - Stair EF/1

Violations	No violations recorded.
Instance on Aluminum - Other: All Facades	Inspected
Instance Condition	2 - Between Good and Fair
Instance Quantity	2,000
Instance Quantity Uom	S.F.
Are these windows insulated	Yes
Installation Year	2010
Source of Installation	Custodial Staff
Deficiency	ALUMINUM - OTHER: BROKEN PANE
Roof Plan reference	K298

Deficiency Quantity	60
Quantity Uom	S.F.
Potential Action	MAINTENANCE
Urgency of Action	PRIORITY 3
Purpose of Action	LEVEL 2
Deficiency Photo1

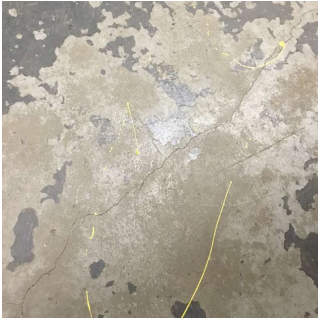
Question	Response
INTERIOR	
STRUCTURAL	Inspected
COLUMNS/BEAMS/BEARING WALLS	Inspected
Condition	2 - Between Good and Fair
Deficiency	No deficiencies recorded
FLOOR STRUCTURE	Inspected
Condition	3 - Fair
Deficiency	CONCRETE SLAB ON GRADE: THRU CRACKS
Deficiency Location/Instance	Basement
Deficiency Quantity	90
Quantity Uom	S.F.
Potential Action	REPAIR
Urgency of Action	PRIORITY 3
Purpose of Action	LEVEL 5
Deficiency Photo1

Violations	Basement Fan Area (Boiler Room, Rooms B6, B8 similar) No violations recorded.
FOUNDATION WALLS	Inspected
Material Type(s)	Concrete
Condition	3 - Fair
Deficiency	CONCRETE: WATER INFILTRATION IN NON- INSTRUCTIONAL SPACE
Deficiency Location/Instance	Basement
Deficiency Quantity	50
Quantity Uom	S.F.
Potential Action	INSTALL WATERPROOFING
Urgency of Action	PRIORITY 5
Purpose of Action	LEVEL 5
Deficiency Photo1

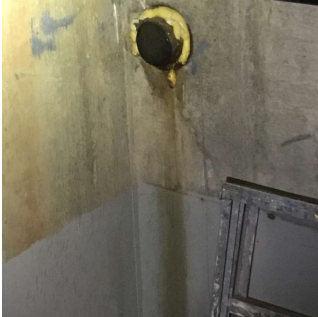
Violations	Oil Tank Room No violations recorded.
ROOF STRUCTURE	Inspected

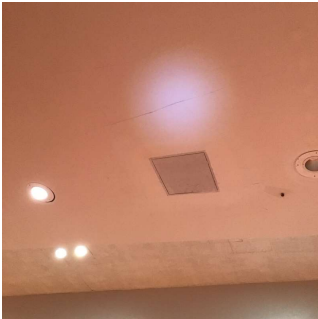
Question	Response
INTERIOR	
STRUCTURAL	
VAULTS-BUNKERS	Inspected
Foundation Walls	Inspected
Condition	2 - Between Good and Fair
Deficiency	No deficiencies recorded
Slab Structure	Inspected
Condition	2 - Between Good and Fair
Deficiency	No deficiencies recorded
Vault/Ash Hoist Doors and Framing	Does not Exist
AUDITORIUM	Inspected
Instance on 1st Floor (427 seats)	Inspected
Ceiling	
Instance on 1st Floor (427 seats)	Inspected
Condition	2 - Between Good and Fair
Deficiency	GYPSUM BOARD: DAMAGED/DETERIORATED
Deficiency Location/Instance	Near right side of stage
Deficiency Quantity	10
Quantity Uom	S.F.
Potential Action	REPLACE
Urgency of Action	PRIORITY 3
Purpose of Action	LEVEL 2
Deficiency Photo1

Violations	Near right side of stage No violations recorded.
Deficiency	ACOUSTIC TILES ON PLASTER: DAMAGED/MISSING
Deficiency Location/Instance	Near stage
Deficiency Quantity	10
Quantity Uom	S.F.
Potential Action	REPLACE
Urgency of Action	PRIORITY 3

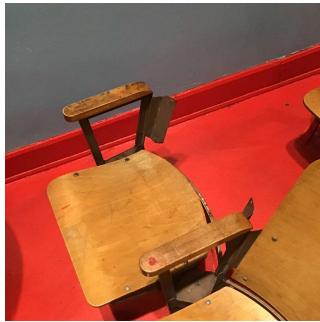
Question	Response
INTERIOR	
AUDITORIUM	
Ceiling	
Violations	No violations recorded.
Door(s)	
Instance on 1st Floor (427 seats)	Inspected
Condition	2 - Between Good and Fair
Deficiency	No deficiencies recorded
Fixed H/C Lift	
Instance on 1st Floor (427 seats)	Does not Exist
Fixed Seating	
Instance on 1st Floor (427 seats)	Inspected
Condition	4 - Between Fair and Poor
Deficiency	DAMAGED/BROKEN/INOPERABLE
Deficiency Location/Instance	Seat A/111, J/8, P/2
Deficiency Quantity	3
Quantity Uom	EACH
Potential Action	REPLACE
Urgency of Action	PRIORITY 5
Purpose of Action	LEVEL 6
Deficiency Photo1

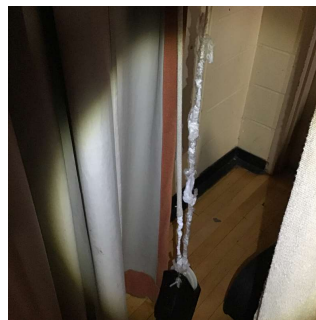
Condition	5 - Poor
-----------	----------

Deficiency	INOPERABLE
Deficiency Location/Instance	Right side
Deficiency Quantity	1
Quantity Uom	EACH
Potential Action	MAINTENANCE
Urgency of Action	PRIORITY 3
Purpose of Action	LEVEL 2
Deficiency Photo1

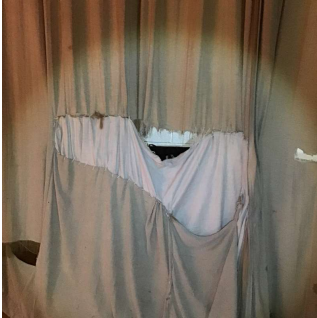
Question	Response
INTERIOR	
AUDITORIUM	
Stage	
Stage Curtain Rigging	Inspected
	Right side
Violations	No violations recorded.
Stage Curtains	Inspected
Instance on 1st Floor (427 seats)	Inspected
Condition	4 - Between Fair and Poor
Deficiency	WORN/DETERIORATED
Deficiency Location/Instance	Right side, left side
Deficiency Quantity	400
Quantity Uom	S.F.
Potential Action	REPLACE
Urgency of Action	PRIORITY 3
Purpose of Action	LEVEL 2
Deficiency Photo1

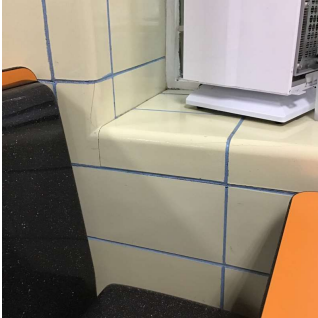
Question	Response
INTERIOR	
CAFETERIA	
Ceiling	
Deficiency Photo1	 
Violations	Near Courtyard exit No violations recorded.
Deficiency	ACOUSTIC TILES ON PLASTER: DAMAGED/MISSING
Deficiency Location/Instance	Near entrance
Deficiency Quantity	10
Quantity Uom	S.F.
Potential Action	REPLACE
Urgency of Action	PRIORITY 5
Purpose of Action	LEVEL 6
Deficiency Photo1	 
Violations	Near Entrance No violations recorded.
Door(s)	
Instance on 1st Floor	Inspected
Condition	2 - Between Good and Fair
Deficiency	No deficiencies recorded
Fixed Equipment	
Instance on 1st Floor	Does not Exist
Floor Finish	
Instance on 1st Floor	Inspected
Condition	2 - Between Good and Fair
Deficiency	No deficiencies recorded
Sliding-folding Partition	
Instance on 1st Floor	Does not Exist
Stage	
Instance on 1st Floor	Does not Exist
Walls	
Instance on 1st Floor	Inspected
Condition	2 - Between Good and Fair
Deficiency	GLAZED BLOCK: CRACKS/SPALLING

Question	Response
INTERIOR	
CAFETERIA	
Walls	
Deficiency Location/Instance	Near Entrance, near windows
Deficiency Quantity	20
Quantity Uom	S.F.
Potential Action	REPLACE
Urgency of Action	PRIORITY 3
Purpose of Action	LEVEL 2
Deficiency Photo1

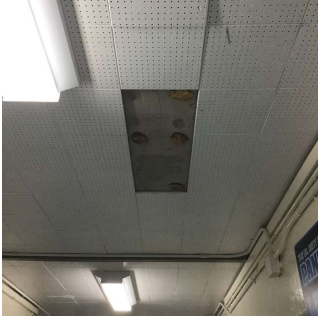
Violations	Near Entrance No violations recorded.
Window Curtains/Shades/Blinds	
Instance on 1st Floor	Does not Exist
CLASSROOMS/CORRIDORS/ADMIN SPACES	
Ceiling	Inspected
Condition	2 - Between Good and Fair
Deficiency	ACOUSTIC TILES ON PLASTER: DAMAGED/MISSING
Deficiency Location/Instance	Corridor near Room 130, 123, exit 10 Vestibule
Deficiency Quantity	20
Quantity Uom	S.F.
Potential Action	REPLACE
Urgency of Action	PRIORITY 3
Purpose of Action	LEVEL 2
Deficiency Photo1

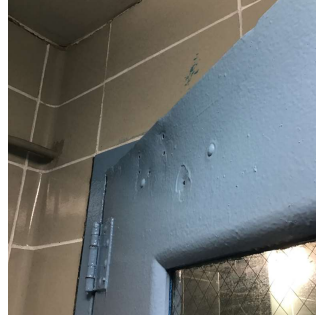
Violations	Corridor near Room 123 No violations recorded.
Door(s)	
Condition	Inspected
Condition	5 - Poor
Deficiency	METAL: DETERIORATED DOOR
Deficiency Location/Instance	Exit 10 Vestibule
Deficiency Quantity	2

Quantity Uom	EACH
Potential Action	MAINTENANCE

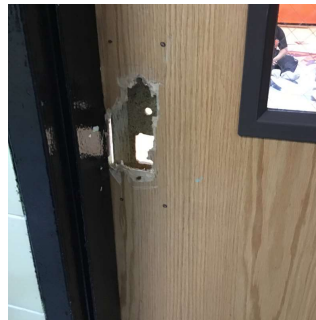
Room 428

WOOD: DETERIORATED DOOR

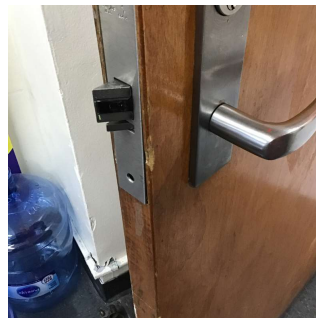
WOOD: DETERIORATED DOOR

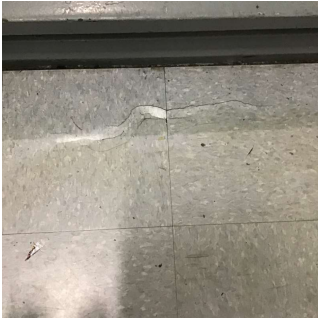
Question	Response
INTERIOR	
CLASSROOMS/CORRIDORS/ADMIN SPACES	
Door(s)	Inspected
	Room 431
Violations	No violations recorded.
Floor Finish	Inspected
Condition	2 - Between Good and Fair
Deficiency	VINYL TILES: DETERIORATED SUBSTRATE
Deficiency Location/Instance	Gymnasium Exit Vestibule
Deficiency Quantity	10
Quantity Uom	S.F.
Potential Action	REPLACE
Urgency of Action	PRIORITY 3
Purpose of Action	LEVEL 2
Deficiency Photo1

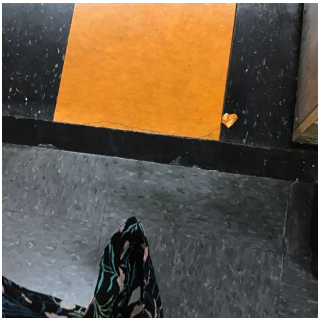
Gymnasium Exit Vestibule
Violations	No violations recorded.
Deficiency	VINYL TILES: BROKEN/DETERIORATED/MISSING TILES
Deficiency Location/Instance	Room 430, 325, 124
Deficiency Quantity	600
Quantity Uom	S.F.
Potential Action	REPLACE
Urgency of Action	PRIORITY 3
Purpose of Action	LEVEL 2
Deficiency Photo1

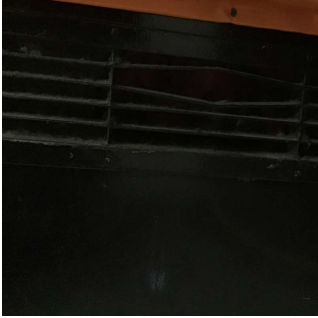
Question	Response
INTERIOR	
CLASSROOMS/CORRIDORS/ADMIN SPACES	
Floor Finish	Inspected
Purpose of Action	LEVEL 2
Deficiency Photo1	 
	Lobby
Violations	No violations recorded.
Walls	Inspected
Condition	2 - Between Good and Fair
Deficiency	GLAZED BLOCK: CRACKS/SPALLING
Deficiency Location/Instance	Corridor near Room 436, 323, 212B, 108, Exit 9 Vestibule, Main Entrance Vestibule
Deficiency Quantity	40
Quantity Uom	S.F.
Potential Action	REPLACE
Urgency of Action	PRIORITY 3
Purpose of Action	LEVEL 2
Deficiency Photo1	 
	Corridor near Room 108
Violations	No violations recorded.
Specialties	Does not Exist
GYMNASIUM	Inspected
Instance on 1st Floor	Inspected
Ceiling	
Instance on 1st Floor	Inspected
Condition	2 - Between Good and Fair
Deficiency	No deficiencies recorded
Door(s)	
Instance on 1st Floor	Inspected
Condition	3 - Fair
Deficiency	WOOD: DAMAGED LOUVER
Deficiency Location/Instance	Storage Room
Deficiency Quantity	1
Quantity Uom	EACH

Question	Response
INTERIOR	
GYMNASIUM	
Door(s)	
Potential Action	MAINTENANCE
Urgency of Action	PRIORITY 3
Purpose of Action	LEVEL 2
Deficiency Photo1

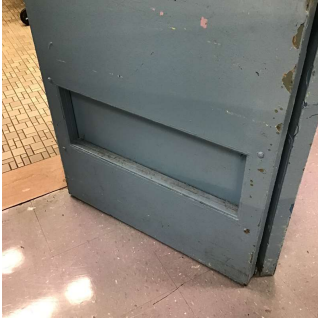
Question	Response
INTERIOR	
KITCHEN	
Door(s)	
Deficiency Location/Instance	Entrance
Deficiency Quantity	2
Quantity Uom	EACH
Potential Action	MAINTENANCE
Urgency of Action	PRIORITY 3
Purpose of Action	LEVEL 2
Deficiency Photo1

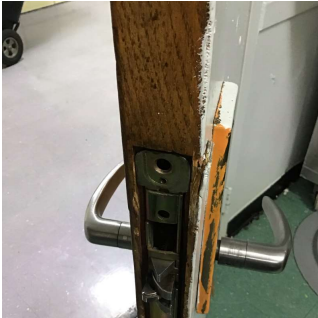
Violations	Entrance No violations recorded.
Deficiency	WOOD: DETERIORATED DOOR
Deficiency Location/Instance	Room 132
Deficiency Quantity	1
Quantity Uom	EACH
Potential Action	MAINTENANCE
Urgency of Action	PRIORITY 3
Purpose of Action	LEVEL 2
Deficiency Photo1

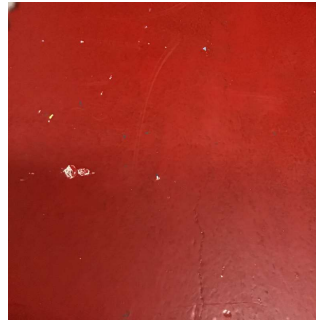
Violations	Room 132 No violations recorded.
Floor Finish	
Instance on 1st Floor	Inspected
Condition	2 - Between Good and Fair
Deficiency	CONCRETE: CRACKS
Deficiency Location/Instance	Office
Deficiency Quantity	10
Quantity Uom	S.F.
Potential Action	REPLACE
Urgency of Action	PRIORITY 3
Purpose of Action	LEVEL 2

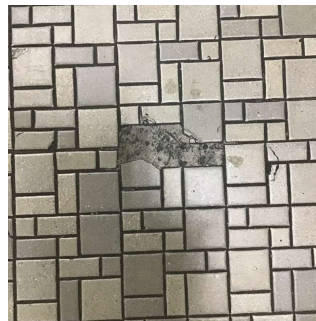
Near Sink

Deficiency	CERAMIC TILE: BROKEN/MISSING TILES
Deficiency Location/Instance	Near Entrance, sink
Deficiency Quantity	10
Quantity Uom	S.F.
Potential Action	REPLACE
Urgency of Action	PRIORITY 3
Purpose of Action	LEVEL 2
Deficiency Photo1

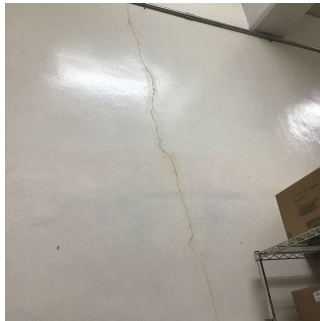
Instance on 1st Floor	Inspected
Condition	2 - Between Good and Fair
Deficiency	MASONRY: CRACKS/SPALLING
Deficiency Location/Instance	Office
Deficiency Quantity	30
Quantity Uom	S.F.
Potential Action	REPLACE
Urgency of Action	PRIORITY 3
Purpose of Action	LEVEL 2

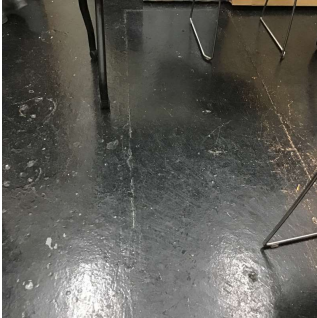
Question	Response
INTERIOR	
LOCKER ROOM	
Floor Finish	
Instance on 1st Floor - Girls	Inspected
Condition	2 - Between Good and Fair
Deficiency	CONCRETE: CRACKS
Deficiency Location/Instance	Center
Deficiency Quantity	10
Quantity Uom	S.F.
Potential Action	REPLACE
Urgency of Action	PRIORITY 3
Purpose of Action	LEVEL 2
Deficiency Photo1

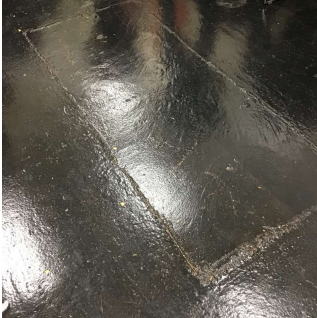
Center
Violations	No violations recorded.
Instance on 1st Floor - Boys	Inspected
Condition	2 - Between Good and Fair
Deficiency	CONCRETE: CRACKS
Deficiency Location/Instance	Center
Deficiency Quantity	10
Quantity Uom	S.F.
Potential Action	REPLACE
Urgency of Action	PRIORITY 3
Purpose of Action	LEVEL 2
Deficiency Photo1

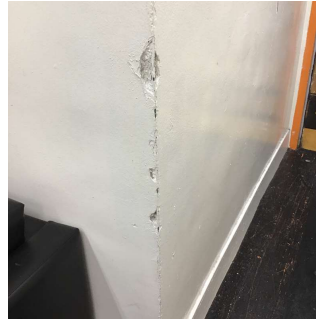
Center
Violations	No violations recorded.
Locker Room Lockers	
Instance on 1st Floor - Girls	Does not Exist
Instance on 1st Floor - Boys	Does not Exist
Walls	
Instance on 1st Floor - Girls	Inspected
Condition	2 - Between Good and Fair
Deficiency	PLASTER: CRACKS/SPALLING

Deficiency Location/Instance	Near Entrance
Deficiency Quantity	10
Quantity Uom	S.F.
Potential Action	REPLACE
Urgency of Action	PRIORITY 3
Purpose of Action	LEVEL 2
Deficiency Photo1

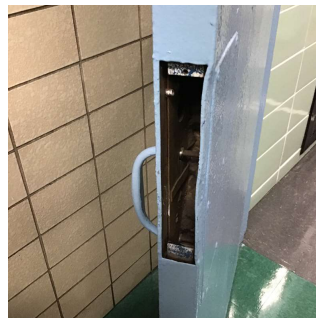
Condition	3 - Fair
-----------	----------

Deficiency	METAL: DETERIORATED DOOR
------------	--------------------------

Deficiency Location/Instance	Stair AB/3, AB/2
------------------------------	------------------

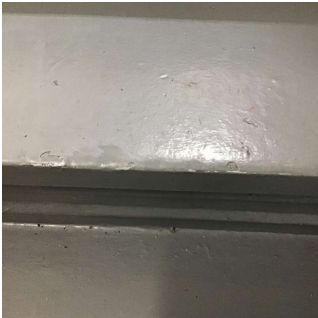
Question	Response
INTERIOR	
STAIRS/RAMPS: INTERIOR	
Door(s)	Inspected
	Stair AB/3
Violations	No violations recorded.
Partition	Does not Exist
Railings	Inspected
Condition	2 - Between Good and Fair
Deficiency	No deficiencies recorded
Stairs and Landings	Inspected
Condition	4 - Between Fair and Poor
Deficiency	VINYL TILES: BROKEN/DETERIORATED/MISSING TILES
Deficiency Location/Instance	Exit 3 near stage
Deficiency Quantity	10
Quantity Uom	S.F.
Potential Action	REPLACE
Urgency of Action	PRIORITY 3
Purpose of Action	LEVEL 2
Deficiency Photo1	 
Violations	Exit 3 near stage No violations recorded.
Deficiency	VINYL TILES: DETERIORATED SUBSTRATE
Deficiency Location/Instance	Stair AB/2
Deficiency Quantity	10
Quantity Uom	S.F.
Potential Action	REPLACE
Urgency of Action	PRIORITY 3
Purpose of Action	LEVEL 2
Deficiency Photo1	 
Violations	Stair AB/2 No violations recorded.
Deficiency	CONCRETE: CRACKS/SPALLING - MAJOR
Deficiency Location/Instance	Stair EF/1, 2, 3, 4, AB/1, 2, 3, 4

Question	Response
INTERIOR	
STAIRS/RAMPS: INTERIOR	
Stairs and Landings	
Deficiency Quantity	200
Quantity Uom	S.F.
Potential Action	REPLACE
Urgency of Action	PRIORITY 3
Purpose of Action	LEVEL 2
Deficiency Photo1

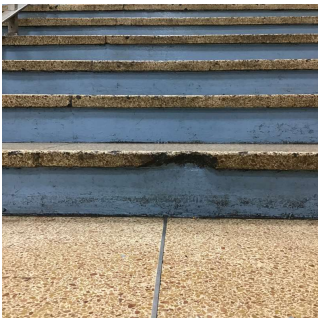
Stair EF/1
Violations	No violations recorded.
Deficiency	TERRAZZO: CRACKS
Deficiency Location/Instance	Lobby Stairs, exit 9 Vestibule
Deficiency Quantity	100
Quantity Uom	S.F.
Potential Action	REPLACE
Urgency of Action	PRIORITY 5
Purpose of Action	LEVEL 6
Deficiency Photo1

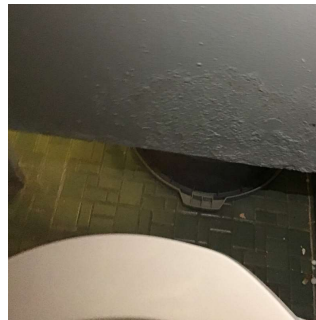
Kitchen Staff

RUST - MAJOR

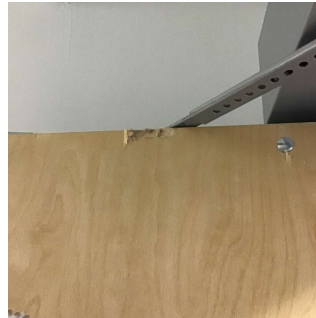
2nd Floor - Boys

WOOD: DETERIORATED DOOR

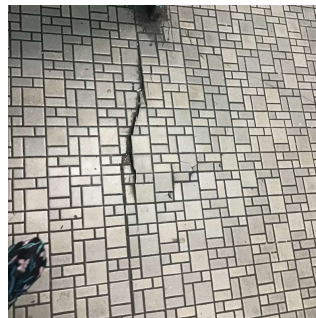
CERAMIC TILE: DETERIORATED SUBSTRATE

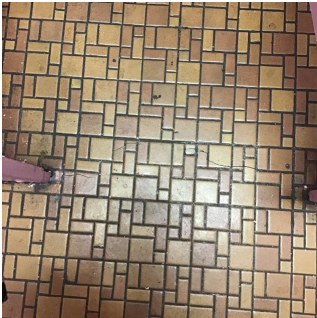
Question	Response
INTERIOR	
TOILET ROOMS - STUDENTS	
Floor Finish	
Violations	4th Floor Boys No violations recorded.
Deficiency	CERAMIC TILE: BROKEN/MISSING TILES
Deficiency Location/Instance	4th Floor Girls, Boys, 3rd Floor - Girls
Deficiency Quantity	20
Quantity Uom	S.F.
Potential Action	REPLACE
Urgency of Action	PRIORITY 3
Purpose of Action	LEVEL 2
Deficiency Photo1

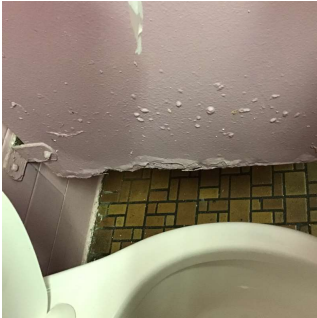
Violations	4th Floor Girls No violations recorded.
Stalls	Inspected
Condition	5 - Poor
Deficiency	RUST - MAJOR
Deficiency Location/Instance	4th Floor Girls, Boys, 3rd Floor - Boys, Girls, 1st Floor Gymnasium - Boys, Girls
Deficiency Quantity	16
Quantity Uom	EACH
Potential Action	REPLACE
Urgency of Action	PRIORITY 3
Purpose of Action	LEVEL 2
Deficiency Photo1

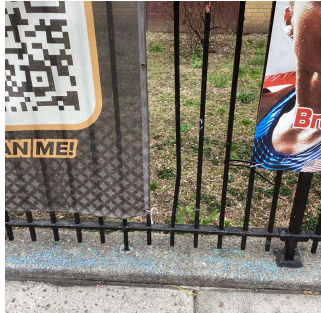
Violations	Near Schoolyard No violations recorded.
Deficiency	CHAIN LINK: RUST - MAJOR
Deficiency Location/Instance	Schoolyard
Deficiency Quantity	1,000
Quantity Uom	S.F.
Potential Action	REPLACE
Urgency of Action	PRIORITY 3
Purpose of Action	LEVEL 2
Deficiency Photo1	No photo recorded
Violations	No violations recorded.
Deficiency	WROUGHT IRON: DAMAGED/DETERIORATED
Deficiency Location/Instance	Along Watkins Street, Glenmore Avenue
Deficiency Quantity	160
Quantity Uom	S.F.

Potential Action	REPLACE
Urgency of Action	PRIORITY 3
Purpose of Action	LEVEL 2
Deficiency Photo1

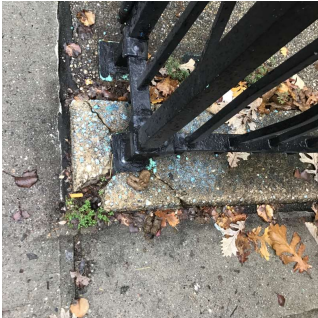
Question	Response
SITE	
FENCES	Inspected
	Along Watkins Stree
Violations	No violations recorded.
Deficiency	CONCRETE CURB: DAMAGED/DETERIORATED
Deficiency Location/Instance	Along Mother Gaston Boulevard, Watkins Street
Deficiency Quantity	10
Quantity Uom	S.F.
Potential Action	REPLACE
Urgency of Action	PRIORITY 3
Purpose of Action	LEVEL 2
Deficiency Photo1

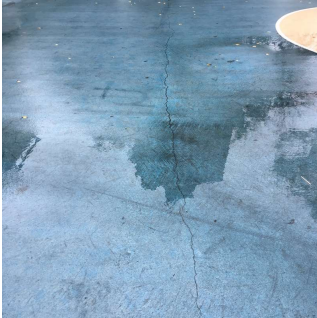
Violations	Along Mother Gaston Boulevard No violations recorded.
IRRIGATION SYSTEM	Does not Exist
PAVING	Inspected
Student Non-Use	Inspected
Gravel Exists?	No
Asphalt	Does not Exist
Concrete	Inspected
Condition	2 - Between Good and Fair
Deficiency	No deficiencies recorded
Pavers	Does not Exist
Student Use	Inspected
Gravel Exists?	No
Asphalt	Inspected
Condition	3 - Fair
Deficiency	CRACKS - MAJOR
Deficiency Location/Instance	Near Playground, center, right side, and left side
Deficiency Quantity	100
Quantity Uom	S.F.
Potential Action	REPLACE
Urgency of Action	PRIORITY 3

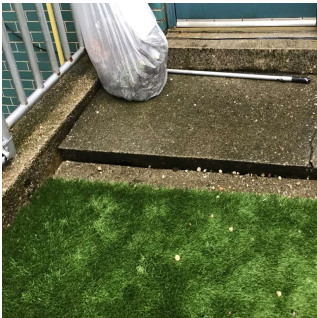
Violations	Near playground No violations recorded.
Concrete	Inspected
Condition	2 - Between Good and Fair
Deficiency	CRACKS - MAJOR
Deficiency Location/Instance	Mother Gaston Boulevard
Deficiency Quantity	25
Quantity Uom	S.F.
Potential Action	REPLACE
Urgency of Action	PRIORITY 3
Purpose of Action	LEVEL 2
Deficiency Photo1	No photo recorded
Violations	No violations recorded.
Pavers	Does not Exist
Site Sidewalks & Walkways	Inspected
Asphalt	Does not Exist
Concrete	Inspected
Condition	3 - Fair
Deficiency	HEAVING
Deficiency Location/Instance	Courtyard, Main Entrance near Mother Gaston Boulevard
Deficiency Quantity	20
Quantity Uom	S.F.
Potential Action	REPLACE
Urgency of Action	PRIORITY 3
Purpose of Action	LEVEL 2
Deficiency Photo1

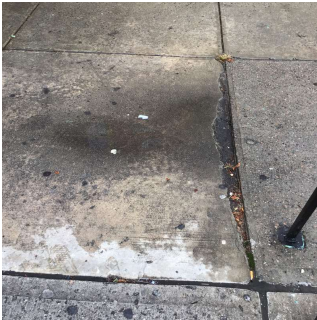
Question	Response
SITE	
PAVING	
Site Sidewalks & Walkways	
Concrete	
Deficiency	CRACKS - MAJOR
Deficiency Location/Instance	Courtyard, Main Entrance along Watkins Street
Deficiency Quantity	50
Quantity Uom	S.F.
Potential Action	REPLACE
Urgency of Action	PRIORITY 3
Purpose of Action	LEVEL 2
Deficiency Photo1

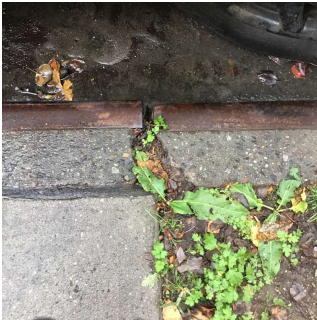
Violations	Main Entrance along Watkins Street No violations recorded.
Pavers	Does not Exist
DOT Sidewalk	Inspected
Asphalt	Does not Exist
Concrete	Inspected
Condition	4 - Between Fair and Poor
Deficiency	DAMAGED CURBS
Deficiency Location/Instance	Along Mother Gaston Boulevard, Glenmore Avenue, and Watkins Street
Deficiency Quantity	70
Quantity Uom	L.F.
Potential Action	REPLACE
Urgency of Action	PRIORITY 3
Purpose of Action	LEVEL 2
Deficiency Photo1

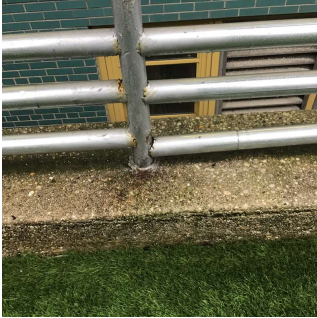
Question	Response
SITE	
RETAINING WALLS	
Deficiency Quantity	50
Quantity Uom	S.F.
Potential Action	REPLACE
Urgency of Action	PRIORITY 3
Purpose of Action	LEVEL 2
Deficiency Photo1	 
Violations	Schoolyard near Entrance No violations recorded.
SEATING	Inspected
Benches	Inspected
Concrete	Does not Exist
Metal/Wood/Plastic	Inspected
Condition	4 - Between Fair and Poor
Deficiency	DAMAGED/DETERIORATED
Deficiency Location/Instance	Near Playground
Deficiency Quantity	2
Quantity Uom	EACH
Potential Action	REPLACE
Urgency of Action	PRIORITY 3
Purpose of Action	LEVEL 2
Deficiency Photo1	 
Violations	Near Playground No violations recorded.
Bleachers	Does not Exist
SITE WALLS (NOT RETAINING WALLS)	Does not Exist
STAIRS/RAMPS: EXTERIOR	Inspected
Railings	Inspected
Condition	3 - Fair
Deficiency	DAMAGED
Deficiency Location/Instance	Courtyard
Deficiency Quantity	10

Question	Response
SITE	
STAIRS/RAMPS: EXTERIOR	
Railings	
Quantity Uom	L.F.
Potential Action	REPLACE
Urgency of Action	PRIORITY 3
Purpose of Action	LEVEL 2
Deficiency Photo1
