NYC Department of Education
Building Condition Assessment Survey 2023 - 2024

Architectural Inspection

Asset: P.S. 299 - BROOKLYN, 88 WOODBINE STREET, New York, 11221

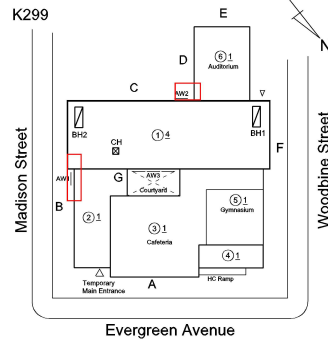
AREAWAY WALLS: CRACKS AND SPALLING

10
S.F.
REPAIR
PRIORITY 3
LEVEL 2

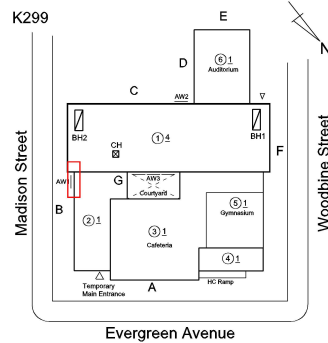
AREAWAY STAIRS: DETERIORATED TREADS/RISERS/NOSINGS

80
S.F.
REPLACE
PRIORITY 4
LEVEL 2

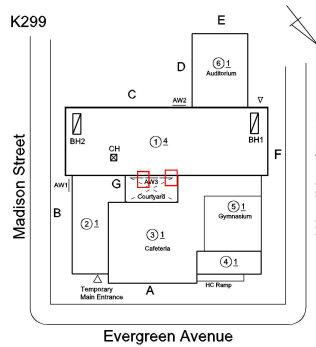
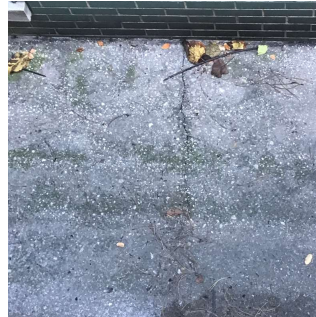
AW3

AREAWAY SLAB: CRACKS AND SPALLING

10

REPAIR

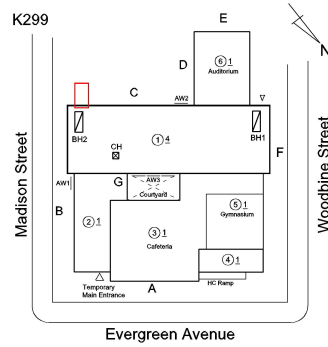
AWNINGS AND CANOPIES

80
S.F.
REPLACE
PRIORITY 4
LEVEL 2

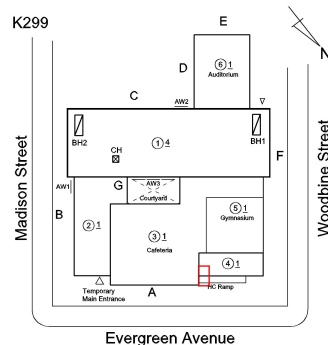
METAL: DETERIORATED DOOR AND FRAME - MAJOR DETERIORATION

Deficiency Quantity	2
Quantity Uom	EACH
Potential Action	REPLACE
Urgency of Action	PRIORITY 4
Purpose of Action	LEVEL 2
Deficiency Photo1

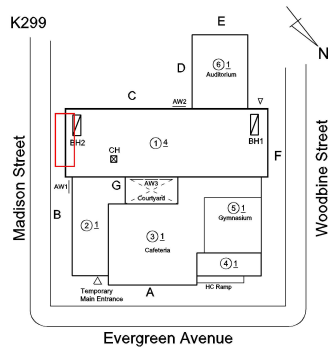
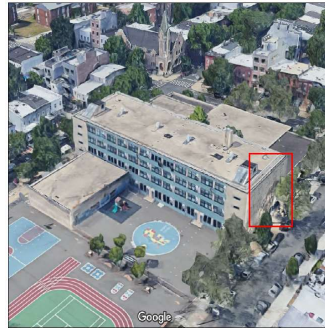
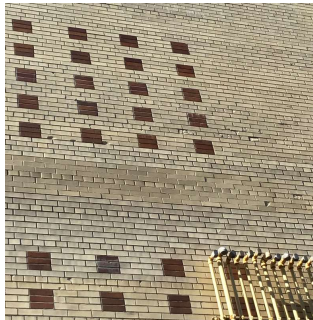
Facade B

Deficiency BRICK: MINOR CRACKS AND SPALLING

300

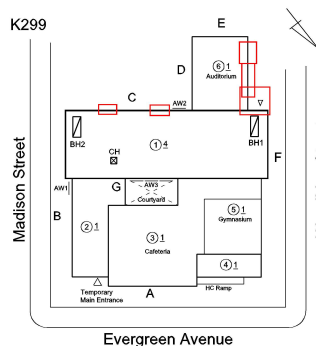
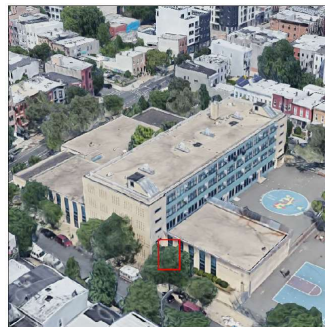
CERAMIC TILE: CHIPPED, SPALLED, BROKEN PIECES

100

REPLACE

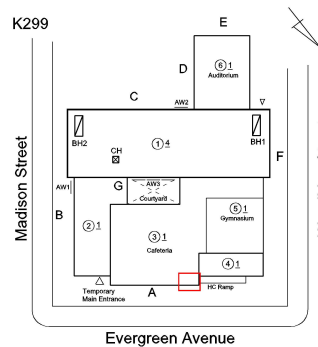
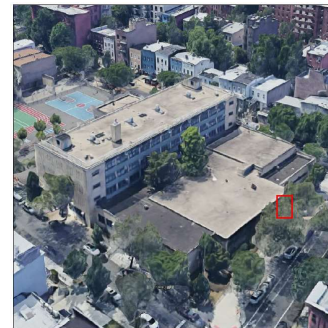
BRICK: DETERIORATED MASONRY SILLS - MAJOR

10

L.F.

REMOVE AND REPLACE

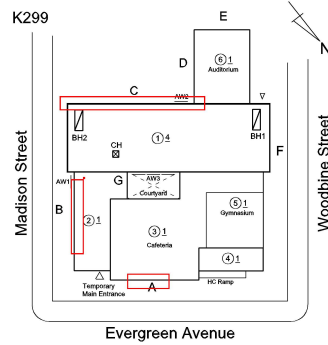
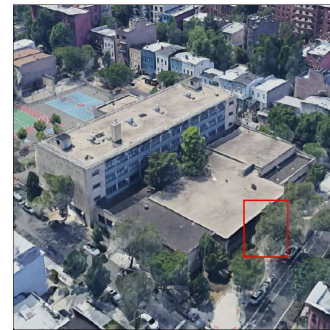
BRICK: DETERIORATED MASONRY SILLS - MINOR

100

REPAIR

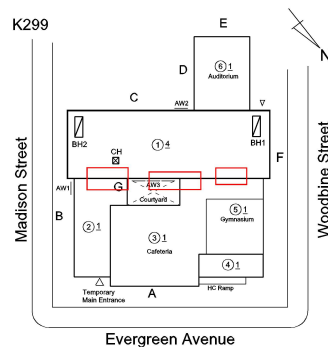
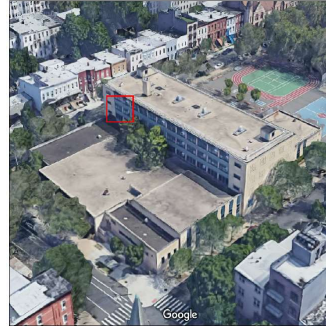
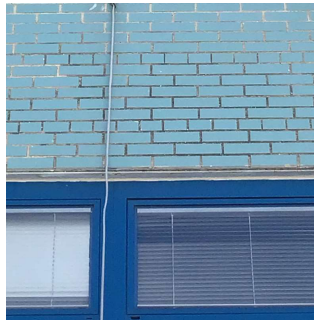
Facade G South View

BRICK: DETERIORATED JOINTS

200

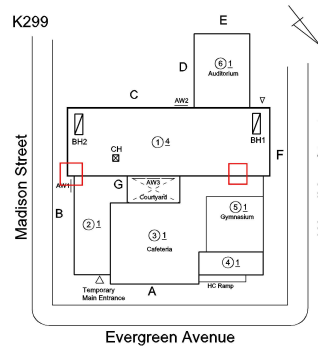
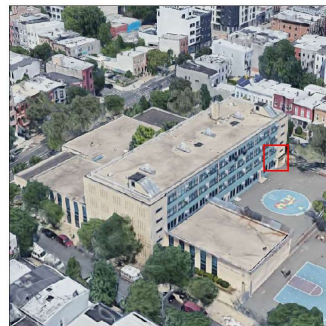
BRICK: CRACKS/DISPLACED/SPALLED BRICK AT BUILDING CORNERS

50

Question	Response
EXTERIOR	
EXTERIOR WALLS	
Potential Action	REMOVE AND REBUILD
Urgency of Action	PRIORITY 4
Purpose of Action	LEVEL 2
Deficiency Photo1	 
	Facade - North view
Violations	No violations recorded.
EXTERIOR SOFFITS	Does not Exist
LOADING DOCK	Does not Exist
LOUVER	Inspected
Condition	2 - Between Good and Fair
Deficiency	No deficiencies recorded
PARAPETS	Inspected
Material Type(s)	Masonry
Replacement Quantity	5,500
Replacement Uom	C.F.
Instance on Roofs 2, 4, 5, 6	Inspected
Instance Condition	2 - Between Good and Fair
Instance Quantity	5,500
Instance Quantity Uom	C.F.
Deficiency	No deficiencies recorded
PLAZA DECK	Does not Exist
ROOF	Inspected
Roofing	Inspected
Replacement Quantity	36,500
Replacement Uom	S.F.
ROOF HATCH/SMOKE HATCH	Does not Exist
LEADERS, GUTTERS, DOWNSPOUTS, SCUPPERS	Inspected
Condition	2 - Between Good and Fair
Deficiency	No deficiencies recorded
ROOF BARRIER/FENCE	Inspected
Condition	2 - Between Good and Fair

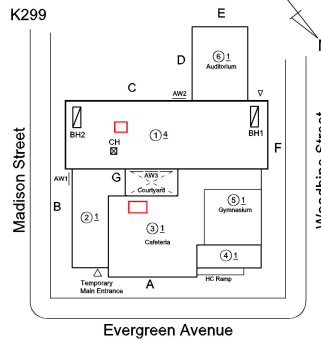
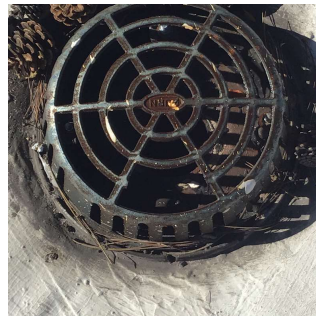
Roof 3

Deficiency	DETERIORATED
------------	--------------

Deficiency Quantity	1
Quantity Uom	EACH
Potential Action	REPLACE
Urgency of Action	PRIORITY 4
Purpose of Action	LEVEL 2
Deficiency Photo1

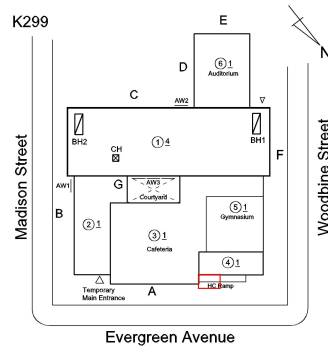
BUILDING CHEEK/FLANK WALLS

10
S.F.
REPAIR
PRIORITY 3
LEVEL 2

Facade A near Exit 2
No violations recorded.

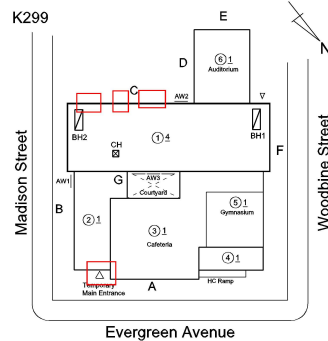
STONE: DETERIORATED JOINTS

40
L.F.
REPOINT
PRIORITY 3
LEVEL 2

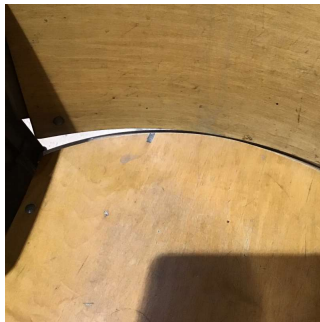
Violations	Entrance No violations recorded.
Fixed H/C Lift	
Instance on 1st Floor (442 Seats)	Does not Exist
Fixed Seating	
Instance on 1st Floor (442 Seats)	Inspected
Condition	4 - Between Fair and Poor
Deficiency	DAMAGED/BROKEN/INOPERABLE
Deficiency Location/Instance	Seats B/1, C/7, F/3, J/1, P/7, and others
Deficiency Quantity	37
Quantity Uom	EACH
Potential Action	REPLACE
Urgency of Action	PRIORITY 3
Purpose of Action	LEVEL 2
Deficiency Photo1

Violations	Seat B/1 No violations recorded.
Floor Finish	
Instance on 1st Floor (442 Seats)	Inspected
Condition	2 - Between Good and Fair
Deficiency	No deficiencies recorded
Sliding-folding Partition	
Instance on 1st Floor (442 Seats)	Does not Exist
Stage	
Instance on 1st Floor (442 Seats)	Inspected
Stage	Inspected
Instance on 1st Floor (442 Seats)	Inspected
Condition	2 - Between Good and Fair
Deficiency	No deficiencies recorded

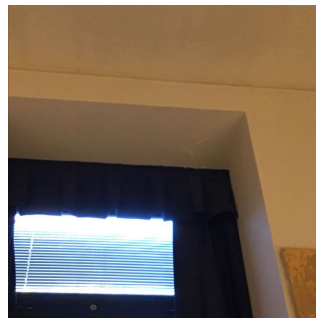
Instance on 1st Floor (442 Seats)	Inspected
Condition	2 - Between Good and Fair
Deficiency	PLASTER: CRACKS/SPALLING
Deficiency Location/Instance	Left Side
Deficiency Quantity	10
Quantity Uom	S.F.
Potential Action	REPLACE
Urgency of Action	PRIORITY 3
Purpose of Action	LEVEL 2
Deficiency Photo1

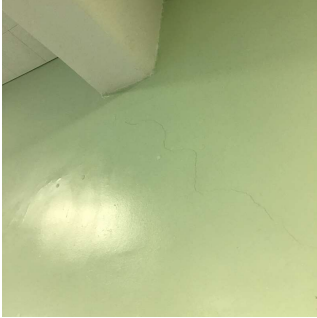
Violations	Columns at Center No violations recorded.
Deficiency	PLASTER: CRACKS/SPALLING
Deficiency Location/Instance	Near Main Entrance, Opposite the Kitchen
Deficiency Quantity	40
Quantity Uom	S.F.
Potential Action	REPLACE
Urgency of Action	PRIORITY 3
Purpose of Action	LEVEL 2
Deficiency Photo1

Violations	Opposite the Kitchen No violations recorded.
Window Curtains/Shades/Blinds	
Instance on 1st Floor	Does not Exist
CLASSROOMS/CORRIDORS/ADMIN SPACES	
Ceiling	Inspected
Condition	2 - Between Good and Fair
Deficiency	ACOUSTIC TILES ON PLASTER: DAMAGED/MISSING
Deficiency Location/Instance	Corridor near Rooms 126, 212, 329, 431, Room 127, and others
Deficiency Quantity	110
Quantity Uom	S.F.
Potential Action	REPLACE
Urgency of Action	PRIORITY 3
Purpose of Action	LEVEL 2

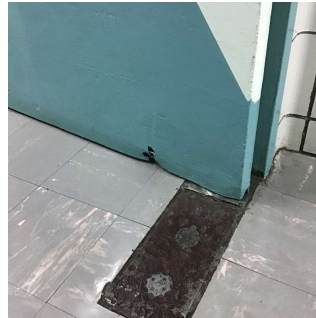
Corridor near Room 326

METAL: DETERIORATED DOOR

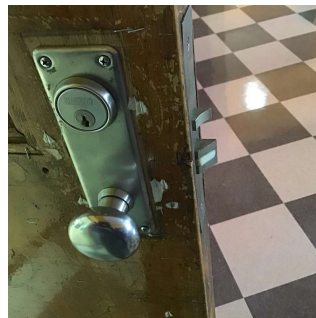
WOOD: DETERIORATED DOOR

Question	Response
INTERIOR	
CLASSROOMS/CORRIDORS/ADMIN SPACES	
Door(s)	Inspected
	Room 127
Violations	No violations recorded.
Floor Finish	Inspected
Condition	2 - Between Good and Fair
Deficiency	VINYL TILES: BROKEN/DETERIORATED/MISSING TILES
Deficiency Location/Instance	Corridor near Rooms 216, 234, 302, 402, 431, and others
Deficiency Quantity	200
Quantity Uom	S.F.
Potential Action	REPLACE
Urgency of Action	PRIORITY 3
Purpose of Action	LEVEL 2
Deficiency Photo1

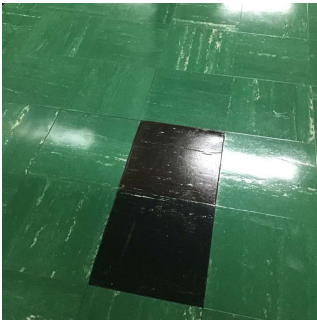
Corridor near Room 431
Violations	No violations recorded.
Deficiency	VINYL TILES: TRIPPING HAZARD - ELECTRICAL OUTLET
Deficiency Location/Instance	Room 425
Deficiency Quantity	10
Quantity Uom	S.F.
Potential Action	REMOVE
Urgency of Action	PRIORITY 5
Purpose of Action	LEVEL 6
Deficiency Photo1

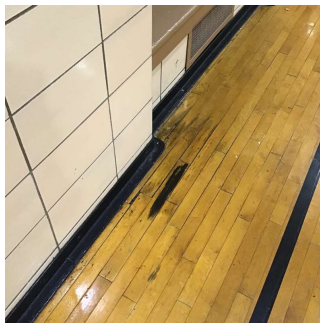
Question	Response
INTERIOR	
GYMNASIUM	
Floor Finish	
Deficiency Photo1

Violations	Left Side No violations recorded.
Seating	
Instance on 1st Floor	Inspected
Condition	4 - Between Fair and Poor
Deficiency	DAMAGED FIXED SEATING
Deficiency Location/Instance	Left Side
Deficiency Quantity	2
Quantity Uom	EACH
Potential Action	REPLACE
Urgency of Action	PRIORITY 3
Purpose of Action	LEVEL 2
Deficiency Photo1

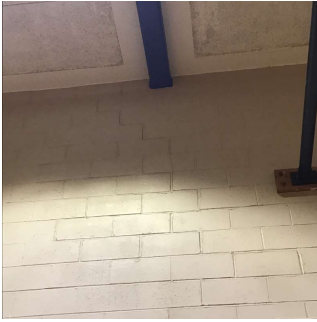
Question	Response
INTERIOR	
GYMNASIUM	
Walls	
Deficiency Photo1	 
Violations	Near the seating No violations recorded.
Deficiency	MASONRY: CRACKS/SPALLING
Deficiency Location/Instance	Near Locker Rooms, Near Entrance
Deficiency Quantity	40
Quantity Uom	S.F.
Potential Action	REPLACE
Urgency of Action	PRIORITY 3
Purpose of Action	LEVEL 2
Deficiency Photo1

Violations	Near Locker Rooms No violations recorded.
Deficiency	PLASTER: CRACKS/SPALLING
Deficiency Location/Instance	Office
Deficiency Quantity	20
Quantity Uom	S.F.
Potential Action	REPLACE
Urgency of Action	PRIORITY 3
Purpose of Action	LEVEL 2
Deficiency Photo1	 
Violations	Office No violations recorded.

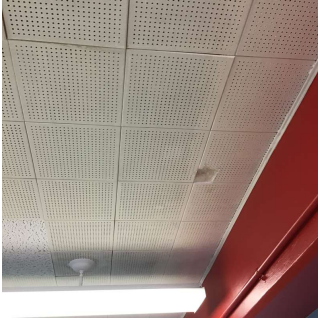
Violations	Near Locker Room No violations recorded.
LIBRARY	
Instance on Room 224	Inspected
Instance on Room 226	Inspected
Built-in Furnishing	
Instance on Room 226	Inspected
Condition	2 - Between Good and Fair
Deficiency	No deficiencies recorded
Instance on Room 224	Inspected
Condition	2 - Between Good and Fair
Deficiency	No deficiencies recorded
Ceiling	
Instance on Room 224	Inspected
Condition	2 - Between Good and Fair
Deficiency	ACOUSTIC TILES ON PLASTER: DAMAGED/MISSING

Question	Response
INTERIOR	
LIBRARY	
Ceiling	
Deficiency Location/Instance	Left Side, Right Side
Deficiency Quantity	20
Quantity Uom	S.F.
Potential Action	REPLACE
Urgency of Action	PRIORITY 3
Purpose of Action	LEVEL 2
Deficiency Photo1

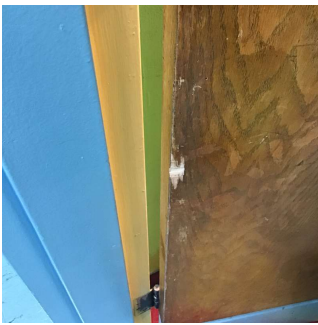
Violations	Entrance No violations recorded.
Instance on Room 224	Inspected
Condition	3 - Fair
Deficiency	WOOD: DETERIORATED DOOR
Deficiency Location/Instance	Entrance
Deficiency Quantity	1
Quantity Uom	EACH
Potential Action	MAINTENANCE
Urgency of Action	PRIORITY 3
Purpose of Action	LEVEL 2

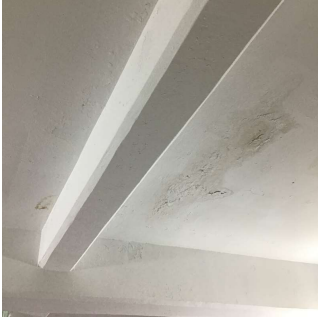
Question	Response
INTERIOR	
SCIENCE DEMO ROOM	Does not Exist
SCIENCE LAB	Does not Exist
SCIENCE PREP ROOM	Does not Exist
SHOWER ROOM	Inspected
Instance on 1st Floor - Boys	Inaccessible
Instance on 1st Floor - Girls	Inaccessible
STAIRS/RAMPS: INTERIOR	Inspected
Do Letter Stair Signs Exist?	Partially
Ceiling	Inspected
Condition	2 - Between Good and Fair
Deficiency	PLASTER: CRACKS/SPALLING
Deficiency Location/Instance	Stair AB/2,4
Deficiency Quantity	20
Quantity Uom	S.F.
Potential Action	REPLACE
Urgency of Action	PRIORITY 3
Purpose of Action	LEVEL 2
Deficiency Photo1

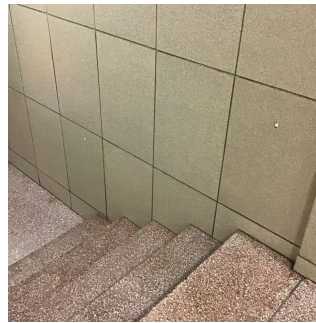
Violations	Stair AB/4 No violations recorded.
Door(s)	Inspected
Condition	2 - Between Good and Fair
Deficiency	No deficiencies recorded
Partition	Does not Exist
Railings	Inspected
Condition	3 - Fair
Deficiency	METAL: MISSING
Deficiency Location/Instance	Near Gymnasium
Deficiency Quantity	10
Quantity Uom	L.F.
Potential Action	REPLACE
Urgency of Action	PRIORITY 5

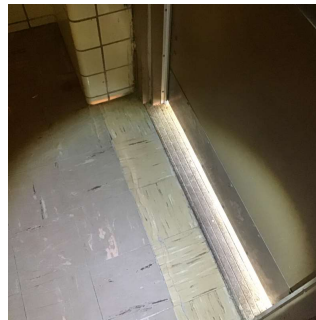
Exit 10 Stair

VINYL TILES: DETERIORATED SUBSTRATE

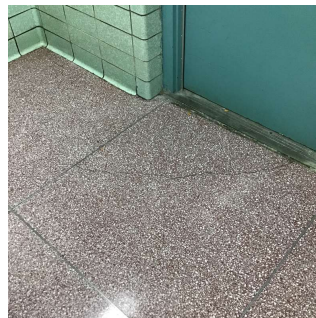
TERRAZZO: CRACKS

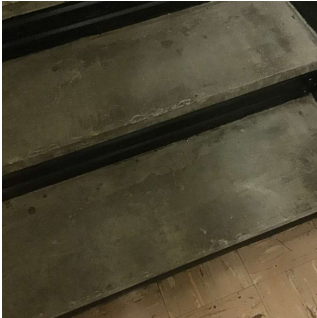
Question	Response
INTERIOR	
STAIRS/RAMPS: INTERIOR	
Stairs and Landings	Inspected
	Stair AB/1 Vestibule
Violations	No violations recorded.
Deficiency	STONE: BROKEN/MISSING
Deficiency Location/Instance	Stairs AB/2, CD/1,2,3, Exit 10
Deficiency Quantity	50
Quantity Uom	S.F.
Potential Action	REPLACE
Urgency of Action	PRIORITY 3
Purpose of Action	LEVEL 2
Deficiency Photo1

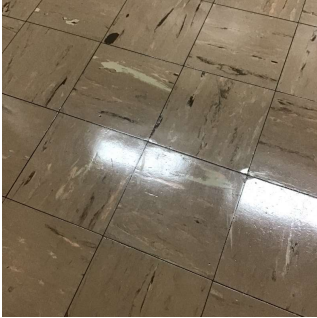
Exit 10
Violations	No violations recorded.
Deficiency	VINYL TILES: BROKEN/DETERIORATED/MISSING TILES
Deficiency Location/Instance	Stairs AB/4, CD/1,2,4, Exit 9, Exit 10
Deficiency Quantity	65
Quantity Uom	S.F.
Potential Action	REPLACE
Urgency of Action	PRIORITY 3
Purpose of Action	LEVEL 2
Deficiency Photo1

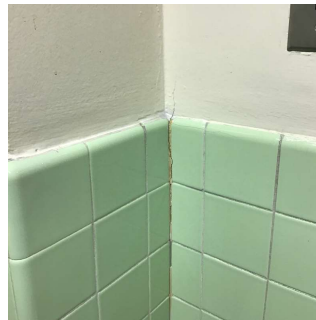
Room 136

CERAMIC TILE: BROKEN/ MISSING

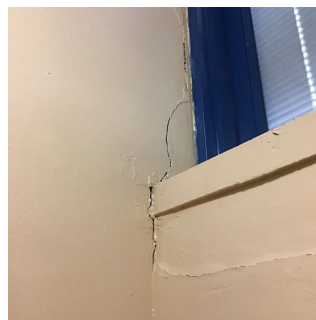
PLASTER: CRACKS/SPALLING

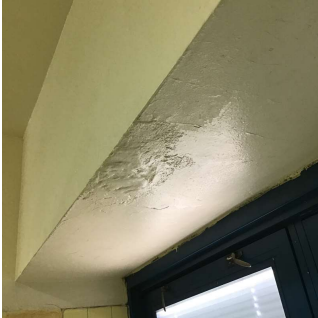
Question	Response
INTERIOR	
TOILET ROOMS - STAFF	Inspected
Walls	Inspected
Violations	Gymnasium Office No violations recorded.
TOILET ROOMS - STUDENTS	Inspected
Ceiling	Inspected
Condition	2 - Between Good and Fair
Deficiency	PLASTER: CRACKS/SPALLING
Deficiency Location/Instance	Room 402
Deficiency Quantity	10
Quantity Uom	S.F.
Potential Action	REPLACE
Urgency of Action	PRIORITY 3
Purpose of Action	LEVEL 2
Deficiency Photo1

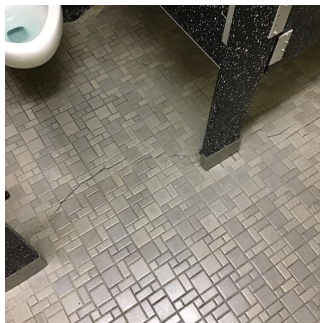
Room 113
Violations	No violations recorded.
Deficiency	CERAMIC TILE: DETERIORATED SUBSTRATE
Deficiency Location/Instance	Rooms 109, 113, 202
Deficiency Quantity	30
Quantity Uom	S.F.
Potential Action	REPLACE
Urgency of Action	PRIORITY 3
Purpose of Action	LEVEL 2

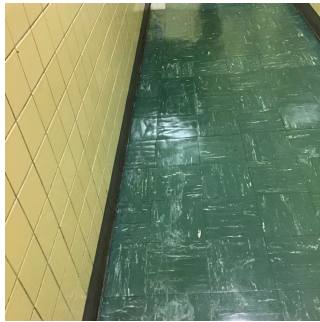
Violations	Room 113 No violations recorded.
Deficiency	VINYL TILES: BROKEN/DETERIORATED/MISSING TILES
Deficiency Location/Instance	Rooms 302, 402
Deficiency Quantity	30
Quantity Uom	S.F.
Potential Action	REPLACE
Urgency of Action	PRIORITY 3
Purpose of Action	LEVEL 2
Deficiency Photo1

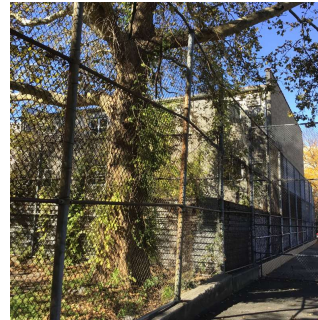
Schoolyard

CHAIN LINK: DAMAGED POST/RAIL

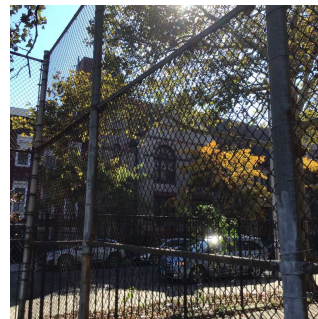
Schoolyard

CHAIN LINK: RUST - MAJOR

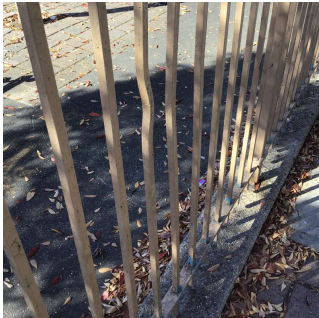
WROUGHT IRON: DAMAGED/DETERIORATED

Question	Response
SITE	
FENCES	
Deficiency Location/Instance	Schoolyard, Woodbine Street, Madison Street
Deficiency Quantity	360
Quantity Uom	S.F.
Potential Action	REPLACE
Urgency of Action	PRIORITY 3
Purpose of Action	LEVEL 2
Deficiency Photo1

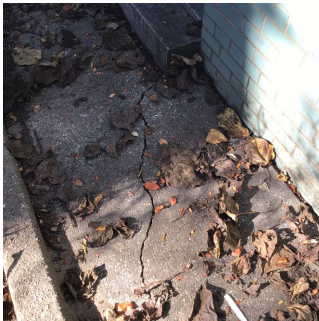
Schoolyard
Violations	No violations recorded.
IRRIGATION SYSTEM	Does not Exist
PAVING	Inspected
Student Non-Use	Inspected
Gravel Exists?	No
Asphalt	Does not Exist
Concrete	Inspected
Condition	3 - Fair
Deficiency	DAMAGED/DETERIORATED/MISSING SECTIONS
Deficiency Location/Instance	Courtyard, Madison Street
Deficiency Quantity	75
Quantity Uom	S.F.
Potential Action	REPLACE
Urgency of Action	PRIORITY 3
Purpose of Action	LEVEL 2
Deficiency Photo1

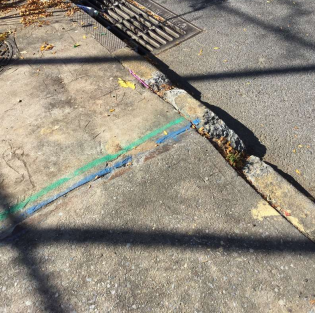
Woodbine Street
Violations	51516
Deficiency	DAMAGED CURBS
Deficiency Location/Instance	Woodbine Street, Evergreen Avenue, Madison Street
Deficiency Quantity	255
Quantity Uom	L.F.
Potential Action	REPLACE
Urgency of Action	PRIORITY 4

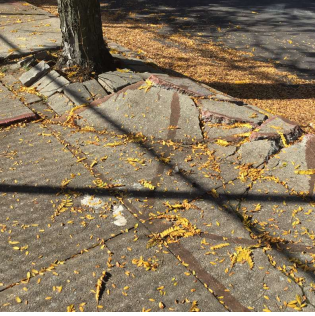
Woodbine Street
	51516
Violations	DAMAGED/DETERIORATED/MISSING SECTIONS
Deficiency	Woodbine Street, Madison Street
Deficiency Location/Instance	350
Deficiency Quantity	S.F.
Quantity Uom	REPLACE
Potential Action	PRIORITY 5
Urgency of Action	LEVEL 6
Purpose of Action

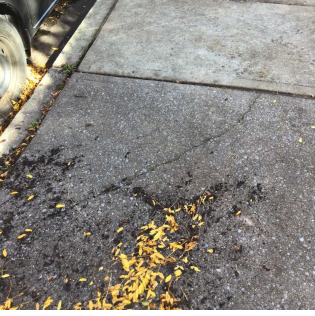
Deficiency Photo1	Woodbine Street
	51516
Violations	DAMAGED/DETERIORATED/MISSING SECTIONS
Deficiency	Woodbine Street, Evergreen Avenue, Madison Street
Deficiency Location/Instance	1,650
Deficiency Quantity	S.F.
Quantity Uom	REPLACE
Potential Action	PRIORITY 4
Urgency of Action	LEVEL 4
Purpose of Action

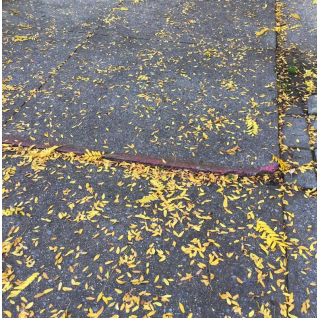
Question	Response
SITE	
PAVING	
DOT Sidewalk	
Concrete	
Deficiency	HEAVING
Deficiency Location/Instance	Woodbine Street, Evergreen Avenue, Madison Street
Deficiency Quantity	400
Quantity Uom	S.F.
Potential Action	REPLACE
Urgency of Action	PRIORITY 4
Purpose of Action	LEVEL 4
Deficiency Photo1

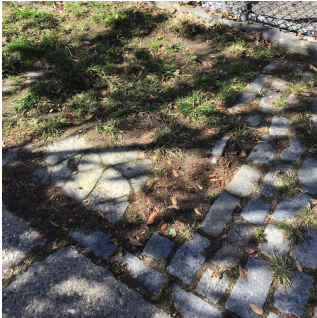
Woodbine Street
Violations	51516
Pavers	Inspected
Condition	3 - Fair
Deficiency	DAMAGED/MISSING
Deficiency Location/Instance	Madison Street
Deficiency Quantity	75
Quantity Uom	S.F.
Potential Action	REPLACE
Urgency of Action	PRIORITY 4
Purpose of Action	LEVEL 4
Deficiency Photo1
