**NYC Department of Education**  
**Building Condition Assessment Survey 2023 - 2024**

Architectural Inspection

**Asset:** P.S. 305 - BROOKLYN, 344 MONROE STREET, New York, 11216

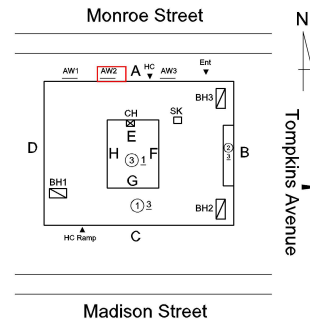
Question	Response
<b>Architectural</b>	
<b>EXTERIOR</b>	Inspected
<b>AREAWAY</b>	Inspected
Instance on AW1 - AW3	Inspected
Instance Condition	3 - Fair
Instance Quantity	3
Instance Quantity Uom	EACH
Deficiency	AREAWAY STAIRS: DETERIORATED TREADS/RISERS/NOSINGS

REPAIR

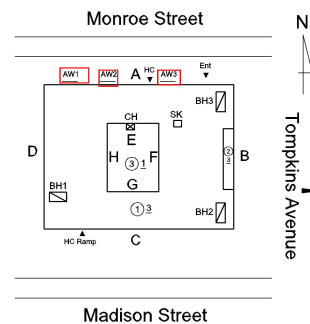
AREAWAY WALLS: CRACKS AND SPALLING

REPLACE

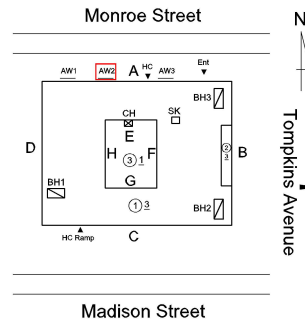
AREAWAY STAIRS: DETERIORATED MATERIAL SLIDE  
K305

25  
S.F.  
REPAIR  
PRIORITY 3  
LEVEL 2

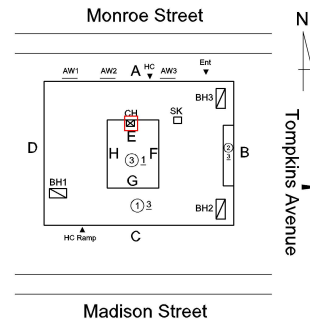
BRICK: DETERIORATED JOINTS

80  
S.F.  
REPOINT  
PRIORITY 3  
LEVEL 2

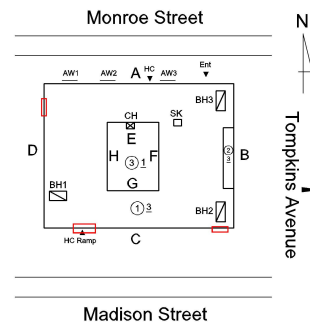
METAL: DETERIORATED DOOR AND FRAME - MAJOR DETERIORATION

8  
EACH  
REPLACE  
PRIORITY 4  
LEVEL 2

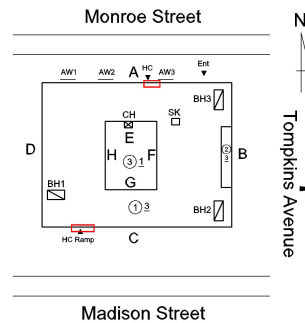
METAL: DENTED, MAJOR RUSTING

REPLACE

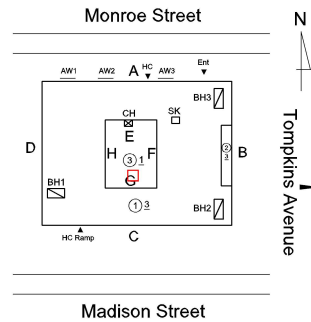
Condition	3 - Fair
Deficiency	DETERIORATED
Roof Plan reference	K305

Deficiency Quantity	1
Quantity Uom	EACH
Potential Action	REPLACE
Urgency of Action	PRIORITY 4
Purpose of Action	LEVEL 2

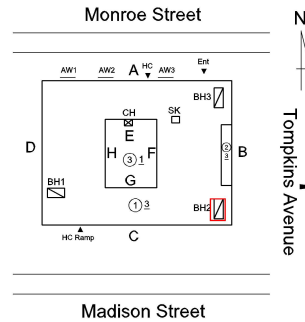
Violations	BH1 No violations recorded.
Deficiency	BULKHEAD/PENTHOUSE DOORS: DETERIORATED DOOR AND FRAME

1  
 EACH  
 REPLACE DOOR AND FRAME  
 PRIORITY 4  
 LEVEL 2

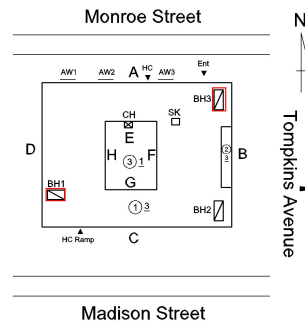
BULKHEAD/PENTHOUSE ROOF: MINOR LEAKAGE  
 K305

100  
 S.F.  
 MAINTENANCE  
 PRIORITY 3  
 LEVEL 2

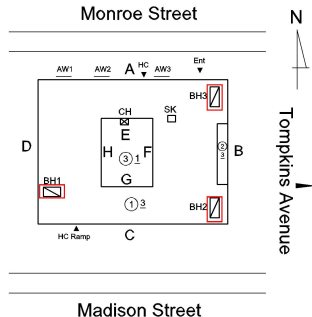
Violations	BH1 No violations recorded.
Deficiency	BULKHEAD/PENTHOUSE WALLS/EXTERIOR: DETERIORATED JOINTS
Roof Plan reference	K305

Deficiency Quantity	100
Quantity Uom	S.F.
Potential Action	REPOINT
Urgency of Action	PRIORITY 3
Purpose of Action	LEVEL 2
Deficiency Photo1

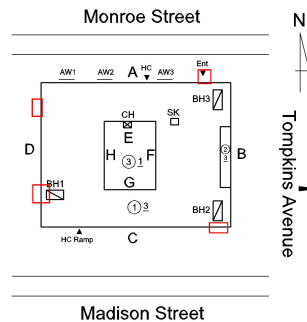
Question	Response
<b>EXTERIOR</b>	
<b>ROOF</b>	Inspected
<b>Specialties</b>	Inspected
<b>ROOF/GRAVITY TANK</b>	Does not Exist
<b>STAIRS/RAMPS: EXTERIOR</b>	Inspected
<b>BUILDING CHEEK/FLANK WALLS</b>	Inspected
Condition	2 - Between Good and Fair
Deficiency	No deficiencies recorded
<b>RAILINGS</b>	Inspected
Condition	2 - Between Good and Fair
Deficiency	No deficiencies recorded
<b>STAIRS/RAMPS</b>	Inspected
Condition	5 - Poor
Deficiency	STONE: DETERIORATED JOINTS
Roof Plan reference	K305

10  
L.F.  
REPOINT  
PRIORITY 4  
LEVEL 2

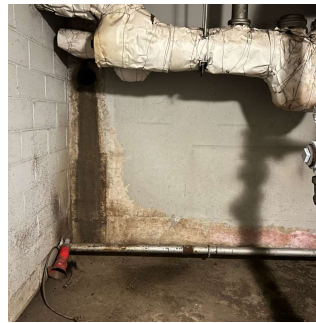
Basement - Room B5
Violations	No violations recorded.
<b>FOUNDATION WALLS</b>	Inspected
Material Type(s)	Concrete
Condition	4 - Between Fair and Poor
Deficiency	CONCRETE: WATER INFILTRATION IN NON- INSTRUCTIONAL SPACE
Deficiency Location/Instance	Basement - Sump Pump Room
Deficiency Quantity	100

Quantity Uom	S.F.
Potential Action	INSTALL WATERPROOFING
Urgency of Action	PRIORITY 5
Purpose of Action	LEVEL 5

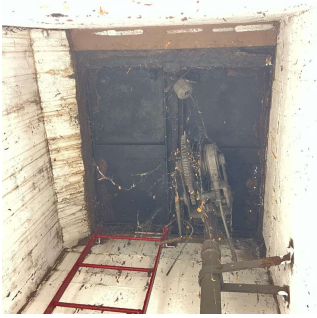
Ash Hoist Vault
Violations	No violations recorded.
<b>Slab Structure</b>	Inspected
Condition	2 - Between Good and Fair
Deficiency	No deficiencies recorded
<b>Vault/Ash Hoist Doors and Framing</b>	Inspected
Condition	5 - Poor
Deficiency	DETERIORATED/DAMAGED VAULT/ASH HOIST DOORS AND FRAMING
Deficiency Location/Instance	Ash Hoist Vault
Deficiency Quantity	2
Quantity Uom	EACH
Potential Action	REPLACE
Urgency of Action	PRIORITY 4
Purpose of Action	LEVEL 2
Deficiency Photo1

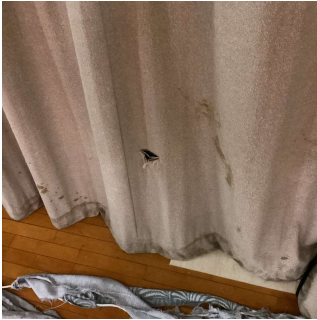
Question	Response
<b>INTERIOR</b>	
<b>AUDITORIUM</b>	
<b>Stage</b>	
<b>Stage Curtain Rigging</b>	Inspected
Deficiency	No deficiencies recorded
<b>Stage Curtains</b>	Inspected
Instance on 1st Floor (400Seats)	Inspected
Condition	3 - Fair
Deficiency	WORN/DETERIORATED
Deficiency Location/Instance	Rear
Deficiency Quantity	100
Quantity Uom	S.F.
Potential Action	REPLACE
Urgency of Action	PRIORITY 3
Purpose of Action	LEVEL 2
Deficiency Photo1

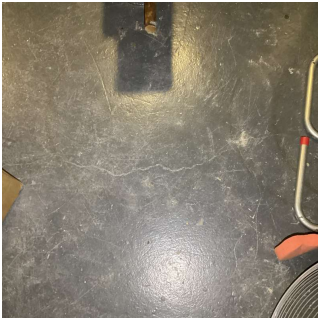
Violations	Entrance No violations recorded.
<b>Floor Finish</b>	
Instance on 2nd Floor	Inspected
Condition	2 - Between Good and Fair
Deficiency	CONCRETE: CRACKS
Deficiency Location/Instance	Center
Deficiency Quantity	15
Quantity Uom	S.F.
Potential Action	REPLACE
Urgency of Action	PRIORITY 3
Purpose of Action	LEVEL 2
Deficiency Photo1

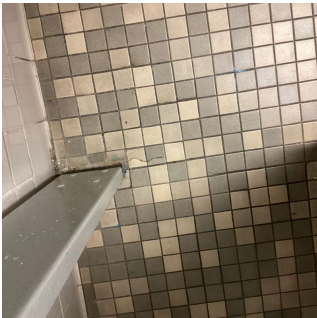
Room 143
Violations	No violations recorded.
<b>Floor Finish</b>	Inspected
Condition	3 - Fair
Deficiency	CERAMIC TILE: BROKEN/MISSING TILES
Deficiency Location/Instance	Room 143, 145, 223
Deficiency Quantity	15
Quantity Uom	S.F.
Potential Action	REPLACE
Urgency of Action	PRIORITY 3
Purpose of Action	LEVEL 2
Deficiency Photo1

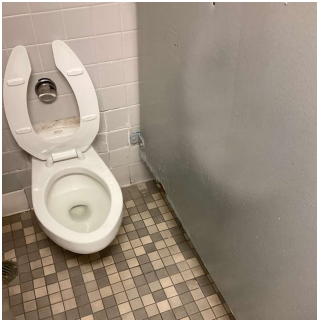
Room 145
Violations	No violations recorded.
<b>Stalls</b>	Inspected
Condition	5 - Poor
Deficiency	RUST - MAJOR
Deficiency Location/Instance	Room 143, 145, inside Kitchen Staff Locker Room
Deficiency Quantity	3
Quantity Uom	EACH
Potential Action	REPLACE
Urgency of Action	PRIORITY 3
Purpose of Action	LEVEL 2

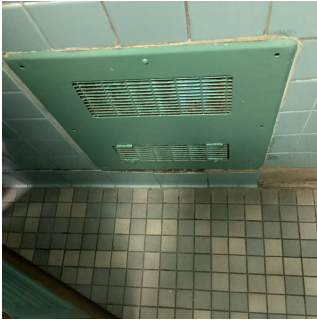
Violations	Room 143 No violations recorded.
<b>Walls</b>	Inspected
Condition	2 - Between Good and Fair
Deficiency	CERAMIC TILE: BROKEN/ MISSING
Deficiency Location/Instance	Inside Nurses Office, inside Principals Office
Deficiency Quantity	15
Quantity Uom	S.F.
Potential Action	REPLACE
Urgency of Action	PRIORITY 3
Purpose of Action	LEVEL 2
Deficiency Photo1

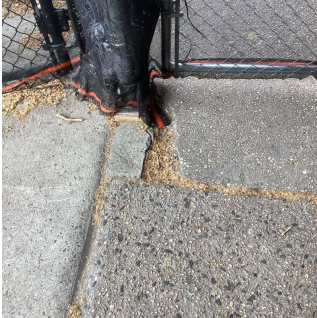
Question	Response
<b>SITE</b>	
<b>PAVING</b>	
<b>Site Sidewalks &amp; Walkways</b>	Inspected
<b>Asphalt</b>	Does not Exist
<b>Concrete</b>	Inspected
Condition	3 - Fair
Deficiency	CRACKS - MAJOR
Deficiency Location/Instance	Near Park
Deficiency Quantity	100
Quantity Uom	S.F.
Potential Action	REPLACE
Urgency of Action	PRIORITY 3
Purpose of Action	LEVEL 2
Deficiency Photo1

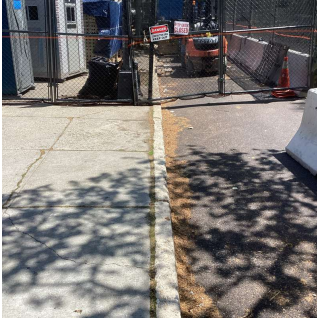
Near Park
Violations	No violations recorded.
<b>Pavers</b>	Does not Exist
<b>DOT Sidewalk</b>	Inspected
<b>Asphalt</b>	Does not Exist
<b>Concrete</b>	Inspected
Condition	4 - Between Fair and Poor
Deficiency	DAMAGED CURBS
Deficiency Location/Instance	Madison Street
Deficiency Quantity	50
Quantity Uom	L.F.
Potential Action	REPLACE
Urgency of Action	PRIORITY 3
Purpose of Action	LEVEL 2
Deficiency Photo1

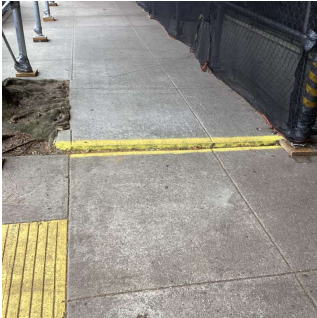
Monroe Street
Violations	No violations recorded.
Deficiency	HEAVING
Deficiency Location/Instance	Madison Street, Monroe Street
Deficiency Quantity	400
Quantity Uom	S.F.
Potential Action	REPLACE
Urgency of Action	PRIORITY 3
Purpose of Action	LEVEL 2
Deficiency Photo1

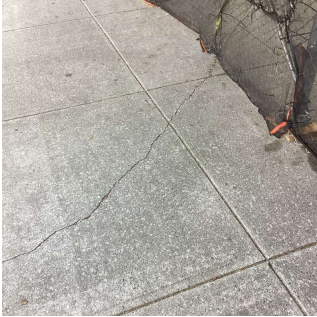
Monroe Street
Violations	No violations recorded.
Deficiency	DAMAGED/DETERIORATED/MISSING SECTIONS
Deficiency Location/Instance	Madison Street , Monroe Street
Deficiency Quantity	800
Quantity Uom	S.F.
Potential Action	REPLACE
Urgency of Action	PRIORITY 3
Purpose of Action	LEVEL 2

Question	Response
<b>SITE</b>	
<b>PAVING</b>	
<b>DOT Sidewalk</b>	
<b>Concrete</b>	
Deficiency Photo1

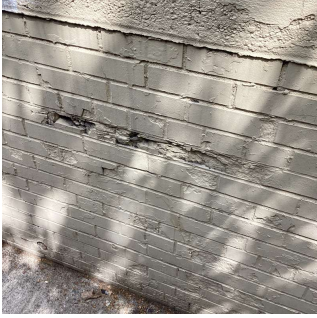
Question	Response
<b>SITE</b>	
<b>RETAINING WALLS</b>	
Deficiency Photo1	 
Violations	<p>Madison Street No violations recorded.</p>
Deficiency	<b>BRICK: CRACKS/SPALLING - MAJOR</b>
Deficiency Location/Instance	Madison Street
Deficiency Quantity	250
Quantity Uom	S.F.
Potential Action	REPLACE
Urgency of Action	PRIORITY 3
Purpose of Action	LEVEL 2
Deficiency Photo1
