NYC Department of Education
Building Condition Assessment Survey 2023 - 2024

Architectural Inspection

Asset: P.S. 309 - BROOKLYN, 794 MONROE STREET, New York, 11221

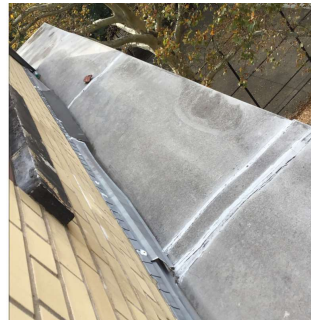
Bulk Head 3 and Coping Facade H
No violations recorded.

Deficiency

10
L.F.
REPLACE-IN-KIND
PRIORITY 4
LEVEL 2

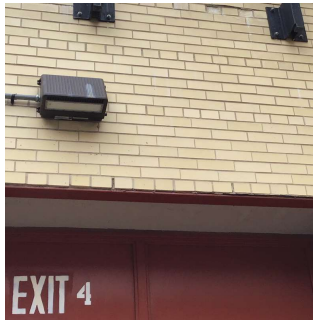
Exit 4

BRICK: MAJOR / THRU CRACKS

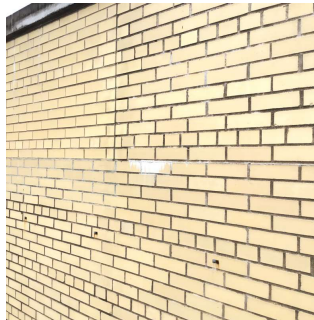
Roof 5

BRICK: DETERIORATED JOINTS

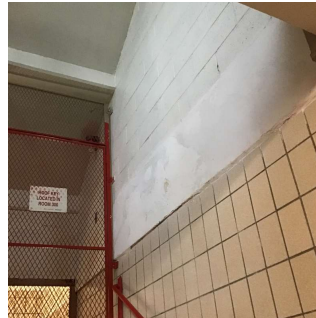
Roof 1 BH2 - Stair G/3

<p>Roof 4</p>
Violations	No violations recorded.
ROOFING DRAINS	Inspected
Condition	2 - Between Good and Fair
Deficiency	No deficiencies recorded
Specialties	Inspected
BULKHEAD/PENTHOUSE	Inspected
Condition	3 - Fair
Deficiency	BULKHEAD/PENTHOUSE WALLS/EXTERIOR: WATER INFILTRATION
Roof Plan reference	<p>K309</p>

Deficiency Quantity	50
Quantity Uom	S.F.
Potential Action	REPAIR
Urgency of Action	PRIORITY 5
Purpose of Action	LEVEL 2

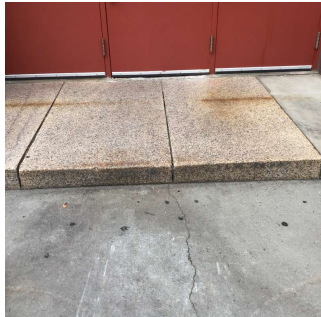
Question	Response
EXTERIOR	
ROOF	Inspected
Specialties	Inspected
ROOF/GRAVITY TANK	Does not Exist
STAIRS/RAMPS: EXTERIOR	Inspected
BUILDING CHEEK/FLANK WALLS	Does not Exist
RAILINGS	Inspected
Condition	2 - Between Good and Fair
Deficiency	No deficiencies recorded
STAIRS/RAMPS	Inspected
Condition	3 - Fair
Deficiency	STONE: DETERIORATED JOINTS
Roof Plan reference	K309
Deficiency Quantity	100
Quantity Uom	L.F.
Potential Action	REPOINT
Urgency of Action	PRIORITY 3
Purpose of Action	LEVEL 2
Deficiency Photo1

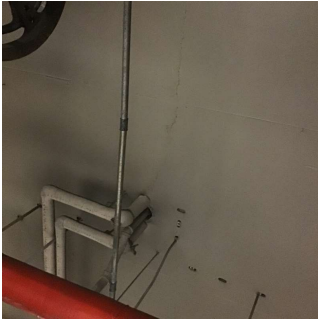
Boiler Room

Question	Response
EXTERIOR	
WINDOWS	
WINDOWS	
Instance Condition	2 - Between Good and Fair
Instance Quantity	7,300
Instance Quantity Uom	S.F.
Are these windows insulated	Yes
Installation Year	2008
Source of Installation	Custodial Staff
Deficiency	No deficiencies recorded
Instance on Aluminum - Other: Facades A, B, H	Inspected
Instance Condition	2 - Between Good and Fair
Instance Quantity	200
Instance Quantity Uom	S.F.
Are these windows insulated	Yes
Installation Year	2008
Source of Installation	Custodial Staff
Deficiency	No deficiencies recorded
INTERIOR	Inspected
POOLS	Does not Exist
STRUCTURAL	Inspected
COLUMNS/BEAMS/BEARING WALLS	Inspected
Condition	2 - Between Good and Fair
Deficiency	No deficiencies recorded
FLOOR STRUCTURE	Inspected
Condition	3 - Fair
Deficiency	CONCRETE: CRACKS/SPALLED/REINFORCEMENT EXPOSED
Deficiency Location/Instance	Boiler Room, Universal Waste Lamp Storage Area Crawl Space
Deficiency Quantity	150

Quantity Uom	S.F.
Potential Action	REPAIR
Urgency of Action	PRIORITY 3
Purpose of Action	LEVEL 5
Deficiency Photo1

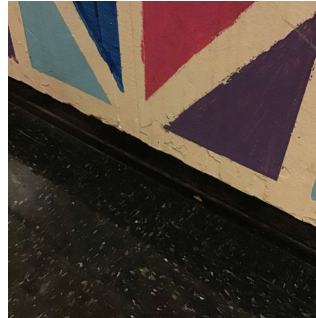
Left Side

Deficiency	DAMAGED FASCIA
------------	----------------

Potential Action	REPLACE
------------------	---------

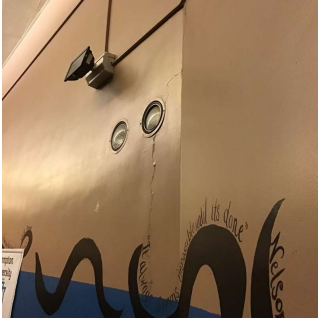
Question	Response
INTERIOR	
AUDITORIUM	
Stage	
Stage Curtains	
Violations	Left Side No violations recorded.
Walls	
Instance on 1st Floor (402 Seats)	Inspected
Condition	2 - Between Good and Fair
Deficiency	PLASTER: CRACKS/SPALLING
Deficiency Location/Instance	Left Side
Deficiency Quantity	10
Quantity Uom	S.F.
Potential Action	REPLACE
Urgency of Action	PRIORITY 3
Purpose of Action	LEVEL 2
Deficiency Photo1

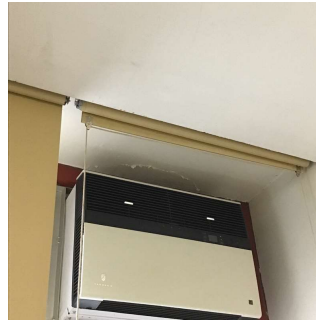
Near Windows

Violations	Left Side No violations recorded.
Window Curtains/Shades/Blinds	
Instance on 1st Floor (402 Seats)	Does not Exist
CAFETERIA	
Instance on 1st Floor - Staff (600 SF)	Inspected
Instance on 1st Floor - Students	Inspected
Ceiling	
Instance on 1st Floor - Staff (600 SF)	Inspected
Condition	2 - Between Good and Fair
Deficiency	PLASTER: CRACKS/SPALLING
Deficiency Location/Instance	Near Windows, Center
Deficiency Quantity	20
Quantity Uom	S.F.
Potential Action	REPLACE
Urgency of Action	PRIORITY 3
Purpose of Action	LEVEL 2

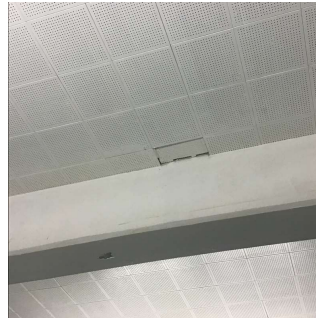
Center

ACOUSTIC TILES ON PLASTER: DAMAGED/MISSING

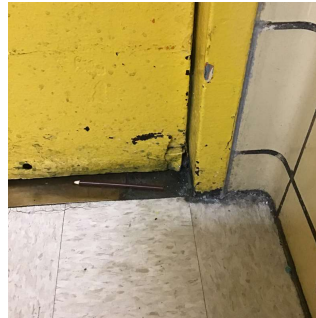
Corridor near Room 210

METAL: DETERIORATED DOOR

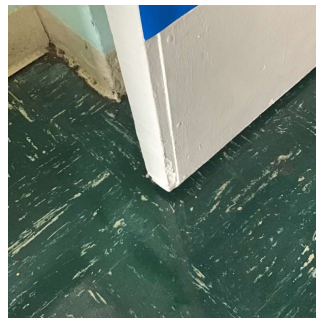
WOOD: DETERIORATED DOOR

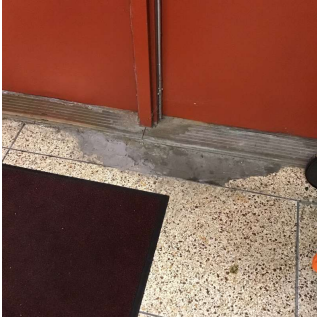
Question	Response
INTERIOR	
CLASSROOMS/CORRIDORS/ADMIN SPACES	
Door(s)	Inspected
	Room 307
Violations	No violations recorded.
Floor Finish	Inspected
Condition	2 - Between Good and Fair
Deficiency	TERRAZZO: CRACKS
Deficiency Location/Instance	Exit 4 Vestibule
Deficiency Quantity	10
Quantity Uom	S.F.
Potential Action	REPLACE
Urgency of Action	PRIORITY 3
Purpose of Action	LEVEL 2
Deficiency Photo1

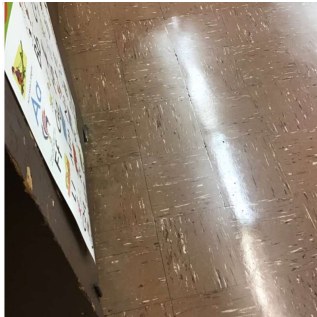
Violations	Exit 4 Vestibule No violations recorded.
Deficiency	VINYL TILES: BROKEN/DETERIORATED/MISSING TILES
Deficiency Location/Instance	Rooms 206, 212, 216, 310, 316, and others
Deficiency Quantity	120
Quantity Uom	S.F.
Potential Action	REPLACE
Urgency of Action	PRIORITY 3
Purpose of Action	LEVEL 2
Deficiency Photo1

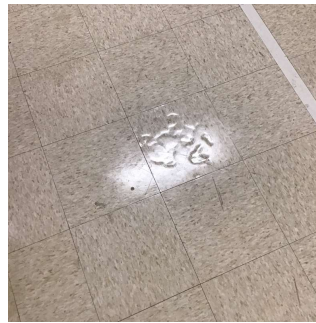
Violations	Room 212 No violations recorded.
Deficiency	VINYL TILES: DETERIORATED SUBSTRATE
Deficiency Location/Instance	Corridor near Room 221
Deficiency Quantity	10
Quantity Uom	S.F.
Potential Action	REPLACE

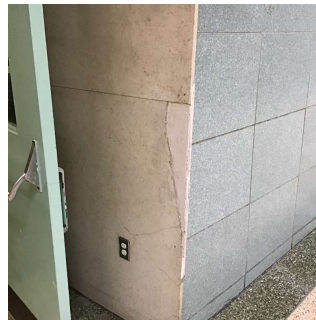
Near Auditorium

STONE: CRACKS/SPALLING

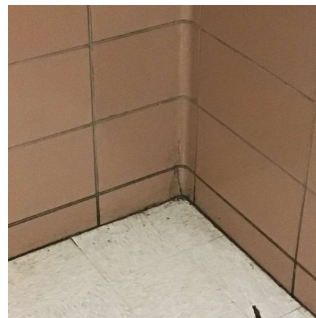
GLAZED BLOCK: CRACKS/SPALLING

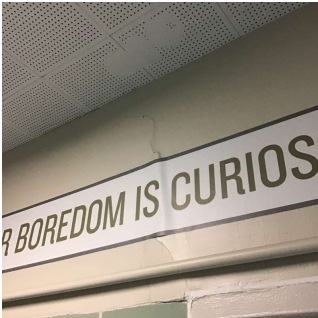
Question	Response
INTERIOR	
CLASSROOMS/CORRIDORS/ADMIN SPACES	
Walls	
Violations	Corridor near Stair G/2 No violations recorded.
Deficiency	PLASTER: CRACKS/SPALLING
Deficiency Location/Instance	Room 147, Corridor near Rooms 100, 305
Deficiency Quantity	35
Quantity Uom	S.F.
Potential Action	REPLACE
Urgency of Action	PRIORITY 3
Purpose of Action	LEVEL 2
Deficiency Photo1

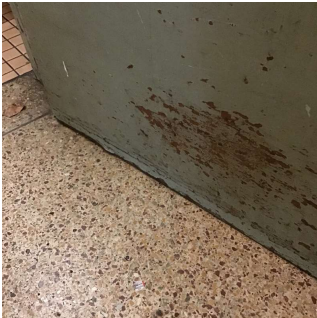
Violations	Corridor near Auditorium Stage Entrance No violations recorded.
KITCHEN	
	Inspected
Instance on 1st Floor	Inspected
Ceiling	
Instance on 1st Floor	Inspected
Condition	2 - Between Good and Fair
Deficiency	No deficiencies recorded
Door(s)	
Instance on 1st Floor	Inspected
Condition	4 - Between Fair and Poor
Deficiency	METAL: DETERIORATED DOOR
Deficiency Location/Instance	Exit Vestibule
Deficiency Quantity	1
Quantity Uom	EACH
Potential Action	MAINTENANCE
Urgency of Action	PRIORITY 3
Purpose of Action	LEVEL 2
Deficiency Photo1

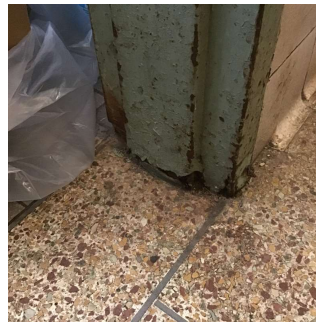
Violations	Exit Vestibule No violations recorded.
Deficiency	METAL: DETERIORATED DOOR AND FRAME
Deficiency Location/Instance	Mop Room
Deficiency Quantity	1
Quantity Uom	EACH
Potential Action	MAINTENANCE
Urgency of Action	PRIORITY 3
Purpose of Action	LEVEL 2

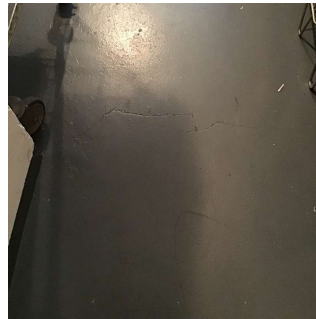
Storage Room

Condition	5 - Poor
-----------	----------

Deficiency CONCRETE: CRACKS

Potential Action REPLACE

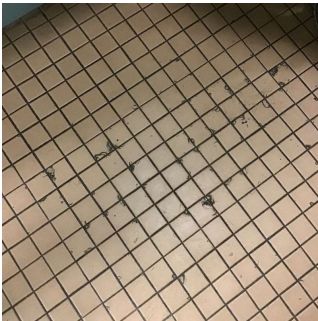
Deficiency CERAMIC TILE: BROKEN/MISSING TILES

Deficiency Location/Instance Near Entrance from Student Cafeteria, Center, Near Exit Vestibule, Near Windows

Potential Action REPLACE

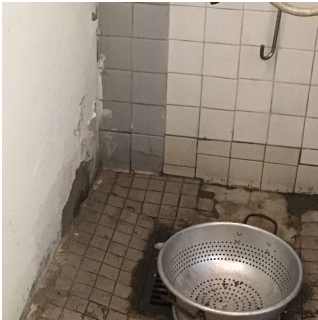
Violations	Near Entrance from Student Cafeteria No violations recorded.
Walls	
Instance on 1st Floor	Inspected
Condition	2 - Between Good and Fair
Deficiency	CERAMIC TILE: BROKEN/ MISSING
Deficiency Location/Instance	Student Serving Area, Mop Room
Deficiency Quantity	25
Quantity Uom	S.F.
Potential Action	REPLACE
Urgency of Action	PRIORITY 3
Purpose of Action	LEVEL 2
Deficiency Photo1

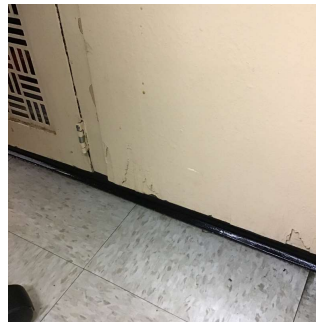
Violations	Mop Room No violations recorded.
LIBRARY	
Instance on Room 211	Inspected
Instance on Room 349	Inspected
Built-in Furnishing	
Instance on Room 211	Inspected
Condition	2 - Between Good and Fair
Deficiency	SINK/STORAGE CABINET - DAMAGED/DETERIORATED
Deficiency Location/Instance	Left Side
Deficiency Quantity	10
Quantity Uom	L.F.
Potential Action	REPLACE
Urgency of Action	PRIORITY 3
Purpose of Action	LEVEL 2

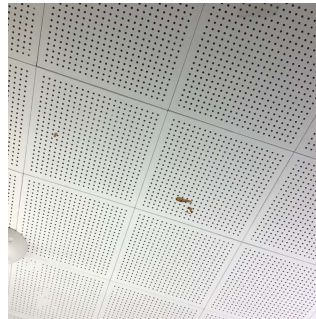
Instance on Room 211	Inspected
Condition	2 - Between Good and Fair
Deficiency	ACOUSTIC TILES ON PLASTER: DAMAGED/MISSING
Deficiency Location/Instance	Left Side
Deficiency Quantity	10
Quantity Uom	S.F.
Potential Action	REPLACE
Urgency of Action	PRIORITY 3
Purpose of Action	LEVEL 2
Deficiency Photo1

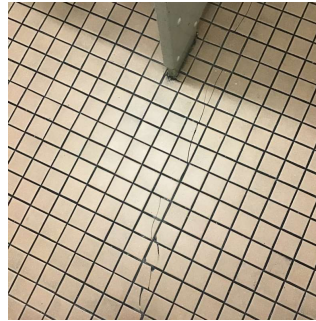
Room 335
Violations	No violations recorded.
Floor Finish	Inspected
Condition	3 - Fair
Deficiency	CERAMIC TILE: DETERIORATED SUBSTRATE
Deficiency Location/Instance	Room 337
Deficiency Quantity	10
Quantity Uom	S.F.
Potential Action	REPLACE
Urgency of Action	PRIORITY 3
Purpose of Action	LEVEL 2

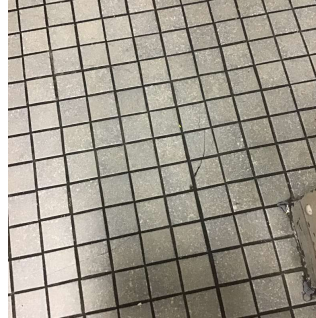
Room 235

CERAMIC TILE: BROKEN/MISSING TILES

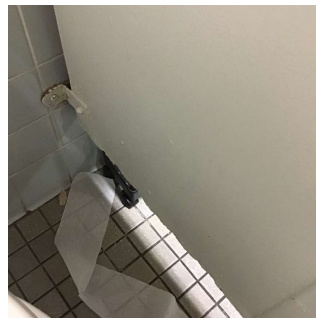
RUST - MAJOR

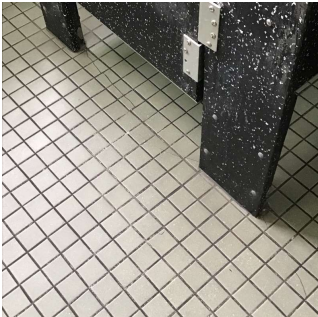
Question	Response
INTERIOR	
TOILET ROOMS - STUDENTS	
Door(s)	
Deficiency	WOOD: DETERIORATED DOOR
Deficiency Location/Instance	In Room 141, Rooms 315, 321
Deficiency Quantity	3
Quantity Uom	EACH
Potential Action	MAINTENANCE
Urgency of Action	PRIORITY 3
Purpose of Action	LEVEL 2
Deficiency Photo1	 
Violations	Room 321 No violations recorded.
Floor Finish	Inspected
Condition	2 - Between Good and Fair
Deficiency	CERAMIC TILE: DETERIORATED SUBSTRATE
Deficiency Location/Instance	Rooms 215, 321
Deficiency Quantity	20
Quantity Uom	S.F.
Potential Action	REPLACE
Urgency of Action	PRIORITY 3
Purpose of Action	LEVEL 2
Deficiency Photo1

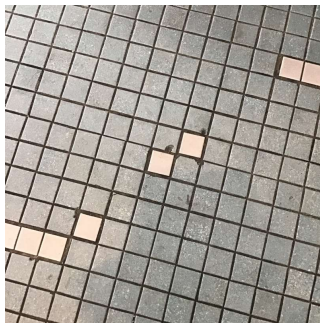
Violations	Room 321 No violations recorded.
Deficiency	CERAMIC TILE: BROKEN/MISSING TILES
Deficiency Location/Instance	In Room 147, Room 315
Deficiency Quantity	15
Quantity Uom	S.F.
Potential Action	REPLACE
Urgency of Action	PRIORITY 3
Purpose of Action	LEVEL 2

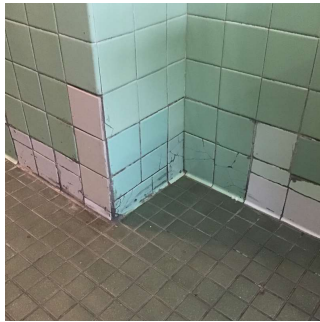
Violations	Room 315 No violations recorded.
Stalls	Inspected
Condition	2 - Between Good and Fair
Deficiency	No deficiencies recorded
Walls	Inspected
Condition	2 - Between Good and Fair
Deficiency	CERAMIC TILE: BROKEN/ MISSING
Deficiency Location/Instance	Rooms 215, 221, 315, 321
Deficiency Quantity	45
Quantity Uom	S.F.
Potential Action	REPLACE
Urgency of Action	PRIORITY 3
Purpose of Action	LEVEL 2
Deficiency Photo1

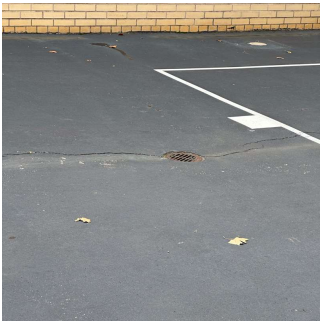
Question	Response
SITE	
PAVING	Inspected
DOT Sidewalk	
Concrete	Inspected
Violations	No violations recorded.
Pavers	Does not Exist
PLAYGROUNDS	
Instance on Along Ralph Avenue	Inspected
Benches	
Instance on Along Ralph Avenue	Inspected
Condition	2 - Between Good and Fair
Deficiency	No deficiencies recorded
Fence	
Instance on Along Ralph Avenue	Inspected
Condition	2 - Between Good and Fair
Deficiency	No deficiencies recorded
Pavement	
Instance on Along Ralph Avenue	Inspected
Condition	2 - Between Good and Fair
Deficiency	ASPHALT: CRACKS - MINOR
Deficiency Location/Instance	Near Exit 9
Deficiency Quantity	20
Quantity Uom	S.F.
Potential Action	MAINTENANCE
Urgency of Action	PRIORITY 3
Purpose of Action	LEVEL 2
Deficiency Photo1	No photo recorded
Violations	No violations recorded.
Deficiency	ASPHALT: CRACKS - MAJOR
Deficiency Location/Instance	Near Exit 8
Deficiency Quantity	25
Quantity Uom	S.F.
Potential Action	REPLACE
Urgency of Action	PRIORITY 3

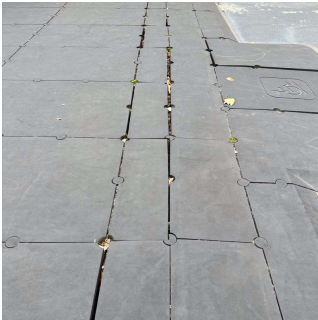
Question	Response
SITE	
PLAYGROUNDS	Inspected
Safety Surfacing	
Instance on Along Ralph Avenue	Inspected
Condition	3 - Fair
Deficiency	DETERIORATED/MISSING
Deficiency Location/Instance	Right Side
Deficiency Quantity	50
Quantity Uom	S.F.
Potential Action	REPLACE
Urgency of Action	PRIORITY 5
Purpose of Action	LEVEL 6
Deficiency Photo1
