NYC Department of Education
Building Condition Assessment Survey 2023 - 2024

Architectural Inspection

K310

Asset: PS 310 THE SCHOOL FOR FUTURE LEADERS - BROOKLYN, 942 62 STREET, New York, 11219

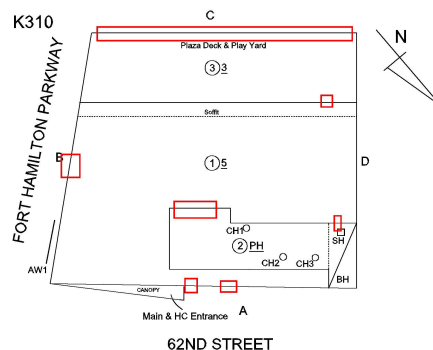
Question	Response
Architectural	
EXTERIOR	Inspected
AREAWAY	Inspected
Instance on AW1	Inspected
Instance Condition	2 - Between Good and Fair
Instance Quantity	1
Instance Quantity Uom	EACH
Deficiency	No deficiencies recorded
AWNINGS AND CANOPIES	Inspected
Condition	2 - Between Good and Fair
Deficiency	No deficiencies recorded
CHIMNEY	Inspected
Material Type(s)	Metal
Condition	2 - Between Good and Fair
Deficiency	No deficiencies recorded
COPING	Inspected
Condition	2 - Between Good and Fair
Deficiency	CAST STONE: DETERIORATED TRANSVERSE JOINTS
Roof Plan reference	
Deficiency Quantity	40
Quantity Uom	L.F.

Question	Response
EXTERIOR	
COPING	
Potential Action	MAINTENANCE
Urgency of Action	PRIORITY 3
Purpose of Action	LEVEL 2
Deficiency Photo1	 
	Roof 1 - Facade C
Violations	No violations recorded.
CORNICE	Does not Exist
DOORS	Inspected
DOORS AND FRAMES	Inspected
Condition	3 - Fair
Deficiency	METAL: DETERIORATED DOOR AND FRAME - MINOR DETERIORATION
Roof Plan reference	<p>K310</p>  
Deficiency Quantity	3
Quantity Uom	EACH
Potential Action	MAINTENANCE
Urgency of Action	PRIORITY 3
Purpose of Action	LEVEL 2
Deficiency Photo1	 
	Facade B
Violations	No violations recorded.
DOOR HARDWARE	Inspected
Condition	2 - Between Good and Fair

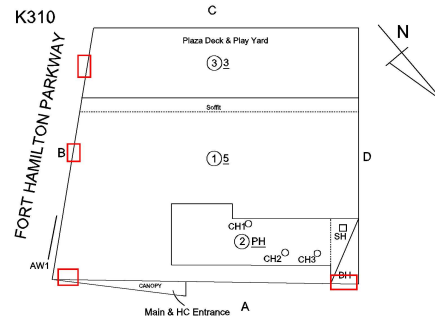
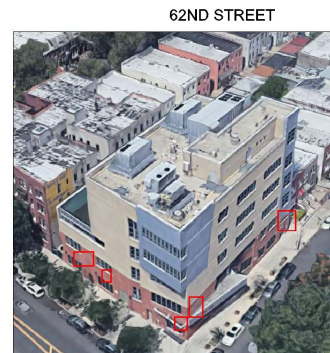
Roof Plan reference

BRICK: EFFLORESCENCE

100

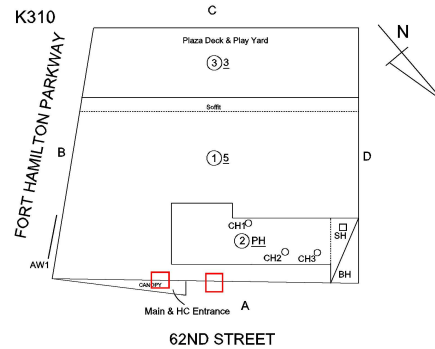
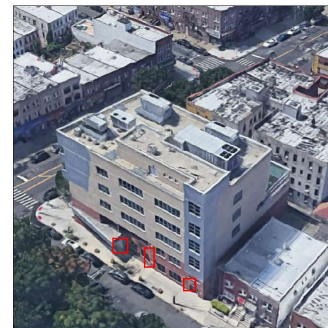
Roof Plan reference

BRICK: MINOR CRACKS AND SPALLING

40

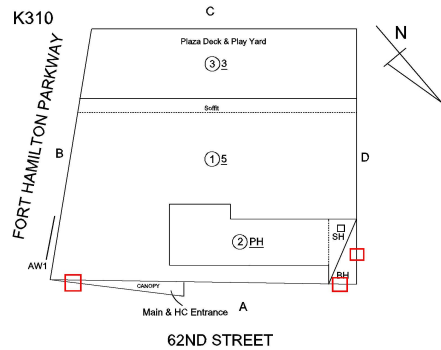
Question	Response
EXTERIOR	
EXTERIOR SOFFITS	Inspected
Condition	2 - Between Good and Fair
Deficiency	No deficiencies recorded
LOADING DOCK	Does not Exist
LOUVER	Inspected
Condition	2 - Between Good and Fair
Deficiency	No deficiencies recorded
PARAPETS	Inspected
Material Type(s)	Concrete, Masonry
Replacement Quantity	6,000
Replacement Uom	C.F.
Instance on All Roofs	Inspected
Instance Condition	2 - Between Good and Fair
Instance Quantity	6,000
Instance Quantity Uom	C.F.
Deficiency	CONCRETE: DETERIORATED CONTROL/EXPANSION JOINT
Roof Plan reference

Deficiency Quantity	20
Quantity Uom	L.F.
Potential Action	MAINTENANCE
Urgency of Action	PRIORITY 3
Purpose of Action	LEVEL 2
Deficiency Photo1

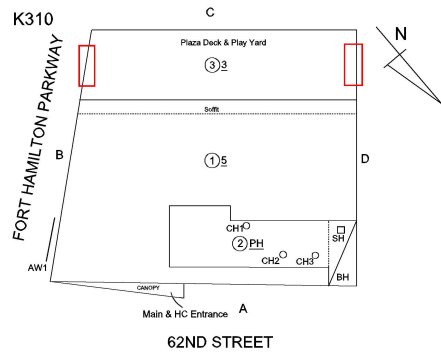
Question	Response
EXTERIOR	
PARAPETS	
Roof Plan reference	
Deficiency Quantity	40
Quantity Uom	S.F.
Potential Action	REPAIR
Urgency of Action	PRIORITY 3
Purpose of Action	LEVEL 2
Deficiency Photo1	
Violations	Roof 3 - Facade C No violations recorded.
PLAZA DECK	Inspected
Instance on Pavers: Roof 3	Inspected
Instance Condition	2 - Between Good and Fair
Instance Quantity	5,000
Instance Quantity Uom	S.F.
Installation Year	2012
Source of Installation	Custodial Staff
Deficiency	No deficiencies recorded
ROOF	Inspected
Roofing	Inspected
Replacement Quantity	14,000
Replacement Uom	S.F.
ROOF HATCH/SMOKE HATCH	Inspected
Condition	2 - Between Good and Fair
Deficiency	No deficiencies recorded
LEADERS, GUTTERS, DOWNSPOUTS, SCUPPERS	Inspected
Condition	2 - Between Good and Fair
Deficiency	No deficiencies recorded
ROOF BARRIER/FENCE	Inspected
Condition	3 - Fair
Deficiency	RAILINGS/PANELS: DETERIORATED, MAJOR RUSTING

Deficiency Quantity	80
Quantity Uom	S.F.
Potential Action	REPLACE
Urgency of Action	PRIORITY 4
Purpose of Action	LEVEL 2
Deficiency Photo1
