NYC Department of Education
Building Condition Assessment Survey 2023 - 2024

Architectural Inspection

Asset: P.S. 312 - BROOKLYN, 7103 AVENUE T, New York, 11234

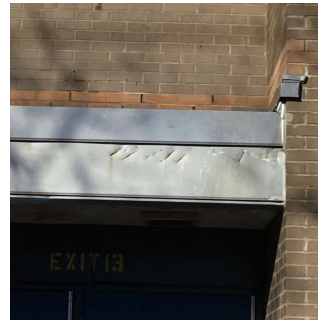
Facade A

METAL: DETERIORATION/DAMAGED/MISSING PIECES

AWNINGS AND CANOPIES

20
S.F.
REPLACE
PRIORITY 4
LEVEL 2

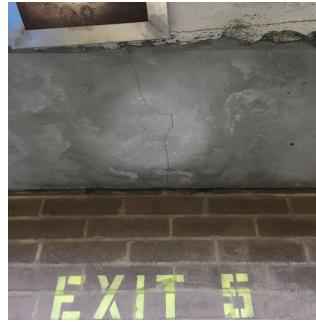
Facade D

CONCRETE: MAJOR CRACKS/SPALLING

AWNINGS AND CANOPIES

30
S.F.
REPAIR
PRIORITY 4
LEVEL 2

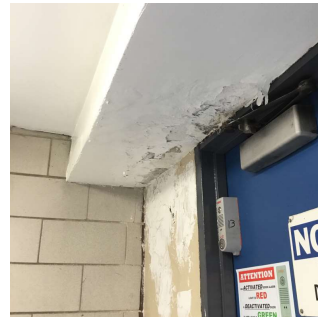
Facade D - Stairwell C Vestibule

METAL: WATER PENETRATION

REPLACE

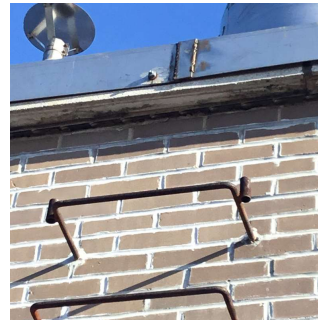
Chimney

BRICK: DETERIORATED LADDER

CHIMNEY

1
EACH
REPLACE
PRIORITY 3
LEVEL 2

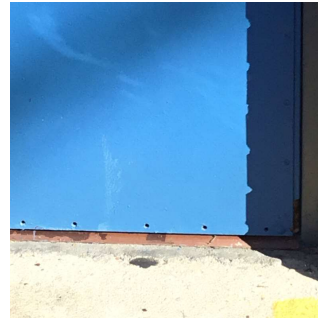
Facade B

METAL CLAD: DETERIORATED DOOR - MINOR DETERIORATION

4
EACH
MAINTENANCE
PRIORITY 3

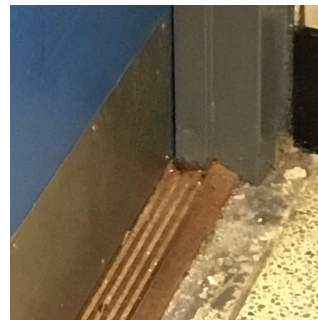
Facade A

METAL CLAD: DETERIORATED DOOR AND FRAME - MINOR DETERIORATION

2
EACH
MAINTENANCE
PRIORITY 3
LEVEL 2

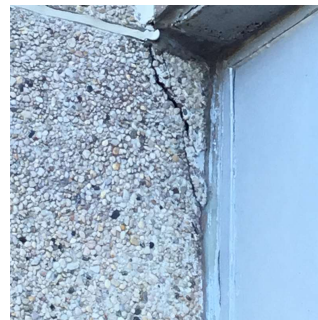
Facade D

DOOR HARDWARE	Inspected
Condition	3 - Fair
Deficiency	No deficiencies recorded
LINTELS	Inspected
Condition	2 - Between Good and Fair
Deficiency	No deficiencies recorded
TRANSOM/SIDE LIGHT	Inspected
Condition	2 - Between Good and Fair
Deficiency	No deficiencies recorded
EXTERIOR WALLS	Inspected
Material Type(s)	Concrete, Masonry
Replacement Quantity	27,000
Replacement Uom	S.F.
Instance on All Facades	Inspected
Instance Condition	3 - Fair
Instance Quantity	27,000
Instance Quantity Uom	S.F.
Deficiency	CAST IN PLACE / PRE-CAST CONCRETE: MINOR CRACKS/SPALLING

REPAIR

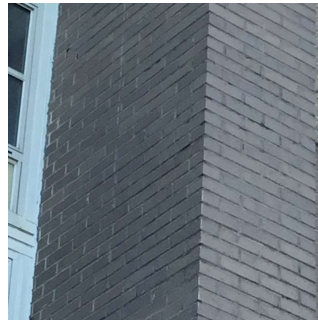
Facade D

BRICK: DETERIORATED JOINTS

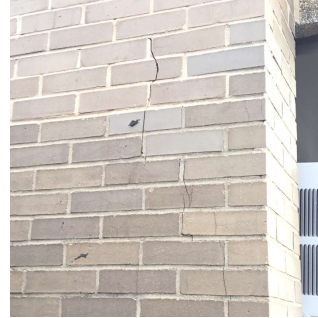
Facade J

BRICK: CRACKS/DISPLACED/SPALLED BRICK AT BUILDING CORNERS

REMOVE AND REBUILD
 PRIORITY 4
 LEVEL 2

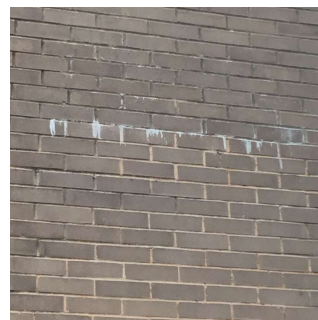
BRICK: EFFLORESCENCE

140
 S.F.
 MAINTENANCE
 PRIORITY 1
 LEVEL 1

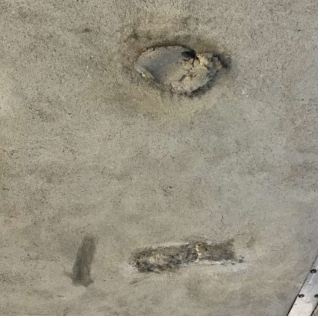
Question	Response
EXTERIOR	
EXTERIOR WALLS	Inspected
Violations	Facade J No violations recorded.
EXTERIOR SOFFITS	Inspected
Condition	3 - Fair
Deficiency	STUCCO/PLASTER: MAJOR CRACKS/SPALLING
Roof Plan reference	K312

Deficiency Quantity	25
Quantity Uom	S.F.
Potential Action	REPLACE
Urgency of Action	PRIORITY 4
Purpose of Action	LEVEL 2
Deficiency Photo1

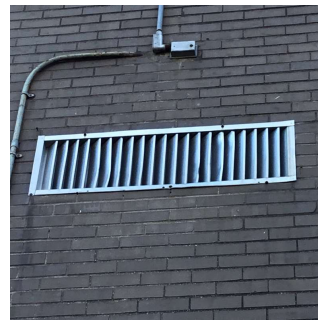
Facade D

Violations	Facade A No violations recorded.
LOADING DOCK	Does not Exist
LOUVER	Inspected
Condition	3 - Fair
Deficiency	BROKEN/ DENTED BLADES

LOUVER

REPLACE

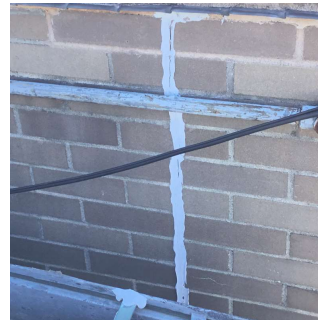
Roof 1
No violations recorded.

BRICK: DETERIORATED CONTROL/EXPANSION JOINT

30
L.F.
MAINTENANCE
PRIORITY 3
LEVEL 2

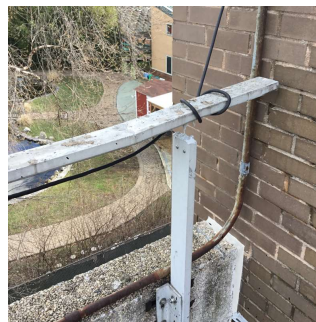
Roof 2
No violations recorded.

RAILINGS/PANELS: DETERIORATED, MAJOR RUSTING

20
S.F.
REPLACE
PRIORITY 4
LEVEL 2

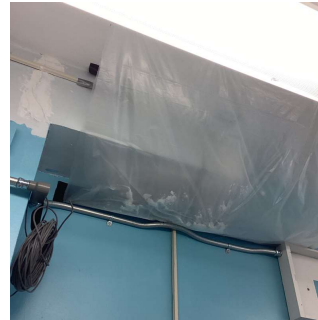
Roof 2 - Room 114

Source of Installation	Custodial Staff
Deficiency	IRMA: ROOFING: MAJOR ACTIVE ROOF LEAKS IN INSTRUCTIONAL SPACE
Roof Plan reference

S.F.
REPLACE ROOFING WITHOUT MAJOR EQUIPMENT
REMOVAL
PRIORITY 5
LEVEL 2

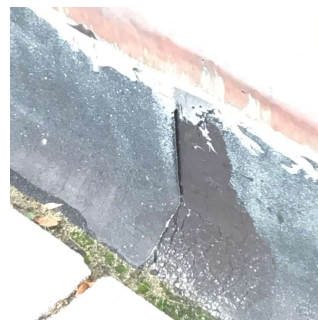
Roof 2

IRMA: FLASHING: BASE FLASHING DETERIORATED

20
S.F.
REPAIR
PRIORITY 3
LEVEL 2

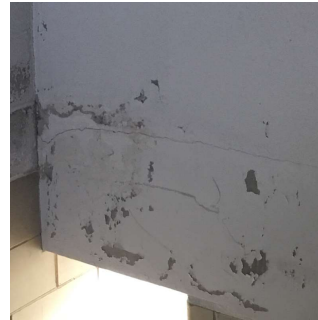
BH3

**BULKHEAD/PENTHOUSE WALLS/INTERIOR: PLASTER
CRACKS/SPALLING**

20
S.F.
REPLACE
PRIORITY 3
LEVEL 2

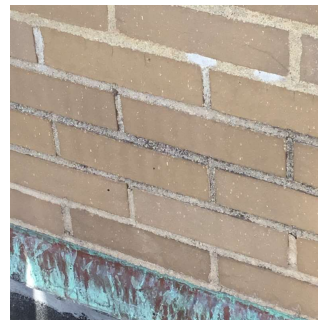
BH2

BULKHEAD/PENTHOUSE WALLS/EXTERIOR: DETERIORATED JOINTS

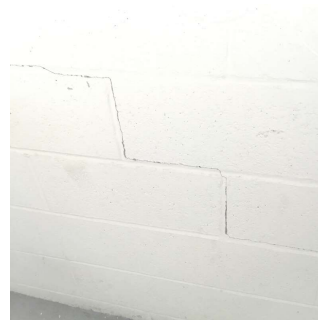
BH2
No violations recorded.

**BULKHEAD/PENTHOUSE WALLS/INTERIOR: CMU
CRACKS/SPALLING**

50
S.F.
REPLACE
PRIORITY 3
LEVEL 2

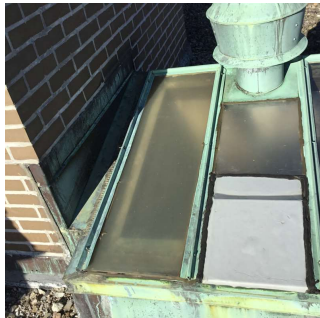
Violations	Roof 2 No violations recorded.
SKYLIGHT/ROOF VENT	Inspected
Material Type(s)	Glass, Plastic
Condition	3 - Fair
Deficiency	DAMAGED GUARDS
Roof Plan reference	K312

Deficiency Quantity	20
Quantity Uom	S.F.
Potential Action	MAINTENANCE
Urgency of Action	PRIORITY 3
Purpose of Action	LEVEL 2
Deficiency Photo1

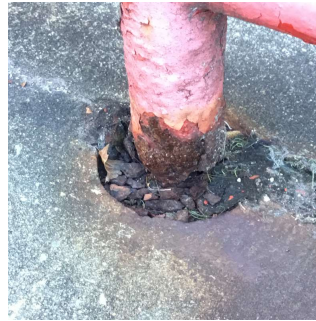
Facade C

RUST - MAJOR

20
L.F.
REPLACE
PRIORITY 4
LEVEL 2

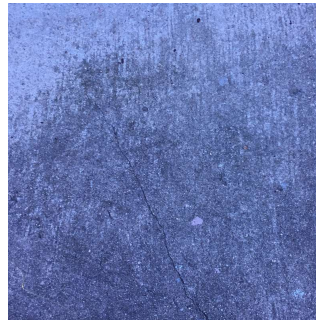
Facade D

CONCRETE: CRACKS/SPALLING - MINOR

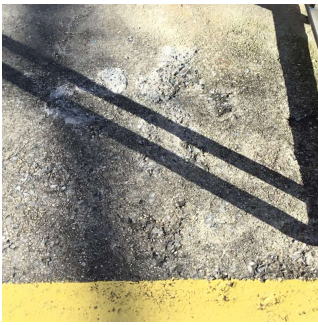
CONCRETE: CRACKS/SPALLING - MAJOR

70
S.F.
REPLACE
PRIORITY 4
LEVEL 2

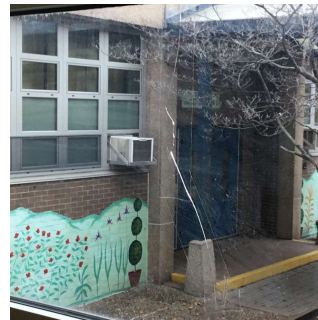
Facade F - Room 126
No violations recorded.

Violations	Facade B No violations recorded.
WINDOWS	Inspected
Replacement Quantity	10,200
Replacement Uom	S.F.
EXTERIOR GUARDS	Inspected
Condition	2 - Between Good and Fair
Deficiency	No deficiencies recorded
LINTELS	Inspected
Condition	2 - Between Good and Fair
Deficiency	No deficiencies recorded
WINDOWS	Inspected
Material Type(s)	Aluminum
Instance on Aluminum - Other: Facade C	Inspected
Instance Condition	3 - Fair
Instance Quantity	1,200
Instance Quantity Uom	S.F.
Are these windows insulated	No
Installation Year	1966
Source of Installation	Custodial Staff
Deficiency	No deficiencies recorded
Instance on Aluminum - Other: Facades A, B, D-G	Inspected
Instance Condition	3 - Fair
Instance Quantity	9,000
Instance Quantity Uom	S.F.
Are these windows insulated	Yes
Installation Year	2011
Source of Installation	Custodial Staff
Deficiency	ALUMINUM - OTHER: BROKEN PANE

360
S.F.
MAINTENANCE
PRIORITY 3
LEVEL 2

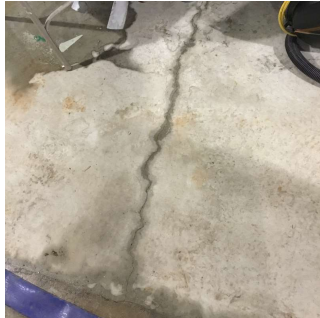
Question	Response
INTERIOR	
STRUCTURAL	
COLUMNS/BEAMS/BEARING WALLS	
Purpose of Action	LEVEL 5
Deficiency Photo1	 
	Boiler Room
Violations	No violations recorded.
FLOOR STRUCTURE	
	Inspected
Condition	3 - Fair
Deficiency	CONCRETE SLAB ON GRADE: THRU CRACKS
Deficiency Location/Instance	Basement
Deficiency Quantity	40
Quantity Uom	S.F.
Potential Action	REPAIR
Urgency of Action	PRIORITY 3
Purpose of Action	LEVEL 5
Deficiency Photo1

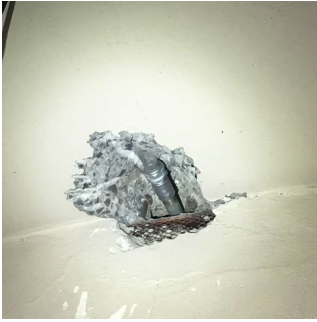
Violations	Room 217 No violations recorded.
Deficiency	CONCRETE: CRACKS/SPALLED/REINFORCEMENT EXPOSED
Deficiency Location/Instance	2nd Floor
Deficiency Quantity	15
Quantity Uom	S.F.
Potential Action	REPAIR
Urgency of Action	PRIORITY 4
Purpose of Action	LEVEL 5
Deficiency Photo1

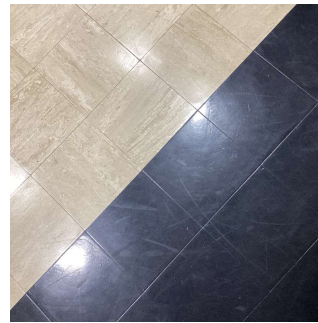
Near Entrance

Seat D/107
Violations	No violations recorded.
Floor Finish	
Instance on 1st Floor (196 Seats)	Inspected
Condition	2 - Between Good and Fair
Deficiency	VINYL TILES: BROKEN/DETERIORATED/MISSING TILES
Deficiency Location/Instance	Near Entrance, Near Stage

Deficiency Quantity	35
Quantity Uom	S.F.
Potential Action	REPLACE
Urgency of Action	PRIORITY 3
Purpose of Action	LEVEL 2

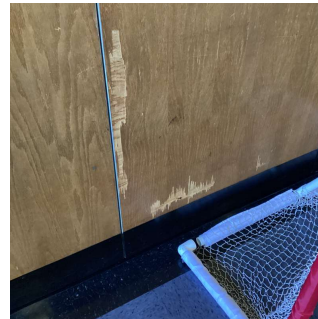
Gymnasium Side

MOVABLE PANELS: DAMAGED

REPLACE

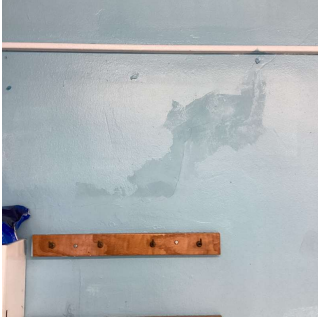
Near Sink
Violations	No violations recorded.
Window Curtains/Shades/Blinds	
Instance on 1st Floor - Staff (600 SF)	Does not Exist
Instance on 1st Floor - Students	Does not Exist
CLASSROOMS/CORRIDORS/ADMIN SPACES	
Ceiling	
Condition	2 - Between Good and Fair
Deficiency	PLASTER: CRACKS/SPALLING - ACTIVE LEAK
Deficiency Location/Instance	Room 114
Deficiency Quantity	20
Quantity Uom	S.F.
Potential Action	REPLACE
Urgency of Action	PRIORITY 5
Purpose of Action	LEVEL 2
Deficiency Photo1

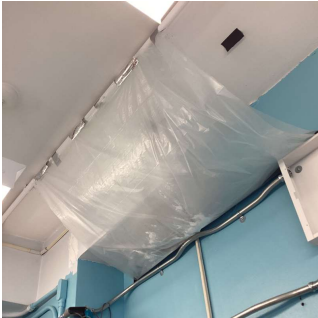
Room 114
Violations	No violations recorded.
Deficiency	PLASTER: CRACKS/SPALLING
Deficiency Location/Instance	Room 350
Deficiency Quantity	20
Quantity Uom	S.F.
Potential Action	REPLACE
Urgency of Action	PRIORITY 3
Purpose of Action	LEVEL 2

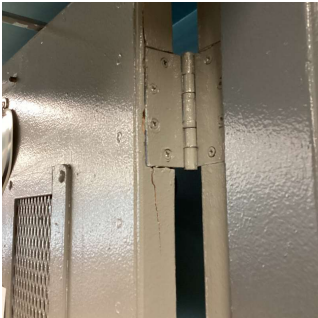
Question	Response
INTERIOR	
CLASSROOMS/CORRIDORS/ADMIN SPACES	
Door(s)	
	Room 235
Violations	No violations recorded.
Deficiency	WOOD: DETERIORATED DOOR
Deficiency Location/Instance	Room 328
Deficiency Quantity	1
Quantity Uom	EACH
Potential Action	MAINTENANCE
Urgency of Action	PRIORITY 3
Purpose of Action	LEVEL 2
Deficiency Photo1

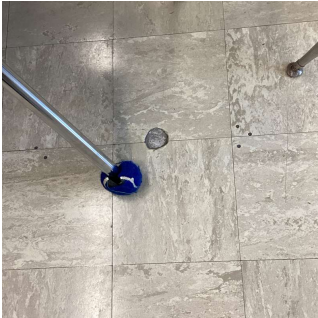
Room 328
Violations	No violations recorded.
Floor Finish	Inspected
Condition	2 - Between Good and Fair
Deficiency	VINYL TILES: BROKEN/DETERIORATED/MISSING TILES
Deficiency Location/Instance	Rooms 223, 241, 328, Corridor near Rooms 106, 118, and others
Deficiency Quantity	220
Quantity Uom	S.F.
Potential Action	REPLACE
Urgency of Action	PRIORITY 3
Purpose of Action	LEVEL 2
Deficiency Photo1

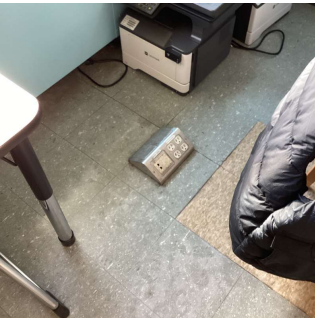
Question	Response
INTERIOR	
CLASSROOMS/CORRIDORS/ADMIN SPACES	
Floor Finish	
Deficiency Photo1 Violations	  Room 133 No violations recorded.
Deficiency Deficiency Location/Instance Deficiency Quantity Quantity Uom Potential Action Urgency of Action Purpose of Action Deficiency Photo1 Violations	VINYL TILES: TRIPPING HAZARD - ELECTRICAL OUTLET Room 337 10 S.F. REMOVE PRIORITY 5 LEVEL 6

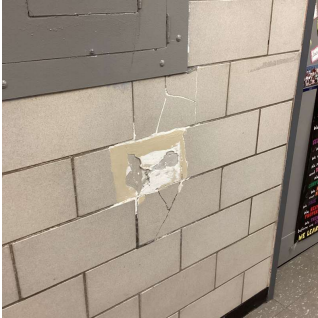
Question	Response
INTERIOR	
CLASSROOMS/CORRIDORS/ADMIN SPACES	
Walls	Inspected
Condition	2 - Between Good and Fair
Deficiency	GLAZED BLOCK: CRACKS/SPALLING
Deficiency Location/Instance	Corridor near Rooms 105, 129, 343, 347, Corridor near Stair D/1, and others
Deficiency Quantity	80
Quantity Uom	S.F.
Potential Action	REPLACE
Urgency of Action	PRIORITY 3
Purpose of Action	LEVEL 2
Deficiency Photo1

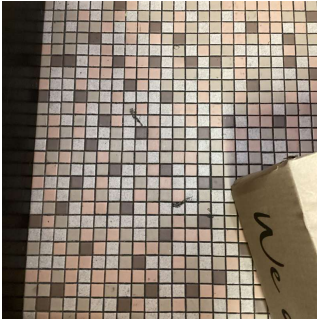
Violations	Closet Near Exit Vestibule No violations recorded.
Floor Finish	
Instance on 1st Floor	Inspected
Condition	2 - Between Good and Fair
Deficiency	CERAMIC TILE: BROKEN/MISSING TILES
Deficiency Location/Instance	Exit Vestibule
Deficiency Quantity	10
Quantity Uom	S.F.
Potential Action	REPLACE
Urgency of Action	PRIORITY 3
Purpose of Action	LEVEL 2
Deficiency Photo1

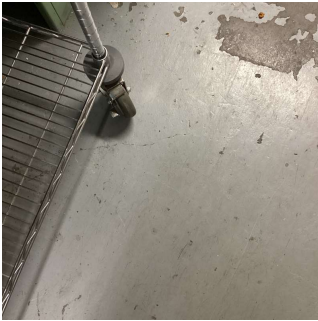
Violations	Exit Vestibule No violations recorded.
Deficiency	CONCRETE: CRACKS
Deficiency Location/Instance	Storage Room
Deficiency Quantity	10
Quantity Uom	S.F.
Potential Action	REPLACE
Urgency of Action	PRIORITY 3
Purpose of Action	LEVEL 2

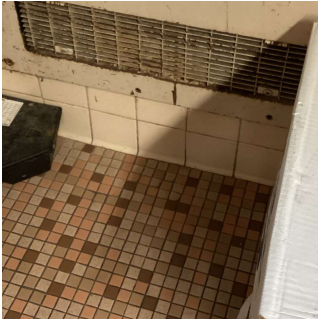
Violations	Storage Room No violations recorded.
Walls	
Instance on 1st Floor	Inspected
Condition	2 - Between Good and Fair
Deficiency	CERAMIC TILE: BROKEN/ MISSING
Deficiency Location/Instance	Near Hand Washing Sink
Deficiency Quantity	10
Quantity Uom	S.F.
Potential Action	REPLACE
Urgency of Action	PRIORITY 3
Purpose of Action	LEVEL 2
Deficiency Photo1

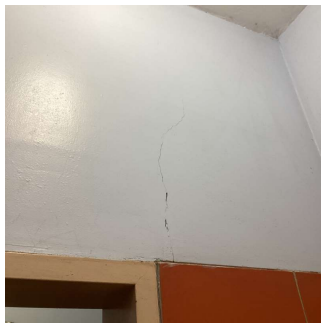
Violations	Near Hand Washing Sink No violations recorded.
Deficiency	PLASTER: CRACKS/SPALLING
Deficiency Location/Instance	Exit Vestibule
Deficiency Quantity	10
Quantity Uom	S.F.
Potential Action	REPLACE
Urgency of Action	PRIORITY 3
Purpose of Action	LEVEL 2

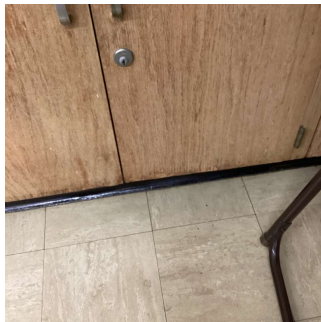
Violations	Exit Vestibule No violations recorded.
LIBRARY	Inspected
Instance on Room 228	Inspected
Built-in Furnishing	
Instance on Room 228	Inspected
Condition	2 - Between Good and Fair
Deficiency	SINK/STORAGE CABINET - DAMAGED/DETERIORATED
Deficiency Location/Instance	Left Side
Deficiency Quantity	10
Quantity Uom	L.F.
Potential Action	REPLACE
Urgency of Action	PRIORITY 3
Purpose of Action	LEVEL 2
Deficiency Photo1

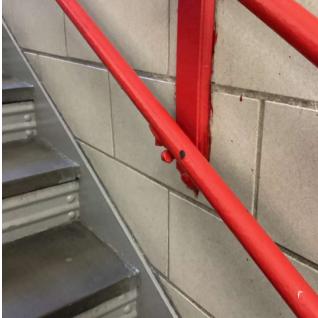
Question	Response
INTERIOR	
STAIRS/RAMPS: INTERIOR	
Ceiling	
Violations	Stair A/3 No violations recorded.
Deficiency	PLASTER: CRACKS/SPALLING - ACTIVE LEAK
Deficiency Location/Instance	Stair C/1 Vestibule
Deficiency Quantity	10
Quantity Uom	S.F.
Potential Action	REPLACE
Urgency of Action	PRIORITY 5
Purpose of Action	LEVEL 2
Deficiency Photo1	 
Violations	Stair C/1 Vestibule No violations recorded.
Door(s)	Inspected
Condition	3 - Fair
Deficiency	METAL: DETERIORATED DOOR AND FRAME
Deficiency Location/Instance	Stair B/1 Vestibule
Deficiency Quantity	2
Quantity Uom	EACH
Potential Action	MAINTENANCE
Urgency of Action	PRIORITY 3
Purpose of Action	LEVEL 2
Deficiency Photo1	 
Violations	Stair B/1 Vestibule No violations recorded.
Partition	Does not Exist
Railings	Inspected
Condition	3 - Fair
Deficiency	METAL: BROKEN BRACKET
Deficiency Location/Instance	Stair C/1
Deficiency Quantity	1

Question	Response
INTERIOR	
STAIRS/RAMPS: INTERIOR	
Railings	
Quantity Uom	EACH
Potential Action	REPLACE
Urgency of Action	PRIORITY 3
Purpose of Action	LEVEL 2
Deficiency Photo1

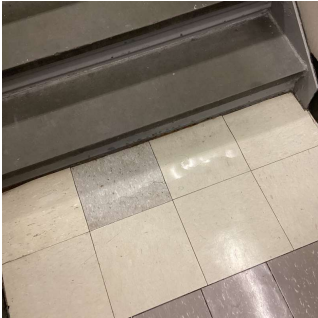
Stair C/1
Violations	No violations recorded.
Stairs and Landings	Inspected
Condition	3 - Fair
Deficiency	VINYL TILES: DETERIORATED SUBSTRATE
Deficiency Location/Instance	Stair A/1
Deficiency Quantity	10
Quantity Uom	S.F.
Potential Action	REPLACE
Urgency of Action	PRIORITY 3
Purpose of Action	LEVEL 2
Deficiency Photo1

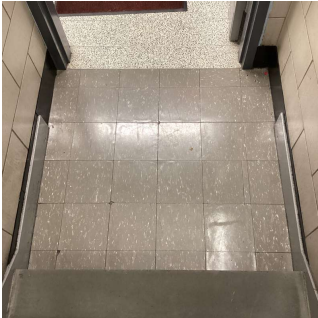
Question	Response
INTERIOR	
STAIRS/RAMPS: INTERIOR	
Stairs and Landings	
Deficiency	VINYL TILES: BROKEN/DETERIORATED/MISSING TILES
Deficiency Location/Instance	Stairs A/1, D/1,2
Deficiency Quantity	35
Quantity Uom	S.F.
Potential Action	REPLACE
Urgency of Action	PRIORITY 3
Purpose of Action	LEVEL 2
Deficiency Photo1

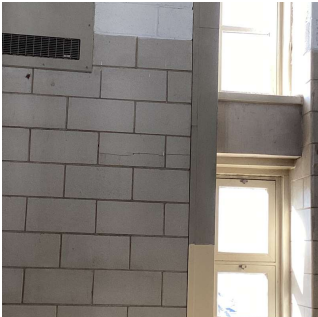
Stair D/1
Violations	No violations recorded.
Walls	Inspected
Condition	2 - Between Good and Fair
Deficiency	GLAZED BLOCK: CRACKS/SPALLING
Deficiency Location/Instance	Stairs B/1,2,3, C/3
Deficiency Quantity	35
Quantity Uom	S.F.
Potential Action	REPLACE
Urgency of Action	PRIORITY 3
Purpose of Action	LEVEL 2
Deficiency Photo1

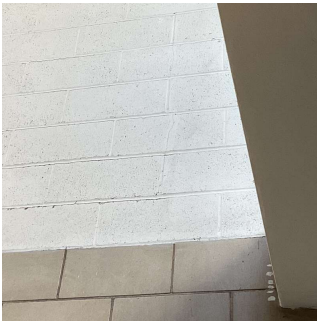
Stair B/3
Violations	No violations recorded.
Deficiency	MASONRY: CRACKS/SPALLING
Deficiency Location/Instance	Stair B/3
Deficiency Quantity	10
Quantity Uom	S.F.
Potential Action	REPLACE
Urgency of Action	PRIORITY 3
Purpose of Action	LEVEL 2

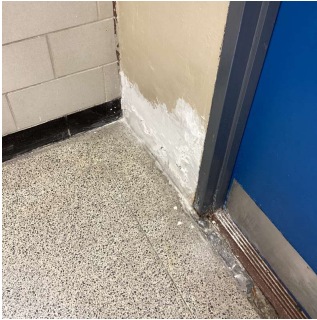
Violations	Stair B/3 No violations recorded.
Deficiency	PLASTER: CRACKS/SPALLING - ACTIVE LEAK
Deficiency Location/Instance	Stair C/1 Vestibule
Deficiency Quantity	20
Quantity Uom	S.F.
Potential Action	REPLACE
Urgency of Action	PRIORITY 5
Purpose of Action	LEVEL 2
Deficiency Photo1

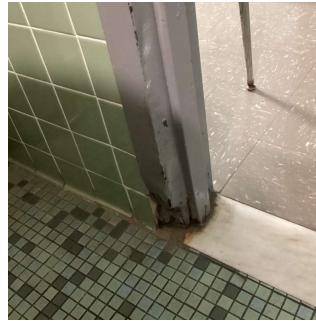
Violations	Stair C/1 Vestibule No violations recorded.
TOILET ROOMS - STAFF	
	Inspected
Ceiling	
Condition	Inspected
	2 - Between Good and Fair
Deficiency	No deficiencies recorded
Door(s)	
	Inspected
Condition	5 - Poor
Deficiency	METAL: DETERIORATED DOOR AND FRAME
Deficiency Location/Instance	Room 119, In Room 106
Deficiency Quantity	2
Quantity Uom	EACH
Potential Action	MAINTENANCE
Urgency of Action	PRIORITY 3
Purpose of Action	LEVEL 2

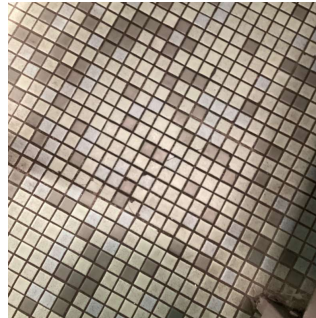
Room 325

CERAMIC TILE: BROKEN/MISSING TILES

REPLACE

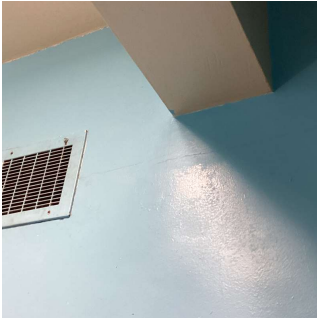
Room 119
Violations	No violations recorded.
Walls	Inspected
Condition	2 - Between Good and Fair
Deficiency	PLASTER: CRACKS/SPALLING
Deficiency Location/Instance	Room 119, In Room 141
Deficiency Quantity	20
Quantity Uom	S.F.
Potential Action	REPLACE
Urgency of Action	PRIORITY 3
Purpose of Action	LEVEL 2
Deficiency Photo1

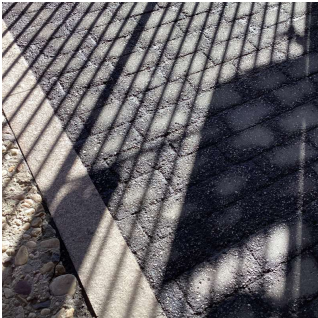
Question	Response
SITE	
PAVING	
Student Use	
Asphalt	Does not Exist
Concrete	Inspected
Condition	2 - Between Good and Fair
Deficiency	No deficiencies recorded
Pavers	Inspected
Condition	2 - Between Good and Fair
Deficiency	DAMAGED/MISSING
Deficiency Location/Instance	Near Main Entrance
Deficiency Quantity	40
Quantity Uom	S.F.
Potential Action	REPLACE
Urgency of Action	PRIORITY 3
Purpose of Action	LEVEL 2
Deficiency Photo1

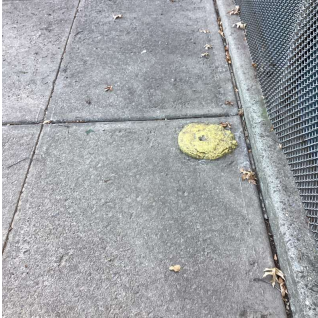
Near Main Entrance
Violations	No violations recorded.
Site Sidewalks & Walkways	Inspected
Asphalt	Does not Exist
Concrete	Inspected
Condition	3 - Fair
Deficiency	DAMAGED/DETERIORATED/MISSING SECTIONS
Deficiency Location/Instance	Near Exit 6
Deficiency Quantity	25
Quantity Uom	S.F.
Potential Action	REPLACE
Urgency of Action	PRIORITY 5
Purpose of Action	LEVEL 6
Deficiency Photo1

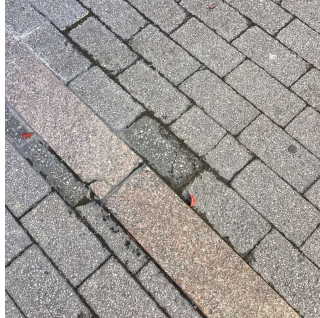
Question	Response
SITE	
PAVING	
Site Sidewalks & Walkways	
Pavers	
Deficiency Photo1

Violations	Near Main Entrance No violations recorded.
Deficiency	DAMAGED/MISSING
Deficiency Location/Instance	Near Main Entrance
Deficiency Quantity	10
Quantity Uom	S.F.
Potential Action	REPLACE
Urgency of Action	PRIORITY 3
Purpose of Action	LEVEL 2

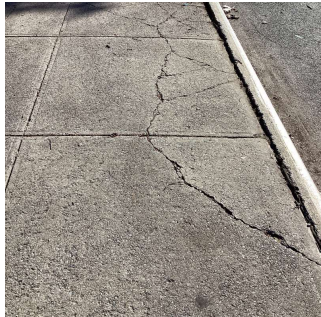
Question	Response
SITE	
PAVING	
DOT Sidewalk	
Concrete	
Deficiency Photo1

Violations	East 71st Street No violations recorded.
Deficiency	DAMAGED/DETERIORATED/MISSING SECTIONS
Deficiency Location/Instance	East 71st Street, Avenue T
Deficiency Quantity	525
Quantity Uom	S.F.
Potential Action	REPLACE
Urgency of Action	PRIORITY 3
Purpose of Action	LEVEL 2

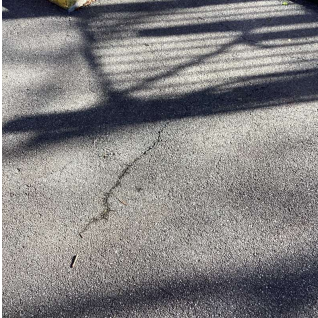
Question	Response
SITE	
PLAYGROUNDS	
Pavement	
Quantity Uom	S.F.
Potential Action	REPLACE
Urgency of Action	PRIORITY 3
Purpose of Action	LEVEL 2
Deficiency Photo1

Violations	Near Exit 12 No violations recorded.
Deficiency	ASPHALT: CRACKS - MAJOR
Deficiency Location/Instance	Near Exit 10, Near Exit 12
Deficiency Quantity	120

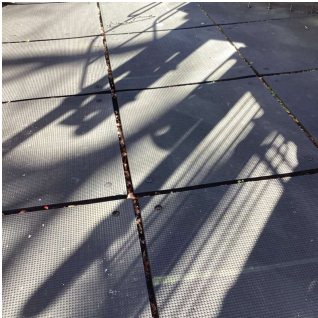
Near Exit 10
Violations	No violations recorded.
Unpaved Area	
Instance on Along East 71 Street	Does not Exist
PLAYING SURFACE	
	Does not Exist
RETAINING WALLS	
Are there any Retaining Walls 6' OR higher facing public street/sidewalk?	No
Condition	2 - Between Good and Fair

Near Exit 10
Violations	No violations recorded.
Play Equipment	
Instance on Along East 71 Street	Inspected
Condition	2 - Between Good and Fair
Deficiency	No deficiencies recorded
Safety Surfacing	
Instance on Along East 71 Street	Inspected
Condition	3 - Fair
Deficiency	DETERIORATED/MISSING
Deficiency Location/Instance	Near Exit 10, Center, Near Exit 12
Deficiency Quantity	100
Quantity Uom	S.F.
Potential Action	REPLACE
Urgency of Action	PRIORITY 5
Purpose of Action	LEVEL 6
Deficiency Photo1

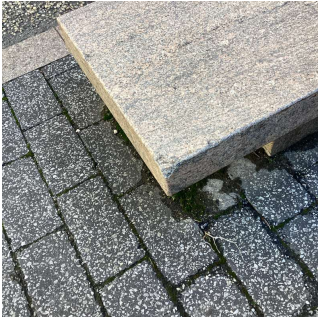
Violations	Near Main Entrance No violations recorded.
Metal/Wood/Plastic	
	Does not Exist
Bleachers	
	Does not Exist
SITE WALLS (NOT RETAINING WALLS)	
	Does not Exist
STAIRS/RAMPS: EXTERIOR	
	Inspected
Railings	
	Inspected
Condition	2 - Between Good and Fair
Deficiency	No deficiencies recorded

Question	Response
SITE	
RETAINING WALLS	
Deficiency	BRICK: DETERIORATED COPING STONE
Deficiency Location/Instance	East 71st Street
Deficiency Quantity	10
Quantity Uom	S.F.
Potential Action	REPLACE
Urgency of Action	PRIORITY 3
Purpose of Action	LEVEL 2
Deficiency Photo1	 
Violations	East 71st Street No violations recorded.
SEATING	
	Inspected
Benches	
	Inspected
Concrete	
	Inspected
Condition	3 - Fair
Deficiency	CRACKS/SPALLING - MAJOR
Deficiency Location/Instance	Near Main Entrance
Deficiency Quantity	1
Quantity Uom	EACH
Potential Action	REPLACE
Urgency of Action	PRIORITY 3
Purpose of Action	LEVEL 2
Deficiency Photo1

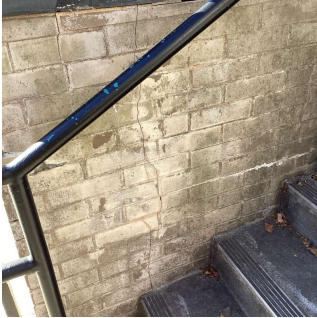
Violations	Playground No violations recorded.

Site Cheek/flank Walls	Inspected
Condition	2 - Between Good and Fair
Deficiency	BRICK: CRACKS/SPALLING - MAJOR
Deficiency Location/Instance	Playground
Deficiency Quantity	10
Quantity Uom	S.F.
Potential Action	REPLACE
Urgency of Action	PRIORITY 3
Purpose of Action	LEVEL 2
Deficiency Photo1

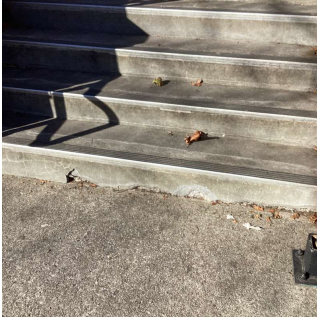
Violations	Playground No violations recorded.

Stairs/ramps	Inspected
Condition	2 - Between Good and Fair
Deficiency	CAST IN PLACE CONCRETE: CRACKS/SPALLING - MAJOR
Deficiency Location/Instance	Playground
Deficiency Quantity	10
Quantity Uom	S.F.
Potential Action	REPLACE
Urgency of Action	PRIORITY 3
Purpose of Action	LEVEL 2
Deficiency Photo1
