**NYC Department of Education**  
**Building Condition Assessment Survey 2023 - 2024**

Architectural Inspection

**K316**

**Asset:** P.S. 316 - BROOKLYN, 750 CLASSON AVENUE, New York, 11238

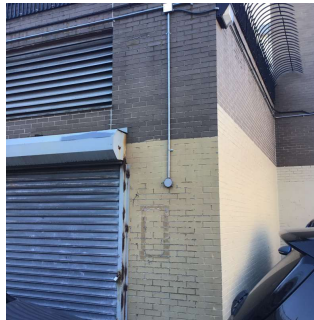
Facade F

**EXTERIOR WALLS**

500

LEVEL 2

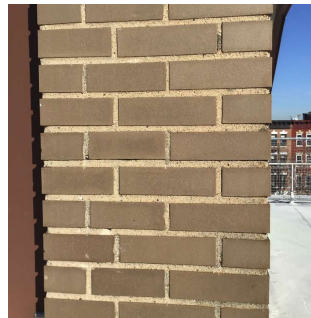
Violations	Bulkhead 1 No violations recorded.
Deficiency	<b>BULKHEAD/PENTHOUSE ROOF: DETERIORATED</b>

Question	Response
<b>EXTERIOR</b>	
<b>ROOF</b>	
<b>Roofing</b>	
<b>ROOFING</b>	Inspected
Installation Year	2020
Source of Installation	Custodial Staff
Deficiency	No deficiencies recorded
<b>ROOFING DRAINS</b>	Inspected
Condition	1 - Good
Deficiency	No deficiencies recorded
<b>Specialties</b>	Inspected
<b>BULKHEAD/PENTHOUSE</b>	Inspected
Condition	3 - Fair
Deficiency	<b>BULKHEAD/PENTHOUSE WALLS/EXTERIOR: DETERIORATED JOINTS</b>
Roof Plan reference

Deficiency Quantity	300
Quantity Uom	S.F.
Potential Action	REPOINT
Urgency of Action	PRIORITY 3
Purpose of Action	LEVEL 2
Deficiency Photo1

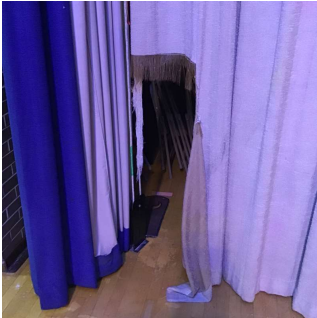
Question	Response
<b>INTERIOR</b>	
<b>AUDITORIUM</b>	
<b>Stage</b>	
<b>Stage</b>	
Deficiency Photo1	 
	Right side
Violations	No violations recorded.
<b>Stage Curtain Rigging</b>	Inspected
Instance on 1st Floor (212 seats)	Inspected
Condition	2 - Between Good and Fair
Deficiency	No deficiencies recorded
<b>Stage Curtains</b>	Inspected
Instance on 1st Floor (212 seats)	Inspected
Condition	4 - Between Fair and Poor
Deficiency	WORN/DETERIORATED
Deficiency Location/Instance	Right side, left side
Deficiency Quantity	300
Quantity Uom	S.F.
Potential Action	REPLACE
Urgency of Action	PRIORITY 3
Purpose of Action	LEVEL 2
Deficiency Photo1

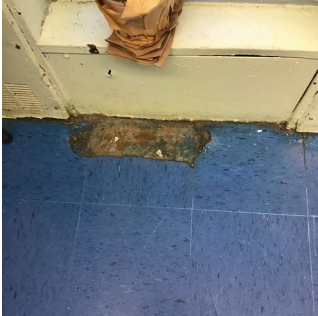
Question	Response
<b>INTERIOR</b>	
<b>CAFETERIA</b>	
<b>Floor Finish</b>	
Urgency of Action	PRIORITY 3
Purpose of Action	LEVEL 2
Deficiency Photo1

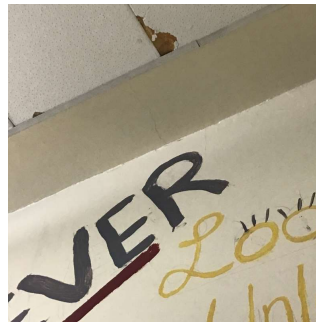
Corridor near Room 308

**Ceiling**

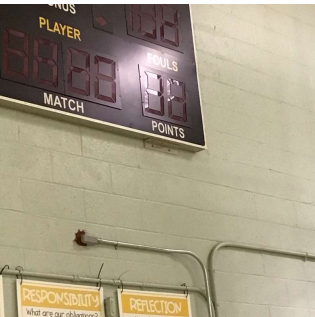
Violations	Near Scoreboard
Violations	No violations recorded.
Deficiency	GLAZED BLOCK: CRACKS/SPALLING
Deficiency Location/Instance	Near water fountain, Entrance
Deficiency Quantity	50
Quantity Uom	S.F.
Potential Action	REPLACE
Urgency of Action	PRIORITY 3
Purpose of Action	LEVEL 2
Deficiency Photo1

Question	Response
<b>INTERIOR</b>	
<b>GYMNASIUM</b>	
<b>Walls</b>	
Purpose of Action	LEVEL 2
Deficiency Photo1

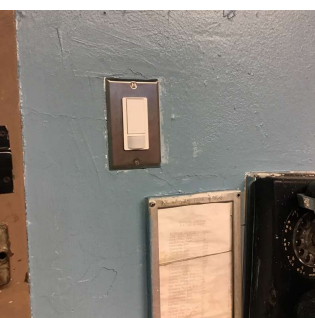
Violations	Office

Violations	Near water fountain
Violations	No violations recorded.
Deficiency	PLASTER: CRACKS/SPALLING
Deficiency Location/Instance	Office
Deficiency Quantity	10
Quantity Uom	S.F.
Potential Action	REPLACE
Urgency of Action	PRIORITY 3
Purpose of Action	LEVEL 2
Deficiency Photo1

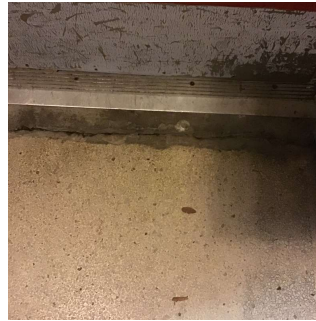
Near exit 2

**Floor Finish**

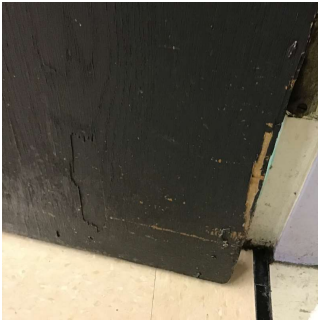
Question	Response
<b>INTERIOR</b>	
<b>LIBRARY</b>	
<b>Ceiling</b>	
Deficiency Photo1	 
Violations	Near Windows No violations recorded.
<b>Door(s)</b>	
Instance on Room 204	Inspected
Condition	3 - Fair
Deficiency	WOOD: DETERIORATED DOOR
Deficiency Location/Instance	Entrance
Deficiency Quantity	1
Quantity Uom	EACH
Potential Action	MAINTENANCE
Urgency of Action	PRIORITY 3
Purpose of Action	LEVEL 2
Deficiency Photo1

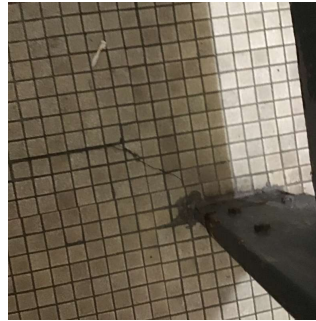
Room 319
Violations	No violations recorded.
<b>Floor Finish</b>	Inspected
Condition	5 - Poor
Deficiency	CERAMIC TILE: BROKEN/MISSING TILES
Deficiency Location/Instance	Rooms 321,319,181,172,134, and others
Deficiency Quantity	100
Quantity Uom	S.F.
Potential Action	REPLACE
Urgency of Action	PRIORITY 3
Purpose of Action	LEVEL 2

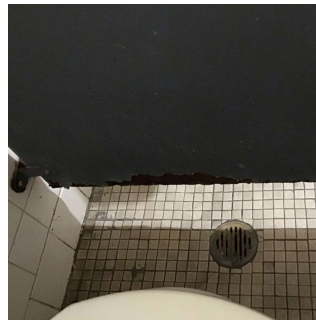
Room 319

Deficiency

RUST - MAJOR

REPLACE

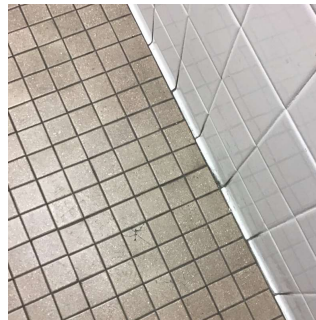
Room 318

Deficiency

CERAMIC TILE: BROKEN/MISSING TILES

REPLACE

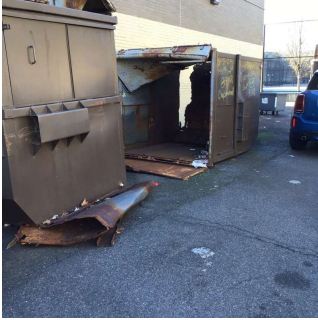
Question	Response
<b>INTERIOR</b>	
<b>TOILET ROOMS - STUDENTS</b>	
<b>Walls</b>	
Deficiency Photo1	 
	Room 226
Violations	No violations recorded.
<b>LIFE SAFETY</b>	
	Inspected
<b>F.D. HOLDING AREA</b>	
	Does not Exist
<b>STEEL STAIRS</b>	
	Does not Exist
<b>SITE</b>	
	Inspected
<b>CONTAINERIZATION</b>	
Condition	5 - Poor
Deficiency	CONCRETE PAD MISSING
Deficiency Location/Instance	Parking lot
Deficiency Quantity	400
Quantity Uom	S.F.
Potential Action	INSTALL NEW
Urgency of Action	PRIORITY 3
Purpose of Action	LEVEL 2
Deficiency Photo1	No photo recorded
Violations	No violations recorded.
Deficiency	FENCING MISSING
Deficiency Location/Instance	Parking lot
Deficiency Quantity	750
Quantity Uom	S.F.
Potential Action	INSTALL NEW
Urgency of Action	PRIORITY 3
Purpose of Action	LEVEL 2
Deficiency Photo1	No photo recorded
Violations	No violations recorded.
Deficiency	CONTAINER DAMAGED
Deficiency Location/Instance	Parking lot
Deficiency Quantity	4

Quantity Uom	EACH
Potential Action	REPLACE
Urgency of Action	PRIORITY 3
Purpose of Action	LEVEL 2

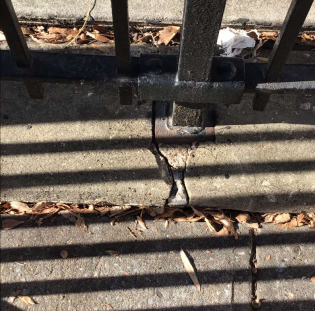
Violations	<p>Near exit 2 No violations recorded.</p>
<b>IRRIGATION SYSTEM</b>	
Does not Exist

Question	Response
<b>SITE</b>	
<b>FENCES</b>	
Deficiency Photo1	 
Violations	<p>Along Classon Avenue No violations recorded.</p>
Deficiency	<b>WROUGHT IRON: DAMAGED/DETERIORATED</b>
Deficiency Location/Instance	Near exit 2, Along Park Place, Classon Avenue, Sterling Place
Deficiency Quantity	800
Quantity Uom	S.F.
Potential Action	REPLACE
Urgency of Action	PRIORITY 3
Purpose of Action	LEVEL 2
Deficiency Photo1	 
Violations	<p>Near exit 2 No violations recorded.</p>
Deficiency	<b>CONCRETE CURB: DAMAGED/DETERIORATED</b>
Deficiency Location/Instance	Near exit 2
Deficiency Quantity	280
Quantity Uom	S.F.
Potential Action	REPLACE
Urgency of Action	PRIORITY 3
Purpose of Action	LEVEL 2
Deficiency Photo1

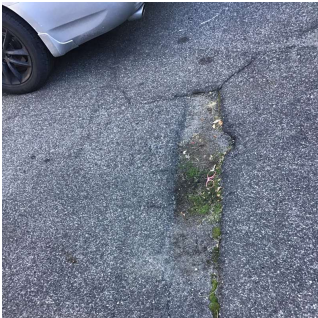
Schoolyard north
Violations	No violations recorded.
<b>Deficiency</b>	<b>CRACKS - MAJOR</b>
Deficiency Location/Instance	Schoolyard Near exit 1, Schoolyard north
Deficiency Quantity	4,000
Quantity Uom	S.F.
Potential Action	<b>REPLACE</b>
Urgency of Action	<b>PRIORITY 3</b>

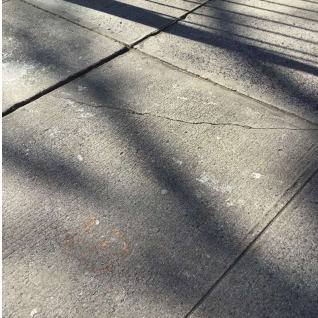
<b>Question</b>	<b>Response</b>
<b>SITE</b>	
<b>PAVING</b>	Inspected
<b>Student Use</b>	
<b>Concrete</b>	Inspected
Condition	3 - Fair
Deficiency	DAMAGED/DETERIORATED/MISSING SECTIONS
Deficiency Location/Instance	Schoolyard Near exit 1
Deficiency Quantity	75
Quantity Uom	S.F.
Potential Action	REPLACE
Urgency of Action	PRIORITY 3
Purpose of Action	LEVEL 2
Deficiency Photo1

Violations	Schoolyard Near exit 1 No violations recorded.
<b>Pavers</b>	Does not Exist
<b>Site Sidewalks &amp; Walkways</b>	Inspected
<b>Asphalt</b>	Inspected
Condition	3 - Fair
Deficiency	CRACKS - MAJOR
Deficiency Location/Instance	Near exit 9
Deficiency Quantity	100
Quantity Uom	S.F.
Potential Action	REPLACE
Urgency of Action	PRIORITY 3
Purpose of Action	LEVEL 2
Deficiency Photo1

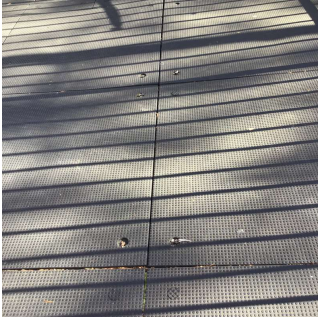
<b>Question</b>	<b>Response</b>
<b>SITE</b>	
<b>PAVING</b>	Inspected
<b>DOT Sidewalk</b>	Inspected
<b>Concrete</b>	Inspected
Violations	No violations recorded.
<b>Pavers</b>	Does not Exist
<b>PLAYGROUNDS</b>	Inspected
Instance on Schoolyard at Sterling Place	Inspected
<b>Benches</b>	
Instance on Schoolyard at Sterling Place	Does not Exist
<b>Fence</b>	
Instance on Schoolyard at Sterling Place	Does not Exist
<b>Pavement</b>	
Instance on Schoolyard at Sterling Place	Does not Exist
<b>Play Equipment</b>	
Instance on Schoolyard at Sterling Place	Inspected
Condition	2 - Between Good and Fair
Deficiency	No deficiencies recorded
<b>Safety Surfacing</b>	
Instance on Schoolyard at Sterling Place	Inspected
Condition	2 - Between Good and Fair
Deficiency	DETERIORATED/MISSING
Deficiency Location/Instance	Schoolyard
Deficiency Quantity	10
Quantity Uom	S.F.
Potential Action	MAINTENANCE
Urgency of Action	PRIORITY 3
Purpose of Action	LEVEL 2

Violations	Schoolyard No violations recorded.
<b>Unpaved Area</b>	
Instance on Schoolyard at Sterling Place	Does not Exist
<b>PLAYING SURFACE</b>	Does not Exist
<b>RETAINING WALLS</b>	Does not Exist
<b>SEATING</b>	Inspected
<b>Benches</b>	Inspected
<b>Concrete</b>	Does not Exist
<b>Metal/Wood/Plastic</b>	Inspected
Condition	2 - Between Good and Fair
Deficiency	No deficiencies recorded
