**NYC Department of Education**  
**Building Condition Assessment Survey 2023 - 2024**

Architectural Inspection

**K317**

**Asset: P.S. 133 WILLIAM A. BUTLER - BROOKLYN, 610 BALTIC STREET, New York, 11217**

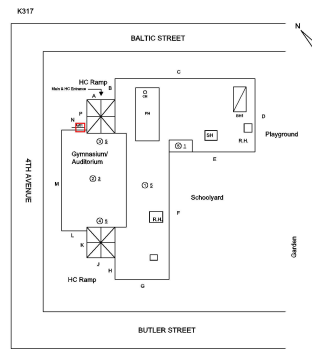
Question	Response
<b>Architectural</b>	
<b>EXTERIOR</b>	Inspected
<b>AREAWAY</b>	Inspected
Instance on AW1	Inspected
Instance Condition	2 - Between Good and Fair
Instance Quantity	1
Instance Quantity Uom	EACH
Deficiency	AREAWAY WALLS: CRACKS AND SPALLING
Roof Plan reference	
Deficiency Quantity	10
Quantity Uom	S.F.

Question	Response
<b>EXTERIOR</b>	
<b>AREAWAY</b>	
Potential Action	REPAIR
Urgency of Action	PRIORITY 3
Purpose of Action	LEVEL 2
Deficiency Photo1

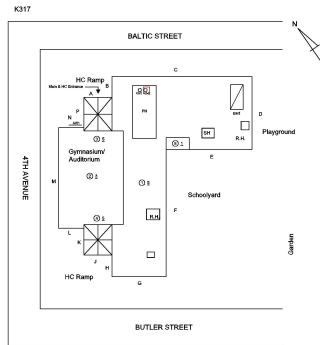
Violations	AW1 No violations recorded.
<b>AWNINGS AND CANOPIES</b>	
	Does not Exist
<b>CHIMNEY</b>	
Material Type(s)	Inspected Metal
Condition	3 - Fair
Deficiency	METAL: LOOSE OR MISSING SUPPORTS
Roof Plan reference

Deficiency Quantity	1
Quantity Uom	EACH
Potential Action	REPLACE
Urgency of Action	PRIORITY 4
Purpose of Action	LEVEL 2
Deficiency Photo1

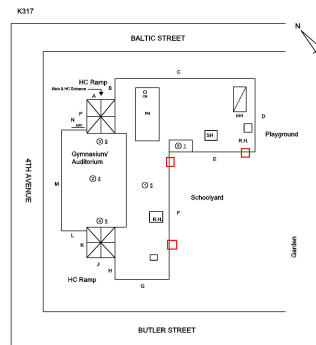
PRE-CAST CONCRETE: DETERIORATED JOINTS

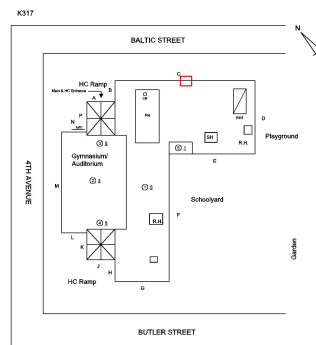
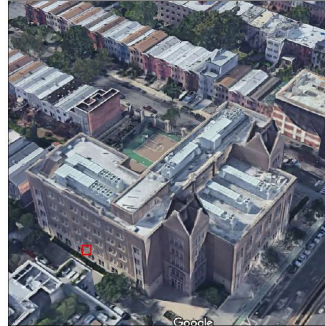
Deficiency	<b>BRICK: DETERIORATED JOINTS</b>
------------	-----------------------------------

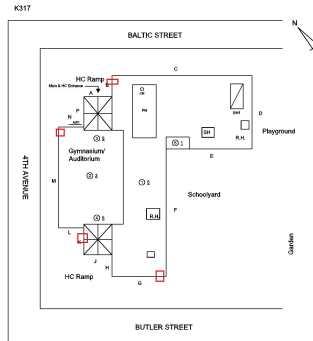
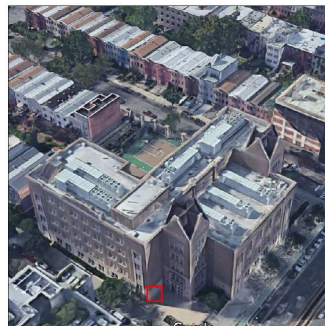
**CAST IN PLACE / PRE-CAST CONCRETE: MAJOR  
CRACKS/SPALLING**

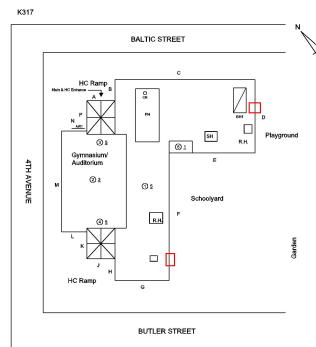
Deficiency	<b>CONCRETE: MINOR CRACKS, SPALLING</b>
------------	---

Deficiency Quantity	20
Quantity Uom	S.F.
Potential Action	REPAIR
Urgency of Action	PRIORITY 3
Purpose of Action	LEVEL 2

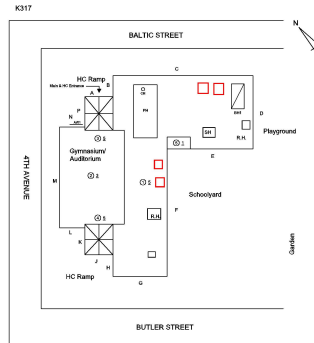
Sustainable Roof Type	White Roof
Sustainable Roof Location (Roof Number)	Roofs 1,2,5
Do solar panels exist on these roofs?	No
Is/Are the roof(s) suitable for Solar Panel installation?	Yes
Installation Year	2013
Source of Installation	Custodial Staff
Deficiency	IRMA: ROOFING: MAJOR ACTIVE ROOF LEAKS IN INSTRUCTIONAL SPACE

400  
S.F.  
REPLACE ROOFING WITH MAJOR EQUIPMENT REMOVAL  
PRIORITY 5  
LEVEL 2

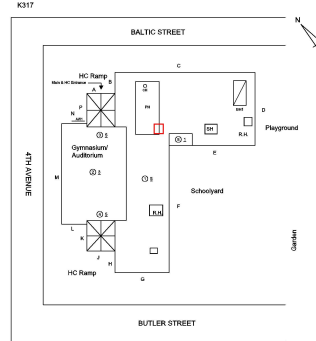
**BULKHEAD/PENTHOUSE WALLS/EXTERIOR:  
CRACKS/SPALLING - MINOR**

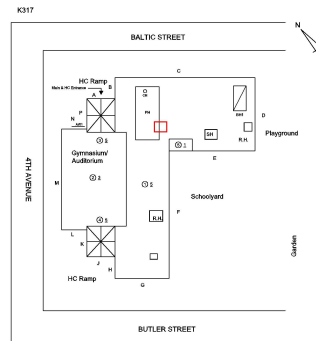
**BULKHEAD/PENTHOUSE WALLS/INTERIOR: CMU  
DETERIORATED JOINTS**

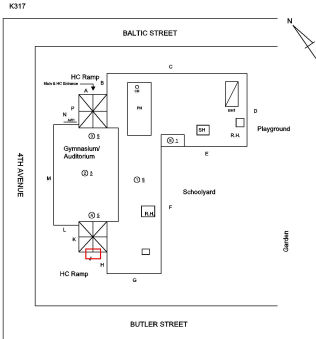
Question	Response
<b>EXTERIOR</b>	
<b>ROOF</b>	Inspected
<b>Specialties</b>	Inspected
<b>SKYLIGHT/ROOF VENT</b>	Does not Exist
<b>ROOF/GRAVITY TANK</b>	Does not Exist
<b>STAIRS/RAMPS: EXTERIOR</b>	Inspected
<b>BUILDING CHEEK/FLANK WALLS</b>	Inspected
Condition	3 - Fair
Deficiency	CAST IN PLACE CONCRETE: CRACKS/SPALLING - MINOR
Roof Plan reference

Deficiency Quantity	30
Quantity Uom	S.F.
Potential Action	REPAIR
Urgency of Action	PRIORITY 3
Purpose of Action	LEVEL 2
Deficiency Photo1

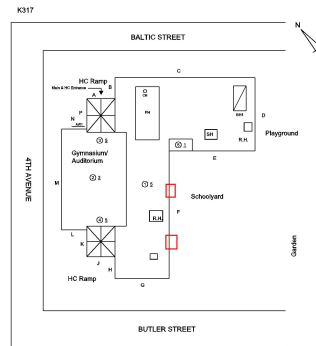
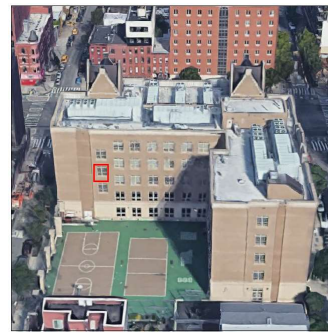
Question	Response
<b>EXTERIOR</b>	
<b>STAIRS/RAMPS: EXTERIOR</b>	Inspected
<b>STAIRS/RAMPS</b>	
Roof Plan reference	 
Deficiency Quantity	50
Quantity Uom	S.F.
Potential Action	REPLACE
Urgency of Action	PRIORITY 4
Purpose of Action	LEVEL 2
Deficiency Photo1	 
Violations	Facade J No violations recorded.
<b>WINDOWS</b>	Inspected
Replacement Quantity	5,300
Replacement Uom	S.F.
<b>EXTERIOR GUARDS</b>	Inspected
Condition	2 - Between Good and Fair
Deficiency	No deficiencies recorded
<b>LINTELS</b>	Inspected
Condition	2 - Between Good and Fair
Deficiency	No deficiencies recorded
<b>WINDOWS</b>	Inspected
Material Type(s)	Aluminum
Instance on Aluminum - Other: All Facades	Inspected
Instance Condition	2 - Between Good and Fair
Instance Quantity	5,300
Instance Quantity Uom	S.F.
Are these windows insulated	Yes
Installation Year	2013
Source of Installation	Custodial Staff
Deficiency	ALUMINUM - OTHER: BROKEN PANE

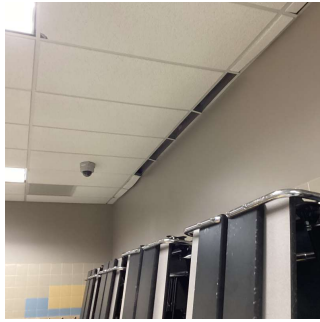
Violations	Near Entrance No violations recorded.
<b>Window Curtains/Shades/Blinds</b>	
Instance on 1st Floor (338 Seats)	Inspected
Condition	2 - Between Good and Fair
Deficiency	No deficiencies recorded
<b>CAFETERIA</b>	
Instance on Cellar	Inspected
<b>Ceiling</b>	
Instance on Cellar	Inspected
Condition	2 - Between Good and Fair
Deficiency	ACOUSTIC TILES: DAMAGED/MISSING
Deficiency Location/Instance	Near servery, center, Entrance
Deficiency Quantity	20
Quantity Uom	S.F.
Potential Action	REPLACE
Urgency of Action	PRIORITY 3
Purpose of Action	LEVEL 2
Deficiency Photo1	 
	Near servery

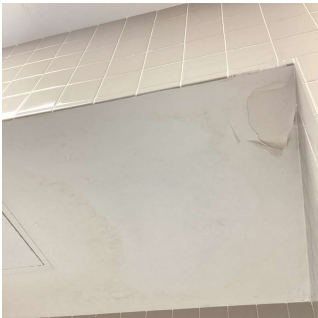
Question	Response
<b>INTERIOR</b>	
<b>STAIRS/RAMPS: INTERIOR</b>	Inspected
<b>Walls</b>	Inspected
Condition	2 - Between Good and Fair
Deficiency	No deficiencies recorded
<b>TOILET ROOMS - STAFF</b>	Inspected
<b>Ceiling</b>	Inspected
Condition	2 - Between Good and Fair
Deficiency	No deficiencies recorded
<b>Door(s)</b>	Inspected
Condition	2 - Between Good and Fair
Deficiency	No deficiencies recorded
<b>Floor Finish</b>	Inspected
Condition	2 - Between Good and Fair
Deficiency	No deficiencies recorded
<b>Stalls</b>	Inspected
Condition	2 - Between Good and Fair
Deficiency	No deficiencies recorded
<b>Walls</b>	Inspected
Condition	2 - Between Good and Fair
Deficiency	No deficiencies recorded
<b>TOILET ROOMS - STUDENTS</b>	Inspected
<b>Ceiling</b>	Inspected
Condition	2 - Between Good and Fair
Deficiency	GYPSUM BOARD: DAMAGED/DETERIORATED
Deficiency Location/Instance	Room 527, 115
Deficiency Quantity	10
Quantity Uom	S.F.
Potential Action	REPLACE

Urgency of Action	PRIORITY 3
Purpose of Action	LEVEL 2
Deficiency Photo1
