**NYC Department of Education**  
**Building Condition Assessment Survey 2023 - 2024**

Architectural Inspection

**K328**

**Asset:** P.S. 328 - BROOKLYN, 330 ALABAMA AVENUE, New York, 11207

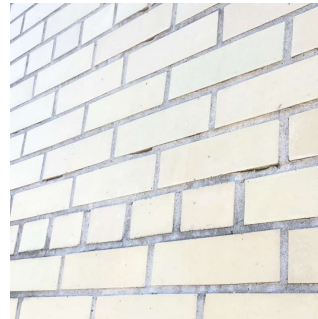
Chimney

**BRICK: DETERIORATED JOINTS**

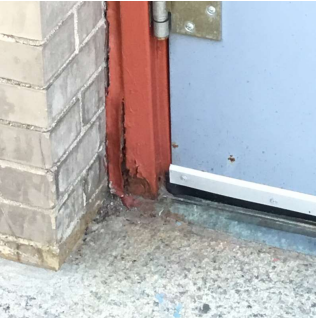
**METAL: DETERIORATED DOOR AND FRAME - MAJOR DETERIORATION**

Violations	Facade A - Exit 6 No violations recorded.
<b>DOOR HARDWARE</b>	Inspected
Condition	3 - Fair
Deficiency	No deficiencies recorded
<b>LINTELS</b>	Inspected
Condition	2 - Between Good and Fair
Deficiency	No deficiencies recorded
<b>TRANSOM/SIDE LIGHT</b>	Inspected
Condition	2 - Between Good and Fair
Deficiency	No deficiencies recorded
<b>EXTERIOR WALLS</b>	Inspected
Material Type(s)	Masonry
Replacement Quantity	40,000
Replacement Uom	S.F.
Instance on All Facades	Inspected
Instance Condition	3 - Fair
Instance Quantity	40,000
Instance Quantity Uom	S.F.
Deficiency	BRICK: EFFLORESCENCE

Deficiency Quantity	9
Quantity Uom	EACH
Potential Action	REPLACE
Urgency of Action	PRIORITY 4
Purpose of Action	LEVEL 2
Deficiency Photo1

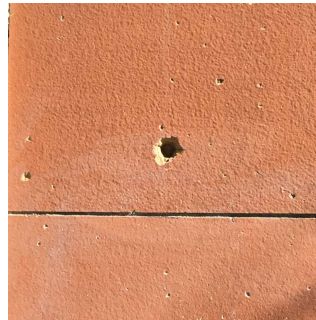
Facade G

CERAMIC TILE: CHIPPED, SPALLED, BROKEN PIECES

REPLACE

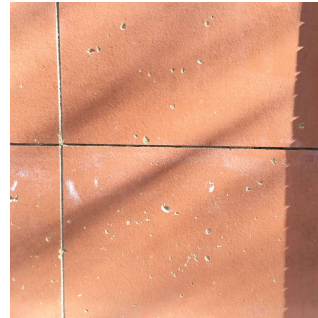
Facade G

CERAMIC TILE: CHIPPED, SPALLED, BROKEN PIECES

REPLACE

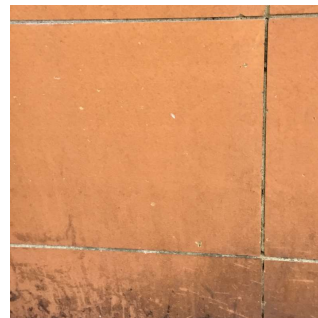
Facade B

**CERAMIC TILE: DETERIORATED JOINTS**

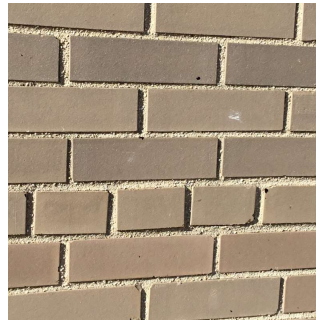
Roof 2

**BRICK: DETERIORATED JOINTS**

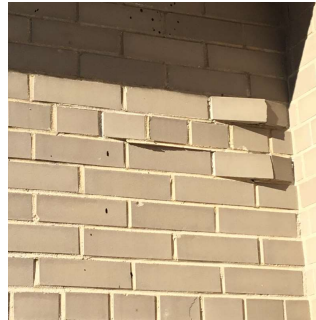
Roof 2

**BRICK: MAJOR / THRU CRACKS**

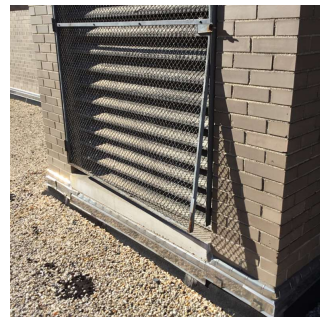
Roof 2

MISSING/DAMAGED SCREEN

REPLACE

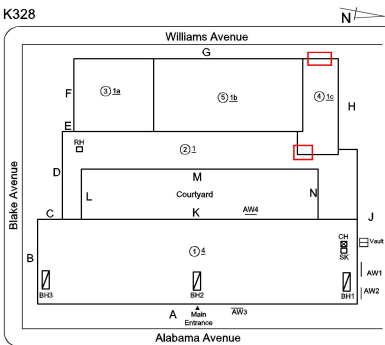
Question	Response
<b>EXTERIOR</b>	
<b>PARAPETS</b>	
Material Type(s)	Masonry, Metal
Replacement Quantity	1,600
Replacement Uom	C.F.
Instance on All Roofs	Inspected
Instance Condition	4 - Between Fair and Poor
Instance Quantity	1,600
Instance Quantity Uom	C.F.
Deficiency	BRICK: EFFLORESCENCE
Roof Plan reference

Deficiency Quantity	25
Quantity Uom	S.F.
Potential Action	MAINTENANCE
Urgency of Action	PRIORITY 1
Purpose of Action	LEVEL 1
Deficiency Photo1

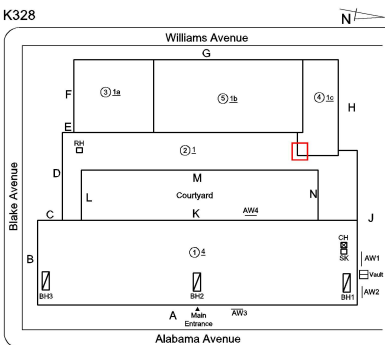
Violations	Roof 4 No violations recorded.
Deficiency	BRICK: MAJOR DETERIORATION/CRACKS
Roof Plan reference

Deficiency Quantity	25
Quantity Uom	S.F.
Potential Action	REMOVE AND REBUILD

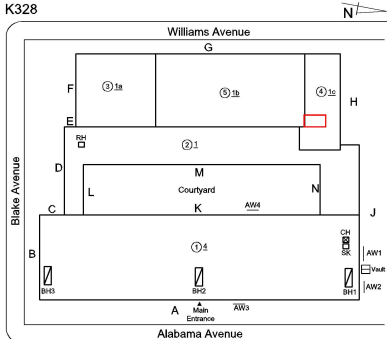
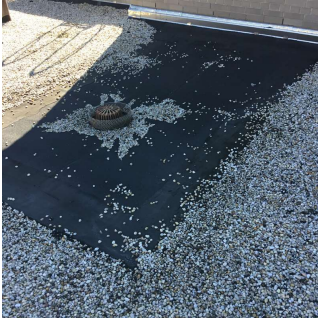
Roof 4
Violations	No violations recorded.
Deficiency	<b>BUILT-UP: FLASHING: CAP FLASHING DAMAGED</b>

Roof 2
Instance Quantity	7,000
Instance Quantity Uom	S.F.
Does the roof have major mechanical equipment sitting on Dunnage Steel less than 18" above the Roofing?	No
Does this roof instance have a Sustainable Roof System?	No
Do solar panels exist on these roofs?	No
Is/Are the roof(s) suitable for Solar Panel installation?	No
Installation Year	1985
Source of Installation	Custodial Staff
Deficiency	<b>BUILT-UP: ROOFING: LOSS OF GRAVEL</b>
Roof Plan reference

Deficiency Quantity	80
Quantity Uom	S.F.
Potential Action	INSTALL NEW GRAVEL
Urgency of Action	PRIORITY 3
Purpose of Action	LEVEL 2
Deficiency Photo1

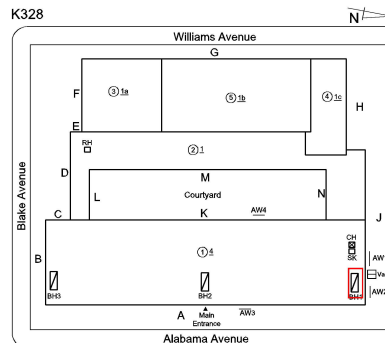
Inspected  
3 - Fair  
BULKHEAD/PENTHOUSE WALLS/INTERIOR: CMU  
CRACKS/SPALLING

10  
S.F.  
REPLACE

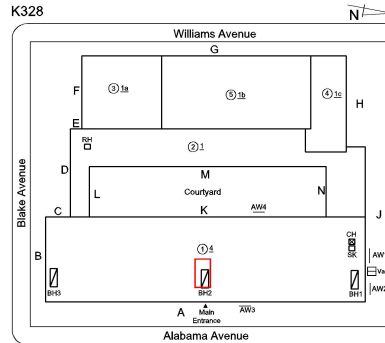
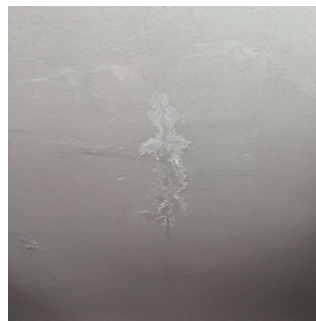
BH2

**BULKHEAD/PENTHOUSE ROOF: MINOR LEAKAGE**

20  
S.F.  
MAINTENANCE  
PRIORITY 3  
LEVEL 2

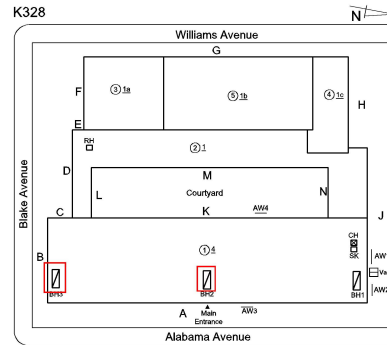
**BULKHEAD/PENTHOUSE CEILING: PLASTER DAMAGED/DETERIORATED**

25  
S.F.  
REPLACE  
PRIORITY 3  
LEVEL 2

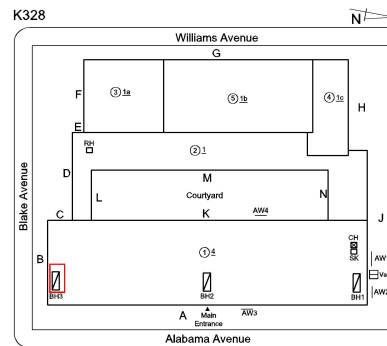
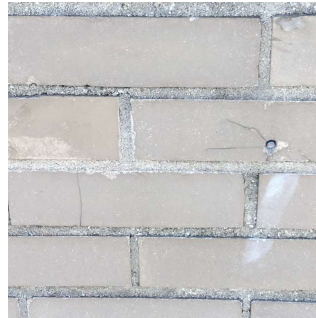
BH3

Deficiency **BULKHEAD/PENTHOUSE WALLS/EXTERIOR:  
CRACKS/SPALLING - MINOR**

10  
S.F.  
REPAIR  
PRIORITY 3  
LEVEL 2

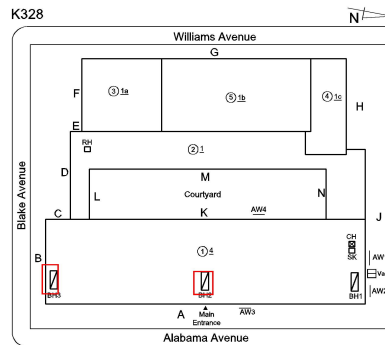
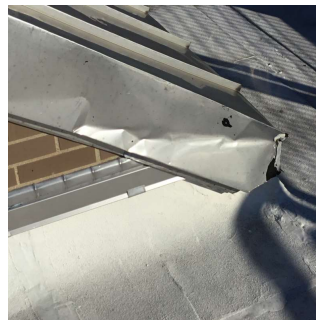
BH2

**BULKHEAD/PENTHOUSE ROOF: DETERIORATED**

REPAIR

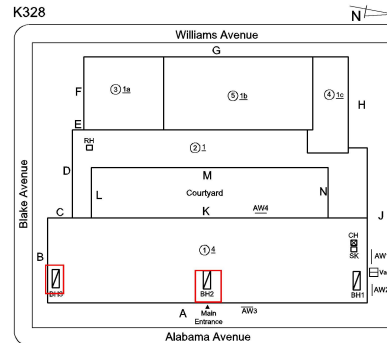
**BULKHEAD/PENTHOUSE WALLS/EXTERIOR: DETERIORATED JOINTS**

30  
S.F.  
REPOINT  
PRIORITY 3  
LEVEL 2

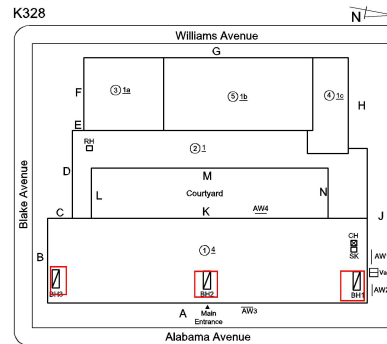
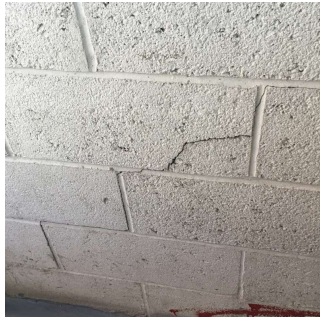
Deficiency **BULKHEAD/PENTHOUSE WALLS/INTERIOR: CMU  
CRACKS/SPALLING**

65  
S.F.  
REPLACE  
PRIORITY 3  
LEVEL 2

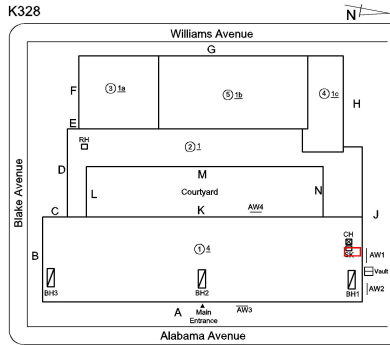
Violations	BH1 No violations recorded.
<b>CUPOLA/ SPIRES/ TOWERS</b>	Does not Exist
<b>DORMER</b>	Does not Exist
<b>DUNNAGE STEEL</b>	Does not Exist
<b>SKYLIGHT/ROOF VENT</b>	Inspected
Material Type(s)	Glass
Condition	3 - Fair
Deficiency	<b>DAMAGED GUARDS</b>
Roof Plan reference	K328

Deficiency Quantity	20
Quantity Uom	S.F.
Potential Action	MAINTENANCE
Urgency of Action	PRIORITY 3
Purpose of Action	LEVEL 2
Deficiency Photo1

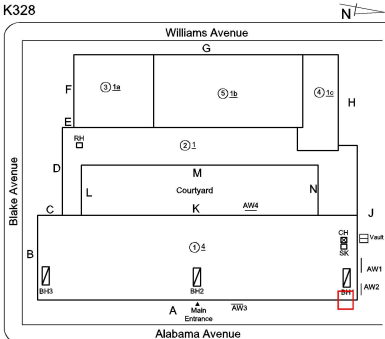
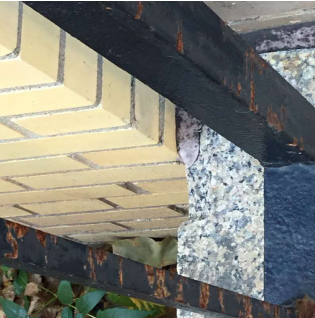
Question	Response
<b>EXTERIOR</b>	
<b>STAIRS/RAMPS: EXTERIOR</b>	
<b>BUILDING CHEEK/FLANK WALLS</b>	Inspected
Condition	2 - Between Good and Fair
Deficiency	STONE: CRACKS/SPALLING - MINOR
Roof Plan reference

Deficiency Quantity	10
Quantity Uom	S.F.
Potential Action	REPAIR
Urgency of Action	PRIORITY 3
Purpose of Action	LEVEL 2
Deficiency Photo1

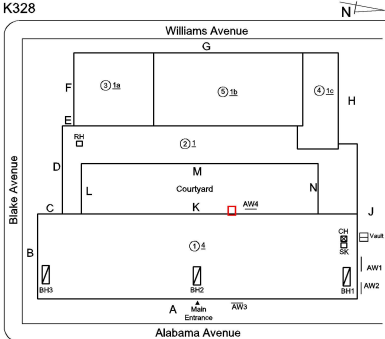
Violations	<p>Facade A</p> <p>No violations recorded.</p>
<b>RAILINGS</b>	
Condition	Inspected
Deficiency	3 - Fair
Roof Plan reference

Deficiency Quantity	10
Quantity Uom	L.F.
Potential Action	REPLACE
Urgency of Action	PRIORITY 4
Purpose of Action	LEVEL 2

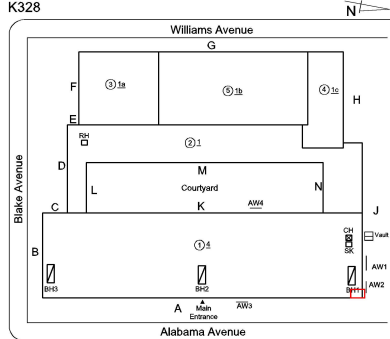
Violations	Facade K No violations recorded.
<b>STAIRS/RAMPS</b>	
Condition	Inspected 3 - Fair
Deficiency	<b>STONE: DETERIORATED JOINTS</b>
Roof Plan reference	K328

Deficiency Quantity	10
Quantity Uom	L.F.
Potential Action	REPOINT
Urgency of Action	PRIORITY 4
Purpose of Action	LEVEL 2
Deficiency Photo1

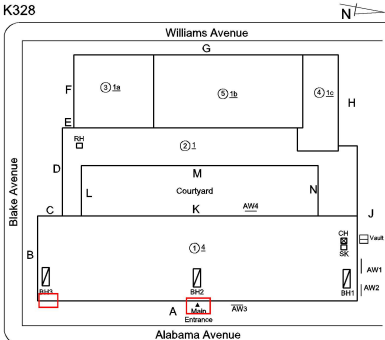
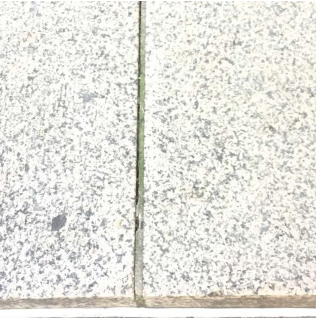
Violations	Facade A No violations recorded.
Deficiency	<b>STONE: DETERIORATED JOINTS</b>

Deficiency Quantity	15
Quantity Uom	L.F.
Potential Action	REPOINT
Urgency of Action	PRIORITY 3
Purpose of Action	LEVEL 2
Deficiency Photo1

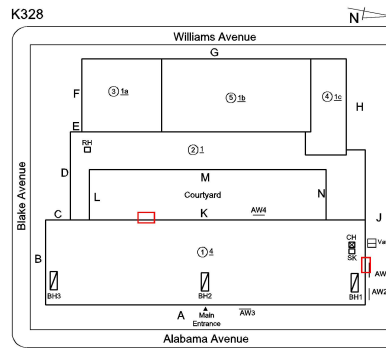
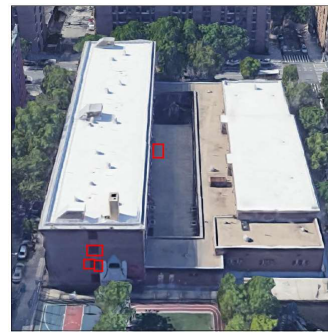
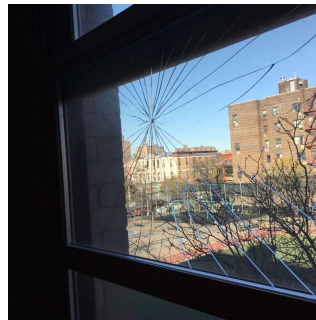
Facade J - 3rd Floor Corridor (Facade J - 2nd Floor Corridor, Facade K - Room 107 similar)

Violations	Facade A No violations recorded.
<b>WINDOWS</b>	Inspected
Replacement Quantity	9,300
Replacement Uom	S.F.
<b>EXTERIOR GUARDS</b>	Inspected
Condition	2 - Between Good and Fair
Deficiency	No deficiencies recorded
<b>LINTELS</b>	Inspected
Condition	2 - Between Good and Fair
Deficiency	No deficiencies recorded
<b>WINDOWS</b>	Inspected
Material Type(s)	Aluminum, Solid Wood
Instance on Aluminum - Double Hung: All Facades	Inspected
Instance Condition	2 - Between Good and Fair
Instance Quantity	9,000
Instance Quantity Uom	S.F.
Are these windows insulated	Yes
Installation Year	2010
Source of Installation	Custodial Staff
Deficiency	ALUMINUM - DOUBLE HUNG: BROKEN PANE

120  
S.F.  
MAINTENANCE  
PRIORITY 3  
LEVEL 2

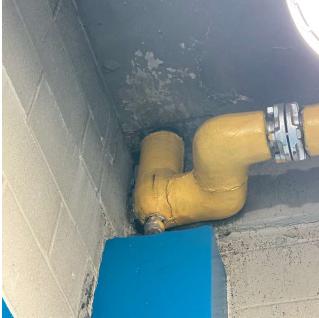
Question	Response
<b>INTERIOR</b>	
<b>STRUCTURAL</b>	
<b>FLOOR STRUCTURE</b>	Inspected
Violations	No violations recorded.
<b>FOUNDATION WALLS</b>	Inspected
Material Type(s)	Concrete
Condition	3 - Fair
Deficiency	CONCRETE: WATER INFILTRATION IN NON- INSTRUCTIONAL SPACE
Deficiency Location/Instance	Basement
Deficiency Quantity	50
Quantity Uom	S.F.
Potential Action	INSTALL WATERPROOFING
Urgency of Action	PRIORITY 5
Purpose of Action	LEVEL 5
Deficiency Photo1

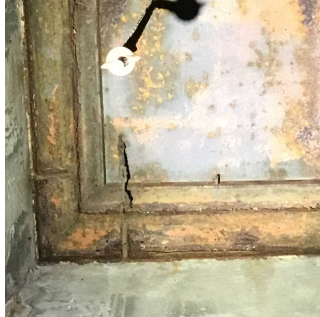
Violations	Paint Room No violations recorded.
<b>ROOF STRUCTURE</b>	Inspected
Condition	2 - Between Good and Fair
Deficiency	No deficiencies recorded
<b>VAULTS-BUNKERS</b>	Inspected
<b>Foundation Walls</b>	Inspected
Condition	2 - Between Good and Fair
Deficiency	No deficiencies recorded
<b>Slab Structure</b>	Inspected
Condition	2 - Between Good and Fair
Deficiency	No deficiencies recorded
<b>Vault/Ash Hoist Doors and Framing</b>	Inspected
Condition	5 - Poor
Deficiency	DETERIORATED/DAMAGED VAULT/ASH HOIST DOORS AND FRAMING

Deficiency Location/Instance	Vault
Deficiency Quantity	2
Quantity Uom	EACH
Potential Action	REPLACE
Urgency of Action	PRIORITY 4
Purpose of Action	LEVEL 2

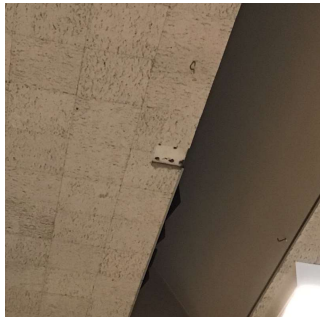
Violations	Vault No violations recorded.
<b>AUDITORIUM</b>	
Instance on 1st Floor (204 Seats)	Inspected
Instance on 1st Floor (204 Seats)	Inspected
<b>Ceiling</b>	
Instance on 1st Floor (204 Seats)	Inspected
Condition	2 - Between Good and Fair
Deficiency	ACOUSTIC TILES ON PLASTER: DAMAGED/MISSING
Deficiency Location/Instance	Near Stage
Deficiency Quantity	10
Quantity Uom	S.F.
Potential Action	REPLACE
Urgency of Action	PRIORITY 3
Purpose of Action	LEVEL 2
Deficiency Photo1

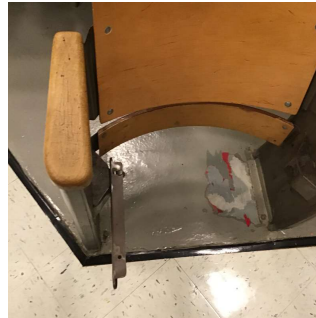
Seat C/1

Deficiency	DAMAGED/BROKEN/INOPERABLE
Deficiency Location/Instance	Seats C/1,3,5, C/101, D/101
Deficiency Quantity	5
Quantity Uom	EACH
Potential Action	REPLACE
Urgency of Action	PRIORITY 5
Purpose of Action	LEVEL 6
Deficiency Photo1

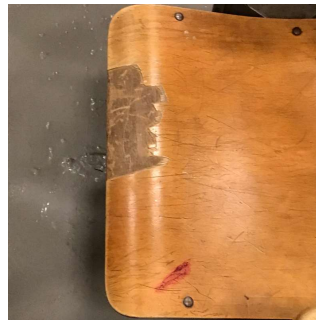
Seat G/113

Deficiency	DAMAGED/BROKEN/INOPERABLE
Deficiency Location/Instance	Seats D/9, F/1,3, G/113, H/1, and others
Deficiency Quantity	25
Quantity Uom	EACH
Potential Action	REPLACE
Urgency of Action	PRIORITY 3
Purpose of Action	LEVEL 2
Deficiency Photo1

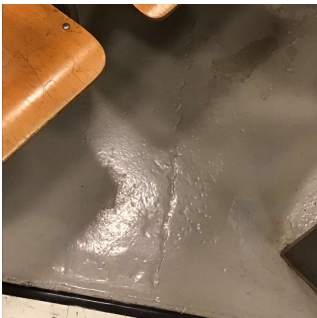
Question	Response
<b>INTERIOR</b>	
<b>AUDITORIUM</b>	
<b>Floor Finish</b>	
Deficiency Quantity	10
Quantity Uom	S.F.
Potential Action	REPLACE
Urgency of Action	PRIORITY 3
Purpose of Action	LEVEL 2
Deficiency Photo1	 
Violations	At Exit 7 Vestibule No violations recorded.
Deficiency	CONCRETE: CRACKS
Deficiency Location/Instance	Near Seats B/101, G/1
Deficiency Quantity	20
Quantity Uom	S.F.
Potential Action	REPLACE
Urgency of Action	PRIORITY 3
Purpose of Action	LEVEL 2
Deficiency Photo1

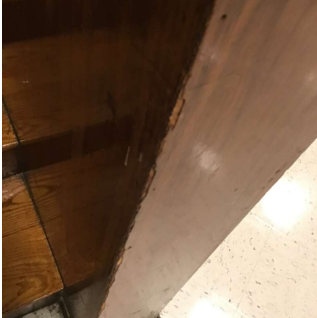
Violations	Near Seat G/1 No violations recorded.
<b>Sliding-folding Partition</b>	
Instance on 1st Floor (204 Seats)	Inspected
Condition	2 - Between Good and Fair
Deficiency	No deficiencies recorded
<b>Stage</b>	
Instance on 1st Floor (204 Seats)	Inspected
<b>Stage</b>	
Instance on 1st Floor (204 Seats)	Inspected
Condition	2 - Between Good and Fair
Deficiency	DAMAGED FASCIA
Deficiency Location/Instance	Right Stage
Deficiency Quantity	10

Question	Response
<b>INTERIOR</b>	
<b>AUDITORIUM</b>	
<b>Stage</b>	
<b>Stage</b>	
Potential Action	REPLACE
Urgency of Action	PRIORITY 3
Purpose of Action	LEVEL 2
Deficiency Photo1

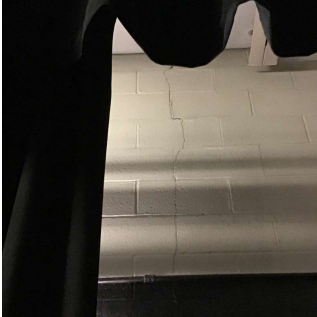
Right Stage
Violations	No violations recorded.
<b>Stage Curtain Rigging</b>	Inspected
Instance on 1st Floor (204 Seats)	Inspected
Condition	2 - Between Good and Fair
Deficiency	No deficiencies recorded
<b>Stage Curtains</b>	Inspected
Instance on 1st Floor (204 Seats)	Inspected
Condition	2 - Between Good and Fair
Deficiency	No deficiencies recorded
<b>Walls</b>	
Instance on 1st Floor (204 Seats)	Inspected
Condition	2 - Between Good and Fair
Deficiency	MASONRY: CRACKS/SPALLING
Deficiency Location/Instance	Rear wall at Stage, Storage Room
Deficiency Quantity	20
Quantity Uom	S.F.
Potential Action	REPLACE
Urgency of Action	PRIORITY 3
Purpose of Action	LEVEL 2
Deficiency Photo1

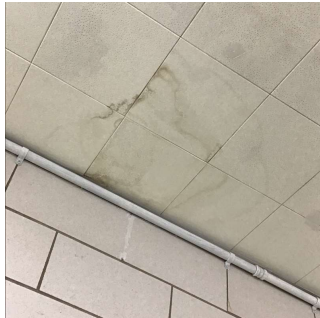
Violations	Left side No violations recorded.
<b>Window Curtains/Shades/Blinds</b>	
Instance on 1st Floor	Does not Exist
<b>CLASSROOMS/CORRIDORS/ADMIN SPACES</b>	
<b>Ceiling</b>	
Condition	Inspected 2 - Between Good and Fair
Deficiency	ACOUSTIC TILES ON PLASTER: DAMAGED/MISSING
Deficiency Location/Instance	Corridor near Rooms 136, 307A, by Stair BC/3, near Main Entrance
Deficiency Quantity	60
Quantity Uom	S.F.
Potential Action	REPLACE
Urgency of Action	PRIORITY 3
Purpose of Action	LEVEL 2
Deficiency Photo1

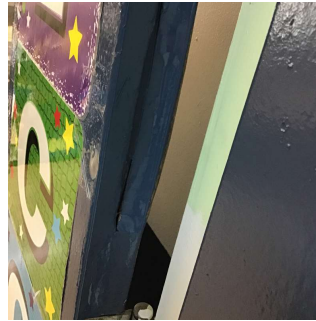
Room 306

Violations	Near Main Entrance No violations recorded.
<b>Door(s)</b>	
Condition	Inspected 5 - Poor
Deficiency	METAL: DETERIORATED DOOR
Deficiency Location/Instance	Rooms 101, 205, 306
Deficiency Quantity	3
Quantity Uom	EACH
Potential Action	MAINTENANCE
Urgency of Action	PRIORITY 3

Purpose of Action	LEVEL 2

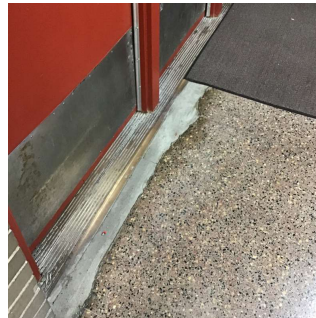
TERRAZZO: CRACKS

REPLACE

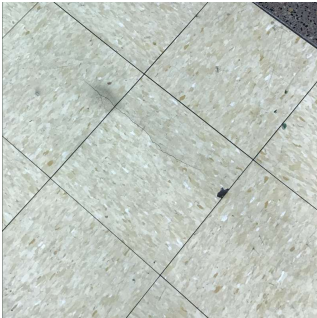
Question	Response
<b>INTERIOR</b>	
<b>CLASSROOMS/CORRIDORS/ADMIN SPACES</b>	
<b>Floor Finish</b>	
Violations	In Exit 5 No violations recorded.
Deficiency	VINYL TILES: BROKEN/DETERIORATED/MISSING TILES
Deficiency Location/Instance	Rooms 304, 305, 309, 404, Corridor near Exit 5, and others
Deficiency Quantity	60
Quantity Uom	S.F.
Potential Action	REPLACE
Urgency of Action	PRIORITY 3
Purpose of Action	LEVEL 2
Deficiency Photo1

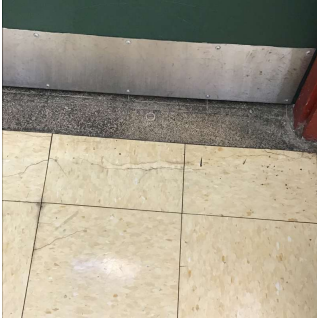
Violations	Corridor near Exit 5 No violations recorded.
Deficiency	VINYL TILES: DETERIORATED SUBSTRATE
Deficiency Location/Instance	Corridor near Rooms 123, by Exit 9, by Courtyard window near Room 101
Deficiency Quantity	50
Quantity Uom	S.F.
Potential Action	REPLACE
Urgency of Action	PRIORITY 3
Purpose of Action	LEVEL 2
Deficiency Photo1

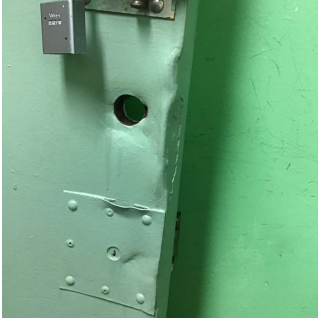
Question	Response
<b>INTERIOR</b>	
<b>KITCHEN</b>	
<b>Door(s)</b>	
Instance on 1st Floor	Inspected
Condition	3 - Fair
Deficiency	METAL: DETERIORATED DOOR
Deficiency Location/Instance	Storage Room
Deficiency Quantity	1
Quantity Uom	EACH
Potential Action	MAINTENANCE
Urgency of Action	PRIORITY 3
Purpose of Action	LEVEL 2
Deficiency Photo1

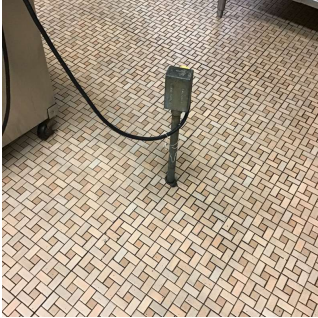
Violations	Storage Room No violations recorded.
<b>Floor Finish</b>	
Instance on 1st Floor	Inspected
Condition	3 - Fair
Deficiency	CERAMIC TILE: TRIPPING HAZARD - ELECTRICAL OUTLET
Deficiency Location/Instance	Food Preparation Area
Deficiency Quantity	10
Quantity Uom	S.F.
Potential Action	REMOVE
Urgency of Action	PRIORITY 5
Purpose of Action	LEVEL 6
Deficiency Photo1

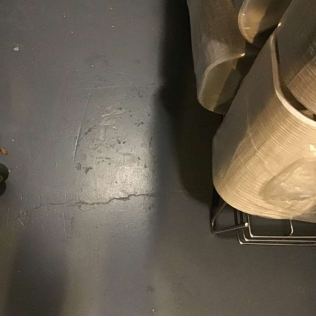
Violations	Food Preparation Area No violations recorded.
Deficiency	CONCRETE: CRACKS
Deficiency Location/Instance	Kitchen Storage Room inside the Gymnasium
Deficiency Quantity	10
Quantity Uom	S.F.
Potential Action	REPLACE

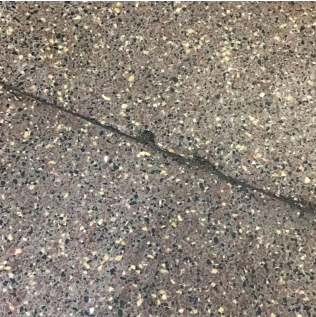
<p data-bbox="917 672 1307 697">Kitchen Storage Room inside the Gymnasium</p> <p data-bbox="917 709 1112 735">No violations recorded.</p>
Violations	No violations recorded.
Deficiency	TERRAZZO: CRACKS
Deficiency Location/Instance	In Exit 8
Deficiency Quantity	10
Quantity Uom	S.F.
Potential Action	REPLACE
Urgency of Action	PRIORITY 3
Purpose of Action	LEVEL 2
Deficiency Photo1

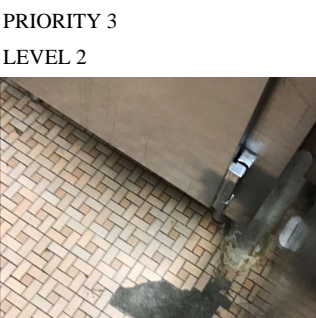
<p data-bbox="917 1900 1112 1925">Food Preparation Area</p>

<p data-bbox="917 1327 998 1352">In Exit 8</p> <p data-bbox="917 1365 1112 1390">No violations recorded.</p>
Violations	No violations recorded.
Deficiency	CERAMIC TILE: BROKEN/MISSING TILES
Deficiency Location/Instance	Food Preparation Area
Deficiency Quantity	15
Quantity Uom	S.F.
Potential Action	REPLACE
Urgency of Action	PRIORITY 3
Purpose of Action	LEVEL 2
Deficiency Photo1

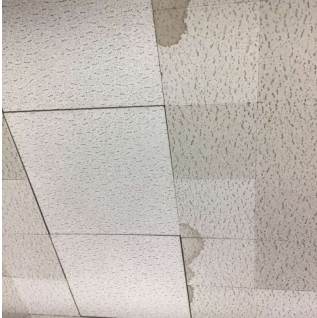
Question	Response
<b>INTERIOR</b>	
<b>LIBRARY</b>	
<b>Ceiling</b>	
Instance on Room 206	Inspected
Condition	2 - Between Good and Fair
Deficiency	ACOUSTIC TILES ON PLASTER: DAMAGED/MISSING
Deficiency Location/Instance	Near the center, by the windows
Deficiency Quantity	20
Quantity Uom	S.F.
Potential Action	REPLACE
Urgency of Action	PRIORITY 3
Purpose of Action	LEVEL 2
Deficiency Photo1

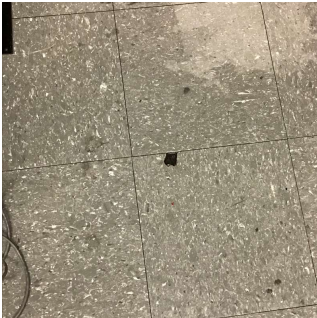
Violations	Near the center No violations recorded.
<b>Door(s)</b>	
Instance on Room 206	Inspected
Condition	2 - Between Good and Fair
Deficiency	No deficiencies recorded
<b>Floor Finish</b>	
Instance on Room 206	Inspected
Condition	2 - Between Good and Fair
Deficiency	VINYL TILES: DETERIORATED SUBSTRATE
Deficiency Location/Instance	Near the circulation desk
Deficiency Quantity	10
Quantity Uom	S.F.
Potential Action	REPLACE
Urgency of Action	PRIORITY 3
Purpose of Action	LEVEL 2
Deficiency Photo1

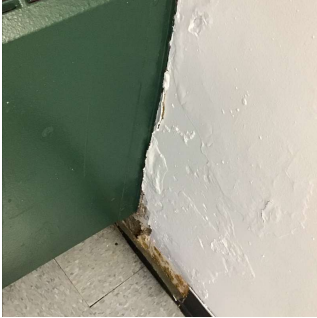
Question	Response
<b>INTERIOR</b>	
<b>LIBRARY</b>	
<b>Walls</b>	
Condition	2 - Between Good and Fair
Deficiency	PLASTER: CRACKS/SPALLING
Deficiency Location/Instance	Near the windows
Deficiency Quantity	10
Quantity Uom	S.F.
Potential Action	REPLACE
Urgency of Action	PRIORITY 3
Purpose of Action	LEVEL 2
Deficiency Photo1

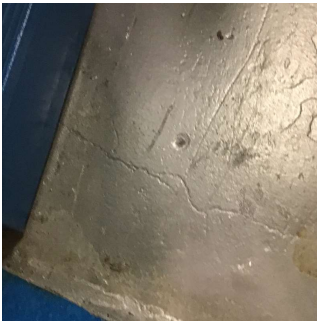
Violations	Near the windows No violations recorded.
<b>LOCKER ROOM</b>	
Instance on 1st Floor	Inspected
Alternative use	Yes
<b>Ceiling</b>	
Instance on 1st Floor	Inspected
Condition	2 - Between Good and Fair
Deficiency	No deficiencies recorded
<b>Door(s)</b>	
Instance on 1st Floor	Inspected
Condition	2 - Between Good and Fair
Deficiency	No deficiencies recorded
<b>Floor Finish</b>	
Instance on 1st Floor	Inspected
Condition	2 - Between Good and Fair
Deficiency	CONCRETE: CRACKS
Deficiency Location/Instance	Near the entrance, center
Deficiency Quantity	20
Quantity Uom	S.F.
Potential Action	REPLACE
Urgency of Action	PRIORITY 3

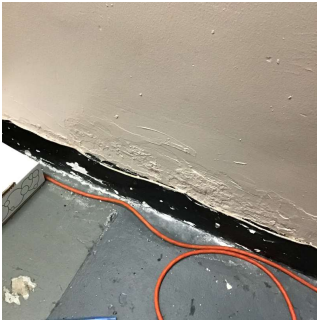
Violations	Near the entrance No violations recorded.
<b>Locker Room Lockers</b>	
Instance on 1st Floor	Does not Exist
<b>Walls</b>	
Instance on 1st Floor	Inspected
Condition	2 - Between Good and Fair
Deficiency	PLASTER: CRACKS/SPALLING
Deficiency Location/Instance	Near the entrance, by the toilet room
Deficiency Quantity	10
Quantity Uom	S.F.
Potential Action	REPLACE
Urgency of Action	PRIORITY 3
Purpose of Action	LEVEL 2
Deficiency Photo1

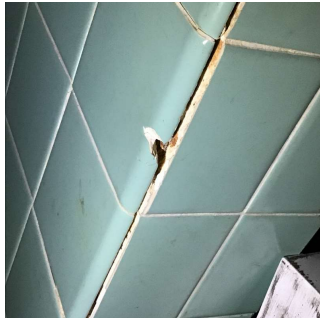
Question	Response
<b>INTERIOR</b>	
<b>SHOWER ROOM</b>	
Alternative use	Yes
<b>Ceiling</b>	
Instance on 1st Floor	Inspected
Condition	2 - Between Good and Fair
Deficiency	No deficiencies recorded
<b>Door(s)</b>	
Instance on 1st Floor	Does not Exist
<b>Floor Finish</b>	
Instance on 1st Floor	Inspected
Condition	2 - Between Good and Fair
Deficiency	No deficiencies recorded
<b>Walls</b>	
Instance on 1st Floor	Inspected
Condition	2 - Between Good and Fair
Deficiency	CERAMIC TILE: BROKEN/ MISSING
Deficiency Location/Instance	Near center
Deficiency Quantity	10
Quantity Uom	S.F.
Potential Action	REPLACE
Urgency of Action	PRIORITY 3
Purpose of Action	LEVEL 2
Deficiency Photo1

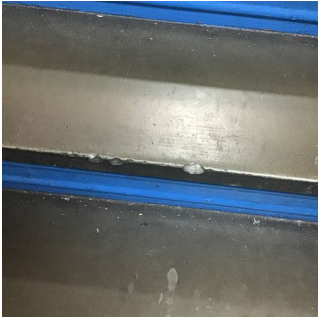
Deficiency	No deficiencies recorded
<b>Partition</b>	
	Does not Exist
<b>Railings</b>	
Condition	2 - Between Good and Fair
Deficiency	No deficiencies recorded
<b>Stairs and Landings</b>	
Condition	4 - Between Fair and Poor
Deficiency	STONE: BROKEN/MISSING
Deficiency Location/Instance	Stairs A/1,2,3, BC/3, D/2, and others

Question	Response
<b>INTERIOR</b>	
<b>STAIRS/RAMPS: INTERIOR</b>	
<b>Stairs and Landings</b>	
Deficiency Quantity	300
Quantity Uom	S.F.
Potential Action	REPLACE
Urgency of Action	PRIORITY 3
Purpose of Action	LEVEL 2
Deficiency Photo1

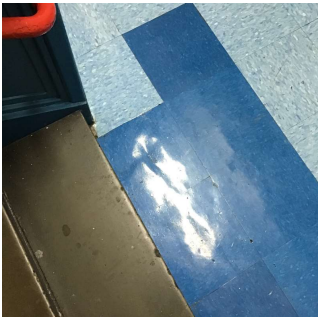
Stair A/1
Violations	No violations recorded.
Deficiency	VINYL TILES: DETERIORATED SUBSTRATE
Deficiency Location/Instance	Stair A/1 (mid-landing)
Deficiency Quantity	10
Quantity Uom	S.F.
Potential Action	REPLACE
Urgency of Action	PRIORITY 3
Purpose of Action	LEVEL 2
Deficiency Photo1

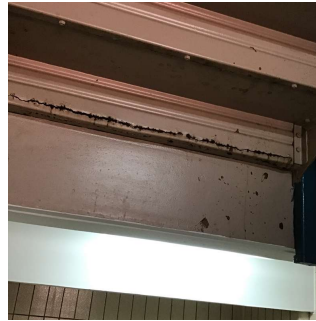
Stair D/2

Stair A/1 (mid-landing)
Violations	No violations recorded.
Deficiency	METAL: RUST - MAJOR
Deficiency Location/Instance	Stair D/1,2,3
Deficiency Quantity	20
Quantity Uom	S.F.
Potential Action	REPLACE
Urgency of Action	PRIORITY 5
Purpose of Action	LEVEL 6

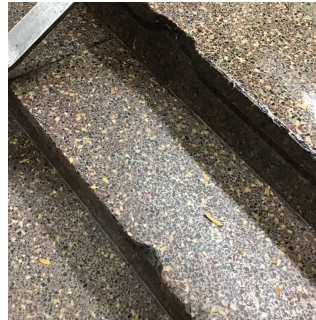
In Exit 4

TERRAZZO: CRACKS

REPLACE

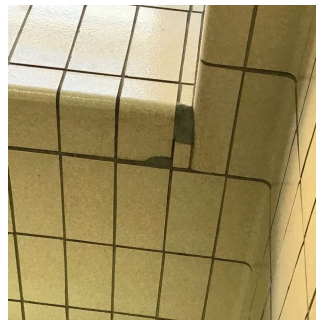
GLAZED BLOCK: CRACKS/SPALLING

REPLACE

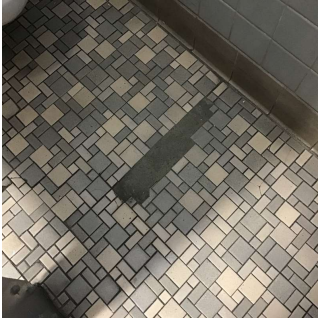
Deficiency	CERAMIC TILE: BROKEN/MISSING TILES

Question	Response
<b>INTERIOR</b>	
<b>TOILET ROOMS - STAFF</b>	Inspected
<b>Floor Finish</b>	
Deficiency Location/Instance	Rooms 123, 125, 132
Deficiency Quantity	20
Quantity Uom	S.F.
Potential Action	REPLACE
Urgency of Action	PRIORITY 3
Purpose of Action	LEVEL 2
Deficiency Photo1

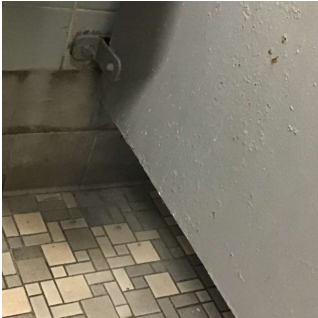
Room 123	
Violations	No violations recorded.
<b>Stalls</b>	
Condition	Inspected
Deficiency	5 - Poor
Deficiency Location/Instance	RUST - MAJOR
Deficiency Quantity	Room 123, 224
Quantity Uom	2
Potential Action	EACH
Urgency of Action	REPLACE
Purpose of Action	PRIORITY 3
Deficiency Photo1	LEVEL 2
Room 123

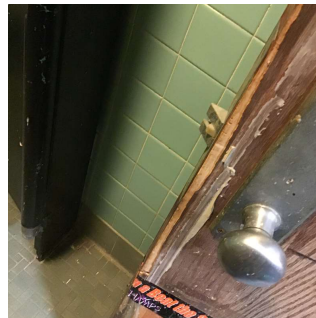
Toilet inside the Locker Room

WOOD: DETERIORATED DOOR

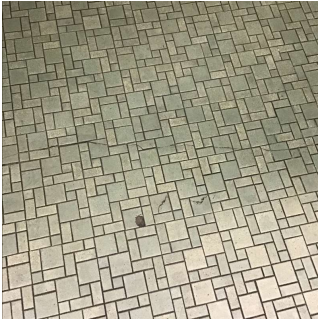
Question	Response
<b>INTERIOR</b>	
<b>TOILET ROOMS - STUDENTS</b>	
<b>Door(s)</b>	Inspected
Violations	No violations recorded.
<b>Floor Finish</b>	Inspected
Condition	2 - Between Good and Fair
Deficiency	CERAMIC TILE: BROKEN/MISSING TILES
Deficiency Location/Instance	Rooms 317, 417, 423
Deficiency Quantity	20
Quantity Uom	S.F.
Potential Action	REPLACE
Urgency of Action	PRIORITY 3
Purpose of Action	LEVEL 2
Deficiency Photo1

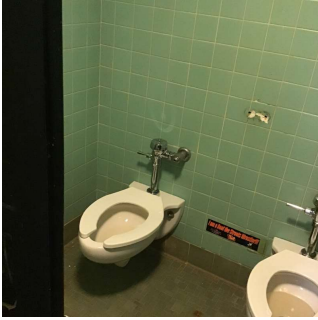
Violations	Room 317 No violations recorded.
<b>Stalls</b>	Inspected
Condition	5 - Poor
Deficiency	BROKEN/MISSING
Deficiency Location/Instance	Toilet inside the Locker Room
Deficiency Quantity	1
Quantity Uom	EACH
Potential Action	REPLACE
Urgency of Action	PRIORITY 3
Purpose of Action	LEVEL 2
Deficiency Photo1

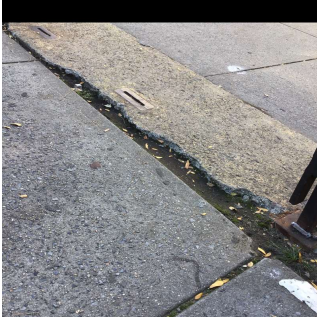
Question	Response
<b>SITE</b>	
<b>Drainage System for Concrete</b>	Inspected
<b>Culverts - Concrete Covering</b>	Does not Exist
<b>Drainage System for Soil</b>	Does not Exist
<b>DRINKING FOUNTAINS</b>	
Condition	2 - Between Good and Fair
Deficiency	No deficiencies recorded
<b>FENCES</b>	
Condition	3 - Fair
Deficiency	CONCRETE CURB: DAMAGED/DETERIORATED
Deficiency Location/Instance	Blake Avenue - Near Exit 4 by the Gate
Deficiency Quantity	10
Quantity Uom	S.F.
Potential Action	REPLACE
Urgency of Action	PRIORITY 5
Purpose of Action	LEVEL 6
Deficiency Photo1

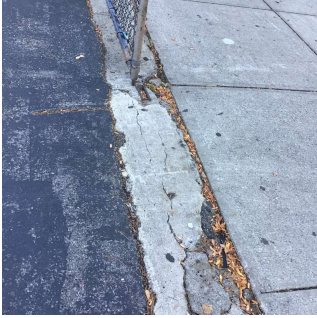
Blake Avenue - Near Exit 4 by the Gate
Violations	No violations recorded.
Deficiency	CONCRETE CURB: DAMAGED/DETERIORATED
Deficiency Location/Instance	Alabama Avenue, Williams Avenue, Blake Avenue, Schoolyard
Deficiency Quantity	200
Quantity Uom	S.F.
Potential Action	REPLACE
Urgency of Action	PRIORITY 3
Purpose of Action	LEVEL 2
Deficiency Photo1

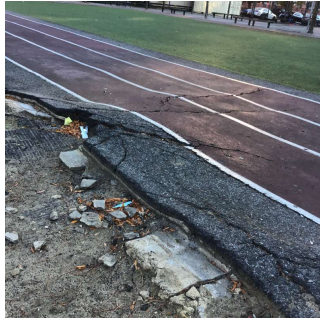
Violations	Schoolyard No violations recorded.
Deficiency	HEAVING
Deficiency Location/Instance	Schoolyard
Deficiency Quantity	250
Quantity Uom	S.F.
Potential Action	REPLACE
Urgency of Action	PRIORITY 5
Purpose of Action	LEVEL 6
Deficiency Photo1

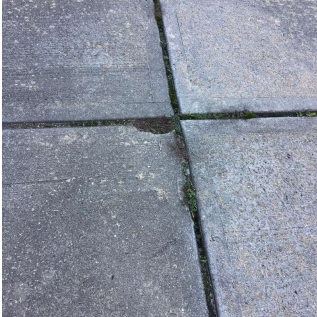
Violations	Schoolyard No violations recorded.
<b>Concrete</b>	Inspected
Condition	3 - Fair
Deficiency	CRACKS - MAJOR
Deficiency Location/Instance	Courtyard
Deficiency Quantity	50
Quantity Uom	S.F.
Potential Action	REPLACE
Urgency of Action	PRIORITY 3
Purpose of Action	LEVEL 2

Courtyard
Violations	No violations recorded.
<b>Pavers</b>	
	Inspected
Condition	3 - Fair
Deficiency	DAMAGED/MISSING
Deficiency Location/Instance	Schoolyard
Deficiency Quantity	100
Quantity Uom	S.F.
Potential Action	REPLACE
Urgency of Action	PRIORITY 3
Purpose of Action	LEVEL 2
Deficiency Photo1

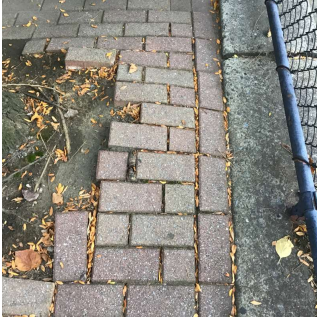
Schoolyard
Violations	No violations recorded.
Deficiency	DAMAGED/MISSING
Deficiency Location/Instance	Schoolyard - Across from Building Areaway/ Exit 9 side
Deficiency Quantity	10
Quantity Uom	S.F.
Potential Action	REPLACE
Urgency of Action	PRIORITY 5
Purpose of Action	LEVEL 6

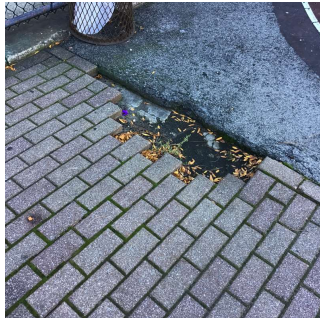
Violations	Schoolyard - Across from Building Areaway/ Exit 9 side No violations recorded.
Deficiency	HEAVING
Deficiency Location/Instance	Schoolyard
Deficiency Quantity	200
Quantity Uom	S.F.
Potential Action	REPLACE
Urgency of Action	PRIORITY 5
Purpose of Action	LEVEL 6
Deficiency Photo1

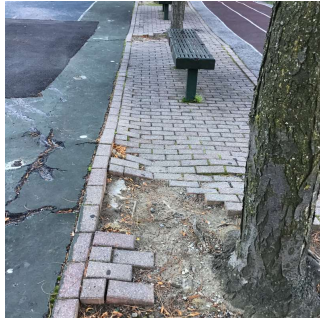
Violations	Schoolyard No violations recorded.
<b>Site Sidewalks &amp; Walkways</b>	Inspected
<b>Asphalt</b>	Does not Exist
<b>Concrete</b>	Inspected
Condition	4 - Between Fair and Poor
Deficiency	HEAVING
Deficiency Location/Instance	Along Exit 9
Deficiency Quantity	75
Quantity Uom	S.F.
Potential Action	REPLACE
Urgency of Action	PRIORITY 3
Purpose of Action	LEVEL 2

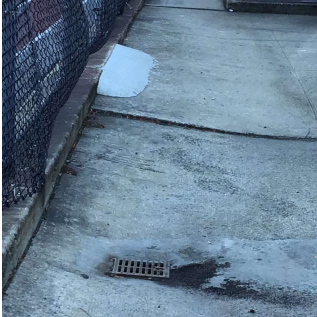
Violations	Along Exit 9 No violations recorded.
Deficiency	DAMAGED/DETERIORATED/MISSING SECTIONS
Deficiency Location/Instance	Williams Avenue, Blake Avenue, along Exit 9
Deficiency Quantity	475
Quantity Uom	S.F.
Potential Action	REPLACE
Urgency of Action	PRIORITY 3
Purpose of Action	LEVEL 2
Deficiency Photo1

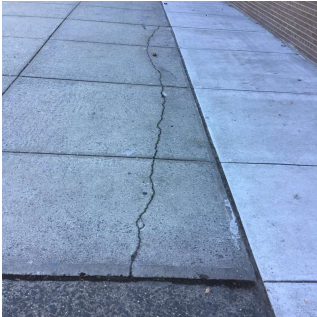
Violations	Williams Avenue No violations recorded.
<b>Pavers</b>	Does not Exist
<b>DOT Sidewalk</b>	Inspected
<b>Asphalt</b>	Does not Exist
<b>Concrete</b>	Inspected
Condition	4 - Between Fair and Poor
Deficiency	DAMAGED CURBS
Deficiency Location/Instance	Alabama Avenue, Williams Avenue, Blake Avenue
Deficiency Quantity	260
Quantity Uom	L.F.
Potential Action	REPLACE
Urgency of Action	PRIORITY 3
Purpose of Action	LEVEL 2

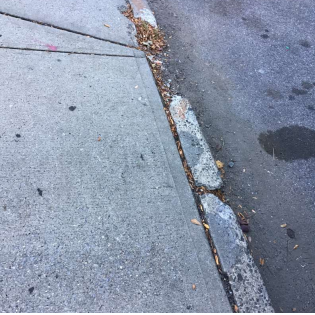
Violations	Williams Avenue No violations recorded.
Deficiency	HEAVING
Deficiency Location/Instance	Alabama Avenue, Williams Avenue, Blake Avenue
Deficiency Quantity	825
Quantity Uom	S.F.
Potential Action	REPLACE
Urgency of Action	PRIORITY 3
Purpose of Action	LEVEL 2
Deficiency Photo1

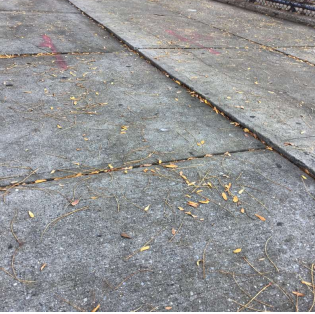
Violations	Williams Avenue No violations recorded.
Deficiency	HEAVING
Deficiency Location/Instance	Williams Avenue
Deficiency Quantity	100
Quantity Uom	S.F.
Potential Action	REPLACE
Urgency of Action	PRIORITY 5
Purpose of Action	LEVEL 6
Deficiency Photo1

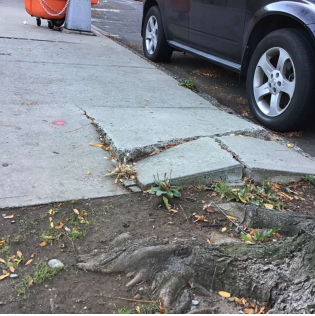
Violations	Williams Avenue No violations recorded.
Deficiency	HEAVING
Deficiency Location/Instance	Williams Avenue
Deficiency Quantity	100
Quantity Uom	S.F.
Potential Action	REPLACE
Urgency of Action	PRIORITY 5
Purpose of Action	LEVEL 6
Deficiency Photo1

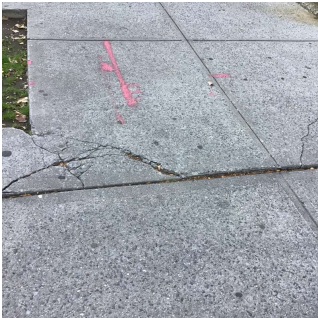
Question	Response
<b>SITE</b>	
<b>PAVING</b>	
<b>DOT Sidewalk</b>	
<b>Concrete</b>	
Violations	No violations recorded.
Deficiency	DAMAGED/DETERIORATED/MISSING SECTIONS
Deficiency Location/Instance	Alabama Avenue, Williams Avenue, Blake Avenue
Deficiency Quantity	1,175
Quantity Uom	S.F.
Potential Action	REPLACE
Urgency of Action	PRIORITY 3
Purpose of Action	LEVEL 2
Deficiency Photo1

Violations	Alabama Avenue No violations recorded.
<b>Pavers</b>	Does not Exist
<b>PLAYGROUNDS</b>	Inspected
Instance on Courtyard	Inspected
Instance on Schoolyard North	Inspected
Instance on Schoolyard South	Inspected
<b>Benches</b>	
Instance on Courtyard	Does not Exist
Instance on Schoolyard North	Does not Exist
Instance on Schoolyard South	Does not Exist
<b>Fence</b>	
Instance on Schoolyard North	Inspected
Condition	2 - Between Good and Fair
Deficiency	No deficiencies recorded
Instance on Courtyard	Does not Exist
Instance on Schoolyard South	Does not Exist

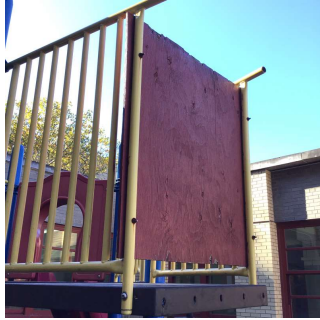
<b>Pavement</b>	
Instance on Courtyard	Does not Exist
Instance on Schoolyard North	Does not Exist
Instance on Schoolyard South	Does not Exist
<b>Play Equipment</b>	
Instance on Courtyard	Inspected
Condition	5 - Poor
Deficiency	BROKEN/DETERIORATED/MISSING
Deficiency Location/Instance	Courtyard
Deficiency Quantity	1
Quantity Uom	EACH

Question	Response
<b>SITE</b>	
<b>PLAYGROUNDS</b>	
<b>Play Equipment</b>	
Potential Action	REPLACE
Urgency of Action	PRIORITY 3
Purpose of Action	LEVEL 2
Deficiency Photo1

Courtyard
Violations	No violations recorded.
Instance on Schoolyard North	Inspected
Condition	5 - Poor
Deficiency	BROKEN/DETERIORATED/MISSING
Deficiency Location/Instance	Schoolyard North
Deficiency Quantity	1
Quantity Uom	EACH
Potential Action	REPLACE
Urgency of Action	PRIORITY 3
Purpose of Action	LEVEL 2
Deficiency Photo1

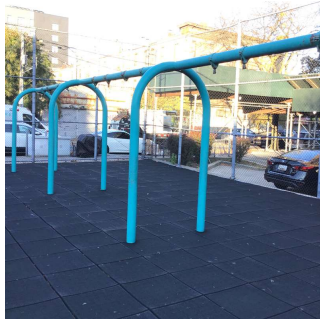
Schoolyard North
Violations	No violations recorded.
<b>Safety Surfacing</b>	
Instance on Courtyard	Inspected
Condition	4 - Between Fair and Poor
Deficiency	DETERIORATED/MISSING
Deficiency Location/Instance	Courtyard
Deficiency Quantity	260
Quantity Uom	S.F.
Potential Action	REPLACE
Urgency of Action	PRIORITY 5
Purpose of Action	LEVEL 6

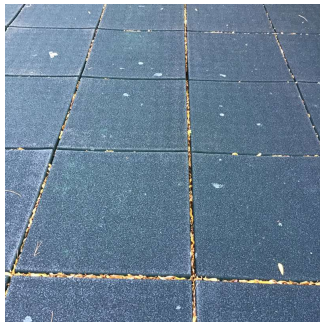
Question	Response
<b>SITE</b>	
<b>PLAYGROUNDS</b>	
<b>Safety Surfacing</b>	
Deficiency Photo1	 
Violations	Courtyard No violations recorded.
Instance on Schoolyard South	Inspected
Condition	3 - Fair
Deficiency	DETERIORATED/MISSING
Deficiency Location/Instance	Schoolyard South
Deficiency Quantity	200
Quantity Uom	S.F.
Potential Action	MAINTENANCE
Urgency of Action	PRIORITY 3
Purpose of Action	LEVEL 2
Deficiency Photo1	 
Violations	Schoolyard South No violations recorded.
Instance on Schoolyard North	Inspected
Condition	3 - Fair
Deficiency	DETERIORATED/MISSING
Deficiency Location/Instance	Schoolyard North
Deficiency Quantity	200
Quantity Uom	S.F.
Potential Action	MAINTENANCE
Urgency of Action	PRIORITY 3
Purpose of Action	LEVEL 2

Violations	Schoolyard North No violations recorded.
<b>Unpaved Area</b>	
Instance on Courtyard	Does not Exist
Instance on Schoolyard North	Does not Exist
Instance on Schoolyard South	Does not Exist
<b>PLAYING SURFACE</b>	Inspected
<b>Playing Field</b>	Inspected
Instance on Schoolyard	Inspected
Instance Condition	2 - Between Good and Fair
Deficiency	ARTIFICIAL TURF: DAMAGED/WORN OUT
Deficiency Location/Instance	Schoolyard
Deficiency Quantity	10
Quantity Uom	S.F.
Potential Action	REPLACE
Urgency of Action	PRIORITY 3
Purpose of Action	LEVEL 2
Deficiency Photo1

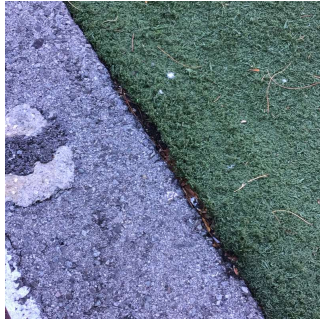
Violations	Schoolyard No violations recorded.
<b>Running Track</b>	Does not Exist
<b>RETAINING WALLS</b>	Does not Exist
<b>SEATING</b>	Inspected
<b>Benches</b>	Inspected
<b>Concrete</b>	Does not Exist
<b>Metal/Wood/Plastic</b>	Inspected
Condition	5 - Poor
Deficiency	DAMAGED/DETERIORATED
