NYC Department of Education
Building Condition Assessment Survey 2023 - 2024

Architectural Inspection

Asset: P.S. 156 - BROOKLYN, 104 SUTTER AVENUE, New York, 11212

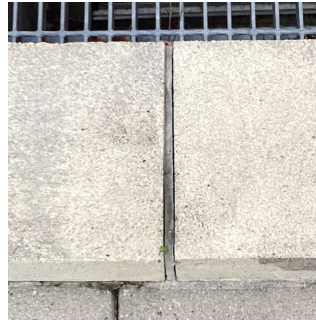
AW4
No violations recorded.

AREAWAY WALLS: DETERIORATED JOINTS AT COPING STONES

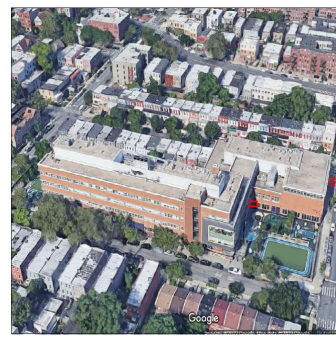
Elevation

Question	Response
EXTERIOR	
DOORS	
DOORS AND FRAMES	Inspected
	Facade C
Violations	No violations recorded.
DOOR HARDWARE	Inspected
Condition	3 - Fair
Deficiency	No deficiencies recorded
LINTELS	Inspected
Condition	2 - Between Good and Fair
Deficiency	No deficiencies recorded
TRANSOM/SIDE LIGHT	Inspected
Condition	2 - Between Good and Fair
Deficiency	No deficiencies recorded
EXTERIOR WALLS	Inspected
Material Type(s)	Masonry, Steel
Replacement Quantity	50,000
Replacement Uom	S.F.
Instance on All Facades	Inspected
Instance Condition	3 - Fair
Instance Quantity	50,000
Instance Quantity Uom	S.F.
Deficiency	BRICK: MINOR CRACKS AND SPALLING
Roof Plan reference

Deficiency Quantity	35
Quantity Uom	S.F.
Potential Action	RESTITCH
Urgency of Action	PRIORITY 3
Purpose of Action	LEVEL 2

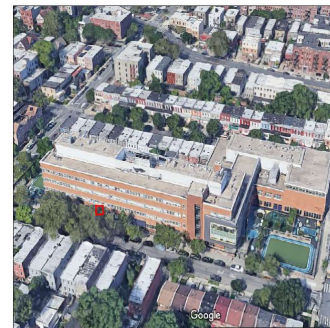
Elevation

CERAMIC TILE: DETERIORATED JOINTS

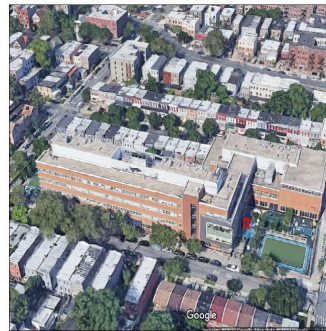
Elevation

METAL/GLASS CURT WALL: WATER INFILTRATION IN INSTRUCTIONAL SPACE

REPAIR

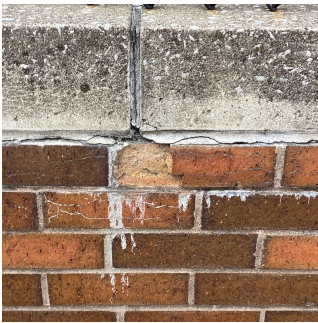
Question	Response
EXTERIOR	
STAIRS/RAMPS: EXTERIOR	
BUILDING CHEEK/FLANK WALLS	
Deficiency Photo1

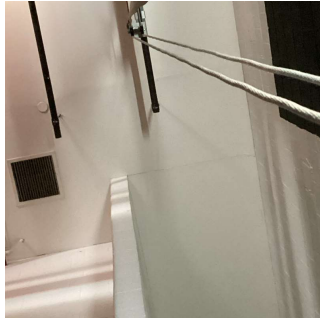
Center
Violations	No violations recorded.
Deficiency	GYPSON BOARD: DAMAGED/DETERIORATED
Deficiency Location/Instance	Near Windows, Right Side Stage, Center
Deficiency Quantity	50
Quantity Uom	S.F.
Potential Action	REPLACE
Urgency of Action	PRIORITY 3
Purpose of Action	LEVEL 2
Deficiency Photo1

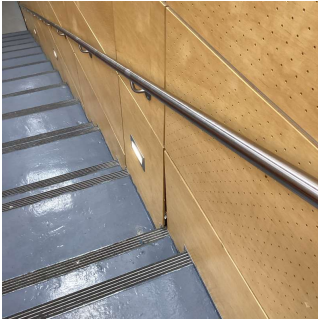
Violations	Left Side No violations recorded.

Instance on 1st Floor (465 Seats)	Inspected
Condition	2 - Between Good and Fair
Deficiency	WOOD PANELING: DETERIORATED
Deficiency Location/Instance	Left Side
Deficiency Quantity	20
Quantity Uom	S.F.
Potential Action	REPLACE
Urgency of Action	PRIORITY 3
Purpose of Action	LEVEL 2
Deficiency Photo1

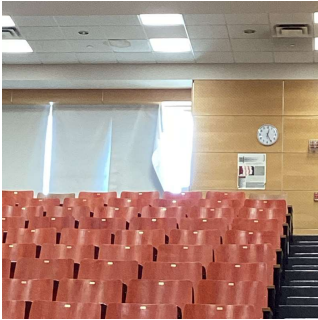
Violations	Rear Wall No violations recorded.

Instance on 1st Floor (465 Seats)	Inspected
Condition	3 - Fair
Deficiency	WORN/DAMAGED CURTAINS
Deficiency Location/Instance	Rear Wall
Deficiency Quantity	50
Quantity Uom	S.F.
Potential Action	MAINTENANCE
Urgency of Action	PRIORITY 3
Purpose of Action	LEVEL 2
Deficiency Photo1

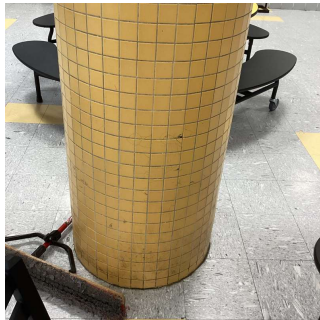
Question	Response
INTERIOR	
CAFETERIA	
Stage	
Instance on Room 131	Does not Exist
Instance on Room 130	Does not Exist
Walls	
Instance on Room 131	Inspected
Condition	2 - Between Good and Fair
Deficiency	CERAMIC TILE: BROKEN/ MISSING
Deficiency Location/Instance	Columns
Deficiency Quantity	20
Quantity Uom	S.F.
Potential Action	REPLACE
Urgency of Action	PRIORITY 3
Purpose of Action	LEVEL 2
Deficiency Photo1

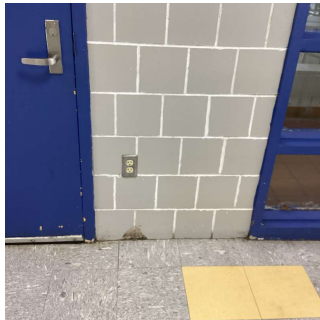
Columns
Violations	No violations recorded.
Deficiency	GLAZED BLOCK: CRACKS/SPALLING
Deficiency Location/Instance	Near Servery
Deficiency Quantity	10
Quantity Uom	S.F.
Potential Action	REPLACE
Urgency of Action	PRIORITY 3
Purpose of Action	LEVEL 2
Deficiency Photo1

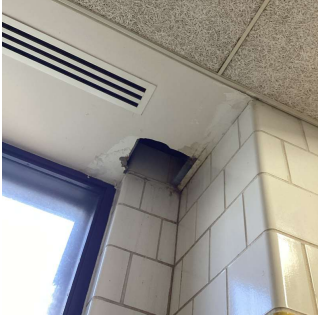
Question	Response
INTERIOR	
CLASSROOMS/CORRIDORS/ADMIN SPACES	
Ceiling	
Deficiency	GYPSUM BOARD: DAMAGED/DETERIORATED
Deficiency Location/Instance	Main Entrance - Vestibule, Corridor near Exit 3, Rooms 221, 223, 228 and others
Deficiency Quantity	380
Quantity Uom	S.F.
Potential Action	REPLACE
Urgency of Action	PRIORITY 3
Purpose of Action	LEVEL 2
Deficiency Photo1

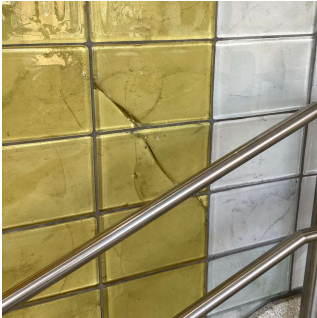
Question	Response
INTERIOR	
CLASSROOMS/CORRIDORS/ADMIN SPACES	
Floor Finish	
Violations	Room 116 No violations recorded.
Deficiency	TERRAZZO: CRACKS
Deficiency Location/Instance	Corridor near Cafeterias, Main Entrance - Vestibule
Deficiency Quantity	40
Quantity Uom	S.F.
Potential Action	REPLACE
Urgency of Action	PRIORITY 3
Purpose of Action	LEVEL 2
Deficiency Photo1	 
Violations	Corridor near Cafeterias No violations recorded.
Walls	Inspected
Condition	2 - Between Good and Fair
Deficiency	GLASS BLOCK: DAMAGED/MISSING
Deficiency Location/Instance	Corridor near Room 223
Deficiency Quantity	10
Quantity Uom	S.F.
Potential Action	REPLACE
Urgency of Action	PRIORITY 5
Purpose of Action	LEVEL 6
Deficiency Photo1

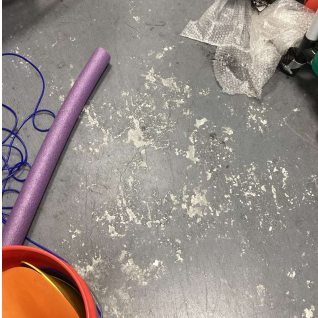
Question	Response
INTERIOR	
GYMNASIUM	
Floor Finish	
Instance on 2nd Floor	Inspected
Condition	2 - Between Good and Fair
Deficiency	CONCRETE: CRACKS
Deficiency Location/Instance	Storage Room
Deficiency Quantity	20
Quantity Uom	S.F.
Potential Action	REPLACE
Urgency of Action	PRIORITY 3
Purpose of Action	LEVEL 2
Deficiency Photo1

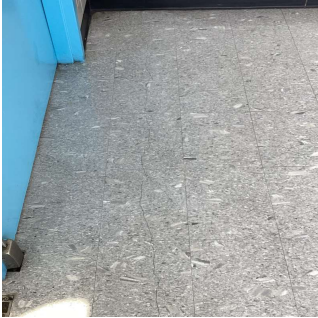
Violations	Storage Room No violations recorded.
Deficiency	VINYL TILES: DETERIORATED SUBSTRATE
Deficiency Location/Instance	Near Main Entrance
Deficiency Quantity	20
Quantity Uom	S.F.
Potential Action	REPLACE
Urgency of Action	PRIORITY 3
Purpose of Action	LEVEL 2
Deficiency Photo1

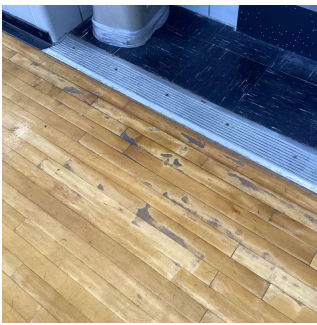
Violations	Near Main Entrance No violations recorded.
Deficiency	WOOD: DAMAGED/DETERIORATED
Deficiency Location/Instance	Near Right and Left Side Drinking Fountain
Deficiency Quantity	40
Quantity Uom	S.F.
Potential Action	REPLACE
Urgency of Action	PRIORITY 3
Purpose of Action	LEVEL 2

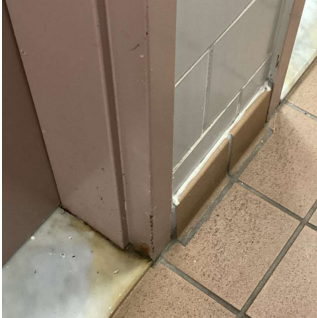
Question	Response
INTERIOR	
KITCHEN	
Door(s)	
Instance on 1st Floor	Inspected
Condition	4 - Between Fair and Poor
Deficiency	METAL: DETERIORATED DOOR AND FRAME
Deficiency Location/Instance	Room 132B
Deficiency Quantity	1
Quantity Uom	EACH
Potential Action	MAINTENANCE
Urgency of Action	PRIORITY 3
Purpose of Action	LEVEL 2
Deficiency Photo1

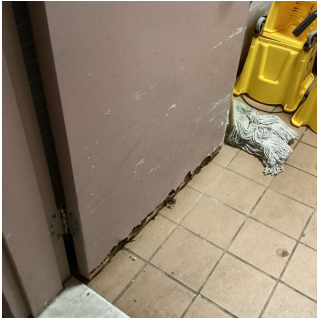
Violations	Room 132B No violations recorded.
Deficiency	METAL: DETERIORATED DOOR
Deficiency Location/Instance	Mopping Room
Deficiency Quantity	1
Quantity Uom	EACH
Potential Action	MAINTENANCE
Urgency of Action	PRIORITY 3
Purpose of Action	LEVEL 2
Deficiency Photo1

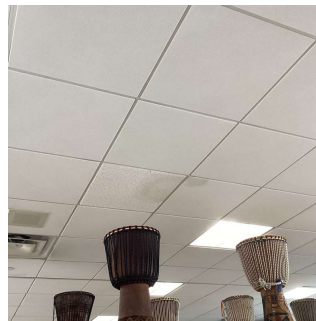
Center

Deficiency	ACOUSTIC TILES: DAMAGED/MISSING
Deficiency Location/Instance	Center, near Main Entrance
Deficiency Quantity	30
Quantity Uom	S.F.
Potential Action	REPLACE
Urgency of Action	PRIORITY 3
Purpose of Action	LEVEL 2
Deficiency Photo1

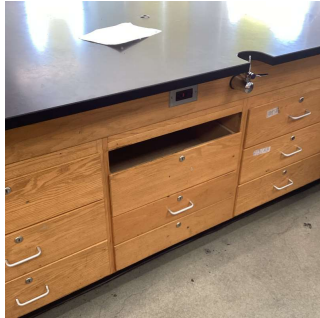
Question	Response
INTERIOR	
SCIENCE DEMO ROOM	Does not Exist
SCIENCE LAB	Inspected
Instance on Room 421	Inspected
Alternative use	No
Instance on Rooms 313, 414	Inspected
Alternative use	No
Fixed Equipment	
Instance on Room 421	Inspected
Condition	4 - Between Fair and Poor
Deficiency	CABINETS: MISSING/DAMAGED
Deficiency Location/Instance	Room 421
Deficiency Quantity	20
Quantity Uom	L.F.
Potential Action	REPLACE
Urgency of Action	PRIORITY 3
Purpose of Action	LEVEL 2
Deficiency Photo1

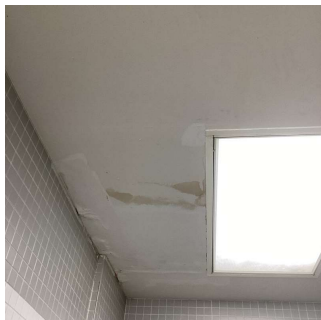
Question	Response
INTERIOR	
STAIRS/RAMPS: INTERIOR	Inspected
Walls	Inspected
Condition	2 - Between Good and Fair
Deficiency	No deficiencies recorded
TOILET ROOMS - STAFF	Inspected
Ceiling	Inspected
Condition	2 - Between Good and Fair
Deficiency	No deficiencies recorded
Door(s)	Inspected
Condition	2 - Between Good and Fair
Deficiency	No deficiencies recorded
Floor Finish	Inspected
Condition	2 - Between Good and Fair
Deficiency	No deficiencies recorded
Stalls	Inspected
Condition	2 - Between Good and Fair
Deficiency	No deficiencies recorded
Walls	Inspected
Condition	2 - Between Good and Fair
Deficiency	No deficiencies recorded
TOILET ROOMS - STUDENTS	Inspected
Ceiling	Inspected
Condition	2 - Between Good and Fair
Deficiency	GYPSUM BOARD: DAMAGED/DETERIORATED
Deficiency Location/Instance	Rooms 316, 224, 416, 418
Deficiency Quantity	50
Quantity Uom	S.F.
Potential Action	REPLACE
Urgency of Action	PRIORITY 3
Purpose of Action	LEVEL 2

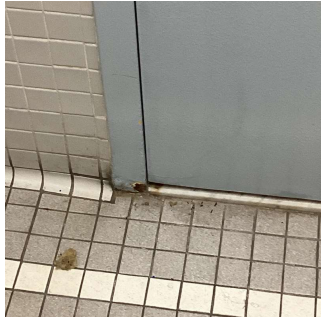
Room 418
Violations	No violations recorded.
Door(s)	Inspected
Condition	3 - Fair
Deficiency	METAL: DETERIORATED DOOR AND FRAME
Deficiency Location/Instance	Room 130B
Deficiency Quantity	1
Quantity Uom	EACH
Potential Action	MAINTENANCE
Urgency of Action	PRIORITY 3

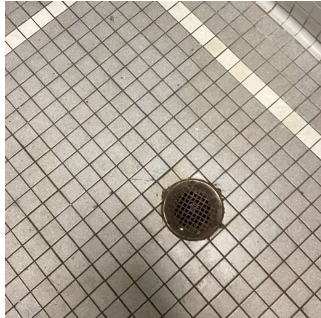
Room 130B
Violations	No violations recorded.
Floor Finish	Inspected
Condition	2 - Between Good and Fair
Deficiency	CERAMIC TILE: BROKEN/MISSING TILES
Deficiency Location/Instance	Room 130B
Deficiency Quantity	10
Quantity Uom	S.F.
Potential Action	REPLACE
Urgency of Action	PRIORITY 3
Purpose of Action	LEVEL 2
Deficiency Photo1

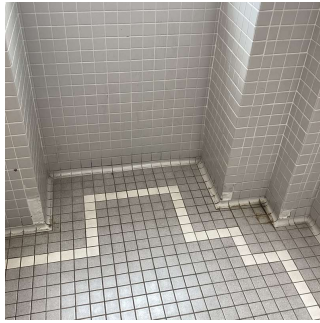
Room 130B
Violations	No violations recorded.
Stalls	Inspected
Condition	2 - Between Good and Fair
Deficiency	No deficiencies recorded
Walls	Inspected
Condition	2 - Between Good and Fair
Deficiency	CERAMIC TILE: BROKEN/ MISSING
Deficiency Location/Instance	Rooms 130A, 224, 226, 318, 418 and Others
Deficiency Quantity	60
Quantity Uom	S.F.
Potential Action	REPLACE
Urgency of Action	PRIORITY 3
Purpose of Action	LEVEL 2

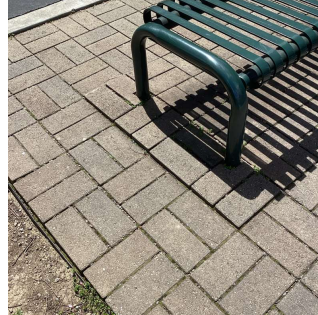
Near North Playing field

Pavers

Deficiency

DAMAGED/MISSING

REPLACE

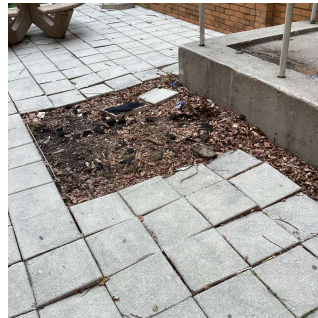
Near Exit 7

Deficiency

CRACKS - MAJOR

REPLACE

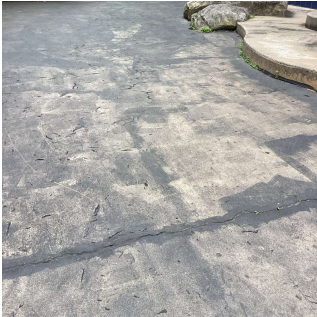
Question	Response
SITE	
PAVING	
Site Sidewalks & Walkways	
Asphalt	
Deficiency Photo1

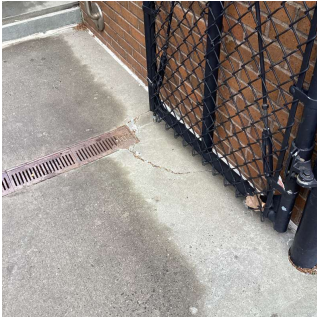
Violations	Near West Playground No violations recorded.
Concrete	Inspected
Condition	3 - Fair
Deficiency	DAMAGED/DETERIORATED/MISSING SECTIONS
Deficiency Location/Instance	Near Exit 1, Legion Steet
Deficiency Quantity	50
Quantity Uom	S.F.
Potential Action	REPLACE
Urgency of Action	PRIORITY 3
Purpose of Action	LEVEL 2
Deficiency Photo1

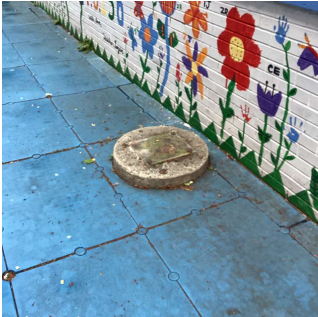
Near Exit 9
Violations	No violations recorded.
Deficiency	DETERIORATED/MISSING
Deficiency Location/Instance	Near Exit 9, by Fences
Deficiency Quantity	200

Question	Response
SITE	
PAVING	Inspected
DOT Sidewalk	
Concrete	Inspected
Violations	No violations recorded.
Pavers	Does not Exist
PLAYGROUNDS	Inspected
Instance on North Playground	Inspected
Instance on West Playground	Inspected
Benches	
Instance on North Playground	Does not Exist
Instance on West Playground	Does not Exist
Fence	
Instance on North Playground	Does not Exist
Instance on West Playground	Does not Exist
Pavement	
Instance on North Playground	Does not Exist
Instance on West Playground	Does not Exist
Play Equipment	
Instance on North Playground	Inspected
Condition	2 - Between Good and Fair
Deficiency	No deficiencies recorded
Instance on West Playground	Inspected
Condition	2 - Between Good and Fair
Deficiency	No deficiencies recorded
Safety Surfacing	
Instance on West Playground	Inspected
Condition	3 - Fair
Deficiency	DETERIORATED/MISSING
Deficiency Location/Instance	Near Exit 9
Deficiency Quantity	10
Quantity Uom	S.F.

Potential Action	REPLACE
Urgency of Action	PRIORITY 5
Purpose of Action	LEVEL 6
Deficiency Photo1

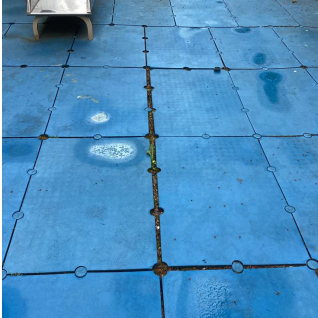
Question	Response
SITE	
PLAYGROUNDS	Inspected
Safety Surfacing	
Quantity Uom	S.F.
Potential Action	MAINTENANCE
Urgency of Action	PRIORITY 3
Purpose of Action	LEVEL 2
Deficiency Photo1

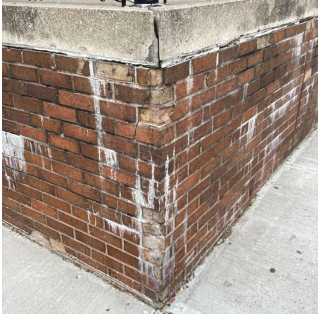
Near Slide
Violations	No violations recorded.
Unpaved Area	
Instance on North Playground	Does not Exist
Instance on West Playground	Does not Exist
PLAYING SURFACE	Inspected
Playing Field	Inspected
Instance on North Playground	Inspected
Instance Condition	2 - Between Good and Fair
Deficiency	No deficiencies recorded
Instance on South Playground	Inspected
Instance Condition	2 - Between Good and Fair
Deficiency	No deficiencies recorded
Running Track	Does not Exist
RETAINING WALLS	Inspected
Are there any Retaining Walls 6' OR higher facing public street/sidewalk?	No
Condition	3 - Fair
Deficiency	BRICK: CRACKS/SPALLING - MAJOR
Deficiency Location/Instance	Sutter Avenue, Legion Street, near West Playground
Deficiency Quantity	100
Quantity Uom	S.F.

Potential Action	REPLACE
Urgency of Action	PRIORITY 3
Purpose of Action	LEVEL 2
Deficiency Photo1

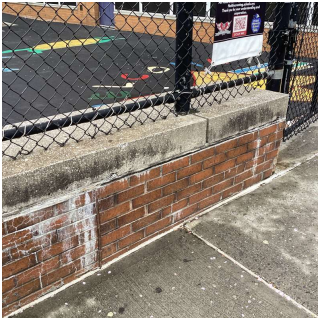
Question	Response
SITE	
RETAINING WALLS	
Violations	Legion Street No violations recorded.
Deficiency	BRICK: DETERIORATED JOINT AT COPING STONE
Deficiency Location/Instance	Sutter Avenue
Deficiency Quantity	20
Quantity Uom	L.F.
Potential Action	MAINTENANCE
Urgency of Action	PRIORITY 3
Purpose of Action	LEVEL 2
Deficiency Photo1

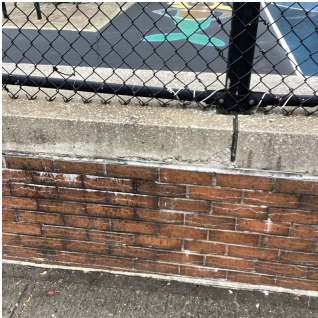
Violations	Sutter Avenue No violations recorded.
Deficiency	BRICK: DETERIORATED COPING STONE
Deficiency Location/Instance	Sutter Avenue, Legion Street, near West Playground
Deficiency Quantity	60
Quantity Uom	S.F.
Potential Action	REPLACE
Urgency of Action	PRIORITY 3
Purpose of Action	LEVEL 2
Deficiency Photo1
