**NYC Department of Education**  
**Building Condition Assessment Survey 2023 - 2024**

Architectural Inspection

**Asset: I.S. 364 - BROOKLYN, 1426 FREEPORT LOOP, New York, 11239**

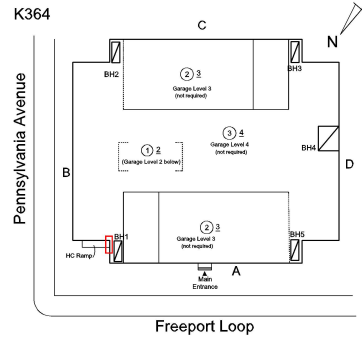
Roof Plan reference

METAL CLAD: DETERIORATED DOOR AND FRAME - MAJOR DETERIORATION

REPLACE

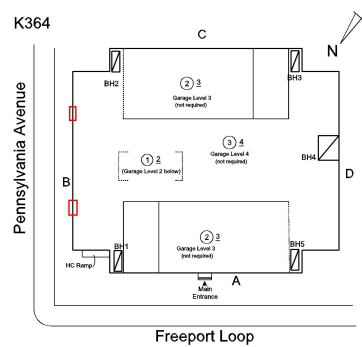
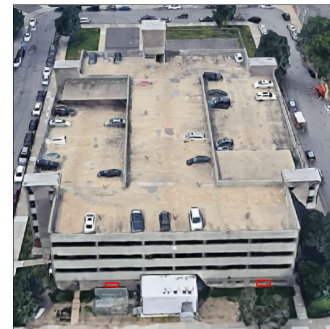
CAST IN PLACE / PRE-CAST CONCRETE: MAJOR CRACKS/SPALLING

REPLACE

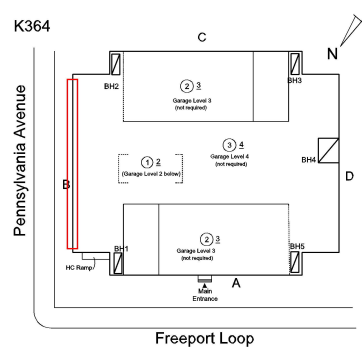
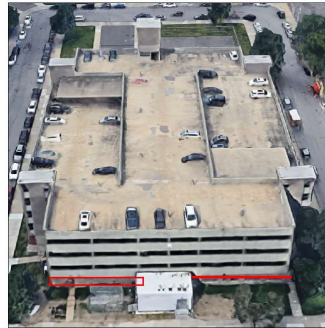
CAST IN PLACE / PRE-CAST CONCRETE: DETERIORATED JOINTS

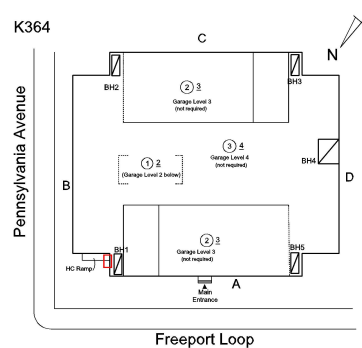
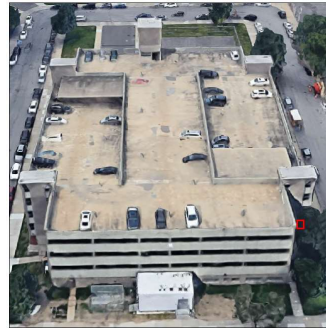
CONCRETE MASONRY UNIT: MINOR CRACKS AND SPALLING

10  
S.F.  
RESTITCH  
PRIORITY 3  
LEVEL 2

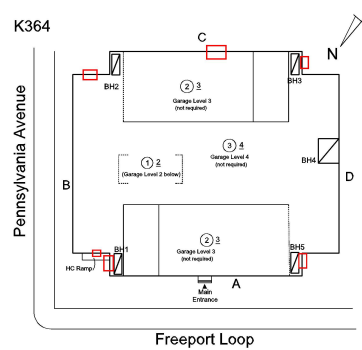
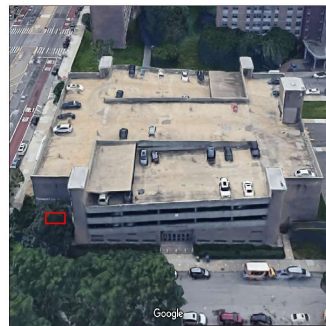
**CAST IN PLACE / PRE-CAST CONCRETE: MAJOR  
CRACKS/SPALLING**

450  
S.F.

Question	Response
<b>EXTERIOR</b>	
<b>EXTERIOR WALLS</b>	
Potential Action	REPLACE
Urgency of Action	PRIORITY 4
Purpose of Action	LEVEL 2
Deficiency Photo1

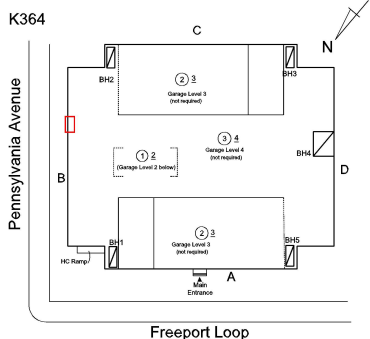
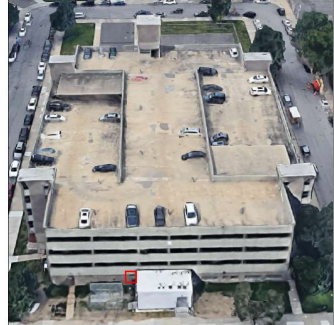
Facade C
Violations	No violations recorded.
<b>EXTERIOR SOFFITS</b>	
Condition	Inspected
Deficiency	2 - Between Good and Fair
	No deficiencies recorded
<b>LOADING DOCK</b>	
	Does not Exist
<b>LOUVER</b>	
Condition	Inspected
Deficiency	3 - Fair
Roof Plan reference	<b>BROKEN/ DENTED BLADES</b>

Deficiency Quantity	20
Quantity Uom	S.F.
Potential Action	REPLACE
Urgency of Action	PRIORITY 4
Purpose of Action	LEVEL 2

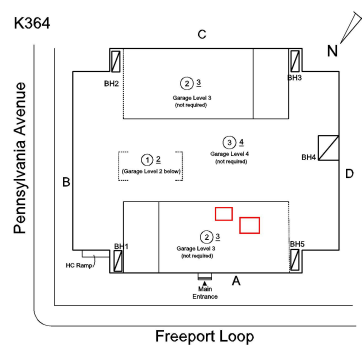
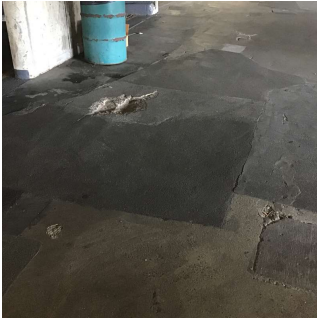
CONCRETE: MAJOR CRACKS

REPLACE

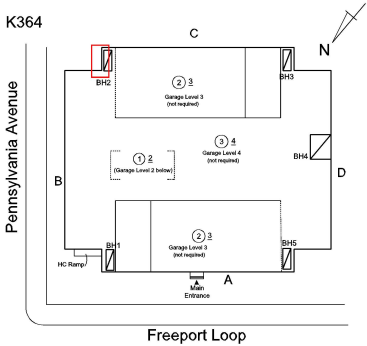
Deficiency	CAST IN PLACE CONCRETE: CRACKS/SPALLING - MAJOR
Roof Plan reference

Deficiency Quantity	20
Quantity Uom	S.F.

Question	Response
<b>EXTERIOR</b>	
<b>STAIRS/RAMPS: EXTERIOR</b>	
<b>BUILDING CHEEK/FLANK WALLS</b>	
Potential Action	REPLACE
Urgency of Action	PRIORITY 4
Purpose of Action	LEVEL 2
Deficiency Photo1

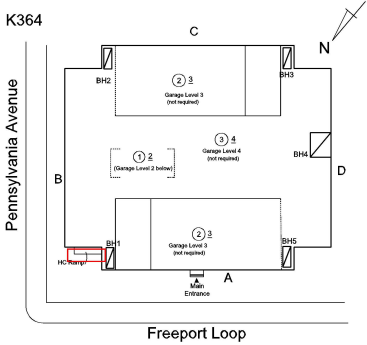
Violations	Facade C No violations recorded.
Deficiency	CAST IN PLACE CONCRETE: CRACKS/SPALLING - MINOR
Roof Plan reference	K364

Deficiency Quantity	20
Quantity Uom	S.F.
Potential Action	REPAIR
Urgency of Action	PRIORITY 3
Purpose of Action	LEVEL 2
Deficiency Photo1

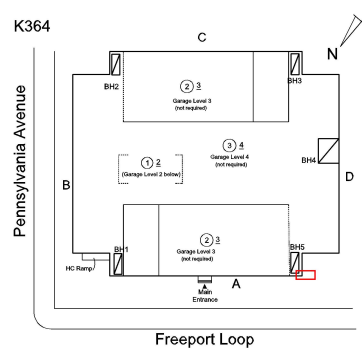
Violations	Facade A No violations recorded.
<b>RAILINGS</b>	
Condition	Inspected
Deficiency	3 - Fair MISSING RAILING

10  
L.F.  
REPLACE  
PRIORITY 5  
LEVEL 6

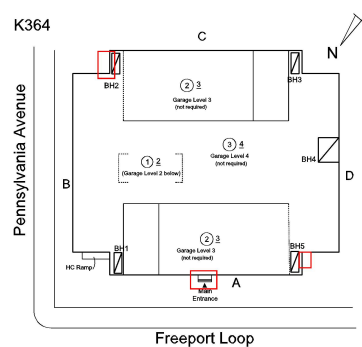
CONCRETE: CRACKS/SPALLING - MAJOR

100  
S.F.  
REPLACE  
PRIORITY 4  
LEVEL 2

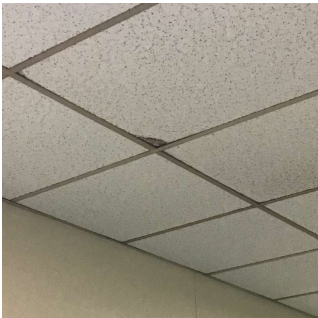
Near center
Violations	No violations recorded.

Question	Response
<b>INTERIOR</b>	
<b>STRUCTURAL</b>	
<b>FLOOR STRUCTURE</b>	Inspected
Deficiency	No deficiencies recorded
<b>FOUNDATION WALLS</b>	Inspected
Material Type(s)	Concrete
Condition	2 - Between Good and Fair
Deficiency	No deficiencies recorded
<b>ROOF STRUCTURE</b>	Inspected
Condition	2 - Between Good and Fair
Deficiency	No deficiencies recorded
<b>VAULTS-BUNKERS</b>	Does not Exist
<b>AUDITORIUM</b>	Does not Exist
<b>CAFETERIA</b>	Inspected
Instance on 1st Floor - Students (1,700 SF)	Inspected
Instance on 1st Floor - Staff (900 SF)	Inspected
<b>Ceiling</b>	
Instance on 1st Floor - Staff (900 SF)	Inspected
Condition	2 - Between Good and Fair
Deficiency	ACOUSTIC TILES: DAMAGED/MISSING
Deficiency Location/Instance	Near center
Deficiency Quantity	10
Quantity Uom	S.F.
Potential Action	REPLACE
Urgency of Action	PRIORITY 3
Purpose of Action	LEVEL 2
Deficiency Photo1

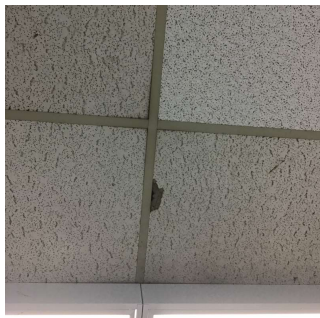
Instance on 1st Floor - Students (1,700 SF)	Inspected
Condition	2 - Between Good and Fair
Deficiency	ACOUSTIC TILES: DAMAGED/MISSING
Deficiency Location/Instance	Near Entrance, center, kitchen
Deficiency Quantity	20
Quantity Uom	S.F.
Potential Action	REPLACE
Urgency of Action	PRIORITY 3
Purpose of Action	LEVEL 2

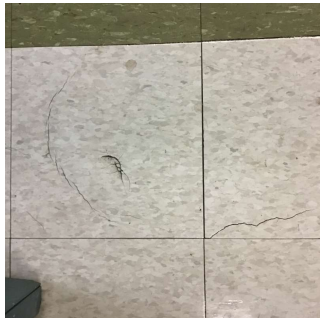
Near Entrance
Violations	No violations recorded.
<b>Door(s)</b>	
Instance on 1st Floor - Students (1,700 SF)	Inspected
Condition	2 - Between Good and Fair
Deficiency	No deficiencies recorded
Instance on 1st Floor - Staff (900 SF)	Inspected
Condition	2 - Between Good and Fair
Deficiency	No deficiencies recorded
<b>Fixed Equipment</b>	
Instance on 1st Floor - Students (1,700 SF)	Does not Exist
Instance on 1st Floor - Staff (900 SF)	Does not Exist
<b>Floor Finish</b>	
Instance on 1st Floor - Staff (900 SF)	Inspected
Condition	2 - Between Good and Fair
Deficiency	VINYL TILES: BROKEN/DETERIORATED/MISSING TILES
Deficiency Location/Instance	Near Entrance
Deficiency Quantity	10
Quantity Uom	S.F.
Potential Action	REPLACE
Urgency of Action	PRIORITY 3
Purpose of Action	LEVEL 2
Deficiency Photo1

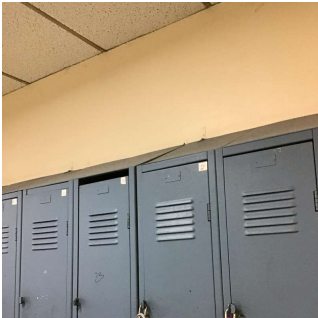
Question	Response
<b>INTERIOR</b>	
<b>CLASSROOMS/CORRIDORS/ADMIN SPACES</b>	
<b>Specialties</b>	Inspected
<b>Classroom Locker(s)</b>	Inspected
Condition	2 - Between Good and Fair
Deficiency	DAMAGED UNITS
Deficiency Location/Instance	Rooms 123,101
Deficiency Quantity	2
Quantity Uom	EACH
Potential Action	REPLACE
Urgency of Action	PRIORITY 3
Purpose of Action	LEVEL 2
Deficiency Photo1

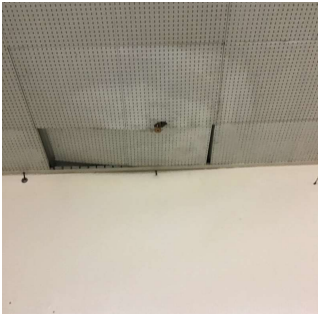
Violations	Room 101 No violations recorded.
<b>Fixed Seating</b>	Does not Exist
<b>GYMNASIUM</b>	Does not Exist
<b>INTERIOR DOOR HARDWARE</b>	Inspected
Condition	3 - Fair
Deficiency	No deficiencies recorded
<b>INTERIOR GUARDS</b>	Does not Exist
<b>KITCHEN</b>	Inspected
Instance on 1st Floor (600 SF)	Inspected
<b>Ceiling</b>	Inspected
Instance on 1st Floor (600 SF)	Inspected
Condition	2 - Between Good and Fair
Deficiency	ACOUSTIC TILES: DAMAGED/MISSING
Deficiency Location/Instance	Near Entrance
Deficiency Quantity	10
Quantity Uom	S.F.
Potential Action	REPLACE

Urgency of Action	PRIORITY 3
Purpose of Action	LEVEL 2
Deficiency Photo1

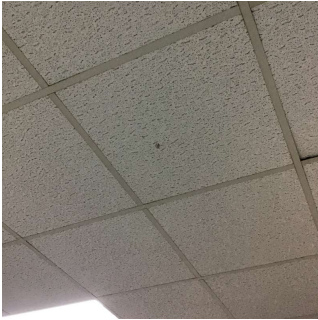
<b>Question</b>	<b>Response</b>
<b>INTERIOR</b>	
<b>KITCHEN</b>	Inspected
<b>Walls</b>	
Violations	No violations recorded.
<b>LIBRARY</b>	Inspected
Instance on Room 131	Inspected
<b>Built-in Furnishing</b>	
Instance on Room 131	Does not Exist
<b>Ceiling</b>	
Instance on Room 131	Inspected
Condition	2 - Between Good and Fair
Deficiency	ACOUSTIC TILES: DAMAGED/MISSING
Deficiency Location/Instance	Near center
Deficiency Quantity	10
Quantity Uom	S.F.
Potential Action	REPLACE
Urgency of Action	PRIORITY 3
Purpose of Action	LEVEL 2
Deficiency Photo1

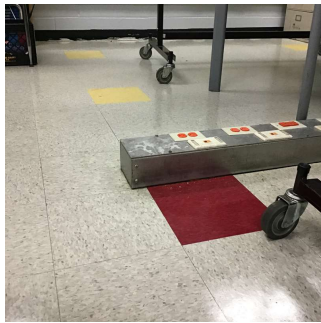
Violations	No violations recorded.
<b>Door(s)</b>	
Instance on Room 131	Inspected
Condition	2 - Between Good and Fair
Deficiency	No deficiencies recorded
<b>Floor Finish</b>	
Instance on Room 131	Inspected
Condition	2 - Between Good and Fair
Deficiency	VINYL TILES: TRIPPING HAZARD - ELECTRICAL OUTLET
Deficiency Location/Instance	Near center
Deficiency Quantity	10
Quantity Uom	S.F.

Potential Action	REMOVE
Urgency of Action	PRIORITY 5
Purpose of Action	LEVEL 6

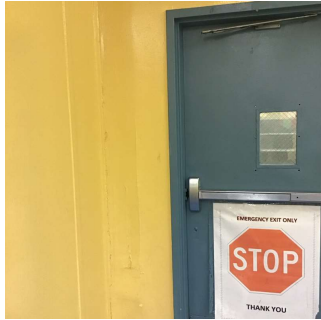
Violations	Near center No violations recorded.
<b>Walls</b>	
Instance on Room 131	Inspected
Condition	2 - Between Good and Fair
Deficiency	PLASTER: CRACKS/SPALLING
Deficiency Location/Instance	Near exit 1
Deficiency Quantity	10
Quantity Uom	S.F.
Potential Action	REPLACE
Urgency of Action	PRIORITY 3
Purpose of Action	LEVEL 2
Deficiency Photo1

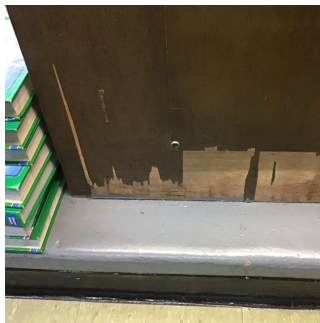
Question	Response
<b>INTERIOR</b>	
<b>SCIENCE DEMO ROOM</b>	
<b>Fixed Equipment</b>	
Deficiency Photo1

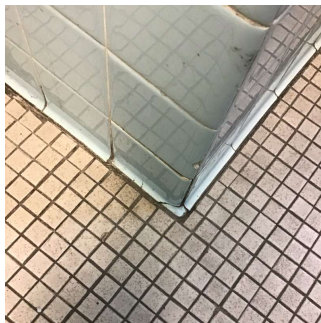
Question	Response
<b>INTERIOR</b>	
<b>TOILET ROOMS - STUDENTS</b>	
<b>Walls</b>	
Deficiency Photo1

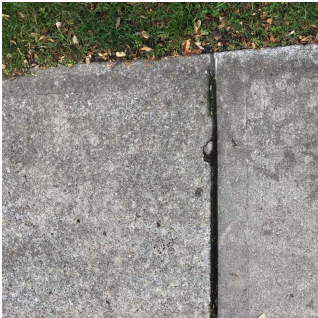
Violations	Schoolyard No violations recorded.
<b>Concrete</b>	Does not Exist
<b>Pavers</b>	Does not Exist
<b>Site Sidewalks &amp; Walkways</b>	Inspected
<b>Asphalt</b>	Does not Exist
<b>Concrete</b>	Inspected
Condition	3 - Fair
Deficiency	DAMAGED/DETERIORATED/MISSING SECTIONS
Deficiency Location/Instance	Along Pennsylvania Avenue, near exit 1, exit 2
Deficiency Quantity	225
Quantity Uom	S.F.
Potential Action	REPLACE
Urgency of Action	PRIORITY 3
Purpose of Action	LEVEL 2
Deficiency Photo1

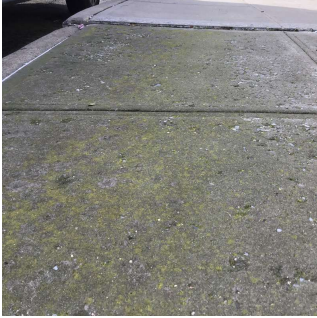
Violations	Along Pennsylvania Avenue No violations recorded.
<b>Pavers</b>	Does not Exist
<b>DOT Sidewalk</b>	Inspected
<b>Asphalt</b>	Does not Exist
<b>Concrete</b>	Inspected
Condition	4 - Between Fair and Poor
Deficiency	HEAVING
Deficiency Location/Instance	Along Freeport Loop
Deficiency Quantity	50
Quantity Uom	S.F.
Potential Action	REPLACE

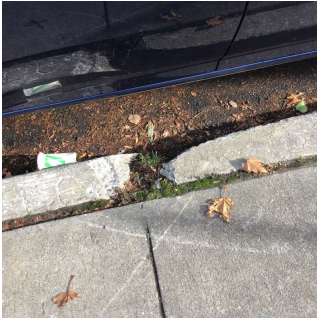
Violations	Along Freeport Loop No violations recorded.
Deficiency	DAMAGED CURBS
Deficiency Location/Instance	Along Pennsylvania Avenue, Freeport loop
Deficiency Quantity	260
Quantity Uom	L.F.
Potential Action	REPLACE
Urgency of Action	PRIORITY 3
Purpose of Action	LEVEL 2
Deficiency Photo1

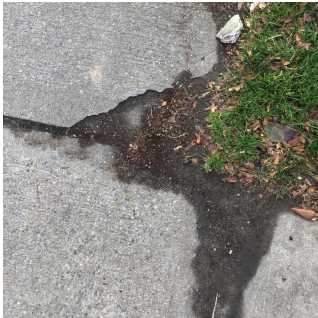
Violations	Along Pennsylvania Avenue No violations recorded.
Deficiency	DAMAGED/DETERIORATED/MISSING SECTIONS
Deficiency Location/Instance	Along Pennsylvania Avenue, Freeport Loop
Deficiency Quantity	1,075
Quantity Uom	S.F.
Potential Action	REPLACE
Urgency of Action	PRIORITY 3
Purpose of Action	LEVEL 2
