**NYC Department of Education**  
**Building Condition Assessment Survey 2023 - 2024**

Architectural Inspection

**K366**

**Asset:**            **SHIRLEY CHISHOLM CAMPUS - K, 965 EAST 107TH STREET, New York, 11236**

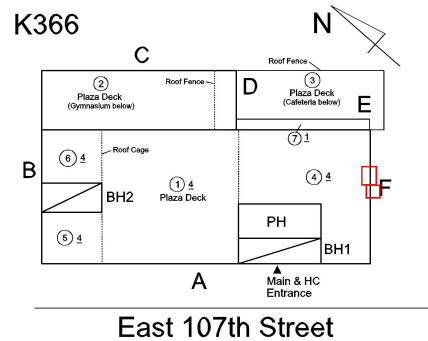
Question	Response
<b>Architectural</b>	
<b>EXTERIOR</b>	Inspected
<b>AREAWAY</b>	Does not Exist
<b>AWNINGS AND CANOPIES</b>	Inspected
Condition	2 - Between Good and Fair
Deficiency	No deficiencies recorded
<b>CHIMNEY</b>	Inspected
Material Type(s)	Metal
Condition	2 - Between Good and Fair
Deficiency	No deficiencies recorded
<b>COPING</b>	Inspected
Condition	2 - Between Good and Fair
Deficiency	No deficiencies recorded
<b>CORNICE</b>	Does not Exist
<b>DOORS</b>	Inspected
<b>DOORS AND FRAMES</b>	Inspected
Condition	3 - Fair
Deficiency	METAL: DETERIORATED DOOR AND FRAME - MINOR DETERIORATION
Roof Plan reference

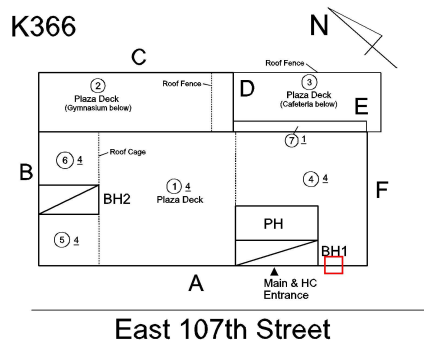
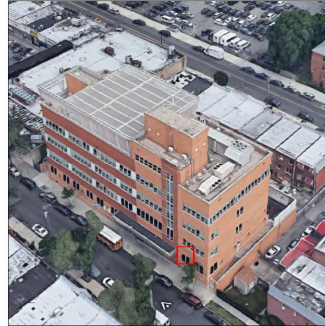
Elevation

BRICK: DETERIORATED MASONRY SILLS - MINOR

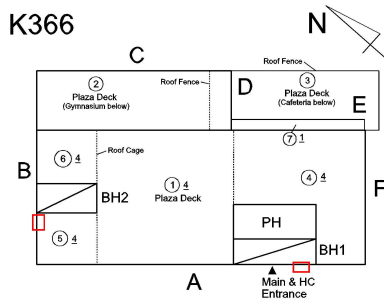
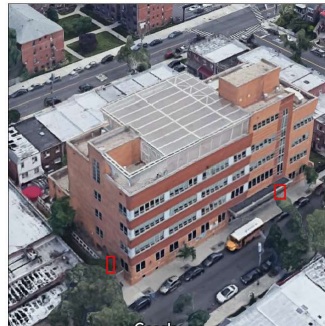
East 107th Street

CAST IN PLACE / PRE-CAST CONCRETE: MAJOR  
 CRACKS/SPALLING

REPLACE  
PRIORITY 4  
LEVEL 2

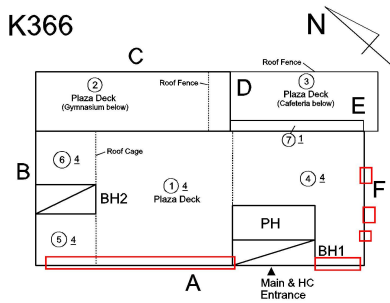
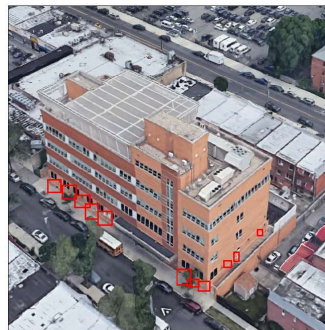
**East 107th Street**

CAST IN PLACE / PRE-CAST CONCRETE: MINOR  
CRACKS/SPALLING

130  
S.F.  
REPAIR  
PRIORITY 3  
LEVEL 2

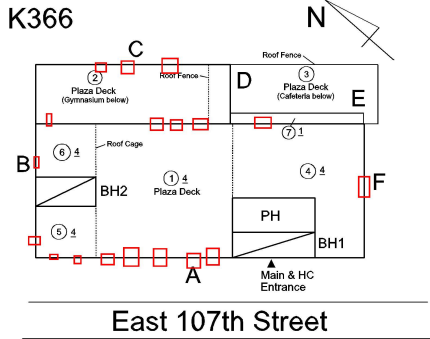
Facade A
Violations	No violations recorded.
<b>EXTERIOR SOFFITS</b>	Inspected
Condition	2 - Between Good and Fair
Deficiency	No deficiencies recorded
<b>LOADING DOCK</b>	Does not Exist
<b>LOUVER</b>	Inspected
Condition	2 - Between Good and Fair
Deficiency	No deficiencies recorded
<b>PARAPETS</b>	Inspected
Material Type(s)	Concrete
Replacement Quantity	2,200
Replacement Uom	C.F.
Instance on All Roofs	Inspected
Instance Condition	3 - Fair
Instance Quantity	2,200
Instance Quantity Uom	C.F.
Deficiency	CONCRETE: MINOR CRACKS, SPALLING
Roof Plan reference

Deficiency Quantity	325
Quantity Uom	S.F.
Potential Action	REPAIR
Urgency of Action	PRIORITY 3
Purpose of Action	LEVEL 2

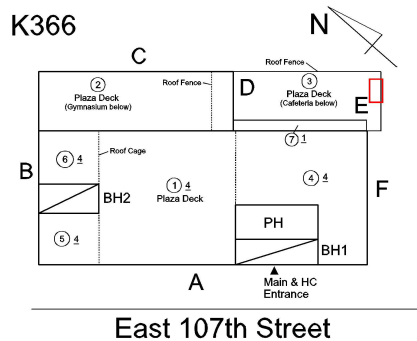
CONCRETE: MAJOR ACTIVE PLAZA DECK LEAKS IN INSTRUCTIONAL SPACE

REPLACE

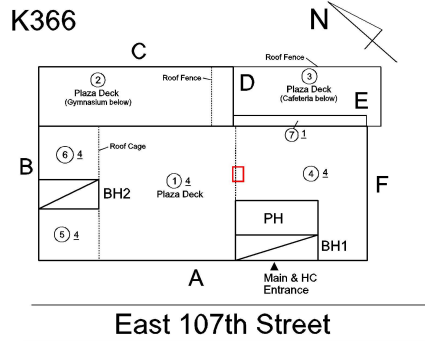
Instance Quantity	7,500
Instance Quantity Uom	S.F.
Installation Year	2009
Source of Installation	Custodial Staff
Deficiency	PAVERS: PAVERS IN POOR CONDITION
Roof Plan reference	K366

Deficiency Quantity	10
Quantity Uom	S.F.
Potential Action	REPLACE
Urgency of Action	PRIORITY 4
Purpose of Action	LEVEL 2
Deficiency Photo1

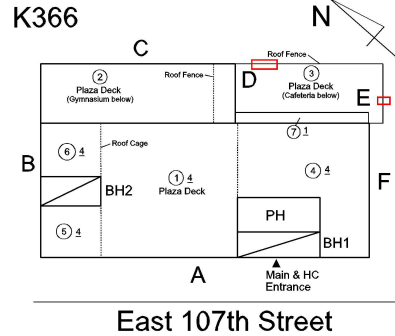
Deficiency	RAILINGS/PANELS: DETERIORATED, MAJOR RUSTING
------------	--

35  
S.F.  
REPLACE  
PRIORITY 4  
LEVEL 2

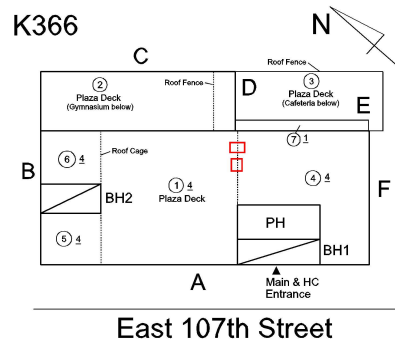
STEEL FRAME: MAJOR RUSTING

100  
S.F.  
REPAIR  
PRIORITY 4  
LEVEL 2

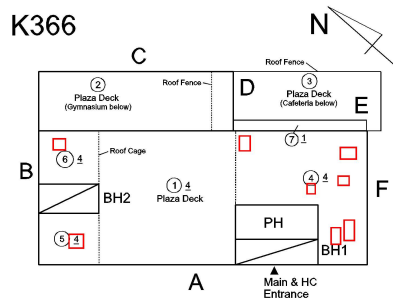
East 107th Street

IRMA: ROOFING: MAJOR ACTIVE ROOF LEAKS IN INSTRUCTIONAL SPACE

REPLACE ROOFING WITHOUT MAJOR EQUIPMENT REMOVAL

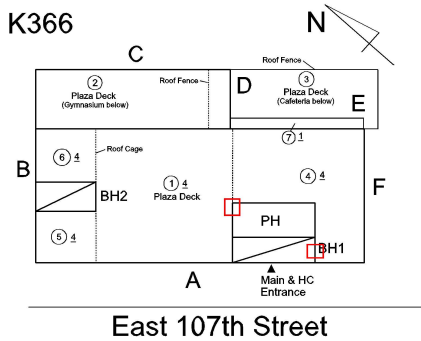
IRMA: ROOFING: DAMAGED INSULATION

REPLACE

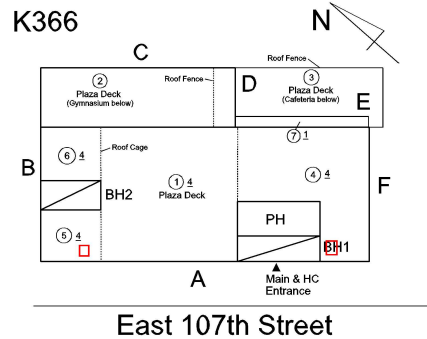
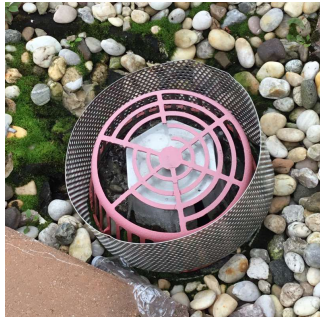
DETERIORATED

2  
EACH  
REPLACE  
PRIORITY 4  
LEVEL 2

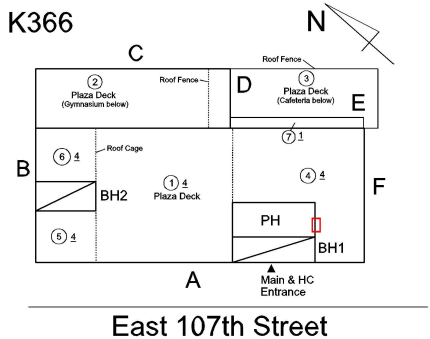
Violations	Roof 5 No violations recorded.
<b>Specialties</b>	Inspected
<b>BULKHEAD/PENTHOUSE</b>	Inspected
Condition	2 - Between Good and Fair
Deficiency	BULKHEAD/PENTHOUSE WALLS/EXTERIOR: CRACKS/SPALLING - MINOR
Roof Plan reference	K366

Deficiency Quantity	10
Quantity Uom	S.F.
Potential Action	REPAIR
Urgency of Action	PRIORITY 3
Purpose of Action	LEVEL 2
Deficiency Photo1

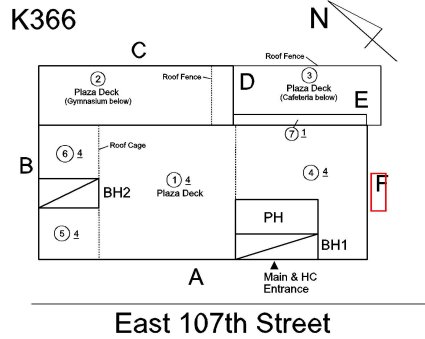
BRICK: DETERIORATED JOINTS

10  
 S.F.  
 REPOINT  
 PRIORITY 4  
 LEVEL 2

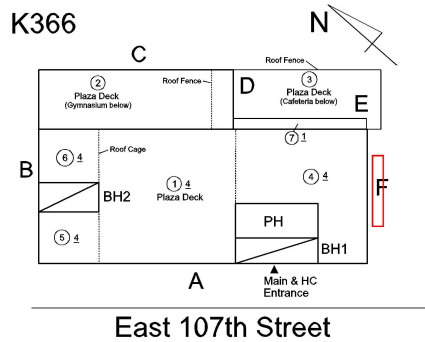
BRICK: DETERIORATED JOINTS

25  
 S.F.  
 REPOINT  
 PRIORITY 3  
 LEVEL 2

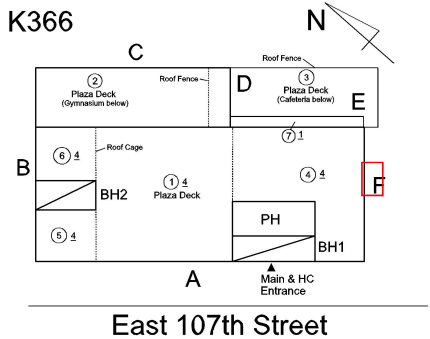
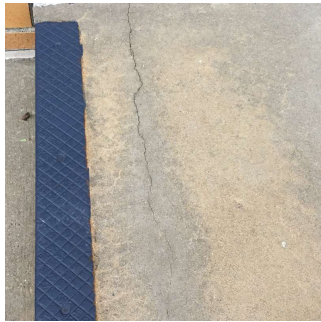
Violations	Facade F No violations recorded.
<b>RAILINGS</b>	Inspected
Condition	2 - Between Good and Fair
Deficiency	No deficiencies recorded
<b>STAIRS/RAMPS</b>	Inspected
Condition	3 - Fair
Deficiency	CONCRETE: CRACKS/SPALLING - MINOR
Roof Plan reference	<p><b>K366</b></p>

<p align="center"><b>East 107th Street</b></p>
Deficiency Quantity	20
Quantity Uom	S.F.
Potential Action	REPAIR
Urgency of Action	PRIORITY 3
Purpose of Action	LEVEL 2
Deficiency Photo1

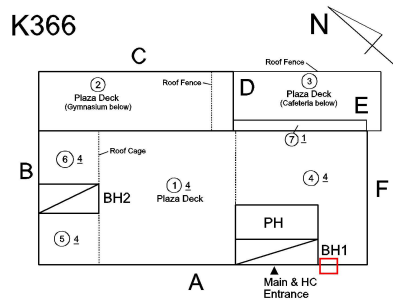
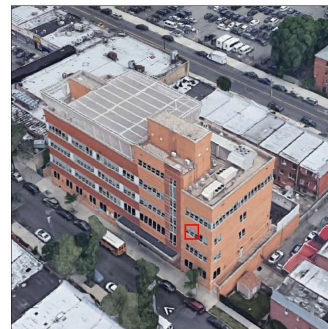
**East 107th Street**

Question	Response
<b>EXTERIOR</b>	
<b>WINDOWS</b>	
<b>EXTERIOR GUARDS</b>	Inspected
Condition	2 - Between Good and Fair
Deficiency	No deficiencies recorded
<b>LINTELS</b>	Inspected
Condition	2 - Between Good and Fair
Deficiency	No deficiencies recorded
<b>WINDOWS</b>	Inspected
Material Type(s)	Aluminum
Instance on Aluminum - Other: All Facades	Inspected
Instance Condition	3 - Fair
Instance Quantity	3,500
Instance Quantity Uom	S.F.
Are these windows insulated	Yes
Installation Year	2009
Source of Installation	Custodial Staff
Deficiency	ALUMINUM - OTHER: BROKEN PANE
Roof Plan reference	K366

30  
S.F.  
MAINTENANCE  
PRIORITY 3  
LEVEL 2

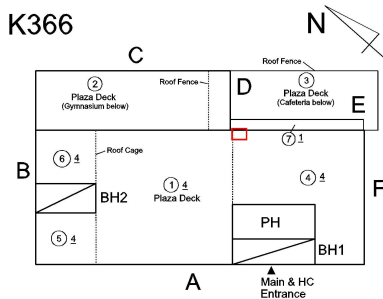
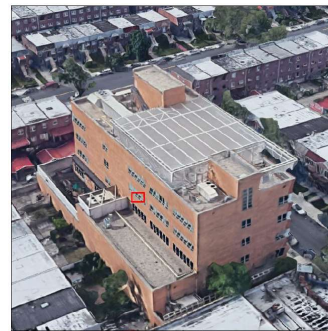
**East 107th Street**

ALUMINUM - OTHER: DETERIORATED

REPLACE WINDOW

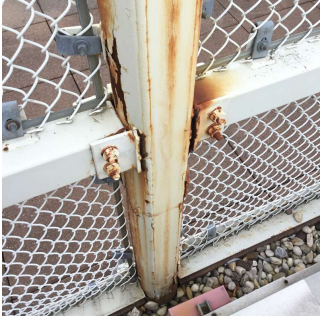
Question	Response
<b>INTERIOR</b>	Inspected
<b>POOLS</b>	Does not Exist
<b>STRUCTURAL</b>	Inspected
<b>COLUMNS/BEAMS/BEARING WALLS</b>	Inspected
Condition	4 - Between Fair and Poor
Deficiency	STEEL COLUMNS/BEAMS: MAJOR RUSTING
Deficiency Location/Instance	Roof 1 - Plaza Deck
Deficiency Quantity	100
Quantity Uom	S.F.
Potential Action	REPLACE
Urgency of Action	PRIORITY 4
Purpose of Action	LEVEL 5
Deficiency Photo1

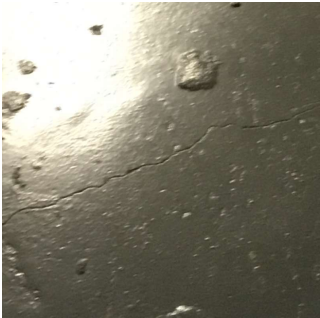
Violations	Roof 1 - Plaza Deck No violations recorded.
<b>FLOOR STRUCTURE</b>	Inspected
Condition	3 - Fair
Deficiency	CONCRETE SLAB ON GRADE: THRU CRACKS
Deficiency Location/Instance	Basement
Deficiency Quantity	30
Quantity Uom	S.F.
Potential Action	REPAIR
Urgency of Action	PRIORITY 3
Purpose of Action	LEVEL 5
Deficiency Photo1

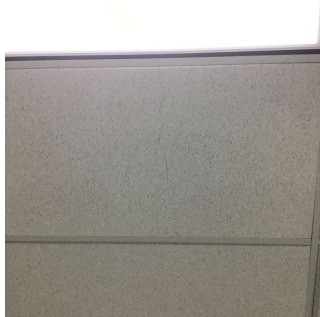
Question	Response
<b>INTERIOR</b>	
<b>CAFETERIA</b>	
<b>Walls</b>	
Violations	Near rear No violations recorded.
<b>Window Curtains/Shades/Blinds</b>	
Instance on Basement	Does not Exist
<b>CLASSROOMS/CORRIDORS/ADMIN SPACES</b>	
<b>Ceiling</b>	Inspected
Condition	2 - Between Good and Fair
Deficiency	ACOUSTIC TILES: DAMAGED/MISSING
Deficiency Location/Instance	Corridor near Room 404, B06
Deficiency Quantity	10
Quantity Uom	S.F.
Potential Action	REPLACE
Urgency of Action	PRIORITY 3
Purpose of Action	LEVEL 2
Deficiency Photo1

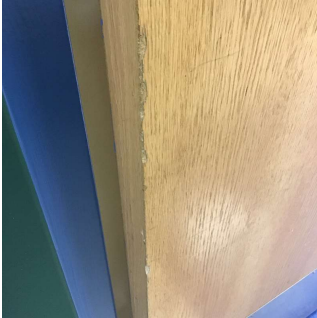
Violations	Room 417 No violations recorded.
<b>Door(s)</b>	Inspected
Condition	5 - Poor
Deficiency	WOOD: DETERIORATED DOOR

Question	Response
<b>INTERIOR</b>	
<b>CLASSROOMS/CORRIDORS/ADMIN SPACES</b>	
<b>Door(s)</b>	
Deficiency Location/Instance	Room 403, 405, 406, 318, 217, and others
Deficiency Quantity	8
Quantity Uom	EACH
Potential Action	MAINTENANCE
Urgency of Action	PRIORITY 3
Purpose of Action	LEVEL 2
Deficiency Photo1

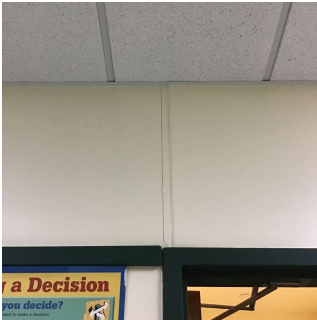
Room 405
Violations	No violations recorded.
<b>Floor Finish</b>	Inspected
Condition	2 - Between Good and Fair
Deficiency	No deficiencies recorded
<b>Walls</b>	Inspected
Condition	2 - Between Good and Fair
Deficiency	GYPSUM BOARD: DETERIORATED
Deficiency Location/Instance	Corridor near Room 308A, 107E, B06
Deficiency Quantity	10
Quantity Uom	S.F.
Potential Action	REPLACE
Urgency of Action	PRIORITY 3
Purpose of Action	LEVEL 2
Deficiency Photo1

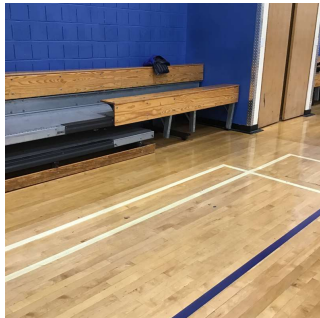
Question	Response
<b>INTERIOR</b>	
<b>GYMNASIUM</b>	
<b>Door(s)</b>	
Instance on Basement	Inspected
Condition	2 - Between Good and Fair
Deficiency	No deficiencies recorded
<b>Fixed Equipment</b>	
Instance on Basement	Inspected
Condition	2 - Between Good and Fair
Deficiency	No deficiencies recorded
<b>Floor Finish</b>	
Instance on Basement	Inspected
Condition	2 - Between Good and Fair
Deficiency	No deficiencies recorded
<b>Seating</b>	
Instance on Basement	Inspected
Condition	2 - Between Good and Fair
Deficiency	DAMAGED BLEACHERS
Deficiency Location/Instance	Near center
Deficiency Quantity	20
Quantity Uom	S.F.
Potential Action	REPLACE
Urgency of Action	PRIORITY 3
Purpose of Action	LEVEL 2
Deficiency Photo1

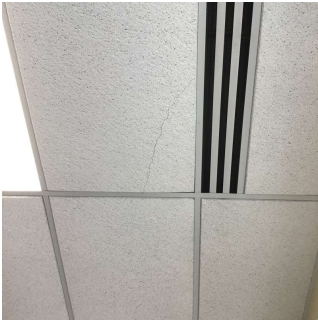
Question	Response
<b>INTERIOR</b>	
<b>LIBRARY</b>	
<b>Ceiling</b>	
Instance on Room 419	Inspected
Condition	2 - Between Good and Fair
Deficiency	ACOUSTIC TILES: DAMAGED/MISSING
Deficiency Location/Instance	Near windows
Deficiency Quantity	10
Quantity Uom	S.F.
Potential Action	REPLACE
Urgency of Action	PRIORITY 3
Purpose of Action	LEVEL 2
Deficiency Photo1

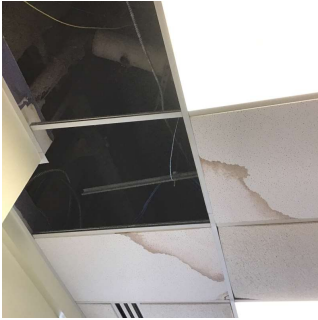
Violations	Near windows No violations recorded.
Deficiency	ACOUSTIC TILES: DAMAGED/MISSING - ACTIVE LEAK
Deficiency Location/Instance	Near windows, center
Deficiency Quantity	20
Quantity Uom	S.F.
Potential Action	REPLACE
Urgency of Action	PRIORITY 5
Purpose of Action	LEVEL 2
Deficiency Photo1

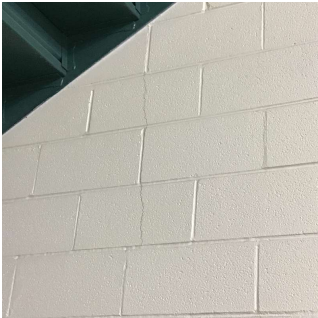
Question	Response
<b>INTERIOR</b>	
<b>STAIRS/RAMPS: INTERIOR</b>	
<b>Ceiling</b>	Inspected
Condition	2 - Between Good and Fair
Deficiency	No deficiencies recorded
<b>Door(s)</b>	Inspected
Condition	2 - Between Good and Fair
Deficiency	No deficiencies recorded
<b>Partition</b>	Does not Exist
<b>Railings</b>	Inspected
Condition	2 - Between Good and Fair
Deficiency	No deficiencies recorded
<b>Stairs and Landings</b>	Inspected
Condition	2 - Between Good and Fair
Deficiency	No deficiencies recorded
<b>Walls</b>	Inspected
Condition	2 - Between Good and Fair
Deficiency	MASONRY: CRACKS/SPALLING
Deficiency Location/Instance	Stair A/1
Deficiency Quantity	10
Quantity Uom	S.F.
Potential Action	REPLACE
Urgency of Action	PRIORITY 3
Purpose of Action	LEVEL 2
Deficiency Photo1

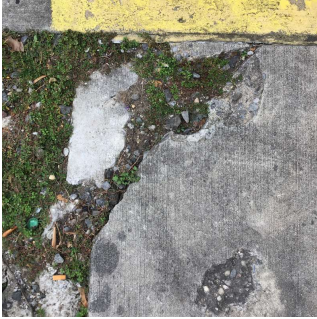
Near 1st Floor Plaza Deck	
Violations	No violations recorded.
<b>Pavers</b>	Does not Exist
<b>DOT Sidewalk</b>	Inspected
<b>Asphalt</b>	Does not Exist
<b>Concrete</b>	Inspected
Condition	3 - Fair

Deficiency	DAMAGED/DETERIORATED/MISSING SECTIONS
Deficiency Location/Instance	Along East 107th Street
Deficiency Quantity	225
Quantity Uom	S.F.
Potential Action	REPLACE
Urgency of Action	PRIORITY 3
Purpose of Action	LEVEL 2

Question	Response
<b>SITE</b>	
<b>PAVING</b>	Inspected
<b>DOT Sidewalk</b>	
<b>Concrete</b>	
Deficiency Photo1

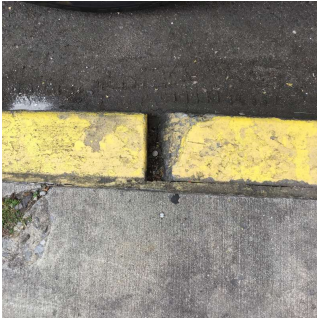
Violations	Along East 107th Street No violations recorded.
Deficiency	DAMAGED CURBS
Deficiency Location/Instance	Along East 107th Street
Deficiency Quantity	40
Quantity Uom	L.F.
Potential Action	REPLACE
Urgency of Action	PRIORITY 3
Purpose of Action	LEVEL 2
Deficiency Photo1
