NYC Department of Education
Building Condition Assessment Survey 2023 - 2024

Architectural Inspection

Asset: P.S. 369 (COY COX SCHOOL) - K, 383 STATE STREET, New York, 11217

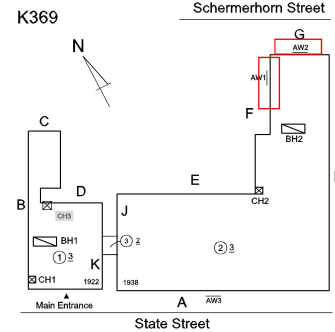
AREAWAY WALLS: DETERIORATED JOINTS

150
S.F.
REPAIR
PRIORITY 3
LEVEL 2

AW1, AW2 water Infiltration

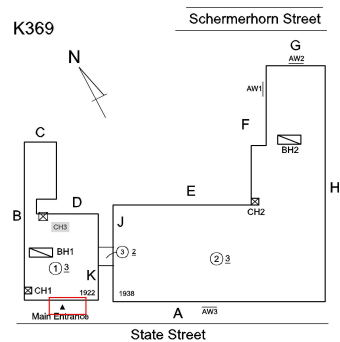
STONE: WORN-OUT TREAD/RISER/NOSING

10
S.F.
REPLACE
PRIORITY 4
LEVEL 2

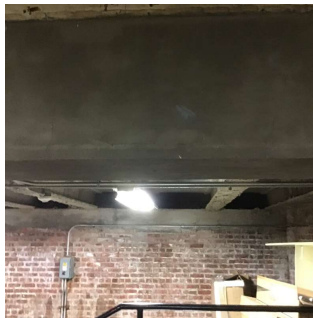
CONCRETE COLUMNS/BEAMS:
CRACKED/SPALLED/REINFORCEMENT EXPOSED

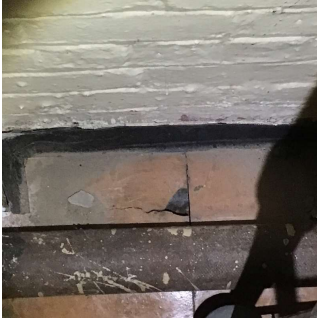
Violations	Basement Boiler Room 1, Storage Room, Tank Room No violations recorded.
Deficiency	CONCRETE SLAB ON GRADE: WATER INFILTRATION IN INSTRUCTIONAL SPACE
Deficiency Location/Instance	Cafeteria - Facade A
Deficiency Quantity	100

Question	Response
INTERIOR	
STRUCTURAL	
FLOOR STRUCTURE	
Urgency of Action	PRIORITY 5
Purpose of Action	LEVEL 5
Deficiency Photo1

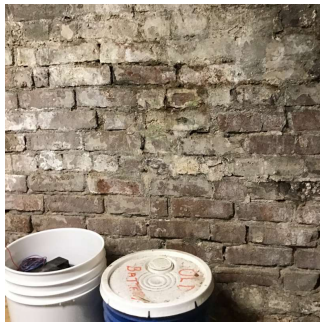
Violations	Basement Storage Room No violations recorded.
Deficiency	BRICK: DETERIORATED JOINTS
Deficiency Location/Instance	Basement Storage Room
Deficiency Quantity	100
Quantity Uom	S.F.
Potential Action	REPOINT
Urgency of Action	PRIORITY 3
Purpose of Action	LEVEL 5

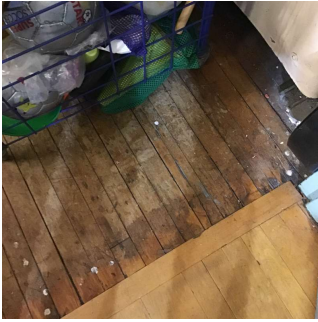
Question	Response
INTERIOR	
GYMNASIUM	Inspected
Fixed Equipment	
Deficiency	No deficiencies recorded
Floor Finish	
Instance on 1st Floor (2000sf)	Inspected
Condition	2 - Between Good and Fair
Deficiency	WOOD: DAMAGED/DETERIORATED
Deficiency Location/Instance	Office
Deficiency Quantity	50
Quantity Uom	S.F.
Potential Action	REPLACE
Urgency of Action	PRIORITY 3
Purpose of Action	LEVEL 2
Deficiency Photo1

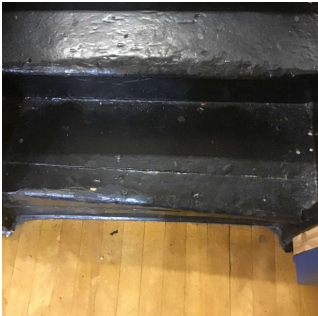
Violations	No violations recorded.
Seating	
Instance on 1st Floor (2000sf)	Does not Exist
Sliding-folding Partition	
Instance on 1st Floor (2000sf)	Does not Exist
Stage	
Instance on 1st Floor (2000sf)	Inspected
Stage	
Instance on 1st Floor (2000sf)	Inspected
Condition	3 - Fair
Deficiency	DAMAGED STEPS
Deficiency Location/Instance	Right side,left side
Deficiency Quantity	50
Quantity Uom	S.F.
Potential Action	REPLACE
Urgency of Action	PRIORITY 3
Purpose of Action	LEVEL 2
Deficiency Photo1

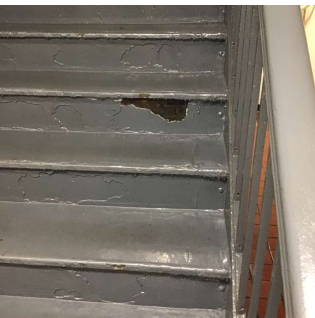
Stair B/Basement No violations recorded.

Stair A/Basement No violations recorded.
Deficiency Deficiency Location/Instance Deficiency Quantity Quantity Uom Potential Action Urgency of Action Purpose of Action Deficiency Photo1 Violations	METAL: RUST - MAJOR Stair B/Basement, A/ Basement 10 S.F. REPLACE PRIORITY 3 LEVEL 2

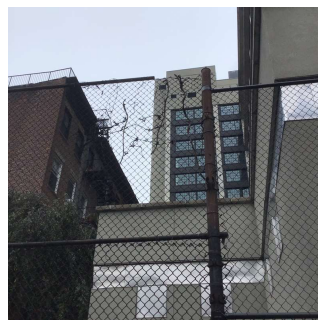
CHAIN LINK: DAMAGED POST/RAIL
Near Playground
10
L.F.
REPLACE
PRIORITY 3
LEVEL 2

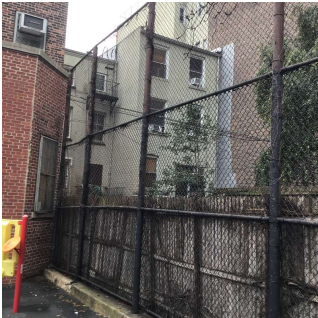
Question	Response
SITE	
FENCES	
Violations	Near Playground No violations recorded.
Deficiency	CHAIN LINK: RUST - MAJOR
Deficiency Location/Instance	Near Playground, near containers
Deficiency Quantity	2,100
Quantity Uom	S.F.
Potential Action	REPLACE
Urgency of Action	PRIORITY 3
Purpose of Action	LEVEL 2
Deficiency Photo1

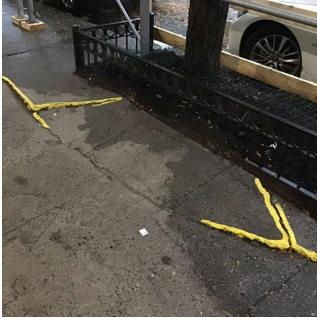
Question	Response
SITE	
PAVING	
DOT Sidewalk	
Concrete	
Condition	4 - Between Fair and Poor
Deficiency	HEAVING
Deficiency Location/Instance	State Street
Deficiency Quantity	125
Quantity Uom	S.F.
Potential Action	REPLACE
Urgency of Action	PRIORITY 5
Purpose of Action	LEVEL 6
Deficiency Photo1

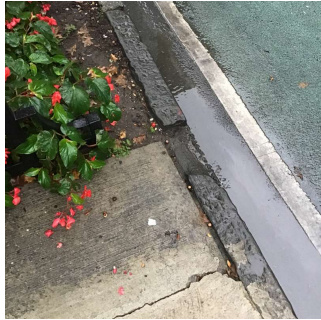
Schermerhorn Street
No violations recorded.

Deficiency	DAMAGED CURBS
Deficiency Location/Instance	Schermerhorn Street, State Street
Deficiency Quantity	30
Quantity Uom	L.F.
Potential Action	REPLACE
Urgency of Action	PRIORITY 3
Purpose of Action	LEVEL 2
Deficiency Photo1

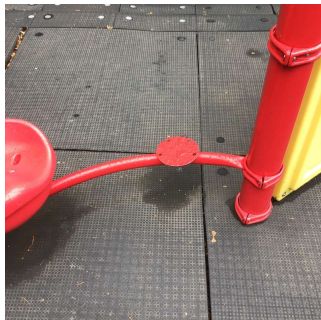
Deficiency	BROKEN/DETERIORATED/MISSING
Deficiency Location/Instance	Schoolyard
Deficiency Quantity	1
Quantity Uom	EACH
Potential Action	REPLACE
Urgency of Action	PRIORITY 5
Purpose of Action	LEVEL 6
Deficiency Photo1

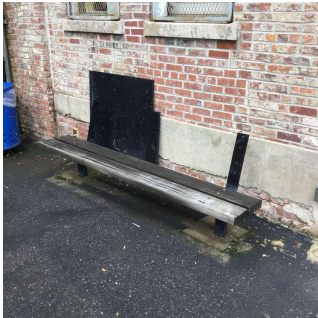
Yes	Protruding Elements	Missing Bench sections creates a potential hazardous condition.	SITE SEATING Benches Metal/Wood/Plastic	Schoolyard	Rohan Depunt	Handyman
Yes	Tripping Hazard	Large gap in safety surfacing creates a potential tripping hazard.	SITE PLAYGROUN DS Safety Surfacing	Near planter	Rohan Depunt	Handyman
