**NYC Department of Education**  
**Building Condition Assessment Survey 2023 - 2024**

Architectural Inspection

**Asset:** P.S. 377 - BROOKLYN, 200 WOODBINE STREET, New York, 11221

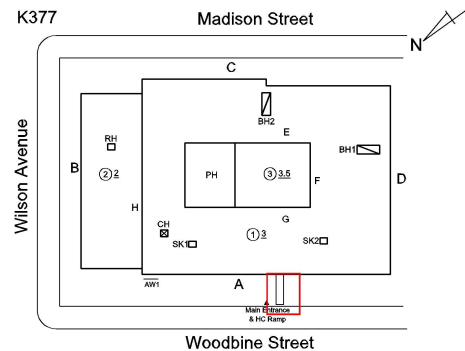
Deficiency Roof Plan reference CONCRETE: MAJOR CRACKS/SPALLING K377

Deficiency Quantity 10  
 Quantity Uom S.F.  
 Potential Action REPAIR  
 Urgency of Action PRIORITY 4  
 Purpose of Action LEVEL 2

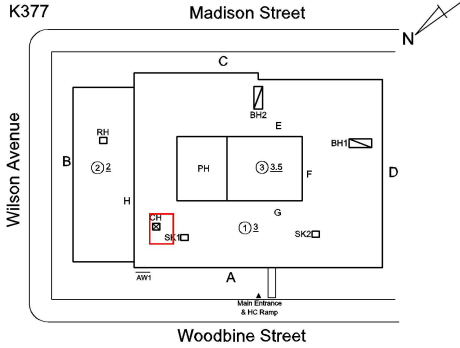
Violations	Facade A No violations recorded.
<b>CHIMNEY</b>	
Material Type(s)	Inspected Masonry
Condition	2 - Between Good and Fair
Deficiency	BRICK: DETERIORATED JOINTS
Roof Plan reference	K377

Deficiency Quantity	10
Quantity Uom	S.F.
Potential Action	REPOINT
Urgency of Action	PRIORITY 3
Purpose of Action	LEVEL 2
Deficiency Photo1

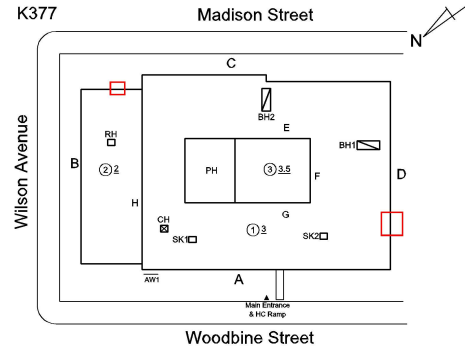
METAL CLAD: DETERIORATED DOOR AND FRAME - MAJOR DETERIORATION

REPLACE

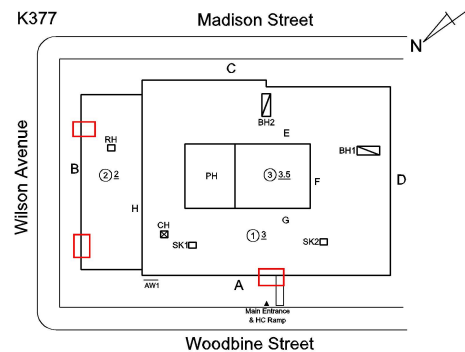
METAL CLAD: DETERIORATED DOOR AND FRAME - MINOR DETERIORATION

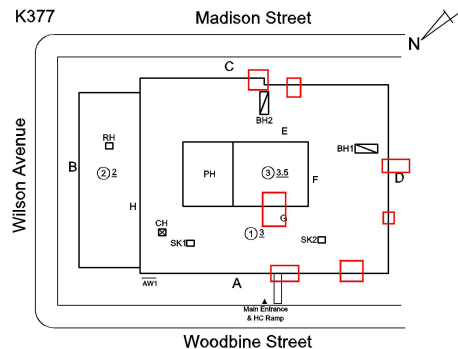
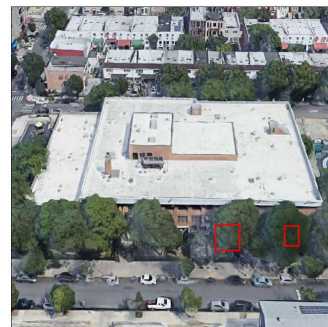
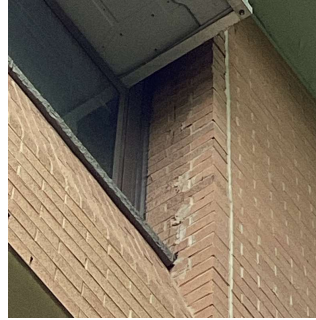
Facade C

BRICK: MINOR CRACKS AND SPALLING

S.F.  
RESTITCH  
PRIORITY 3  
LEVEL 2

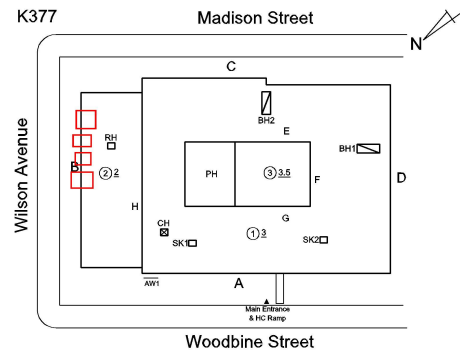
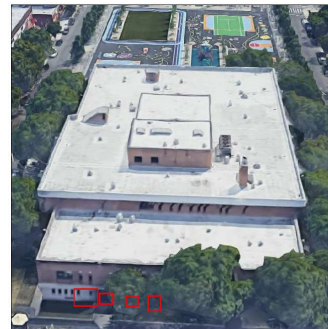
BRICK: DETERIORATED MASONRY SILLS - MAJOR

40  
L.F.  
REMOVE AND REPLACE  
PRIORITY 4  
LEVEL 2

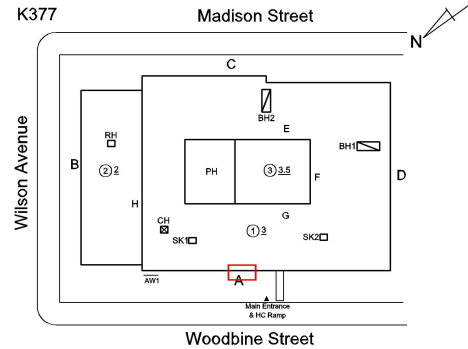
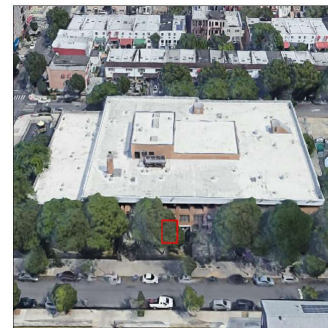
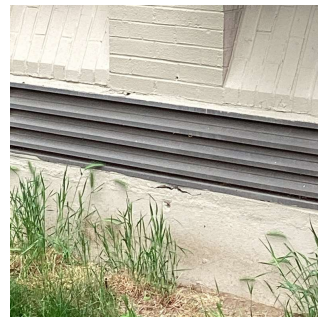
Facade A

STUCCO CEMENT SURFACE: CRACKS, SPALLING

REPLACE

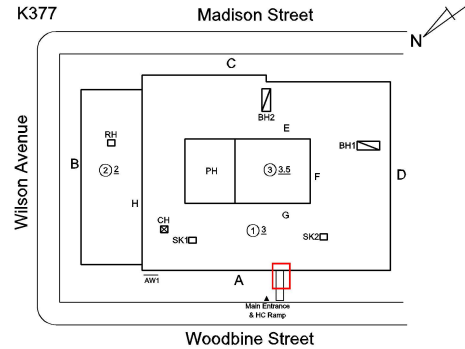
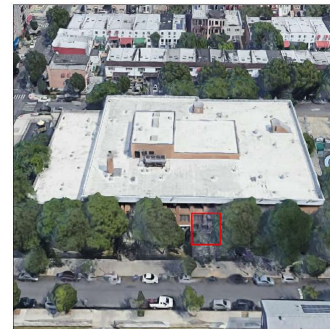
CAST IN PLACE / PRE-CAST CONCRETE: MINOR CRACKS/SPALLING

REPAIR

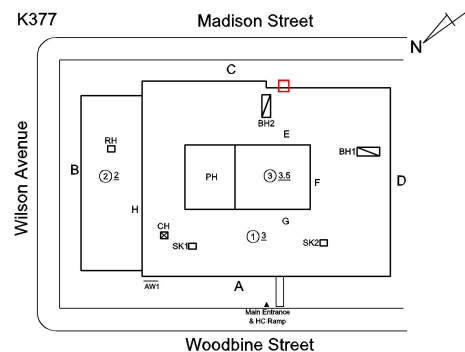
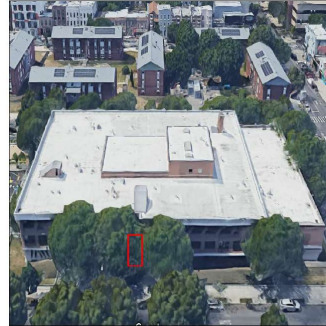
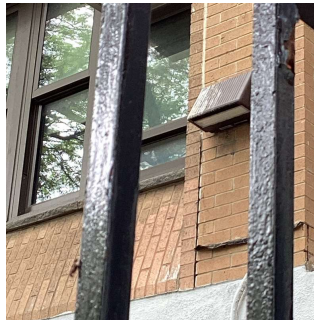
Facade C

BRICK: DETERIORATED CONTROL/EXPANSION JOINTS

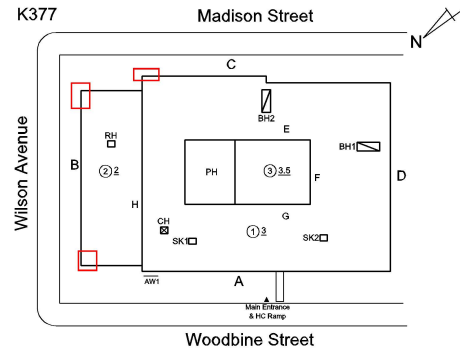
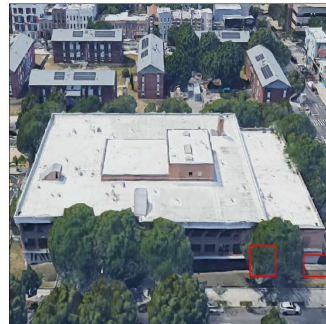
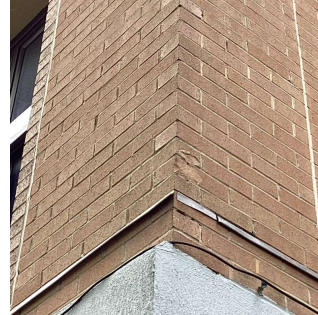
Facade C

BRICK: CRACKS/DISPLACED/SPALLED BRICK AT BUILDING CORNERS

REMOVE AND REBUILD  
PRIORITY 4  
LEVEL 2

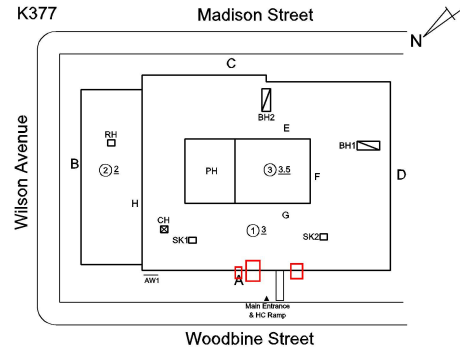
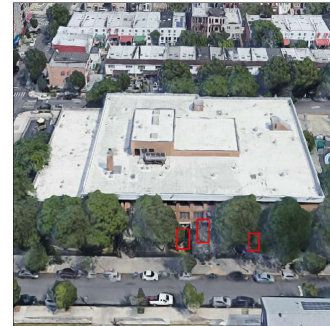
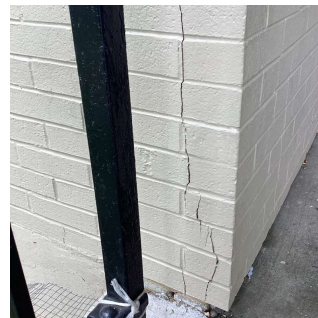
**BRICK: MAJOR / THRU CRACKS**

30  
S.F.  
REMOVE AND REBUILD  
PRIORITY 4  
LEVEL 2

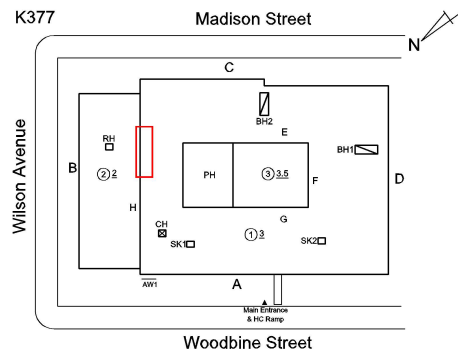
Question	Response
<b>EXTERIOR</b>	
<b>EXTERIOR WALLS</b>	Inspected
	Facade A
Violations	No violations recorded.
<b>EXTERIOR SOFFITS</b>	Inspected
Condition	2 - Between Good and Fair
Deficiency	No deficiencies recorded
<b>LOADING DOCK</b>	Does not Exist
<b>LOUVER</b>	Inspected
Condition	2 - Between Good and Fair
Deficiency	No deficiencies recorded
<b>PARAPETS</b>	Inspected
Material Type(s)	Concrete, Masonry
Replacement Quantity	6,000
Replacement Uom	C.F.
Instance on All Facades	Inspected
Instance Condition	4 - Between Fair and Poor
Instance Quantity	6,000
Instance Quantity Uom	C.F.
Deficiency	<b>BRICK: MINOR CRACKS, SPALLING</b>
Roof Plan reference	<p>K377</p>

Deficiency Quantity	10
Quantity Uom	S.F.
Potential Action	REPAIR
Urgency of Action	PRIORITY 3
Purpose of Action	LEVEL 2
Deficiency Photo1

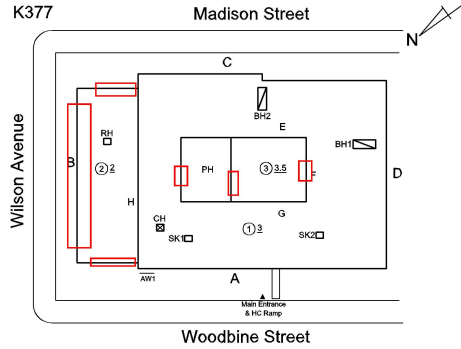
<p>The photograph shows a close-up view of a brick wall. The bricks are light-colored and arranged in a standard running bond pattern. The mortar joints between the bricks are significantly deteriorated, showing crumbling and missing mortar, which is consistent with the 'BRICK: DETERIORATED JOINTS' deficiency noted.</p>
Violations	No violations recorded.
Deficiency	<b>BRICK: DETERIORATED JOINTS</b>

100  
 S.F.  
 REPOINT  
 PRIORITY 4  
 LEVEL 2

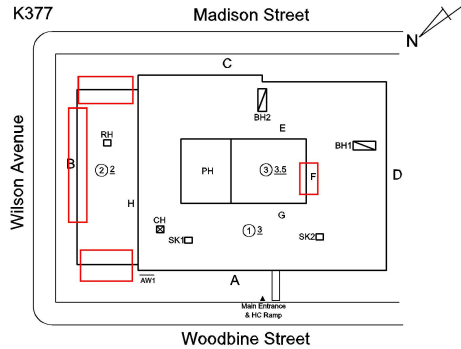
**BRICK: EFFLORESCENCE**

280  
 S.F.  
 MAINTENANCE  
 PRIORITY 1  
 LEVEL 1  
 No photo recorded  
 No violations recorded.

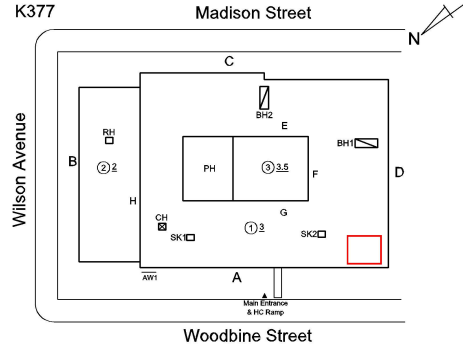
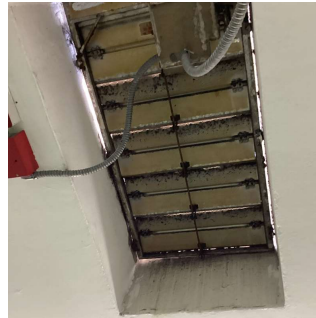
Stair A/3 - Smoke Hatch

**WATER INFILTRATION**

REPAIR

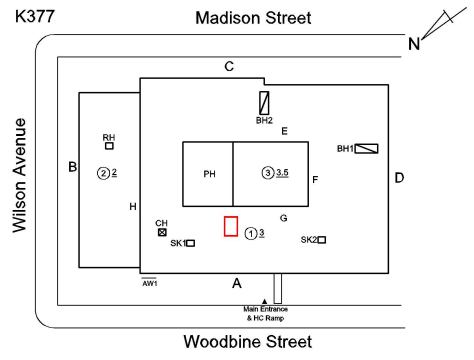
Question	Response
<b>EXTERIOR</b>	
<b>ROOF</b>	
<b>Roofing</b>	
<b>ROOFING</b>	
Instance Quantity	41,000
Instance Quantity Uom	S.F.
Does the roof have major mechanical equipment sitting on Dunnage Steel less than 18" above the Roofing?	Yes
Does this roof instance have a Sustainable Roof System?	Yes
Sustainable Roof Type	White Roof
Sustainable Roof Location (Roof Number)	All Roofs
Do solar panels exist on these roofs?	No
Is/Are the roof(s) suitable for Solar Panel installation?	Yes
Installation Year	2016
Source of Installation	Custodial Staff
Deficiency	MODIFIED BITUMEN: ROOFING: DELAMINATION
Roof Plan reference

Deficiency Quantity	10
Quantity Uom	S.F.
Potential Action	REPLACE ROOFING WITHOUT MAJOR EQUIPMENT REMOVAL
Urgency of Action	PRIORITY 4
Purpose of Action	LEVEL 2
Deficiency Photo1

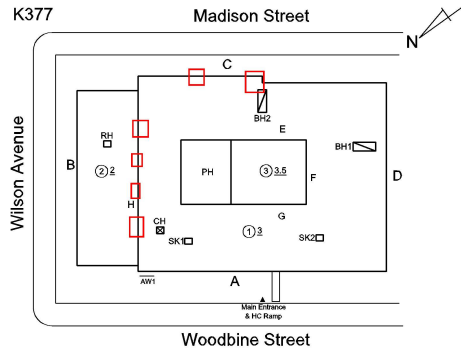
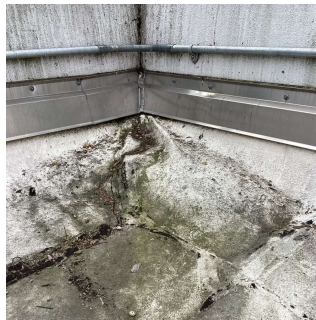
Violations	Roof 1 No violations recorded.
Deficiency	MODIFIED BITUMEN: FLASHING: BASE FLASHING DETERIORATED

60  
 S.F.  
 REPLACE  
 PRIORITY 4  
 LEVEL 2

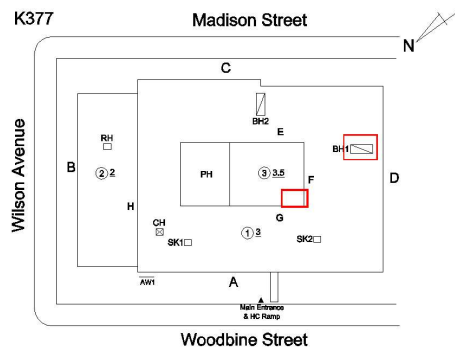
Inspected  
 3 - Fair  
 BULKHEAD/PENTHOUSE WALLS/INTERIOR: GLAZED BLOCK  
 CRACKS/SPALLING

20  
 S.F.  
 REPLACE

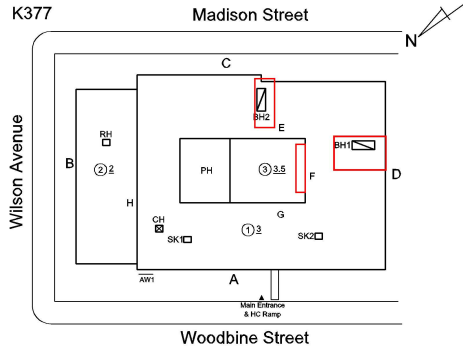
Violations	PH No violations recorded.
Deficiency	BULKHEAD/PENTHOUSE WALLS/EXTERIOR: EFFLORESCENCE
Roof Plan reference	K377

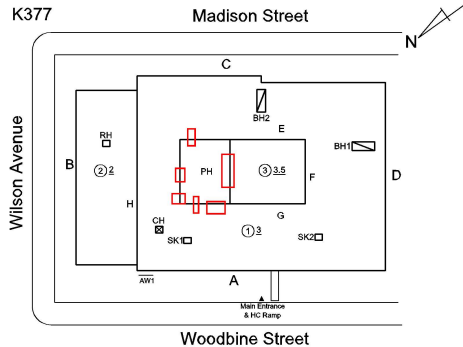
Deficiency Quantity	170
Quantity Uom	S.F.
Potential Action	MAINTENANCE
Urgency of Action	PRIORITY 1
Purpose of Action	LEVEL 1
Deficiency Photo1	No photo recorded
Violations	No violations recorded.
Deficiency	BULKHEAD/PENTHOUSE WALLS/EXTERIOR: CRACKS/SPALLING - MAJOR
Roof Plan reference	K377

Deficiency Quantity	60
Quantity Uom	S.F.
Potential Action	REPLACE

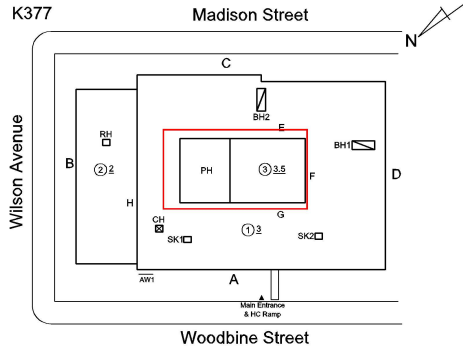
Violations	PH No violations recorded.
Deficiency	BULKHEAD/PENTHOUSE WALLS/EXTERIOR: DETERIORATED JOINTS
Roof Plan reference	K377

Deficiency Quantity	120
Quantity Uom	S.F.
Potential Action	REPOINT
Urgency of Action	PRIORITY 3
Purpose of Action	LEVEL 2
Deficiency Photo1

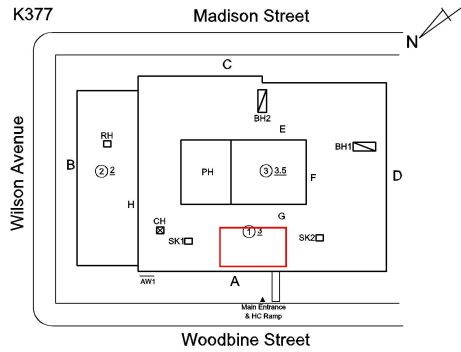
Violations	PH No violations recorded.
<b>CUPOLA/ SPIRES/ TOWERS</b>	Does not Exist
<b>DORMER</b>	Does not Exist
<b>DUNNAGE STEEL</b>	Inspected
Condition	2 - Between Good and Fair
Deficiency	HEIGHT LESS THAN 18"

35  
L.F.  
REPLACE  
PRIORITY 3  
LEVEL 2

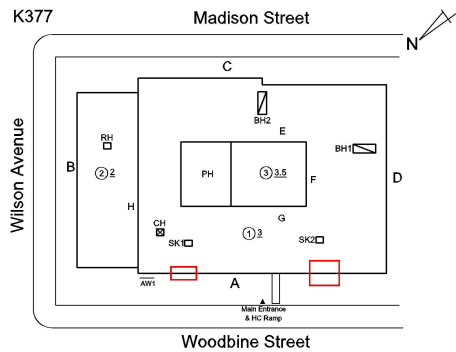
MISSING RAILING

20  
 L.F.  
 REPLACE  
 PRIORITY 5  
 LEVEL 6

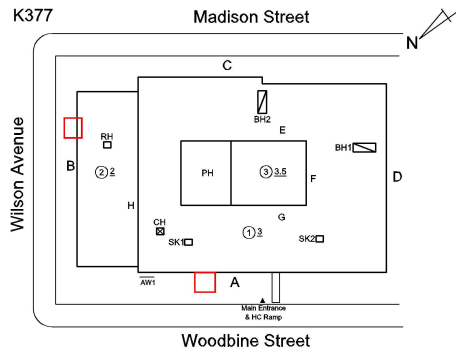
STONE: DETERIORATED JOINTS

20  
 L.F.  
 REPOINT  
 PRIORITY 4  
 LEVEL 2

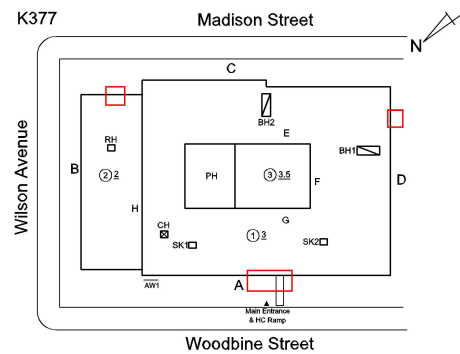
**CONCRETE: CRACKS/SPALLING - MAJOR**

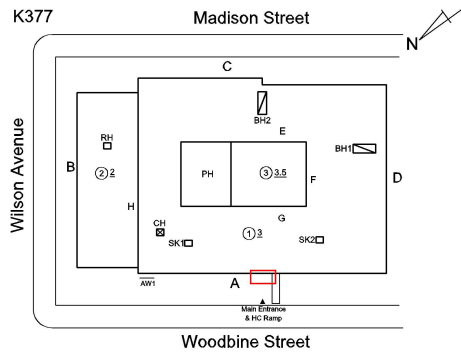
**CONCRETE: CRACKS/SPALLING - MINOR**

10  
S.F.  
REPAIR  
PRIORITY 3  
LEVEL 2

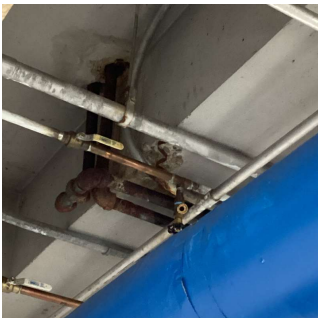
Question	Response
<b>INTERIOR</b>	
<b>STRUCTURAL</b>	Inspected
<b>COLUMNS/BEAMS/BEARING WALLS</b>	Inspected
Condition	3 - Fair
Deficiency	CONCRETE COLUMNS/BEAMS: CRACKED/SPALLED/REINFORCEMENT EXPOSED
Deficiency Location/Instance	Basement - Sprinkler Room
Deficiency Quantity	25
Quantity Uom	S.F.
Potential Action	REPLACE
Urgency of Action	PRIORITY 4
Purpose of Action	LEVEL 5
Deficiency Photo1

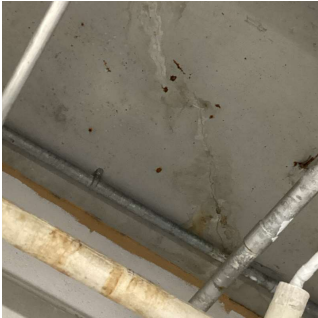
Violations	Basement - Sprinkler Room No violations recorded.
<b>FLOOR STRUCTURE</b>	Inspected
Condition	3 - Fair
Deficiency	CONCRETE: CRACKS/SPALLED/REINFORCEMENT EXPOSED
Deficiency Location/Instance	Basement - Sprinkler Room
Deficiency Quantity	10
Quantity Uom	S.F.
Potential Action	REPAIR
Urgency of Action	PRIORITY 3
Purpose of Action	LEVEL 5
Deficiency Photo1

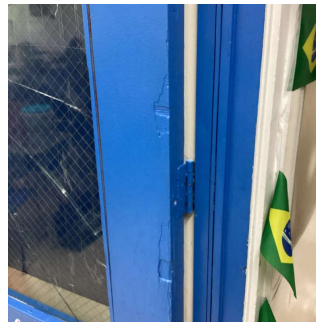
Room 233A

Violations	Main Entrance Lobby No violations recorded.
<b>Door(s)</b>	Inspected
Condition	4 - Between Fair and Poor
Deficiency	WOOD: DETERIORATED DOOR
Deficiency Location/Instance	Rooms 309, 255A (2), 235A, 233A
Deficiency Quantity	5
Quantity Uom	EACH
Potential Action	MAINTENANCE

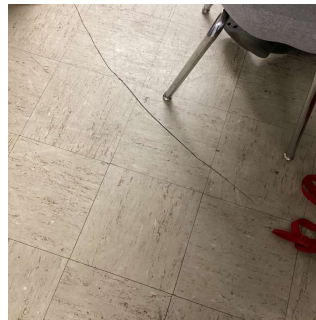
Room 235A

VINYL TILES: BROKEN/DETERIORATED/MISSING TILES

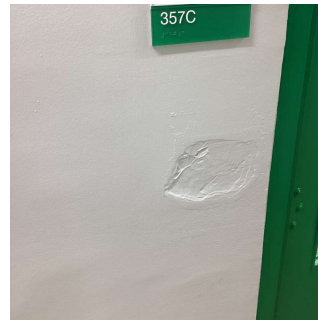
Corridor near Room 357C

PLASTER: CRACKS/SPALLING

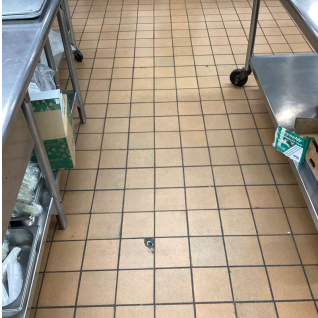
Violations	Near Prep area No violations recorded.

Instance on 1st Floor	Inspected
Condition	2 - Between Good and Fair
Deficiency	QUARRY TILE: BROKEN/MISSING TILES
Deficiency Location/Instance	Near Prep area, Room 157B
Deficiency Quantity	20
Quantity Uom	S.F.
Potential Action	REPLACE
Urgency of Action	PRIORITY 3
Purpose of Action	LEVEL 2
Deficiency Photo1

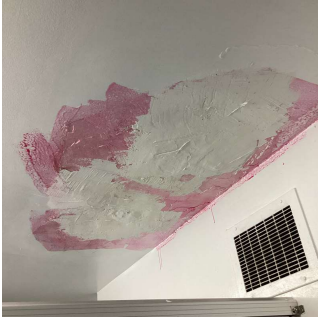
Question	Response
<b>INTERIOR</b>	
<b>STAIRS/RAMPS: INTERIOR</b>	Inspected
<b>Walls</b>	Inspected
Violations	Stair C/3 No violations recorded.
<b>TOILET ROOMS - STAFF</b>	Inspected
<b>Ceiling</b>	Inspected
Condition	2 - Between Good and Fair
Deficiency	GYPSUM BOARD: DAMAGED/DETERIORATED - ACTIVE LEAK
Deficiency Location/Instance	Room 107
Deficiency Quantity	10
Quantity Uom	S.F.
Potential Action	REPLACE
Urgency of Action	PRIORITY 5
Purpose of Action	LEVEL 2
Deficiency Photo1

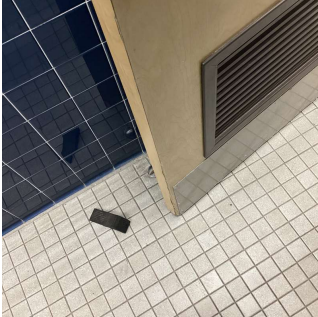
Violations	Room 107 No violations recorded.
<b>Door(s)</b>	Inspected
Condition	5 - Poor
Deficiency	WOOD: DETERIORATED DOOR
Deficiency Location/Instance	Room 220, 227
Deficiency Quantity	2
Quantity Uom	EACH
Potential Action	MAINTENANCE
Urgency of Action	PRIORITY 3
Purpose of Action	LEVEL 2
Deficiency Photo1

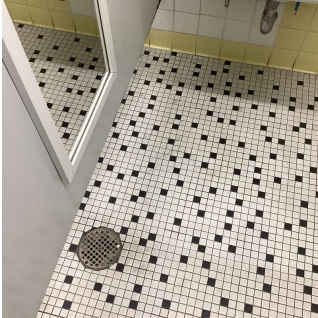
Violations	Room 220 No violations recorded.
<b>Floor Finish</b>	Inspected
Condition	4 - Between Fair and Poor
Deficiency	CERAMIC TILE: DETERIORATED SUBSTRATE

Question	Response
<b>INTERIOR</b>	
<b>TOILET ROOMS - STAFF</b>	Inspected
<b>Floor Finish</b>	
Deficiency Location/Instance	3rd Floor - Mens, Rooms 227, 225, 219C
Deficiency Quantity	40
Quantity Uom	S.F.
Potential Action	REPLACE
Urgency of Action	PRIORITY 3
Purpose of Action	LEVEL 2
Deficiency Photo1

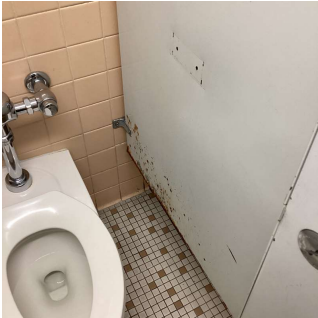
Violations	3rd Floor - Mens No violations recorded.
<b>Stalls</b>	Inspected
Condition	5 - Poor
Deficiency	RUST - MAJOR
Deficiency Location/Instance	Room 157F, 3rd Floor - Mens and Womens
Deficiency Quantity	3
Quantity Uom	EACH
Potential Action	REPLACE
Urgency of Action	PRIORITY 3
Purpose of Action	LEVEL 2
Deficiency Photo1

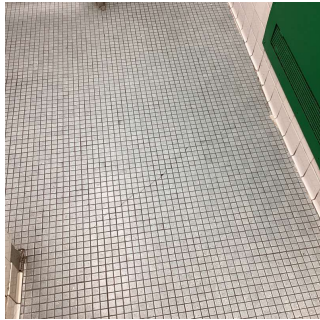
Question	Response
<b>INTERIOR</b>	
<b>TOILET ROOMS - STUDENTS</b>	
<b>Door(s)</b>	Inspected Room 233 Boys
Violations	No violations recorded.
<b>Floor Finish</b>	Inspected
Condition	2 - Between Good and Fair
Deficiency	CERAMIC TILE: DETERIORATED SUBSTRATE
Deficiency Location/Instance	Rooms 328, 332
Deficiency Quantity	20
Quantity Uom	S.F.
Potential Action	REPLACE
Urgency of Action	PRIORITY 3
Purpose of Action	LEVEL 2
Deficiency Photo1

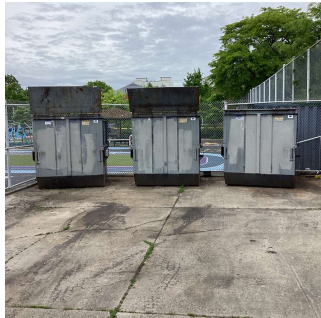
Violations	Rooms 263A No violations recorded.
<b>STEEL STAIRS</b>	Does not Exist
<b>SITE</b>	Inspected
<b>CONTAINERIZATION</b>	Inspected
Condition	3 - Fair
Deficiency	CONCRETE PAD DAMAGED
Deficiency Location/Instance	Madison Street
Deficiency Quantity	100
Quantity Uom	S.F.
Potential Action	REPAIR
Urgency of Action	PRIORITY 3
Purpose of Action	LEVEL 2
Deficiency Photo1

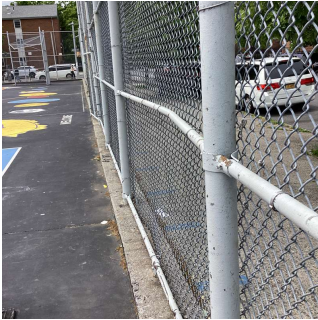
Question	Response
<b>SITE</b>	
<b>Drainage System for Concrete</b>	Inspected
<b>Catch Basins/Manhole - Surrounded by concrete</b>	Inspected
Condition	2 - Between Good and Fair
Deficiency	No deficiencies recorded
<b>Culverts - Concrete Covering</b>	Does not Exist
<b>Drainage System for Soil</b>	Inspected
<b>Catch Basins/Manhole - Surrounded by Soil</b>	Inspected
Condition	2 - Between Good and Fair
Deficiency	No deficiencies recorded
<b>Culverts - Soil Covering</b>	Does not Exist
<b>DRINKING FOUNTAINS</b>	Inspected
Condition	5 - Poor
Deficiency	INOPERABLE
Deficiency Location/Instance	South Schoolyard
Deficiency Quantity	1
Quantity Uom	EACH
Potential Action	MAINTENANCE
Urgency of Action	PRIORITY 3
Purpose of Action	LEVEL 2
Deficiency Photo1	No photo recorded
Violations	No violations recorded.
<b>FENCES</b>	Inspected
Condition	3 - Fair
Deficiency	CHAIN LINK: DAMAGED POST/RAIL
Deficiency Location/Instance	Woodbine Street, Near Containers

Deficiency Quantity	20
Quantity Uom	L.F.
Potential Action	REPLACE
Urgency of Action	PRIORITY 3
Purpose of Action	LEVEL 2
Deficiency Photo1

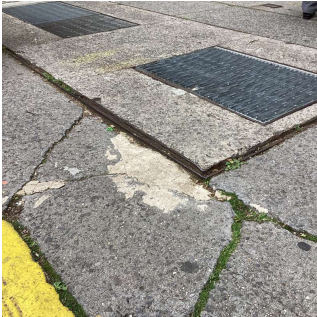
Violations	Near Exit 8 No violations recorded.
<b>Pavers</b>	Does not Exist
<b>DOT Sidewalk</b>	Inspected
<b>Asphalt</b>	Does not Exist
<b>Concrete</b>	Inspected
Condition	4 - Between Fair and Poor
Deficiency	HEAVING
Deficiency Location/Instance	Woodbine Street Near Main Entrance
Deficiency Quantity	50

Question	Response
<b>SITE</b>	
<b>PAVING</b>	
<b>DOT Sidewalk</b>	
<b>Concrete</b>	
Quantity Uom	S.F.
Potential Action	REPLACE
Urgency of Action	PRIORITY 5
Purpose of Action	LEVEL 6
Deficiency Photo1

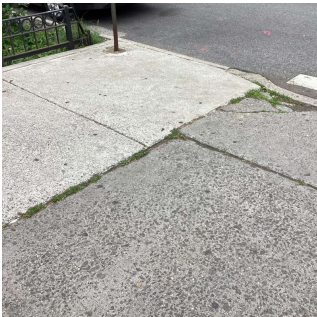
Woodbine Street Near Main Entrance
Violations	No violations recorded.
Deficiency	HEAVING
Deficiency Location/Instance	Woodbine Street, Madison Street
Deficiency Quantity	300
Quantity Uom	S.F.
Potential Action	REPLACE
Urgency of Action	PRIORITY 3
Purpose of Action	LEVEL 2
Deficiency Photo1

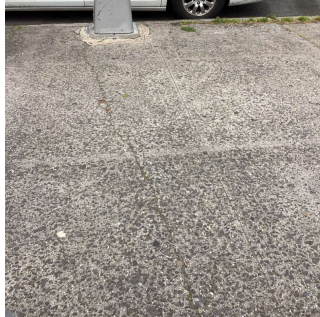
Woodbine Street
Violations	No violations recorded.
Deficiency	DAMAGED/DETERIORATED/MISSING SECTIONS
Deficiency Location/Instance	Woodbine Street, Madison Street, Wilson Avenue
Deficiency Quantity	3,500
Quantity Uom	S.F.
Potential Action	REPLACE
Urgency of Action	PRIORITY 3
Purpose of Action	LEVEL 2

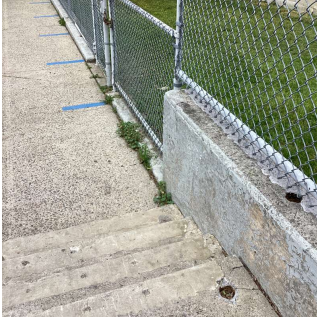
Question	Response
<b>SITE</b>	
<b>STAIRS/RAMPS: EXTERIOR</b>	
<b>Railings</b>	
Deficiency Location/Instance	Madison Street
Deficiency Quantity	10
Quantity Uom	L.F.
Potential Action	REPLACE
Urgency of Action	PRIORITY 5
Purpose of Action	LEVEL 6
Deficiency Photo1

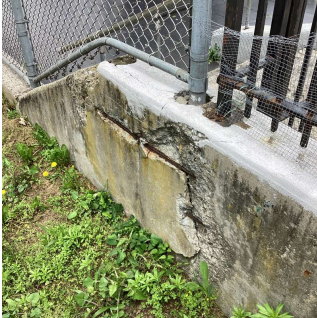
Violations	Madison Street No violations recorded.
<b>Site Cheek/flank Walls</b>	Inspected
Condition	3 - Fair
Deficiency	CAST IN PLACE CONCRETE: CRACKS/SPALLING - MAJOR
Deficiency Location/Instance	Madison Street, Madison Street Near Playground
Deficiency Quantity	50
Quantity Uom	S.F.
Potential Action	REPLACE
Urgency of Action	PRIORITY 3
Purpose of Action	LEVEL 2
Deficiency Photo1

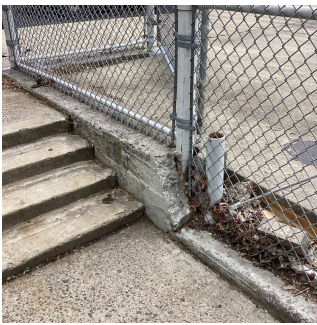
Violations	Madison Street Near Playground No violations recorded.
Deficiency	CAST IN PLACE CONCRETE: CRACKS/SPALLING - MAJOR
Deficiency Location/Instance	Madison Street
Deficiency Quantity	20
Quantity Uom	S.F.
Potential Action	REPLACE
Urgency of Action	PRIORITY 5
Purpose of Action	LEVEL 6
