**NYC Department of Education**  
**Building Condition Assessment Survey 2023 - 2024**

Architectural Inspection

**Asset: I.S. 391 - BROOKLYN, 790 EAST NEW YORK AVENUE, New York, 11203**

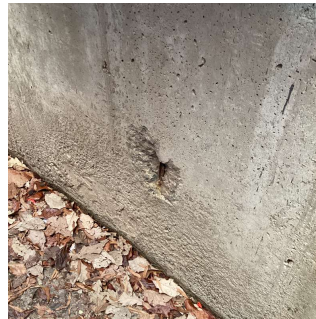
Facade A - AW1

**AREAWAY WALLS: CRACKS AND SPALLING**

REPAIR

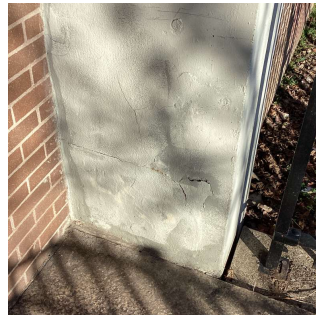
Facade B

**CAST IN PLACE / PRE-CAST CONCRETE: MAJOR  
CRACKS/SPALLING**

REPLACE

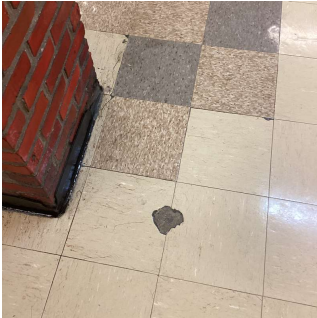
Question	Response
<b>INTERIOR</b>	
<b>CAFETERIA</b>	
<b>Fixed Equipment</b>	
Instance on Basement - Staff (600 SF)	Does not Exist
<b>Floor Finish</b>	
Instance on Basement - Students	Inspected
Condition	5 - Poor
Deficiency	VINYL TILES: BROKEN/DETERIORATED/MISSING TILES
Deficiency Location/Instance	Near center, side, rear
Deficiency Quantity	300
Quantity Uom	S.F.
Potential Action	REPLACE
Urgency of Action	PRIORITY 3
Purpose of Action	LEVEL 2
Deficiency Photo1

Near the center
Violations	No violations recorded.
Deficiency	VINYL TILES: DETERIORATED SUBSTRATE
Deficiency Location/Instance	Near the Kitchen, center, side
Deficiency Quantity	120
Quantity Uom	S.F.
Potential Action	REPLACE
Urgency of Action	PRIORITY 3
Purpose of Action	LEVEL 2
Deficiency Photo1

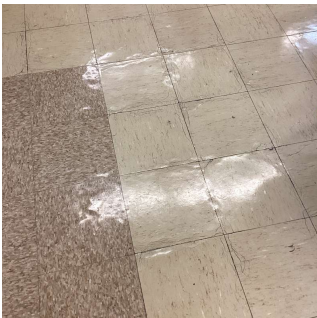
Near the Kitchen side
Violations	No violations recorded.
Instance on Basement - Staff (600 SF)	Inspected
Condition	3 - Fair
Deficiency	VINYL TILES: BROKEN/DETERIORATED/MISSING TILES

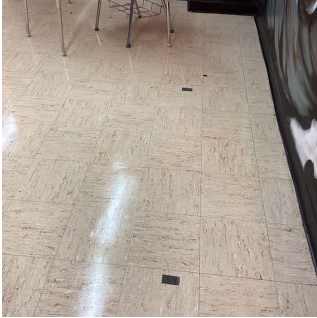
Question	Response
<b>INTERIOR</b>	
<b>CLASSROOMS/CORRIDORS/ADMIN SPACES</b>	
<b>Floor Finish</b>	Inspected
Condition	2 - Between Good and Fair
Deficiency	VINYL TILES: BROKEN/DETERIORATED/MISSING TILES
Deficiency Location/Instance	Rooms B46, 137, 217, 223, 2nd floor corridor near Room C22, and others
Deficiency Quantity	200
Quantity Uom	S.F.
Potential Action	REPLACE
Urgency of Action	PRIORITY 3
Purpose of Action	LEVEL 2
Deficiency Photo1

2nd floor corridor near Room C22
Violations	No violations recorded.
Deficiency	VINYL TILES: WORN-OUT TILES
Deficiency Location/Instance	Room 103, Corridor near Room 103
Deficiency Quantity	10
Quantity Uom	S.F.
Potential Action	REPLACE
Urgency of Action	PRIORITY 3
Purpose of Action	LEVEL 2
Deficiency Photo1	 
	Room 103
Violations	No violations recorded.
Deficiency	VINYL TILES: DETERIORATED SUBSTRATE
Deficiency Location/Instance	Room B44, corridor near Rooms 151,157, 251
Deficiency Quantity	50

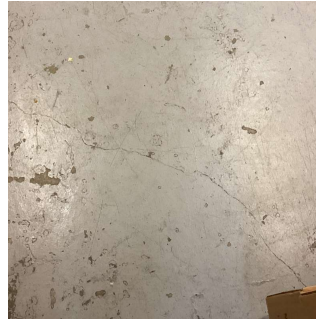
Storage Room

**Floor Finish**

Quantity Uom	S.F.
Potential Action	REPLACE
Urgency of Action	PRIORITY 3
Purpose of Action	LEVEL 2
Deficiency Photo1

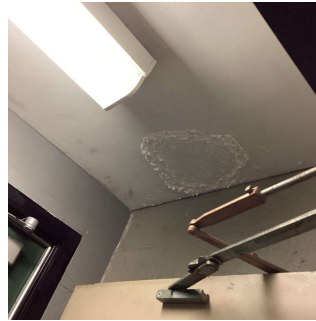
Stair H/1 Vestibule

Deficiency	PLASTER: CRACKS/SPALLING - ACTIVE LEAK
Deficiency Location/Instance	Stairs B/Basement Vestibule, H/1
Deficiency Quantity	50
Quantity Uom	S.F.
Potential Action	REPLACE
Urgency of Action	PRIORITY 5
Purpose of Action	LEVEL 2
Deficiency Photo1

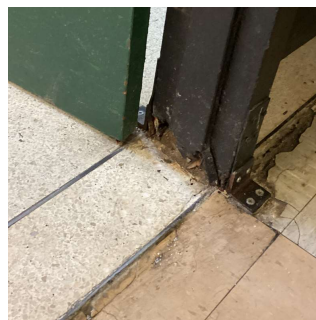
Condition	4 - Between Fair and Poor
-----------	---------------------------

Deficiency	METAL: DETERIORATED DOOR AND FRAME
Deficiency Location/Instance	Stairs C/ Basement Vestibule, G/Basement Vestibule
Deficiency Quantity	5
Quantity Uom	EACH
Potential Action	MAINTENANCE
Urgency of Action	PRIORITY 3
Purpose of Action	LEVEL 2
Deficiency Photo1

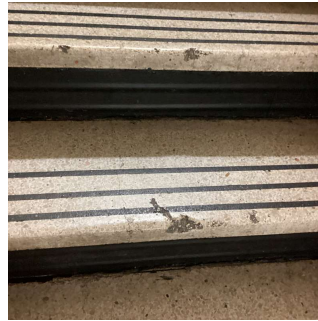
Stair B/Basement

Violations	Auditorium Dressing Room No violations recorded.
Deficiency	TERRAZZO: CRACKS
Deficiency Location/Instance	Stairs B/Basement,1, C/Basement, E/1, F/1, and others
Deficiency Quantity	70
Quantity Uom	S.F.
Potential Action	REPLACE
Urgency of Action	PRIORITY 3
Purpose of Action	LEVEL 2

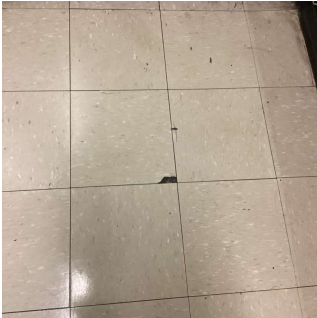
Question	Response
<b>INTERIOR</b>	
<b>STAIRS/RAMPS: INTERIOR</b>	
<b>Stairs and Landings</b>	
Deficiency	VINYL TILES: BROKEN/DETERIORATED/MISSING TILES
Deficiency Location/Instance	Stairs B/Basement, D/Basement, corridor near Auditorium
Deficiency Quantity	50
Quantity Uom	S.F.
Potential Action	REPLACE
Urgency of Action	PRIORITY 3
Purpose of Action	LEVEL 2
Deficiency Photo1

Stair B/Basement
Violations	No violations recorded.
<b>Walls</b>	Inspected
Condition	2 - Between Good and Fair
Deficiency	CERAMIC TILE: BROKEN/ MISSING
Deficiency Location/Instance	Stairs D/Basement Vestibule, E/Basement,1, F/1, G/Basement, and others
Deficiency Quantity	50
Quantity Uom	S.F.
Potential Action	REPLACE
Urgency of Action	PRIORITY 3
Purpose of Action	LEVEL 2
Deficiency Photo1

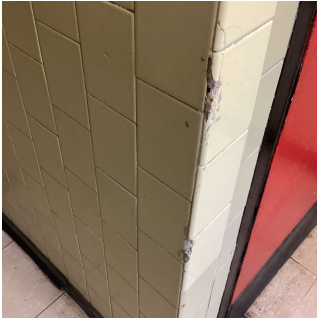
Stair D/Basement Vestibule
Violations	No violations recorded.
Deficiency	MASONRY: CRACKS/SPALLING
Deficiency Location/Instance	Stair H/Basement Vestibule,1

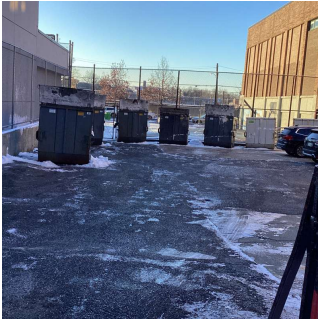
Question	Response
<b>SITE</b>	
<b>CONTAINERIZATION</b>	
Urgency of Action	PRIORITY 3
Purpose of Action	LEVEL 2
Deficiency Photo1	No photo recorded
Violations	No violations recorded.
Deficiency	FENCING MISSING
Deficiency Location/Instance	Parking Lot
Deficiency Quantity	1,200
Quantity Uom	S.F.
Potential Action	INSTALL NEW
Urgency of Action	PRIORITY 3
Purpose of Action	LEVEL 2
Deficiency Photo1

Violations	Parking Lot No violations recorded.
Deficiency	CONTAINER DAMAGED
Deficiency Location/Instance	Parking Lot
Deficiency Quantity	2
Quantity Uom	EACH
Potential Action	REPLACE
Urgency of Action	PRIORITY 3
Purpose of Action	LEVEL 2
Deficiency Photo1

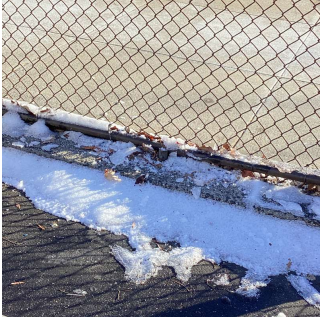
Question	Response
<b>SITE</b>	
<b>Drainage System for Concrete</b>	Inspected
<b>Catch Basins/Manhole - Surrounded by concrete</b>	Inspected
Condition	2 - Between Good and Fair
Deficiency	No deficiencies recorded
<b>Culverts - Concrete Covering</b>	Does not Exist
<b>Drainage System for Soil</b>	Inspected
<b>Catch Basins/Manhole - Surrounded by Soil</b>	Inspected
Condition	2 - Between Good and Fair
Deficiency	No deficiencies recorded
<b>Culverts - Soil Covering</b>	Does not Exist
<b>DRINKING FOUNTAINS</b>	Inspected
Condition	2 - Between Good and Fair
Deficiency	No deficiencies recorded
<b>FENCES</b>	Inspected
Condition	4 - Between Fair and Poor
Deficiency	CHAIN LINK: DAMAGED POST/RAIL
Deficiency Location/Instance	Schoolyard
Deficiency Quantity	20
Quantity Uom	L.F.
Potential Action	REPLACE
Urgency of Action	PRIORITY 3
Purpose of Action	LEVEL 2
Deficiency Photo1

Violations	Schoolyard No violations recorded.
Deficiency	CONCRETE CURB: DAMAGED/DETERIORATED

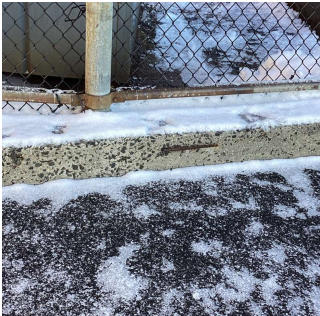
Deficiency Location/Instance	Schoolyard, Troy Avenue
Deficiency Quantity	20
Quantity Uom	S.F.
Potential Action	REPLACE
Urgency of Action	PRIORITY 3
Purpose of Action	LEVEL 2
Deficiency Photo1

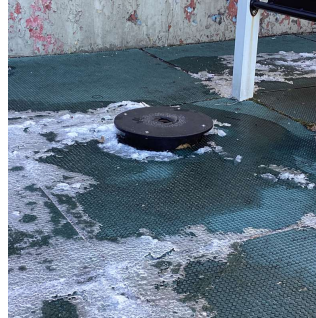
Deficiency	BROKEN/DETERIORATED/MISSING
Deficiency Location/Instance	Schoolyard
Deficiency Quantity	1
Quantity Uom	EACH
Potential Action	REPLACE
Urgency of Action	PRIORITY 5
Purpose of Action	LEVEL 6
Deficiency Photo1

Violations	Schoolyard No violations recorded.
------------	---------------------------------------

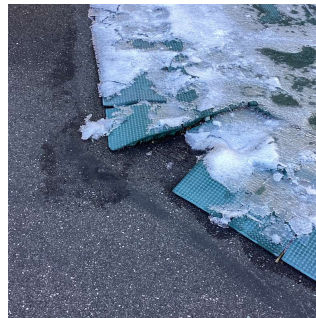
Instance on Schoolyard	Inspected
Condition	2 - Between Good and Fair
Deficiency	DETERIORATED/MISSING
Deficiency Location/Instance	Schoolyard
Deficiency Quantity	10
Quantity Uom	S.F.
Potential Action	REPLACE
Urgency of Action	PRIORITY 3
Purpose of Action	LEVEL 2
Deficiency Photo1

Violations	Schoolyard No violations recorded.
------------	---------------------------------------

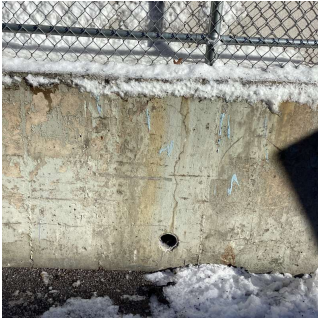
<b>Question</b>	<b>Response</b>
<b>SITE</b>	
<b>RETAINING WALLS</b>	
Deficiency Location/Instance	Near Playground, Parking Lot
Deficiency Quantity	40
Quantity Uom	S.F.
Potential Action	REPLACE
Urgency of Action	PRIORITY 3
Purpose of Action	LEVEL 2
Deficiency Photo1

Parking Lot
Violations	No violations recorded.
<b>SEATING</b>	Inspected
<b>Benches</b>	Inspected
<b>Concrete</b>	Does not Exist
<b>Metal/Wood/Plastic</b>	Inspected
Condition	2 - Between Good and Fair
Deficiency	No deficiencies recorded
<b>Bleachers</b>	Does not Exist
<b>SITE WALLS (NOT RETAINING WALLS)</b>	Does not Exist
<b>STAIRS/RAMPS: EXTERIOR</b>	Does not Exist
<b>ARTWORK</b>	Inspected
Instance	Exterior - East New York Avenue - 11209
Instance Photo	 
	East New York Avenue
Instance ID	11209
Artwork exist at stated location?	Yes
Instance	Exterior - Paps Storefront - 11221
Instance ID	11221
Artwork exist at stated location?	Yes
