**NYC Department of Education
Building Condition Assessment Survey 2023 - 2024**

Architectural Inspection

K395

Asset: P.S./I.S. 395 - BROOKLYN, 1001 EAST 45TH STREET, New York, 11203

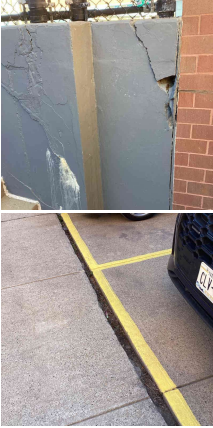
Yes	Potential Falling Debris	Severely damaged retaining wall, resulting in potential hazardous condition	SITE RETAINING WALLS	Parking Lot	Nicholas Geraci	Fireman

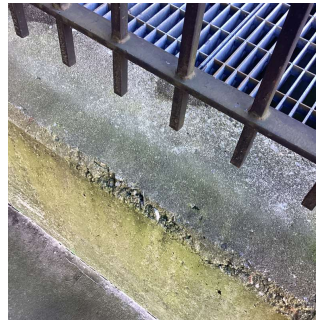
AW3
No violations recorded.

Question	Response
Architectural	
EXTERIOR	Inspected
AREAWAY	Inspected
Instance on AW1 - AW4	Inspected
Instance Condition	2 - Between Good and Fair
Instance Quantity	4
Instance Quantity Uom	EACH
Deficiency	AREAWAY WALLS: CRACKS AND SPALLING

10
S.F.
REPAIR
PRIORITY 3
LEVEL 2

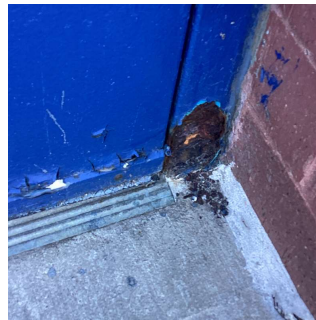
Facade B - Exit 1

METAL: DETERIORATED DOOR AND FRAME - MINOR DETERIORATION

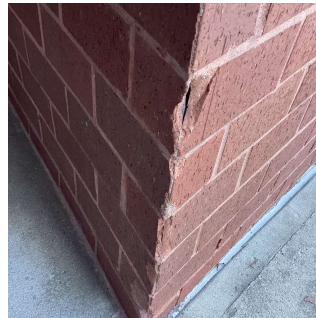
Facade E - Near HC Ramp

Question	Response
EXTERIOR	
EXTERIOR WALLS	Inspected
Material Type(s)	Concrete, Masonry, Steel
Replacement Quantity	52,000
Replacement Uom	S.F.
Instance on All Facades	Inspected
Instance Condition	3 - Fair
Instance Quantity	52,000
Instance Quantity Uom	S.F.
Deficiency	CAST IN PLACE / PRE-CAST CONCRETE: DETERIORATED JOINTS
Roof Plan reference	
Elevation	
Deficiency Quantity	150
Quantity Uom	L.F.
Potential Action	REPOINT
Urgency of Action	PRIORITY 3
Purpose of Action	LEVEL 2
Deficiency Photo1	
Violations	Facade H No violations recorded.
Deficiency	BRICK: CRACKS/DISPLACED/SPALLED BRICK AT BUILDING CORNERS

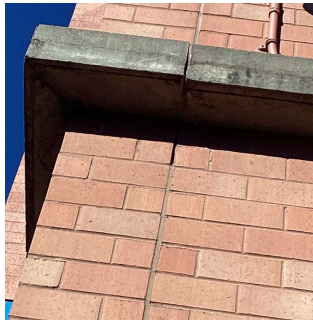
Facade F - Near Exit 14

BRICK: DETERIORATED CONTROL/EXPANSION JOINTS

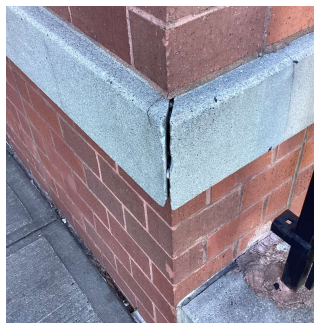
Deficiency
 CAST IN PLACE / PRE-CAST CONCRETE: DETERIORATED JOINTS

Violations
 Facade A - Near Main Entrance
 No violations recorded.

30
 L.F.
 REPOINT
 PRIORITY 4
 LEVEL 2

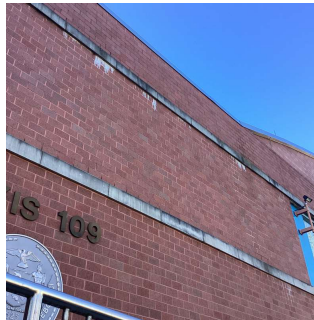
Facade E

BRICK: EFFLORESCENCE

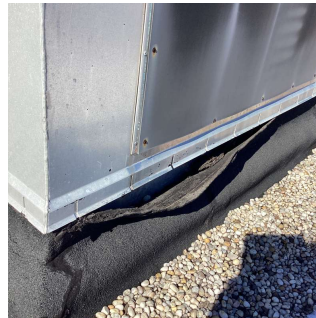
Roof 2 - Near Roof Hatch

Deficiency **BUILT-UP: FLASHING: BASE FLASHING DETERIORATED**

REMOVE AND REPLACE

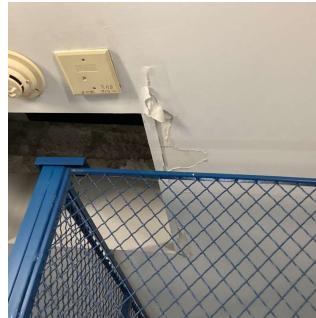
Roof 1 - BH1

BULKHEAD/PENTHOUSE CEILING: GYPSUM BOARD DAMAGED/DETERIORATED

30
 S.F.
 REPLACE
 PRIORITY 3
 LEVEL 2

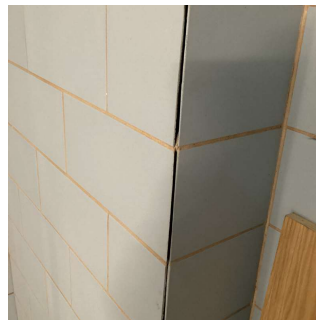
Roof 4 - BH2

**BULKHEAD/PENTHOUSE WALLS/INTERIOR: GLAZED BLOCK
DETERIORATED JOINTS**

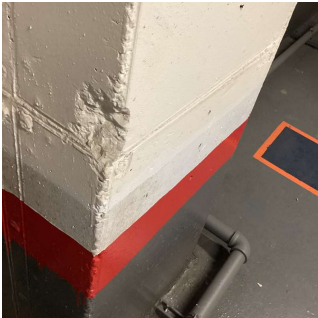
Question	Response
EXTERIOR	
WINDOWS	
EXTERIOR GUARDS	Inspected
Deficiency	No deficiencies recorded
LINTELS	Inspected
Condition	2 - Between Good and Fair
Deficiency	No deficiencies recorded
WINDOWS	Inspected
Material Type(s)	Aluminum
Instance on Aluminum - Double Hung: All facades	Inspected
Instance Condition	3 - Fair
Instance Quantity	19,000
Instance Quantity Uom	S.F.
Are these windows insulated	Yes
Installation Year	2004
Source of Installation	Custodial Staff
Deficiency	No deficiencies recorded
Instance on Aluminum - Other: Facades A, F	Inspected
Instance Condition	3 - Fair
Instance Quantity	1,000
Instance Quantity Uom	S.F.
Are these windows insulated	Yes
Installation Year	2004
Source of Installation	Custodial Staff
Deficiency	No deficiencies recorded
INTERIOR	Inspected
POOLS	Does not Exist
STRUCTURAL	Inspected
COLUMNS/BEAMS/BEARING WALLS	Inspected
Condition	3 - Fair
Deficiency	STEEL COLUMNS/BEAMS: DETERIORATED CONCRETE FIREPROOFING

Deficiency Location/Instance	Basement - Boiler Room
Deficiency Quantity	10
Quantity Uom	S.F.
Potential Action	REPLACE
Urgency of Action	PRIORITY 4
Purpose of Action	LEVEL 5
Deficiency Photo1

Basement - Boiler Room
Violations	No violations recorded.
FLOOR STRUCTURE	Inspected

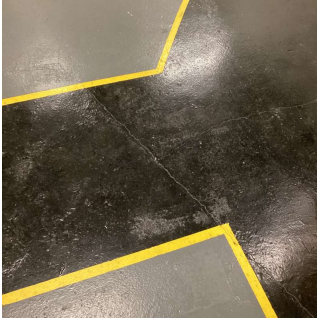
Question	Response
INTERIOR	
STRUCTURAL	
FLOOR STRUCTURE	
Condition	3 - Fair
Deficiency	CONCRETE SLAB ON GRADE: THRU CRACKS
Deficiency Location/Instance	Basement - Rooms B01, B11
Deficiency Quantity	50
Quantity Uom	S.F.
Potential Action	REPAIR
Urgency of Action	PRIORITY 3
Purpose of Action	LEVEL 5
Deficiency Photo1

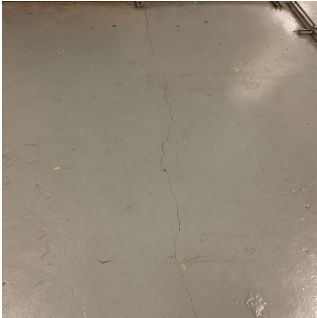
Violations	Basement - Room B01 No violations recorded.
Deficiency	CONCRETE: CRACKS/SPALLED/REINFORCEMENT EXPOSED
Deficiency Location/Instance	PH
Deficiency Quantity	100
Quantity Uom	S.F.
Potential Action	REPAIR
Urgency of Action	PRIORITY 3
Purpose of Action	LEVEL 5
Deficiency Photo1

Violations	PH - Near the Air Compressor No violations recorded.
FOUNDATION WALLS	
Material Type(s)	Inspected Concrete
Condition	4 - Between Fair and Poor
Deficiency	CONCRETE: WATER INFILTRATION IN NON- INSTRUCTIONAL SPACE
Deficiency Location/Instance	Basement - Room B02 Gas Meter
Deficiency Quantity	100
Quantity Uom	S.F.

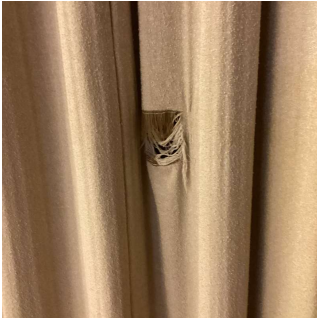
Question	Response
INTERIOR	
AUDITORIUM	
Stage	
Stage Curtains	
Deficiency	WORN/DETERIORATED
Deficiency Location/Instance	Right Side
Deficiency Quantity	100
Quantity Uom	S.F.
Potential Action	REPLACE
Urgency of Action	PRIORITY 3
Purpose of Action	LEVEL 2
Deficiency Photo1

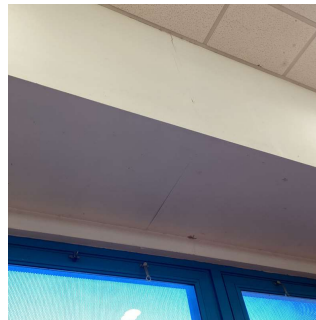
Along Windows

PLASTER: CRACKS/SPALLING

REPLACE

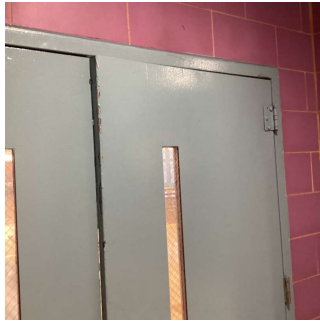
Question	Response
INTERIOR	
CAFETERIA	
Door(s)	
Deficiency Photo1	 
	Corridor Entrance
Violations	No violations recorded.
Instance on 1st Floor - Students	Inspected
Condition	3 - Fair
Deficiency	METAL: DETERIORATED DOOR AND FRAME
Deficiency Location/Instance	Entrance
Deficiency Quantity	1
Quantity Uom	EACH
Potential Action	MAINTENANCE
Urgency of Action	PRIORITY 3
Purpose of Action	LEVEL 2
Deficiency Photo1

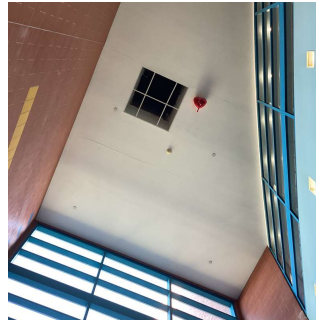
Room 301
Violations	No violations recorded.
Deficiency	GYPSUM BOARD: DAMAGED/DETERIORATED
Deficiency Location/Instance	Lobby
Deficiency Quantity	20
Quantity Uom	S.F.
Potential Action	REPLACE
Urgency of Action	PRIORITY 3

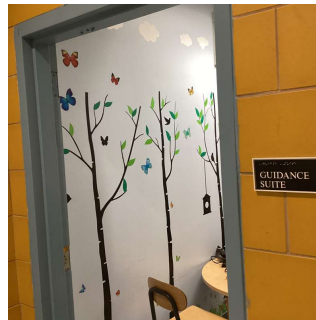
Room 215

Deficiency	METAL: MISSING DOOR
Deficiency Location/Instance	Rooms 215, and Room next to 215
Deficiency Quantity	2
Quantity Uom	EACH
Potential Action	MAINTENANCE
Urgency of Action	PRIORITY 3
Purpose of Action	LEVEL 2
Deficiency Photo1

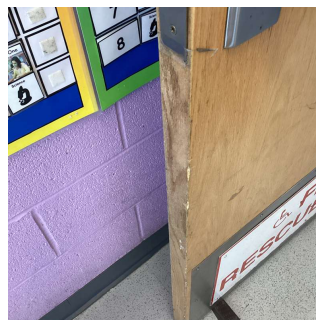
Deficiency	WOOD: DETERIORATED DOOR
Deficiency Location/Instance	Rooms 301, 303, 304,308,
Deficiency Quantity	4
Quantity Uom	EACH
Potential Action	MAINTENANCE
Urgency of Action	PRIORITY 3
Purpose of Action	LEVEL 2
Deficiency Photo1

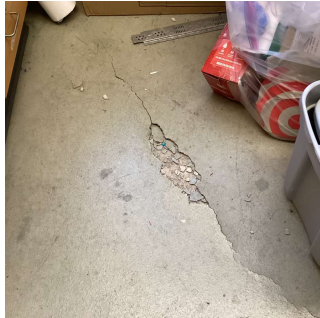
Question	Response
INTERIOR	
CLASSROOMS/CORRIDORS/ADMIN SPACES	
Door(s)	Inspected
	Room 301
Violations	No violations recorded.
Floor Finish	Inspected
Condition	2 - Between Good and Fair
Deficiency	VINYL TILES: DETERIORATED SUBSTRATE
Deficiency Location/Instance	Corridor near rooms 105,106, 131, Gymnasium 3rd Floor Womens Restroom
Deficiency Quantity	80
Quantity Uom	S.F.
Potential Action	REPLACE
Urgency of Action	PRIORITY 3
Purpose of Action	LEVEL 2
Deficiency Photo1	 
	Corridor near 3rd Floor Womens
Violations	No violations recorded.
Deficiency	EPOXY FLOORING: DETERIORATED SUBSTRATE
Deficiency Location/Instance	Rooms 329A, 329
Deficiency Quantity	30
Quantity Uom	S.F.
Potential Action	REPLACE
Urgency of Action	PRIORITY 3
Purpose of Action	LEVEL 2
Deficiency Photo1

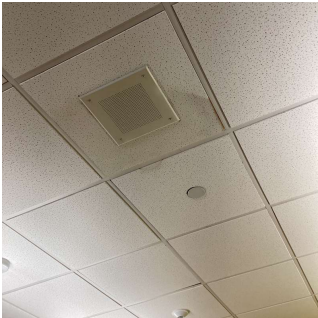
Question	Response
INTERIOR	
KITCHEN	
Floor Finish	
Instance on 1st Floor	Inspected
Condition	2 - Between Good and Fair
Deficiency	No deficiencies recorded
Walls	
Instance on 1st Floor	Inspected
Condition	2 - Between Good and Fair
Deficiency	No deficiencies recorded
LIBRARY	
Instance on Room 212	Inspected
Built-in Furnishing	
Instance on Room 212	Does not Exist
Ceiling	
Instance on Room 212	Inspected
Condition	2 - Between Good and Fair
Deficiency	ACOUSTIC TILES: DAMAGED/MISSING
Deficiency Location/Instance	Near Entrance
Deficiency Quantity	10
Quantity Uom	S.F.
Potential Action	REPLACE
Urgency of Action	PRIORITY 3
Purpose of Action	LEVEL 2
Deficiency Photo1

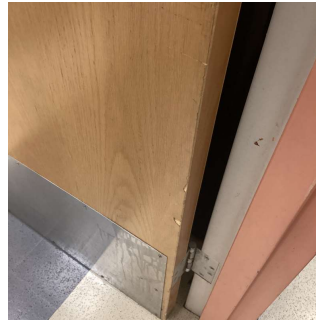
Near Entrance
Violations	No violations recorded.
Door(s)	
Instance on Room 212	Inspected
Condition	3 - Fair
Deficiency	WOOD: DETERIORATED DOOR
Deficiency Location/Instance	Office
Deficiency Quantity	1
Quantity Uom	EACH
Potential Action	MAINTENANCE
Urgency of Action	PRIORITY 3

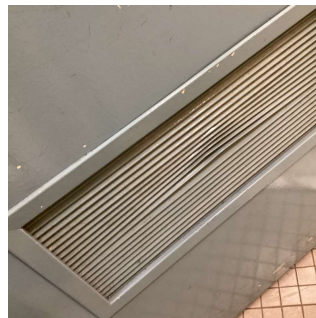
Entrance

METAL: DAMAGED LOUVER

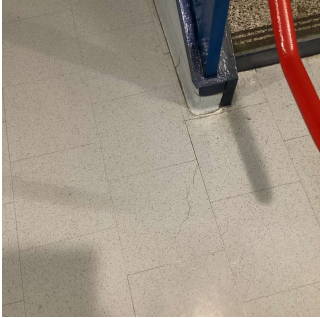
Question	Response
INTERIOR	
STAIRS/RAMPS: INTERIOR	
Door(s)	Inspected
Condition	2 - Between Good and Fair
Deficiency	No deficiencies recorded
Partition	Does not Exist
Railings	Inspected
Condition	2 - Between Good and Fair
Deficiency	No deficiencies recorded
Stairs and Landings	Inspected
Condition	2 - Between Good and Fair
Deficiency	VINYL TILES: DETERIORATED SUBSTRATE
Deficiency Location/Instance	Stairs B/1, D/1, 3
Deficiency Quantity	25
Quantity Uom	S.F.
Potential Action	REPLACE
Urgency of Action	PRIORITY 3
Purpose of Action	LEVEL 2
Deficiency Photo1

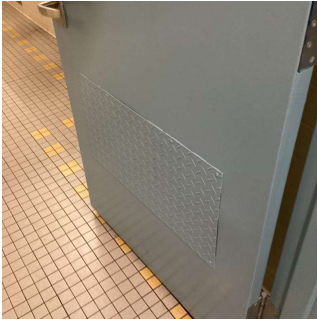
Question	Response
INTERIOR	
TOILET ROOMS - STUDENTS	
Ceiling	Inspected
Condition	2 - Between Good and Fair
Deficiency	No deficiencies recorded
Door(s)	Inspected
Condition	5 - Poor
Deficiency	METAL: DAMAGED LOUVER
Deficiency Location/Instance	Rooms 126, 128, 314 (2nd Floor), 316 (2nd Floor), 323, 327,
Deficiency Quantity	6
Quantity Uom	EACH
Potential Action	MAINTENANCE
Urgency of Action	PRIORITY 3
Purpose of Action	LEVEL 2
Deficiency Photo1

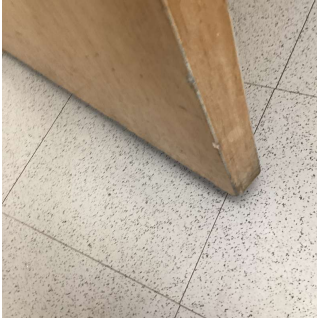
Room 323
Violations	No violations recorded.
Deficiency	WOOD: DETERIORATED DOOR
Deficiency Location/Instance	Room 306A
Deficiency Quantity	1
Quantity Uom	EACH
Potential Action	MAINTENANCE
Urgency of Action	PRIORITY 3
Purpose of Action	LEVEL 2
Deficiency Photo1

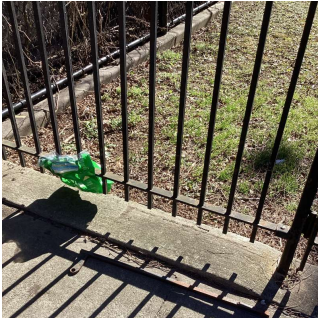
Deficiency	No deficiencies recorded
FENCES	Inspected
Condition	3 - Fair
Deficiency	WROUGHT IRON: DAMAGED/DETERIORATED
Deficiency Location/Instance	Walkway Left Side of School
Deficiency Quantity	40
Quantity Uom	S.F.
Potential Action	REPLACE
Urgency of Action	PRIORITY 3
Purpose of Action	LEVEL 2
Deficiency Photo1

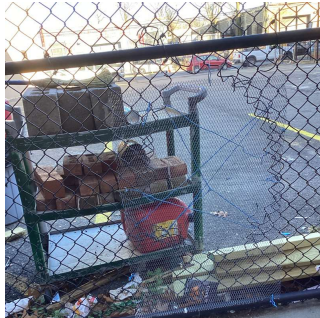
Walkway Left Side of School
Violations	No violations recorded.
Deficiency	CHAIN LINK: DAMAGED/DETERIORATED

Question	Response
SITE	
FENCES	
Deficiency Location/Instance	Students Non Walk Way
Deficiency Quantity	100
Quantity Uom	S.F.
Potential Action	REPLACE
Urgency of Action	PRIORITY 3
Purpose of Action	LEVEL 2
Deficiency Photo1

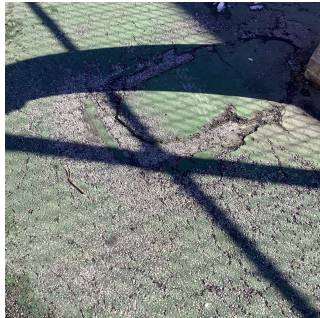
Violations	Parking Lot No violations recorded.
Pavers	Does not Exist
Student Use	Inspected
Gravel Exists?	No
Asphalt	Inspected
Condition	3 - Fair
Deficiency	CRACKS - MAJOR
Deficiency Location/Instance	Schoolyard
Deficiency Quantity	400
Quantity Uom	S.F.
Potential Action	REPLACE
Urgency of Action	PRIORITY 3
Purpose of Action	LEVEL 2
Deficiency Photo1

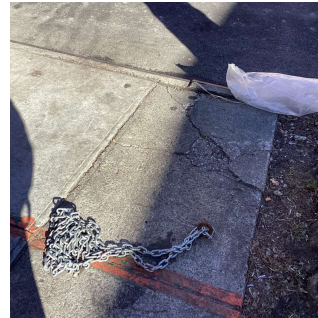
E. 46th Street

Deficiency

DAMAGED/DETERIORATED/MISSING SECTIONS

REPLACE

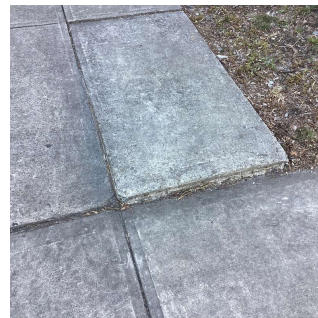
Deficiency

REPLACE

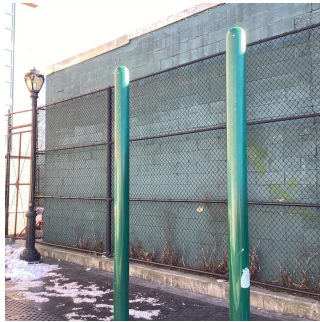
Question	Response
SITE	
PAVING	Inspected
DOT Sidewalk	
Concrete	Inspected
Violations	E. 46th Street No violations recorded.
Pavers	Does not Exist
PLAYGROUNDS	Inspected
Instance on Schoolyard	Inspected
Benches	
Instance on Schoolyard	Does not Exist
Fence	
Instance on Schoolyard	Does not Exist
Pavement	
Instance on Schoolyard	Does not Exist
Play Equipment	
Instance on Schoolyard	Inspected
Condition	5 - Poor
Deficiency	BROKEN/DETERIORATED/MISSING
Deficiency Location/Instance	Schoolyard
Deficiency Quantity	1
Quantity Uom	EACH
Potential Action	REPLACE
Urgency of Action	PRIORITY 3
Purpose of Action	LEVEL 2
Deficiency Photo1

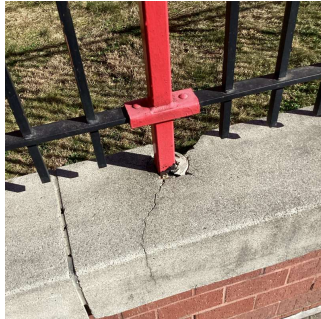
Violations	Parking Lot No violations recorded.
SEATING	Does not Exist
SITE WALLS (NOT RETAINING WALLS)	Inspected
Condition	3 - Fair
Deficiency	BRICK: DETERIORATED COPING STONE
Deficiency Location/Instance	E. 45th Street
Deficiency Quantity	75
Quantity Uom	S.F.
Potential Action	REPLACE
Urgency of Action	PRIORITY 3
Purpose of Action	LEVEL 2
Deficiency Photo1

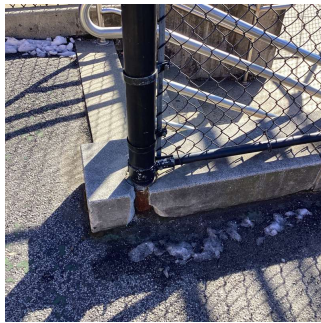
Violations	Parking Lot No violations recorded.
STAIRS/RAMPS: EXTERIOR	Inspected
Railings	Inspected
Condition	2 - Between Good and Fair
Deficiency	No deficiencies recorded
Site Cheek/flank Walls	Inspected
Condition	2 - Between Good and Fair
Deficiency	CAST IN PLACE CONCRETE: CRACKS/SPALLING - MAJOR
Deficiency Location/Instance	Schoolyard
Deficiency Quantity	10
Quantity Uom	S.F.
Potential Action	REPLACE
Urgency of Action	PRIORITY 3
Purpose of Action	LEVEL 2

Question	Response
SITE	
STAIRS/RAMPS: EXTERIOR	
Site Cheek/flank Walls	
Deficiency Photo1
