NYC Department of Education
Building Condition Assessment Survey 2023 - 2024

Architectural Inspection

Asset: P.S. 399 - BROOKLYN, 2707 ALBERMARLE ROAD, New York, 11226

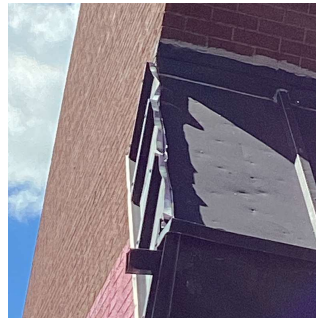
Roof 2
No violations recorded.

Roof 2
Instance Quantity	100
Instance Quantity Uom	S.F.
Does the roof have major mechanical equipment sitting on Dunnage Steel less than 18" above the Roofing?	No
Does this roof instance have a Sustainable Roof System?	No
Do solar panels exist on these roofs?	No
Is/Are the roof(s) suitable for Solar Panel installation?	No
Installation Year	1981
Source of Installation	Custodial Staff
Deficiency	METAL: ROOFING: DETERIORATED
Roof Plan reference	K399

Deficiency Quantity	10
Quantity Uom	S.F.
Potential Action	REPAIR
Urgency of Action	PRIORITY 4
Purpose of Action	LEVEL 2
Deficiency Photo1
