**NYC Department of Education**  
**Building Condition Assessment Survey 2023 - 2024**

Architectural Inspection

**K401**

**Asset: LAFAYETTE AF - BROOKLYN, 2630 BENSON AVENUE, New York, 11214**

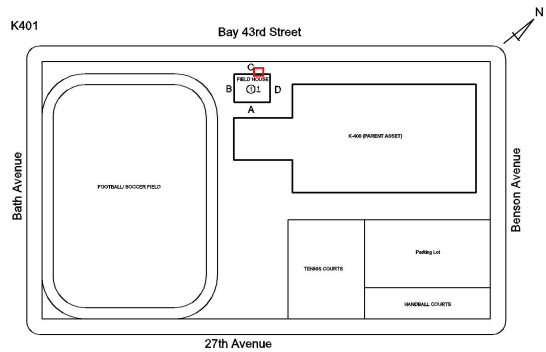
Roof Plan reference

Question	Response
<b>Architectural</b>	
<b>EXTERIOR</b>	Inspected
<b>AREAWAY</b>	Does not Exist
<b>AWNINGS AND CANOPIES</b>	Does not Exist
<b>CHIMNEY</b>	Does not Exist
<b>COPING</b>	Does not Exist
<b>CORNICE</b>	Does not Exist
<b>DOORS</b>	Inspected
<b>DOORS AND FRAMES</b>	Inspected
Condition	5 - Poor
Deficiency	METAL CLAD: DETERIORATED DOOR - MAJOR DETERIORATION

Facade C - Door to Mechanical Equipment Room  
No violations recorded.

1  
EACH  
REPLACE  
PRIORITY 4  
LEVEL 2

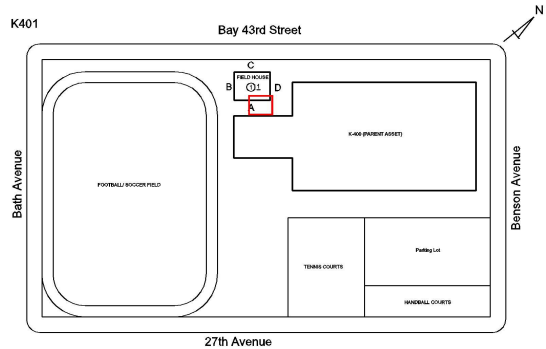
Roof Plan reference

**METAL CLAD: DETERIORATED DOOR AND FRAME - MAJOR DETERIORATION**

1  
EACH  
REPLACE  
PRIORITY 4  
LEVEL 2

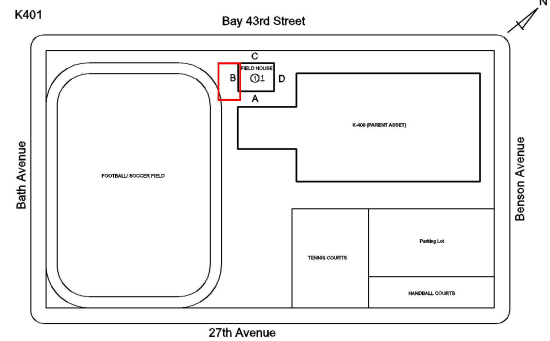
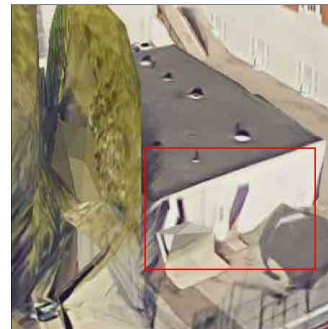
**BRICK: DETERIORATED JOINTS**

100  
S.F.  
REPOINT  
PRIORITY 3  
LEVEL 2

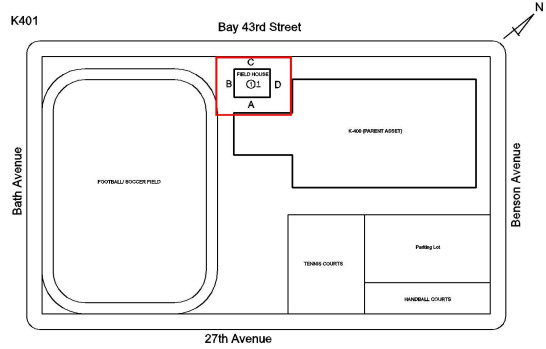
Roof Plan reference

Do solar panels exist on these roofs?	No
Is/Are the roof(s) suitable for Solar Panel installation?	No
Installation Year	2004
Source of Installation	Custodial Staff
Deficiency	BUILT-UP: ROOFING: LOSS OF GRAVEL

Roof 1  
No violations recorded.

100  
S.F.  
INSTALL NEW GRAVEL  
PRIORITY 3  
LEVEL 2

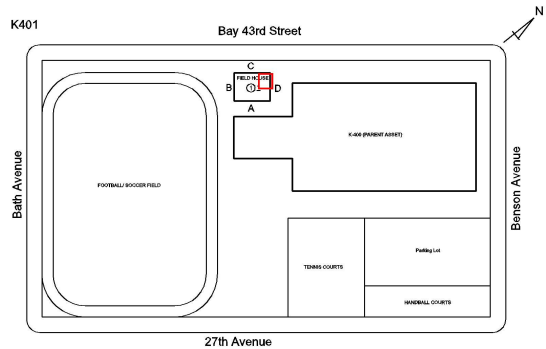
CLOGGED

1  
EACH  
MAINTENANCE  
PRIORITY 5  
LEVEL 2

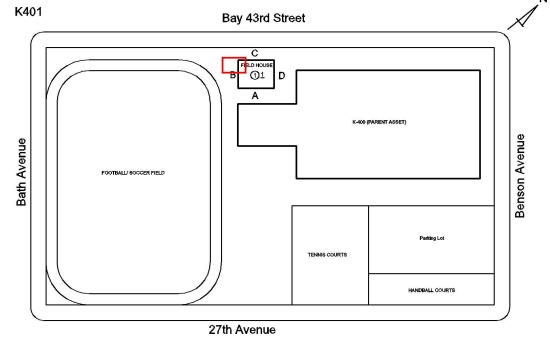
Roof Plan reference

CONCRETE: CRACKS/SPALLING - MINOR

15  
S.F.  
REPAIR  
PRIORITY 3  
LEVEL 2

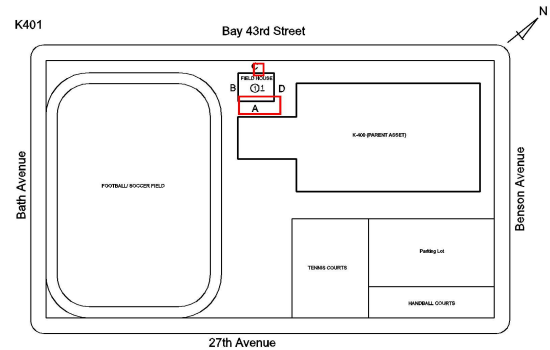
Roof Plan reference

CONCRETE: CRACKS/SPALLING - MAJOR

120  
S.F.  
REPLACE  
PRIORITY 4  
LEVEL 2

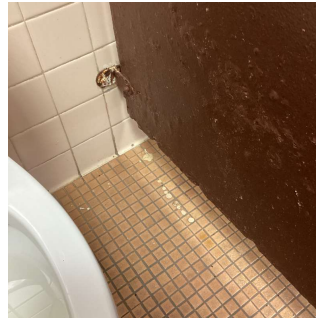
Violations	Near Shower Room No violations recorded.
<b>SHOWER ROOM</b>	
Instance on 1st Floor - North	Inspected Inaccessible
Instance on 1st Floor - South	Inaccessible
<b>STAIRS/RAMPS: INTERIOR</b>	
Does not Exist	
<b>TOILET ROOMS - STAFF</b>	
Inspected	
<b>Ceiling</b>	Does not Exist
<b>Door(s)</b>	Inaccessible
<b>Floor Finish</b>	Inspected
Condition	3 - Fair
Deficiency	CERAMIC TILE: BROKEN/MISSING TILES
Deficiency Location/Instance	Visitors Toilet South Side
Deficiency Quantity	10
Quantity Uom	S.F.
Potential Action	REPLACE
Urgency of Action	PRIORITY 3
Purpose of Action	LEVEL 2
Deficiency Photo1	 
Violations	Visitors Toilet South Side No violations recorded.
<b>Stalls</b>	
Inspected	
Condition	5 - Poor
Deficiency	RUST - MAJOR
Deficiency Location/Instance	Visitors Toilet South Side
Deficiency Quantity	1
Quantity Uom	EACH
Potential Action	REPLACE

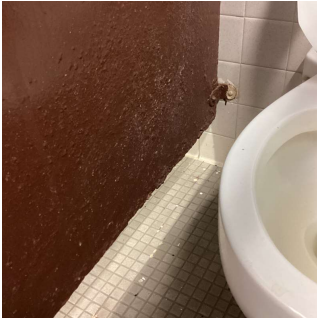
<b>Question</b>	<b>Response</b>
<b>INTERIOR</b>	
<b>TOILET ROOMS - STUDENTS</b>	
<b>Floor Finish</b>	Inspected
	South Locker Room
Violations	No violations recorded.
<b>Stalls</b>	Inspected
Condition	5 - Poor
Deficiency	RUST - MAJOR
Deficiency Location/Instance	South Locker Room, North Locker Room
Deficiency Quantity	4
Quantity Uom	EACH
Potential Action	REPLACE
Urgency of Action	PRIORITY 3
Purpose of Action	LEVEL 2
Deficiency Photo1

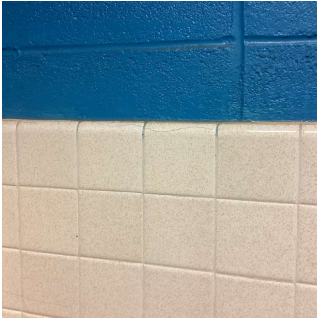
South Locker Room
Violations	No violations recorded.
<b>Walls</b>	Inspected
Condition	2 - Between Good and Fair
Deficiency	CERAMIC TILE: BROKEN/ MISSING
Deficiency Location/Instance	North Locker Room
Deficiency Quantity	10
Quantity Uom	S.F.
Potential Action	REPLACE
Urgency of Action	PRIORITY 3
Purpose of Action	LEVEL 2
Deficiency Photo1

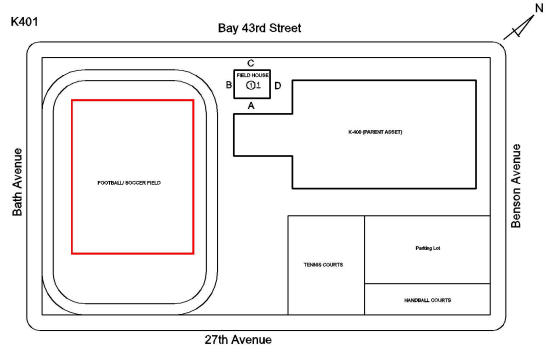
Replacement Uom	S.F.
Instance on Football/Soccer Field	Inspected
Instance Condition	5 - Poor
Instance Quantity	70,000
Instance Quantity Uom	S.F.

Deficiency **ARTIFICIAL TURF: DAMAGED/WORN OUT**  
 Deficiency Location/Instance **Field**  
 Roof Plan reference

Deficiency Quantity **10,000**  
 Quantity Uom **S.F.**  
 Potential Action **REPLACE**  
 Urgency of Action **PRIORITY 4**  
 Purpose of Action **LEVEL 2**  
 Deficiency Photo1

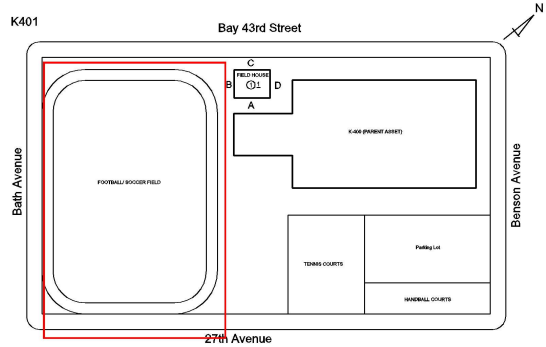
Roof Plan reference

Perimeter Track  
No violations recorded.

5,000  
S.F.  
REPLACE  
PRIORITY 4  
LEVEL 2

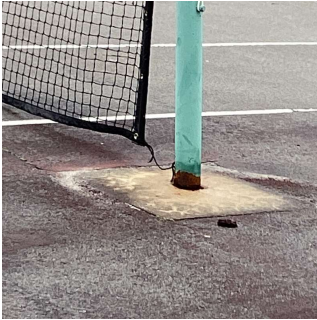
Question	Response
<b>ATHLETIC FIELDS</b>	
<b>PLAYING SURFACE</b>	
Deficiency Photo1	 
Violations	Tennis Courts No violations recorded.
<b>FIXED EQUIPMENT</b>	
<b>Basketball Backboard</b>	Inspected
<b>Basketball Hoops</b>	Does not Exist
<b>Basketball Posts</b>	Does not Exist
<b>Football Goal Posts</b>	Inspected
Condition	2 - Between Good and Fair
Deficiency	No deficiencies recorded
<b>Tennis Net Posts</b>	Inspected
Condition	5 - Poor
Deficiency	RUST - MAJOR
Deficiency Location/Instance	Tennis Court
Deficiency Quantity	1
Quantity Uom	EACH
Potential Action	REPLACE
Urgency of Action	PRIORITY 3
Purpose of Action	LEVEL 2
Deficiency Photo1

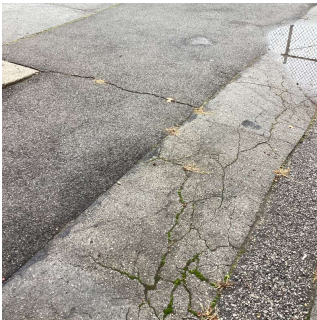
Violations	Near Field House No violations recorded.
<b>IRRIGATION SYSTEM</b>	Does not Exist
<b>PAVING</b>	Inspected
<b>Student Non-Use</b>	Does not Exist
<b>Student Use</b>	Inspected
Gravel Exists?	No
<b>Asphalt</b>	Does not Exist
<b>Concrete</b>	Inspected
Condition	2 - Between Good and Fair
Deficiency	No deficiencies recorded
<b>Pavers</b>	Does not Exist
<b>Site Sidewalks &amp; Walkways</b>	Inspected
<b>Asphalt</b>	Inspected
Condition	3 - Fair
Deficiency	CRACKS - MAJOR
Deficiency Location/Instance	Near Field House
Deficiency Quantity	150
Quantity Uom	S.F.
Potential Action	REPLACE
Urgency of Action	PRIORITY 3
Purpose of Action	LEVEL 2
Deficiency Photo1

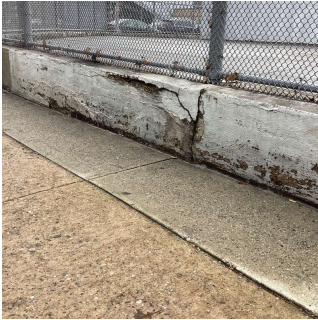
Question	Response
<b>SITE</b>	
<b>PAVING</b>	Inspected
<b>DOT Sidewalk</b>	
<b>Concrete</b>	Inspected
Violations	No violations recorded.
<b>Pavers</b>	Does not Exist
<b>PLAYGROUNDS</b>	Does not Exist
<b>RETAINING WALLS</b>	Inspected
Are there any Retaining Walls 6' OR higher facing public street/sidewalk?	No
Condition	3 - Fair
Deficiency	CAST IN PLACE CONCRETE: CRACKS/SPALLING - MAJOR
Deficiency Location/Instance	Benson Avenue, Stillwell Avenue, 27th Avenue, Bath Avenue
Deficiency Quantity	80
Quantity Uom	S.F.
Potential Action	REPLACE
Urgency of Action	PRIORITY 3
Purpose of Action	LEVEL 2
Deficiency Photo1

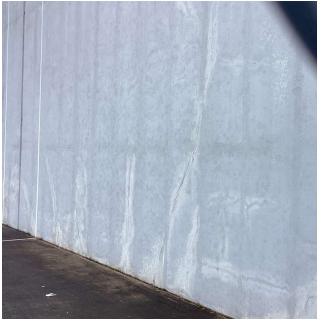
<b>Question</b>	<b>Response</b>
<b>SITE</b>	
<b>SITE WALLS (NOT RETAINING WALLS)</b>	
Violations	No violations recorded.
Deficiency	CAST IN PLACE CONCRETE: CRACKS/SPALLING - MAJOR
Deficiency Location/Instance	Handball Court
Deficiency Quantity	70
Quantity Uom	S.F.
Potential Action	REPLACE
Urgency of Action	PRIORITY 3
Purpose of Action	LEVEL 2
Deficiency Photo1
