**NYC Department of Education
Building Condition Assessment Survey 2023 - 2024**

Architectural Inspection

Asset: 3K CENTER @ 337 74TH STREET - BROOKLYN, 337 74TH STREET, 11209

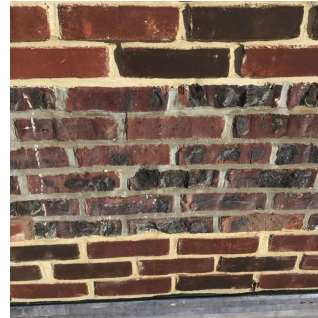
Roof 1 - Facade C
No violations recorded.

Violations	Facade A No violations recorded.
EXTERIOR SOFFITS	Does not Exist
LOADING DOCK	Does not Exist
LOUVER	Inspected
Condition	2 - Between Good and Fair
Deficiency	No deficiencies recorded
PARAPETS	Inspected
Material Type(s)	Masonry
Replacement Quantity	2,500
Replacement Uom	C.F.
Instance on All Facades	Inspected
Instance Condition	3 - Fair
Instance Quantity	2,500
Instance Quantity Uom	C.F.
Deficiency	BRICK: MINOR CRACKS, SPALLING

100
S.F.
REPAIR
PRIORITY 3
LEVEL 2

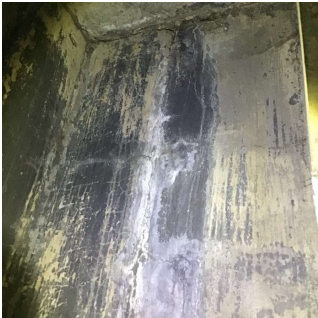
Question	Response
INTERIOR	
STRUCTURAL	
FOUNDATION WALLS	Inspected
Violations	No violations recorded.
ROOF STRUCTURE	Inspected
Condition	2 - Between Good and Fair
Deficiency	No deficiencies recorded
VAULTS-BUNKERS	Inspected
Foundation Walls	Inspected
Condition	2 - Between Good and Fair
Deficiency	CRACKS, SPALLING
Deficiency Location/Instance	Basement - Boiler Room Vault
Deficiency Quantity	20
Quantity Uom	S.F.
Potential Action	REPAIR
Urgency of Action	PRIORITY 3
Purpose of Action	LEVEL 5
Deficiency Photo1

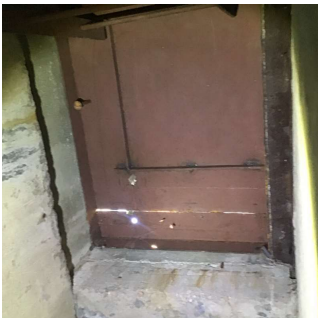
Violations	Boiler Room Vault No violations recorded.
Slab Structure	Inspected
Condition	2 - Between Good and Fair
Deficiency	No deficiencies recorded
Vault/Ash Hoist Doors and Framing	Inspected
Condition	5 - Poor
Deficiency	WATER INFILTRATION
Deficiency Location/Instance	Basement - Boiler Room Vault
Deficiency Quantity	10
Quantity Uom	S.F.
Potential Action	REPAIR
Urgency of Action	PRIORITY 5
Purpose of Action	LEVEL 2

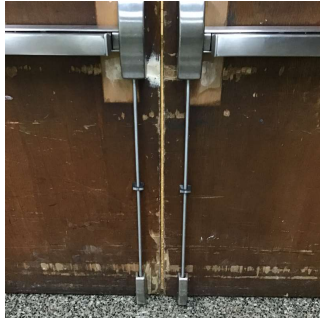
Question	Response
INTERIOR	
STRUCTURAL	Inspected
VAULTS-BUNKERS	
Vault/Ash Hoist Doors and Framing	
Violations	No violations recorded.
AUDITORIUM	Does not Exist
CAFETERIA	Inspected
Instance on Basement	Inspected
Ceiling	
Instance on Basement	Inspected
Condition	2 - Between Good and Fair
Deficiency	No deficiencies recorded
Door(s)	
Instance on Basement	Inspected
Condition	5 - Poor
Deficiency	WOOD: DETERIORATED DOOR
Deficiency Location/Instance	Main Entrance
Deficiency Quantity	8
Quantity Uom	EACH
Potential Action	MAINTENANCE
Urgency of Action	PRIORITY 3
Purpose of Action	LEVEL 2
Deficiency Photo1

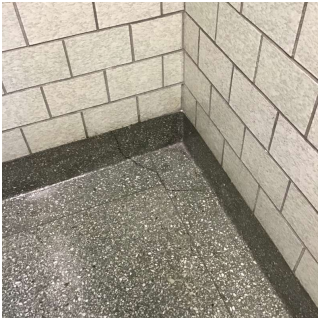
Corridor near Room 302
Violations	No violations recorded.
Walls	Inspected

Corridor near Room 103
Violations	No violations recorded.
Door(s)	Inspected
Condition	1 - Good
Deficiency	No deficiencies recorded
Floor Finish	Inspected
Condition	2 - Between Good and Fair
Deficiency	TERRAZZO: CRACKS
Deficiency Location/Instance	Room 104, Corridor near Room 302, By Cafeteria, Next to Stair A/Basement
Deficiency Quantity	40
Quantity Uom	S.F.
Potential Action	REPLACE
Urgency of Action	PRIORITY 3
Purpose of Action	LEVEL 2
Deficiency Photo1

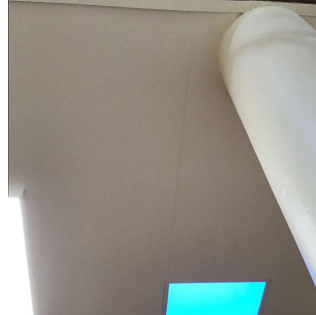
Violations	Near East Exit - Vestibule No violations recorded.
Deficiency	GYPSUM BOARD: DETERIORATED
Deficiency Location/Instance	Room 104
Deficiency Quantity	20
Quantity Uom	S.F.
Potential Action	REPLACE
Urgency of Action	PRIORITY 3
Purpose of Action	LEVEL 2
Deficiency Photo1	 
Violations	Room 104 No violations recorded.
Specialties	Does not Exist
GYMNASIUM	Inspected
Instance on 1st Floor	Inspected
Ceiling	
Instance on 1st Floor	Inspected
Condition	2 - Between Good and Fair
Deficiency	GYPSUM BOARD: DAMAGED/DETERIORATED
Deficiency Location/Instance	Near Bleachers
Deficiency Quantity	10
Quantity Uom	S.F.
Potential Action	REPLACE

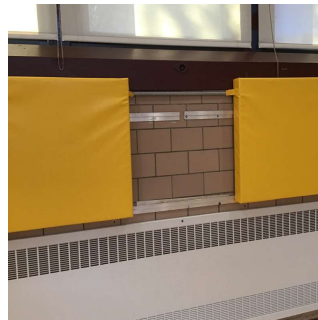
Near Windows

WALL PADDING: DETERIORATED

REPLACE

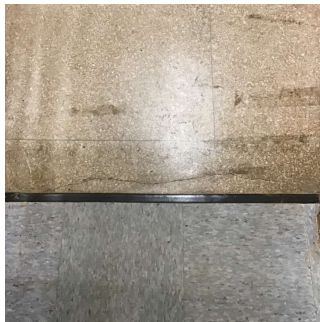
Room 114
Violations	No violations recorded.
Stalls	Inspected
Condition	1 - Good
Deficiency	No deficiencies recorded
Walls	Inspected
Condition	3 - Fair
Deficiency	STONE: CRACKS/SPALLING
Deficiency Location/Instance	Room 114
Deficiency Quantity	10
Quantity Uom	S.F.

Stair A/1
Violations	No violations recorded.
TOILET ROOMS - STAFF	Inspected
Ceiling	Inspected
Condition	2 - Between Good and Fair
Deficiency	No deficiencies recorded
Door(s)	Inspected
Condition	1 - Good
Deficiency	No deficiencies recorded
Floor Finish	Inspected
Condition	3 - Fair
Deficiency	TERRAZZO: CRACKS
Deficiency Location/Instance	Room 114
Deficiency Quantity	10
Quantity Uom	S.F.
Potential Action	REPLACE
Urgency of Action	PRIORITY 3
Purpose of Action	LEVEL 2
Deficiency Photo1

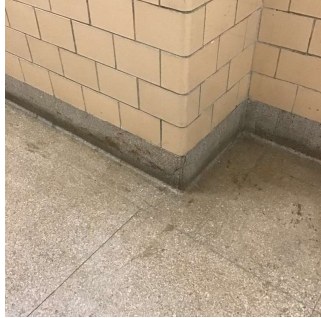
Room 114
Violations	No violations recorded.
Deficiency	GLAZED BLOCK: CRACKS/SPALLING
Deficiency Location/Instance	Room 114
Deficiency Quantity	40
Quantity Uom	S.F.
Potential Action	REPLACE
Urgency of Action	PRIORITY 3
Purpose of Action	LEVEL 2
Deficiency Photo1

Question	Response
INTERIOR	
TOILET ROOMS - STAFF	
Walls	
Potential Action	REPLACE
Urgency of Action	PRIORITY 3
Purpose of Action	LEVEL 2
Deficiency Photo1

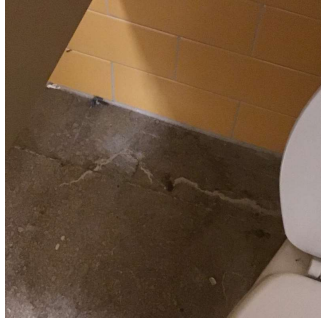
Room 114
Violations	No violations recorded.
TOILET ROOMS - STUDENTS	
Ceiling	Inspected
Condition	2 - Between Good and Fair
Deficiency	No deficiencies recorded
Door(s)	Inspected
Condition	1 - Good
Deficiency	No deficiencies recorded
Floor Finish	Inspected
Condition	2 - Between Good and Fair
Deficiency	TERRAZZO: CRACKS
Deficiency Location/Instance	Rooms 312,108,B109
Deficiency Quantity	30
Quantity Uom	S.F.
Potential Action	REPLACE
Urgency of Action	PRIORITY 3

Violations	Room B109 No violations recorded.
Stalls	
Condition	Inspected
Deficiency	1 - Good
Deficiency	No deficiencies recorded
Walls	
Condition	Inspected
Condition	2 - Between Good and Fair
Deficiency	GLAZED BLOCK: CRACKS/SPALLING
Deficiency Location/Instance	Rooms 106,B107
Deficiency Quantity	20
Quantity Uom	S.F.
Potential Action	REPLACE
Urgency of Action	PRIORITY 3
Purpose of Action	LEVEL 2
Deficiency Photo1
