NYC Department of Education
Building Condition Assessment Survey 2023 - 2024

Architectural Inspection

Asset: MIDWOOD AF (MAIN) - BROOKLYN, 1124 EAST 17TH STREET, New York, 11210

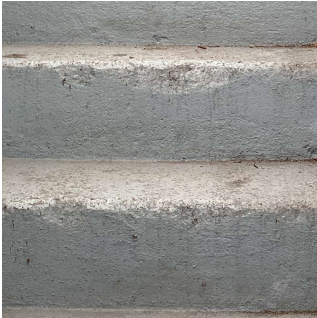
Question	Response
Architectural	
EXTERIOR	Inspected
AREAWAY	Inspected
Instance on AW1	Inspected
Instance Condition	3 - Fair
Instance Quantity	1
Instance Quantity Uom	EACH
Deficiency	AREAWAY STAIRS: DETERIORATED TREADS/RISERS/NOSINGS
Roof Plan reference	
Deficiency Quantity	20
Quantity Uom	S.F.
Potential Action	REPAIR
Urgency of Action	PRIORITY 3
Purpose of Action	LEVEL 2

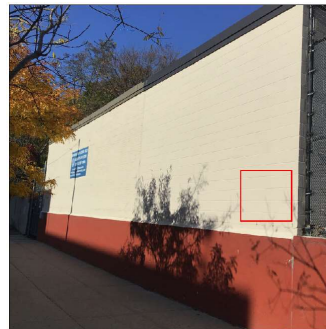
Elevation

BRICK: MINOR CRACKS AND SPALLING

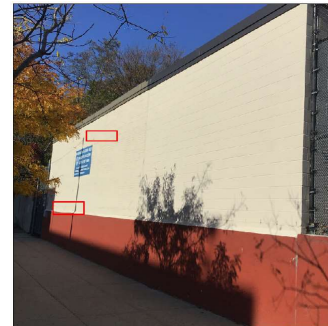
Elevation

BRICK: MAJOR / THRU CRACKS

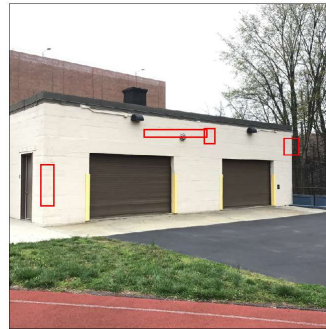
Elevation

CONCRETE MASONRY UNIT: MINOR CRACKS AND SPALLING

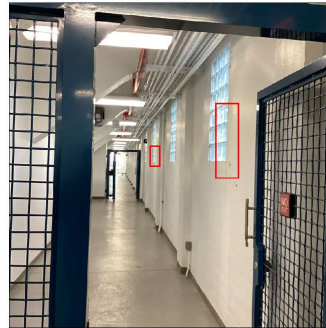
Elevation

GLASS BLOCK: WATER INFILTRATION IN INSTRUCTIONAL SPACE

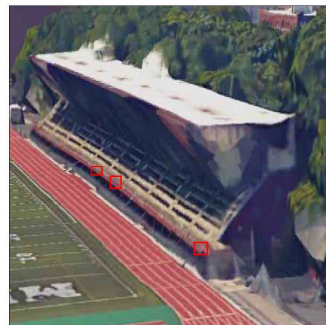
Elevation

STUCCO CEMENT SURFACE: CRACKS, SPALLING

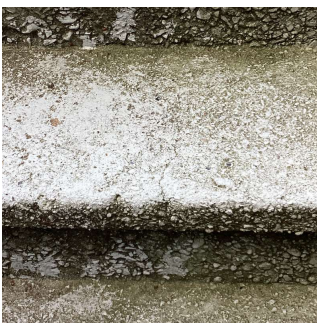
Violations	Facade B - Grandstand No violations recorded.
Deficiency	CONCRETE: CRACKS/SPALLING - MINOR
Roof Plan reference

Deficiency Quantity	10
Quantity Uom	S.F.
Potential Action	REPAIR
Urgency of Action	PRIORITY 3
Purpose of Action	LEVEL 2
Deficiency Photo1

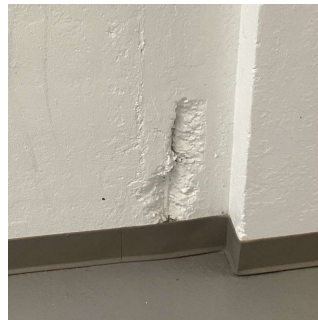
2nd Floor Corridor

**CONCRETE BEARING WALL:
CRACKED/SPALLED/REINFORCEMENT EXPOSED**

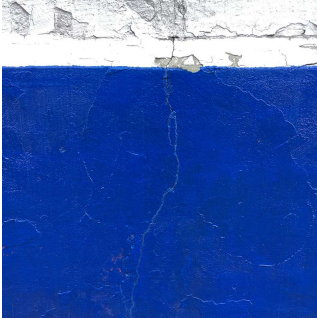
Question	Response
INTERIOR	
STRUCTURAL	
FOUNDATION WALLS	
Urgency of Action	PRIORITY 3
Purpose of Action	LEVEL 5
Deficiency Photo1

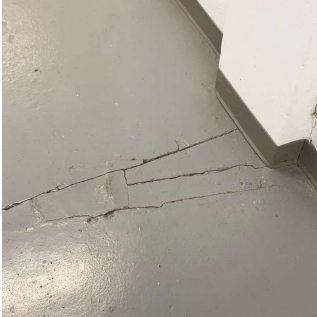
Violations	Garage No violations recorded.
ROOF STRUCTURE	
Condition	Inspected
Deficiency	2 - Between Good and Fair
VAULTS-BUNKERS	
Does not Exist	
CLASSROOMS/CORRIDORS/ADMIN SPACES	
Ceiling	
Condition	Inspected
Deficiency	2 - Between Good and Fair
Door(s)	
Condition	Inspected
Deficiency	2 - Between Good and Fair
Floor Finish	
Condition	Inspected
Deficiency	2 - Between Good and Fair
Deficiency Location/Instance	CONCRETE: CRACKS Corridor between Stairwells
Deficiency Quantity	30
Quantity Uom	S.F.
Potential Action	REPLACE
Urgency of Action	PRIORITY 3
Purpose of Action	LEVEL 2
Deficiency Photo1

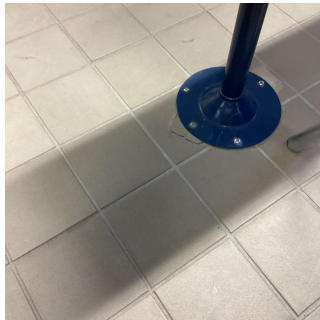
Question	Response
INTERIOR	
LOCKER ROOM	
Ceiling	
Instance on 1st Floor- Room 104 (56 Lockers)	Does not Exist
Instance on 1st Floor- Room 107 (46 Lockers)	Does not Exist
Instance on 1st Floor- Room 108 (61 Lockers)	Does not Exist
Door(s)	
Instance on 1st Floor- Room 104 (56 Lockers)	Inspected
Condition	2 - Between Good and Fair
Deficiency	No deficiencies recorded
Instance on 1st Floor- Room 108 (61 Lockers)	Inspected
Condition	2 - Between Good and Fair
Deficiency	No deficiencies recorded
Instance on 1st Floor- Room 107 (46 Lockers)	Inspected
Condition	2 - Between Good and Fair
Deficiency	No deficiencies recorded
Floor Finish	
Instance on 1st Floor- Room 104 (56 Lockers)	Inspected
Condition	2 - Between Good and Fair
Deficiency	CERAMIC TILE: BROKEN/MISSING TILES
Deficiency Location/Instance	Near Entrance
Deficiency Quantity	10
Quantity Uom	S.F.
Potential Action	REPLACE
Urgency of Action	PRIORITY 3
Purpose of Action	LEVEL 2

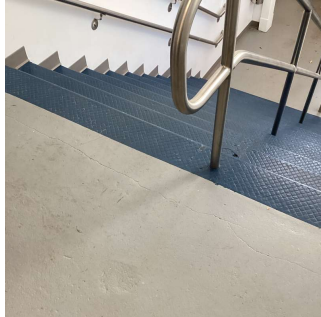
Question	Response
INTERIOR	
LOCKER ROOM	
Walls	
Deficiency	No deficiencies recorded
Instance on 1st Floor- Room 108 (61 Lockers)	Inspected
Condition	2 - Between Good and Fair
Deficiency	No deficiencies recorded
Instance on 1st Floor- Room 107 (46 Lockers)	Inspected
Condition	2 - Between Good and Fair
Deficiency	No deficiencies recorded
SHOWER ROOM	
	Does not Exist
STAIRS/RAMPS: INTERIOR	
	Inspected
Do Letter Stair Signs Exist?	Yes
Ceiling	
	Not Required
Door(s)	
	Does not Exist
Railings	
	Inspected
Condition	2 - Between Good and Fair
Deficiency	No deficiencies recorded
Stairs and Landings	
	Inspected
Condition	2 - Between Good and Fair
Deficiency	CONCRETE: CRACKS/SPALLING - MAJOR
Deficiency Location/Instance	Stair B/1
Deficiency Quantity	20
Quantity Uom	S.F.
Potential Action	REPLACE
Urgency of Action	PRIORITY 3
Purpose of Action	LEVEL 2
Deficiency Photo1

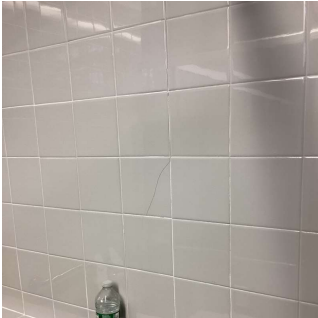
Question	Response
INTERIOR	
TOILET ROOMS - STAFF	
Stalls	Inspected
Condition	2 - Between Good and Fair
Deficiency	No deficiencies recorded
Walls	Inspected
Condition	2 - Between Good and Fair
Deficiency	CERAMIC TILE: BROKEN/ MISSING
Deficiency Location/Instance	Room 110
Deficiency Quantity	10
Quantity Uom	S.F.
Potential Action	REPLACE
Urgency of Action	PRIORITY 3
Purpose of Action	LEVEL 2
Deficiency Photo1

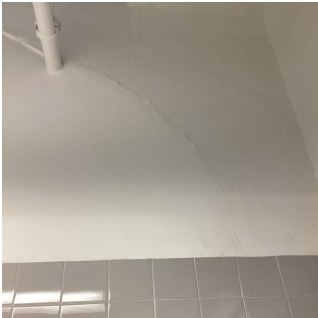
Room 110
Violations	No violations recorded.
Deficiency	PLASTER: CRACKS/SPALLING
Deficiency Location/Instance	Room 110
Deficiency Quantity	10
Quantity Uom	S.F.
Potential Action	REPLACE
Urgency of Action	PRIORITY 3
Purpose of Action	LEVEL 2
Deficiency Photo1

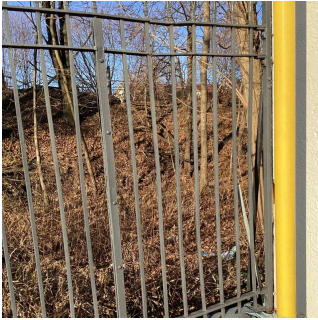
Violations	Avenue L Entrance No violations recorded.
Deficiency	WROUGHT IRON: DAMAGED/DETERIORATED
Deficiency Location/Instance	Avenue L, K Entrances, near Stair A
Deficiency Quantity	240
Quantity Uom	S.F.
Potential Action	REPLACE
Urgency of Action	PRIORITY 3
Purpose of Action	LEVEL 2
Deficiency Photo1

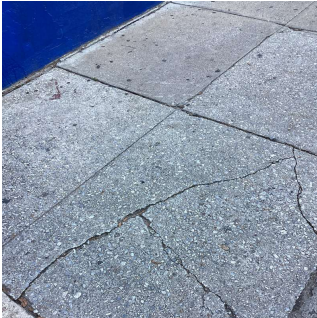
Question	Response
SITE	
PAVING	
Site Sidewalks & Walkways	
Concrete	
Potential Action	REPLACE
Urgency of Action	PRIORITY 3
Purpose of Action	LEVEL 2
Deficiency Photo1	 
Violations	Along Walkway under stands No violations recorded.
Pavers	Does not Exist
DOT Sidewalk	Inspected
Asphalt	Does not Exist
Concrete	Inspected
Condition	4 - Between Fair and Poor
Deficiency	DAMAGED/DETERIORATED/MISSING SECTIONS
Deficiency Location/Instance	Avenue K, Avenue L, E 17th Street
Deficiency Quantity	600
Quantity Uom	S.F.
Potential Action	REPLACE
Urgency of Action	PRIORITY 3
Purpose of Action	LEVEL 2
Deficiency Photo1

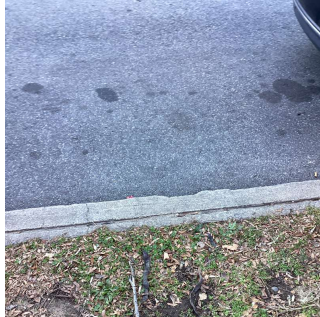
Violations	Avenue K No violations recorded.
Deficiency	DAMAGED CURBS
Deficiency Location/Instance	Avenue K, Avenue L, E 17th Street
Deficiency Quantity	250
Quantity Uom	L.F.
Potential Action	REPLACE
Urgency of Action	PRIORITY 3
Purpose of Action	LEVEL 2

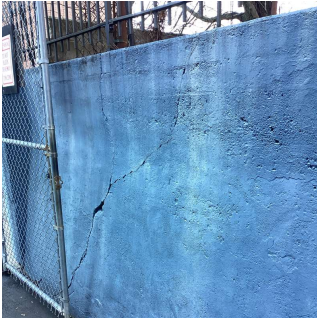
Violations	Avenue K No violations recorded.
Pavers	Does not Exist
PLAYGROUNDS	Does not Exist
RETAINING WALLS	Inspected
Are there any Retaining Walls 6' OR higher facing public street/sidewalk?	Yes
Condition	4 - Between Fair and Poor
Deficiency	CAST IN PLACE CONCRETE: CRACKS/SPALLING - MAJOR
Deficiency Location/Instance	Walkway along Grand Stand
Deficiency Quantity	20
Quantity Uom	S.F.
Potential Action	REPLACE
Urgency of Action	PRIORITY 4
Purpose of Action	LEVEL 4
Deficiency Photo1

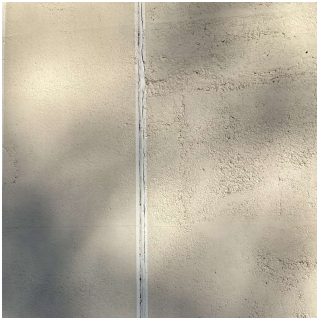
Violations	Avenue L Entrance No violations recorded.
SEATING	Does not Exist
SITE WALLS (NOT RETAINING WALLS)	Inspected
Condition	3 - Fair
Deficiency	CAST IN PLACE CONCRETE: CRACKS/SPALLING - MAJOR
Deficiency Location/Instance	Avenue K
Deficiency Quantity	120
Quantity Uom	S.F.
Potential Action	REPLACE
Urgency of Action	PRIORITY 3
Purpose of Action	LEVEL 2
Deficiency Photo1

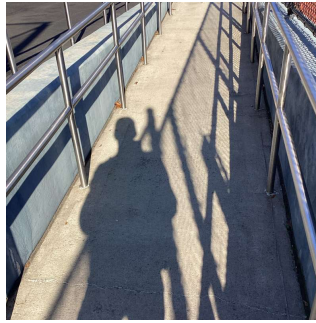
Violations	Avenue K No violations recorded.
STAIRS/RAMPS: EXTERIOR	Inspected
Railings	Inspected
Condition	2 - Between Good and Fair
Deficiency	No deficiencies recorded
Site Cheek/flank Walls	Inspected
Condition	2 - Between Good and Fair
Deficiency	No deficiencies recorded
Stairs/ramps	Inspected
Condition	2 - Between Good and Fair
Deficiency	CAST IN PLACE CONCRETE: CRACKS/SPALLING - MAJOR
Deficiency Location/Instance	Ramp Right of Stands
Deficiency Quantity	20
Quantity Uom	S.F.
Potential Action	REPLACE
