NYC Department of Education
Building Condition Assessment Survey 2023 - 2024

Architectural Inspection

Asset: **LINCOLN AF - BROOKLYN, 2800 OCEAN PARKWAY, New York, 11235**

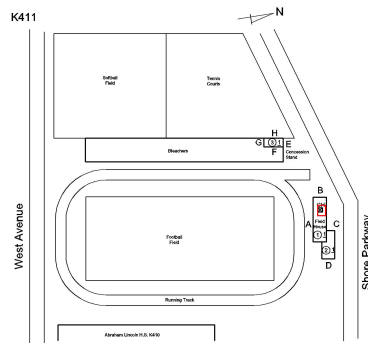
Question	Response
Architectural	
EXTERIOR	Inspected
AREAWAY	Does not Exist
AWNINGS AND CANOPIES	Does not Exist
CHIMNEY	Inspected
Material Type(s)	Masonry
Condition	3 - Fair
Deficiency	BRICK: DETERIORATED JOINTS
Roof Plan reference	
Deficiency Quantity	40
Quantity Uom	S.F.
Potential Action	REPOINT
Urgency of Action	PRIORITY 3
Purpose of Action	LEVEL 2

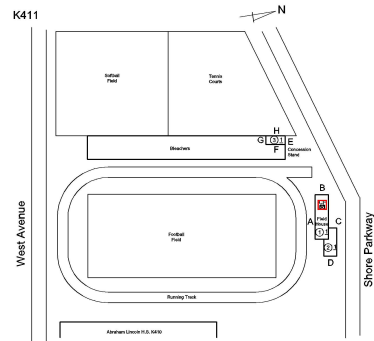
Roof Plan reference

BRICK: MINOR CRACKS AND SPALLING

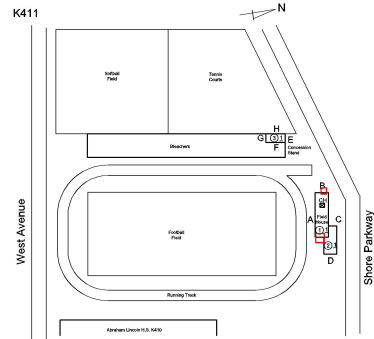
Roof Plan reference

PRE-CAST CONCRETE: DETERIORATED JOINTS

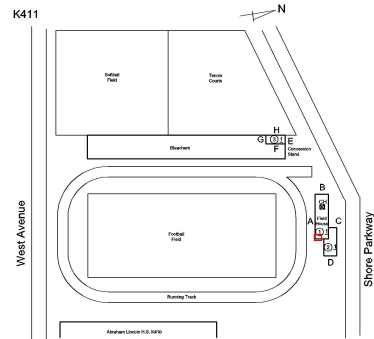
Roof Plan reference

PRE-CAST CONCRETE: MINOR CRACKS, SPALLING

REPAIR

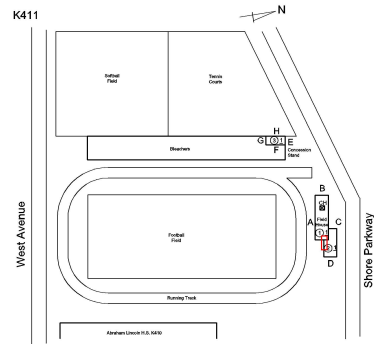
Question	Response
EXTERIOR	
CORNICE	
Deficiency Photo1	 
Violations	Facade A No violations recorded.
DOORS	Inspected
DOORS AND FRAMES	Inspected
Condition	5 - Poor
Deficiency	METAL: DETERIORATED DOOR AND FRAME - MAJOR DETERIORATION
Roof Plan reference	
Deficiency Quantity	2
Quantity Uom	EACH
Potential Action	REPLACE
Urgency of Action	PRIORITY 4
Purpose of Action	LEVEL 2
Deficiency Photo1	 
Violations	Facade A No violations recorded.
Deficiency	METAL: DETERIORATED DOOR AND FRAME - MINOR DETERIORATION

2
EACH
MAINTENANCE
PRIORITY 3
LEVEL 2

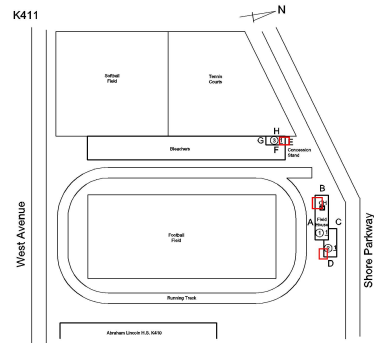
Roof Plan reference

METAL CLAD: DETERIORATED DOOR AND FRAME - MAJOR DETERIORATION

6
EACH
REPLACE
PRIORITY 4
LEVEL 2

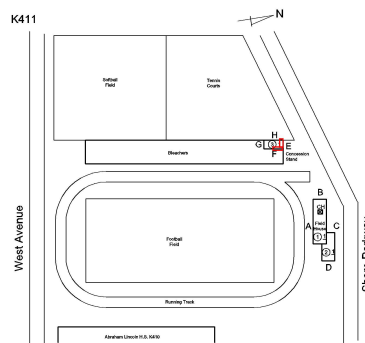
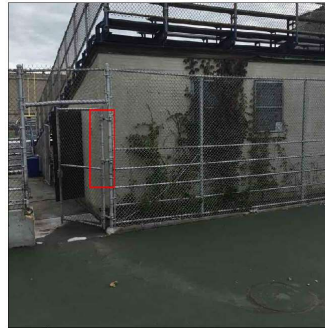
Roof Plan reference

BRICK: WATER INFILTRATION IN NON-INSTRUCTIONAL SPACE

REPAIR

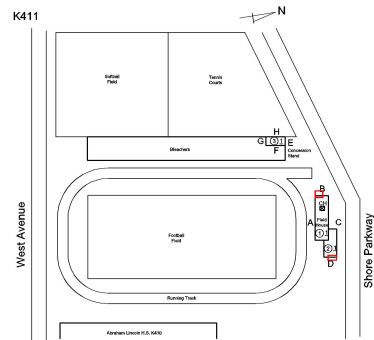
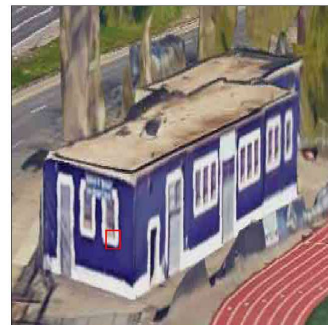
Roof Plan reference

BRICK: DETERIORATED MASONRY SILLS - MAJOR

REMOVE AND REPLACE

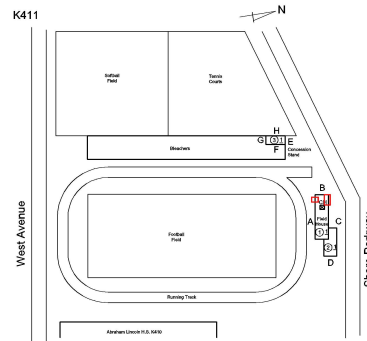
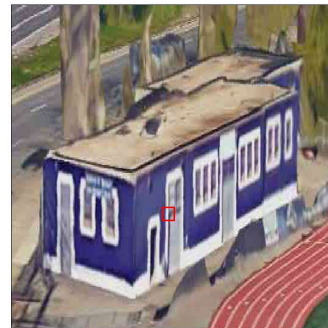
Roof Plan reference

STONE: CHIPPED/SPALLED/BROKEN PIECES - MAJOR

REPLACE

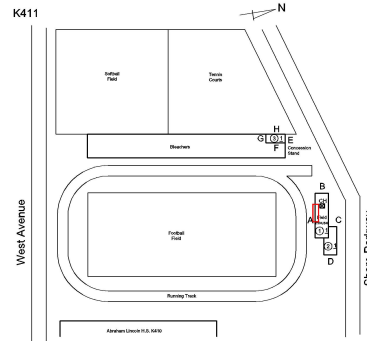
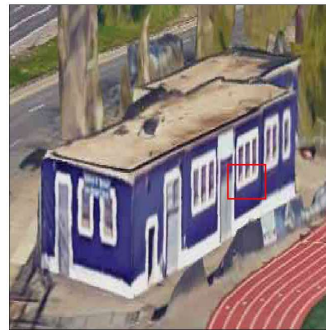
Roof Plan reference

BRICK: DETERIORATED MASONRY SILLS - MINOR

REPAIR

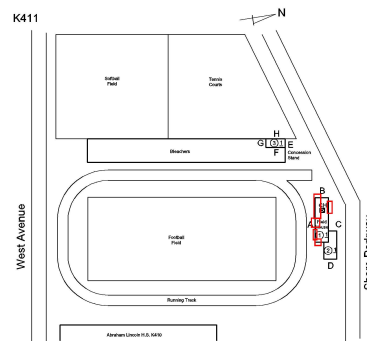
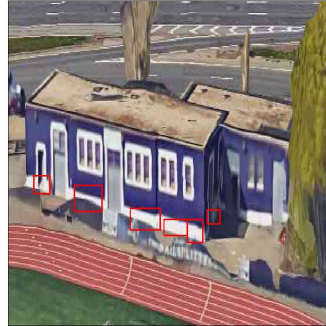
Roof Plan reference

STONE: DETERIORATED JOINTS

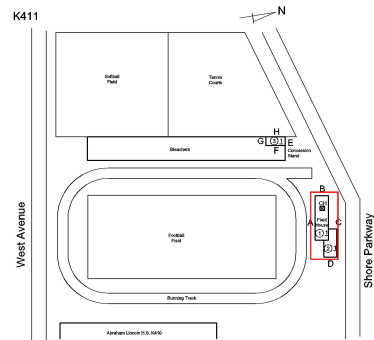
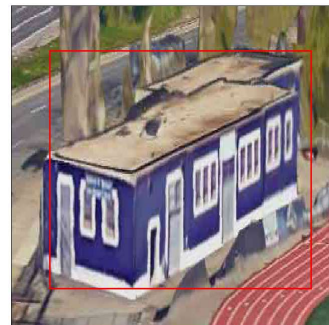
Roof Plan reference

BRICK: DETERIORATED JOINTS

PRIORITY 3
LEVEL 2

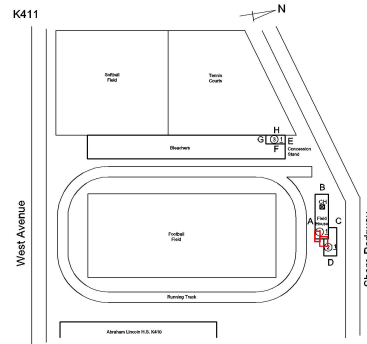
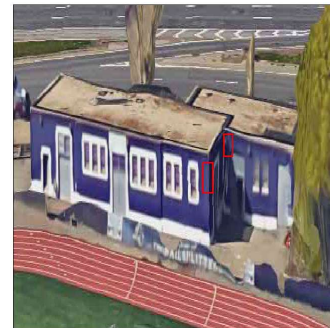
Roof Plan reference

BRICK: CRACKS/DISPLACED/SPALLED BRICK AT BUILDING CORNERS

40
S.F.
REMOVE AND REBUILD
PRIORITY 4
LEVEL 2

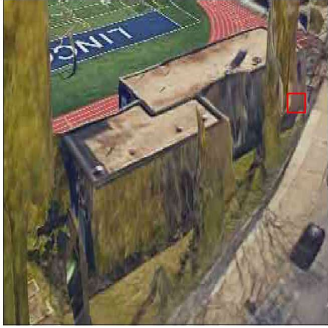
Question	Response
EXTERIOR	
EXTERIOR WALLS	
Violations	Facade A No violations recorded.
Deficiency	CAST IN PLACE / PRE-CAST CONCRETE: MAJOR CRACKS/SPALLING
Roof Plan reference	 
Elevation

Deficiency Quantity	40
Quantity Uom	S.F.
Potential Action	REPLACE
Urgency of Action	PRIORITY 4
Purpose of Action	LEVEL 2
Deficiency Photo1	 
Violations	Facade A No violations recorded.
EXTERIOR SOFFITS	Does not Exist
LOUVER	Inspected
Condition	2 - Between Good and Fair
Deficiency	No deficiencies recorded
PARAPETS	Inspected
Material Type(s)	Masonry
Replacement Quantity	1,800
Replacement Uom	C.F.
Instance on All Roofs	Inspected

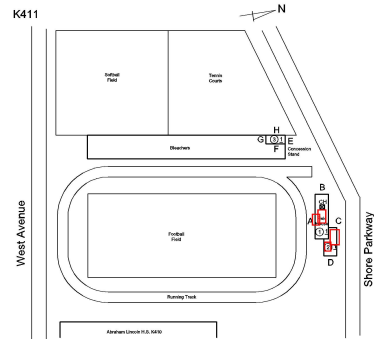
Roof Plan reference

BUILT-UP: ROOFING: MAJOR ACTIVE ROOF LEAKS IN INSTRUCTIONAL SPACE

REPLACE ROOFING WITHOUT MAJOR EQUIPMENT REMOVAL

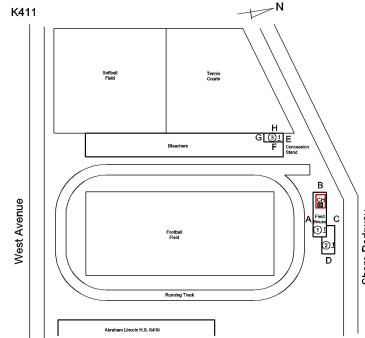
Roof Plan reference

BUILT-UP: ROOFING: MAJOR ACTIVE ROOF LEAKS IN NON-INSTRUCTIONAL SPACE

200
S.F.
REPLACE ROOFING WITHOUT MAJOR EQUIPMENT
REMOVAL
PRIORITY 5
LEVEL 2

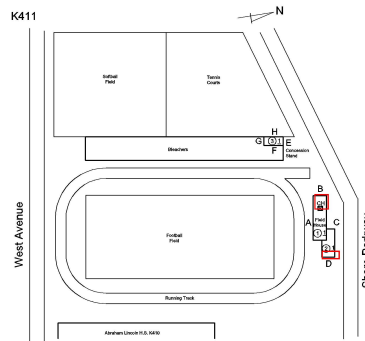
Roof Plan reference

BUILT-UP: ROOFING: LOSS OF GRAVEL

180
S.F.
INSTALL NEW GRAVEL
PRIORITY 3
LEVEL 2

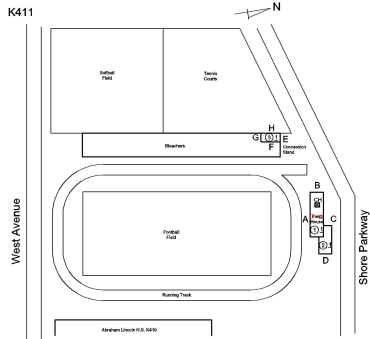
Violations	Roof 2 No violations recorded.
ROOFING DRAINS	Inspected
Condition	5 - Poor
Deficiency	CLOGGED
Roof Plan reference

Deficiency Quantity	2
Quantity Uom	EACH
Potential Action	MAINTENANCE
Urgency of Action	PRIORITY 5
Purpose of Action	LEVEL 2
Deficiency Photo1

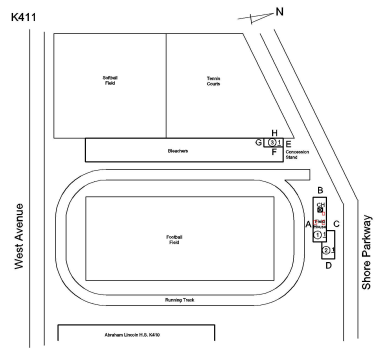
Violations	Roof 1 No violations recorded.
Deficiency	DETERIORATED

Deficiency Quantity	3
Quantity Uom	EACH
Potential Action	REPLACE
Urgency of Action	PRIORITY 4
Purpose of Action	LEVEL 2
Deficiency Photo1

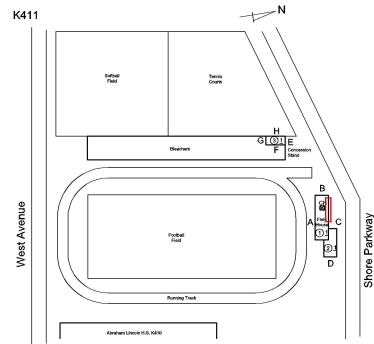
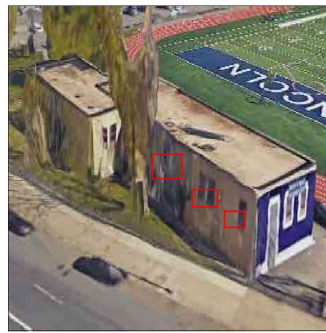
Roof Plan reference

Violations	Roof 1 No violations recorded.
Specialties	Does not Exist
STAIRS/RAMPS: EXTERIOR	Inspected
BUILDING CHEEK/FLANK WALLS	Does not Exist
RAILINGS	Does not Exist
STAIRS/RAMPS	Inspected
Condition	2 - Between Good and Fair
Deficiency	No deficiencies recorded
WINDOWS	Inspected
Replacement Quantity	410
Replacement Uom	S.F.
EXTERIOR GUARDS	Inspected
Condition	3 - Fair
Deficiency	RUST - MAJOR

90
S.F.
REPLACE
PRIORITY 4
LEVEL 2

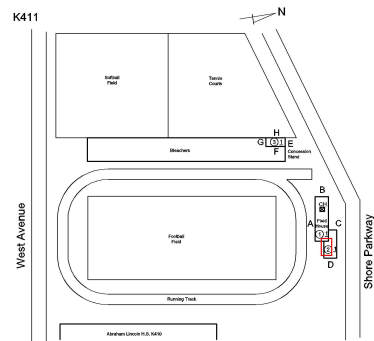
Roof Plan reference

DETERIORATED/TORN-OUT/MISSING

Question	Response
EXTERIOR	
WINDOWS	
EXTERIOR GUARDS	
Elevation	 
Deficiency Quantity	60
Quantity Uom	S.F.
Potential Action	REPLACE
Urgency of Action	PRIORITY 4
Purpose of Action	LEVEL 2
Deficiency Photo1	 
Violations	Facade A No violations recorded.
LINTELS	Inspected
Condition	2 - Between Good and Fair
Deficiency	No deficiencies recorded
WINDOWS	Inspected
Material Type(s)	Solid Wood
Instance on Wood: Facades A-D, H	Inspected
Instance Condition	5 - Poor
Instance Quantity	410
Instance Quantity Uom	S.F.
Are these windows insulated	No
Installation Year	1996
Source of Installation	Custodial Staff
Deficiency	WOOD: INOPERABLE BALANCE

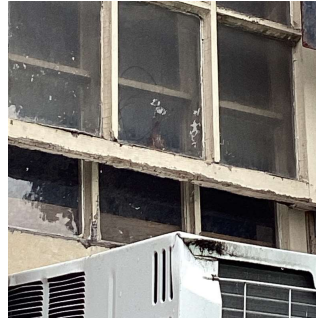
Facade D

WINDOWS

150
S.F.
REPLACE WINDOW
PRIORITY 4
LEVEL 2

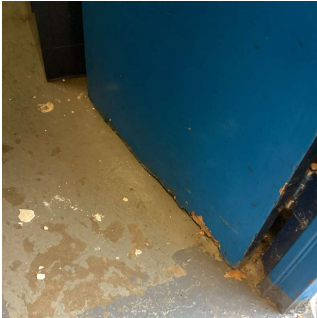
Violations	Concession Building No violations recorded.
VAULTS-BUNKERS	Does not Exist
CLASSROOMS/CORRIDORS/ADMIN SPACES	Inspected
Ceiling	Inspected
Condition	2 - Between Good and Fair
Deficiency	No deficiencies recorded
Door(s)	Inspected
Condition	5 - Poor
Deficiency	WOOD: DETERIORATED DOOR
Deficiency Location/Instance	Office
Deficiency Quantity	1
Quantity Uom	EACH
Potential Action	MAINTENANCE
Urgency of Action	PRIORITY 3
Purpose of Action	LEVEL 2
Deficiency Photo1

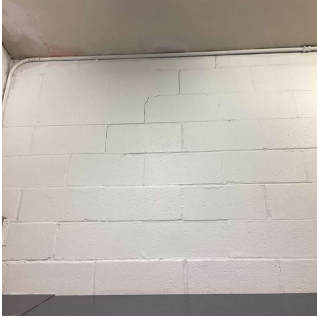
Question	Response
INTERIOR	
LOCKER ROOM	
Locker Room Lockers	
Instance on 1st Floor - Junior Varsity (38 Lockers)	Inspected
Condition	2 - Between Good and Fair
Deficiency	No deficiencies recorded
Walls	
Instance on 1st Floor - Varsity (43 Lockers)	Inspected
Condition	2 - Between Good and Fair
Deficiency	MASONRY: CRACKS/SPALLING
Deficiency Location/Instance	Left Side
Deficiency Quantity	15
Quantity Uom	S.F.
Potential Action	REPLACE
Urgency of Action	PRIORITY 3
Purpose of Action	LEVEL 2
Deficiency Photo1

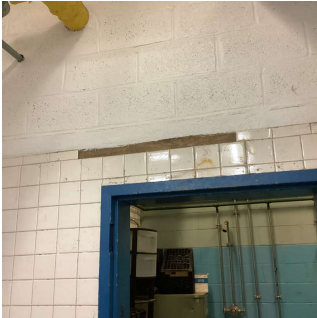
Left Side
Violations	No violations recorded.
Deficiency	CERAMIC TILE: BROKEN/ MISSING
Deficiency Location/Instance	Rear
Deficiency Quantity	10
Quantity Uom	S.F.
Potential Action	REPLACE
Urgency of Action	PRIORITY 3
Purpose of Action	LEVEL 2
Deficiency Photo1

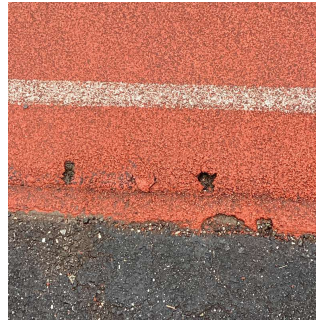
Question	Response
INTERIOR	
TOILET ROOMS - STUDENTS	
Walls	
Deficiency Photo1	 
	Locker Room
Violations	No violations recorded.
ATHLETIC FIELDS	
	Inspected
PLAYING SURFACE	
Synthetic Turf Field exists?	Yes
Year of Installation	2016
Replacement Quantity	186,000
Replacement Uom	S.F.
Instance on Football Field	Inspected
Instance Condition	2 - Between Good and Fair
Instance Quantity	90,000
Instance Quantity Uom	S.F.
Deficiency	No deficiencies recorded
Instance on Running Track	Inspected
Instance Condition	3 - Fair
Instance Quantity	36,000
Instance Quantity Uom	S.F.
Deficiency	ATHLETIC WEARING SURFACE: DAMAGED/DETERIORATED
Deficiency Location/Instance	Running Track
Roof Plan reference	 
Deficiency Quantity	90
Quantity Uom	S.F.
Potential Action	REPLACE
Urgency of Action	PRIORITY 4
Purpose of Action	LEVEL 2

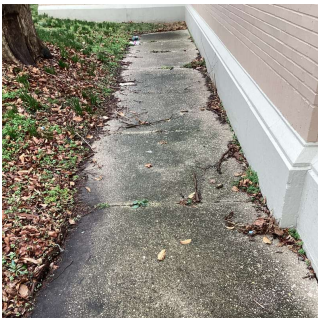
Walkway behind Field House
Violations	No violations recorded.
Pavers	Does not Exist
Student Use	Inspected
Gravel Exists?	Yes

Near Bleachers
Violations	No violations recorded.
IRRIGATION SYSTEM	Does not Exist
PAVING	Inspected
Student Non-Use	Inspected
Gravel Exists?	No
Asphalt	Does not Exist
Concrete	Inspected
Condition	3 - Fair
Deficiency	CRACKS - MAJOR
Deficiency Location/Instance	Walkway behind Field House
Deficiency Quantity	100
Quantity Uom	S.F.
Potential Action	REPLACE
Urgency of Action	PRIORITY 3
Purpose of Action	LEVEL 2
Deficiency Photo1

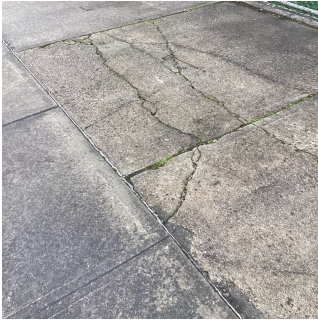
Violations	Along Running Track No violations recorded.
Concrete	Inspected
Condition	2 - Between Good and Fair
Deficiency	No deficiencies recorded
Pavers	Does not Exist
Site Sidewalks & Walkways	Inspected
Asphalt	Inspected
Condition	2 - Between Good and Fair
Deficiency	No deficiencies recorded
Concrete	Inspected
Condition	4 - Between Fair and Poor
Deficiency	CRACKS - MAJOR
Deficiency Location/Instance	Near Football Bleachers
Deficiency Quantity	500
Quantity Uom	S.F.
Potential Action	REPLACE
Urgency of Action	PRIORITY 3
Purpose of Action	LEVEL 2
Deficiency Photo1

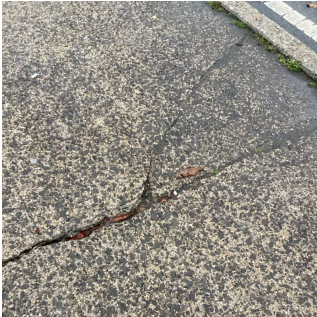
Question	Response
SITE	
PAVING	
Site Sidewalks & Walkways	Inspected
Concrete	Inspected
Violations	No violations recorded.
Pavers	Does not Exist
DOT Sidewalk	Inspected
Asphalt	Does not Exist
Concrete	Inspected
Condition	4 - Between Fair and Poor
Deficiency	DAMAGED/DETERIORATED/MISSING SECTIONS
Deficiency Location/Instance	Shore Parkway, West Avenue
Deficiency Quantity	2,200
Quantity Uom	S.F.
Potential Action	REPLACE
Urgency of Action	PRIORITY 3
Purpose of Action	LEVEL 2
Deficiency Photo1

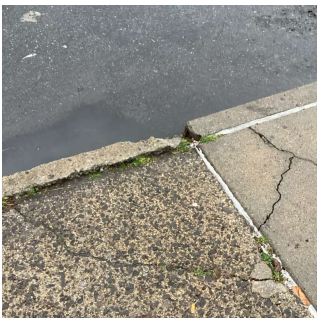
Violations	Shore Parkway No violations recorded.
Deficiency	DAMAGED CURBS
Deficiency Location/Instance	Shore Parkway, West Avenue
Deficiency Quantity	140
Quantity Uom	L.F.
Potential Action	REPLACE
Urgency of Action	PRIORITY 3
Purpose of Action	LEVEL 2
Deficiency Photo1

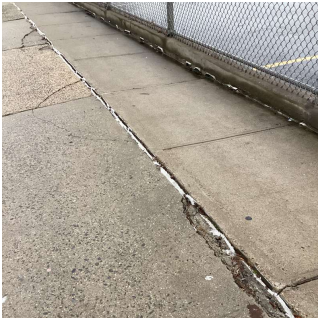
Violations	Shore Parkway No violations recorded.
Deficiency	HEAVING
Deficiency Location/Instance	Shore Parkway, West Avenue
Deficiency Quantity	250

Question	Response
SITE	
PAVING	
DOT Sidewalk	Inspected
Concrete	
Quantity Uom	S.F.
Potential Action	REPLACE
Urgency of Action	PRIORITY 3
Purpose of Action	LEVEL 2
Deficiency Photo1

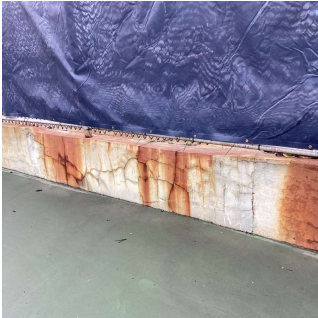
Violations	Shore Parkway No violations recorded.
Pavers	Does not Exist
PLAYGROUNDS	Does not Exist
RETAINING WALLS	Inspected
Are there any Retaining Walls 6' OR higher facing public street/sidewalk?	No
Condition	4 - Between Fair and Poor
Deficiency	MASONRY UNIT: CRACKS/SPALLING - MAJOR
Deficiency Location/Instance	Near Field House, Baseball Field, Tennis Court
Deficiency Quantity	250
Quantity Uom	S.F.
Potential Action	REPLACE
Urgency of Action	PRIORITY 3
Purpose of Action	LEVEL 2
Deficiency Photo1

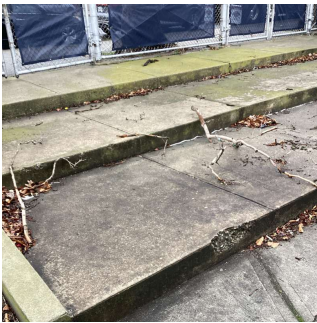
Question	Response
SITE	
STAIRS/RAMPS: EXTERIOR	
Stairs/ramps	
Deficiency Photo1

Near Bleachers	Near Bleachers
Violations	No violations recorded.
ARTWORK	Does not Exist
