**NYC Department of Education
Building Condition Assessment Survey 2023 - 2024**

Architectural Inspection

K412

Asset: 3K CENTER @ 5202 3RD AVENUE - BROOKLYN, 5202 3RD AVENUE, 11220

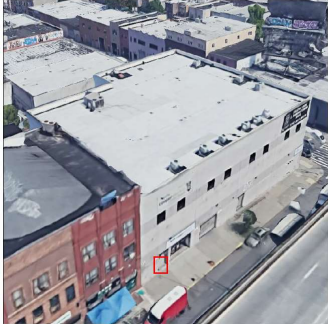
Question	Response
EXTERIOR	
EXTERIOR WALLS	
Elevation

Violations	Roof 1 - Facade A No violations recorded.
CORNICE	Does not Exist
DOORS	Inspected
DOORS AND FRAMES	Inspected
Condition	1 - Good
Deficiency	No deficiencies recorded
DOOR HARDWARE	Inspected
Condition	1 - Good
Deficiency	No deficiencies recorded
LINTELS	Inspected
Condition	1 - Good
Deficiency	No deficiencies recorded
TRANSOM/SIDE LIGHT	Inspected
Condition	1 - Good
Deficiency	No deficiencies recorded
EXTERIOR WALLS	Inspected
Material Type(s)	Masonry
Replacement Quantity	5,000
Replacement Uom	S.F.
Instance on All Facades	Inspected
Instance Condition	3 - Fair
Instance Quantity	5,000
Instance Quantity Uom	S.F.
Deficiency	CONCRETE MASONRY UNIT: MAJOR / THRU CRACKS
Roof Plan reference

Deficiency Quantity	20
Quantity Uom	S.F.
Potential Action	REMOVE AND REBUILD
Urgency of Action	PRIORITY 4
Purpose of Action	LEVEL 2
Deficiency Photo1
