NYC Department of Education
Building Condition Assessment Survey 2023 - 2024

Architectural Inspection

Asset: SAMUEL J. TILDEN HS - K, 5800 TILDEN AVENUE, New York, 11203

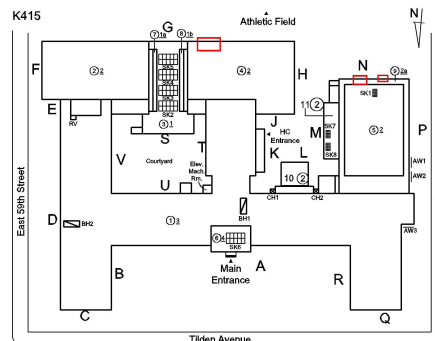
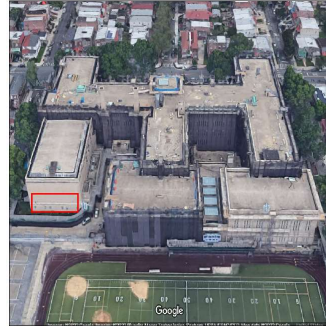
BRICK: DETERIORATED JOINTS

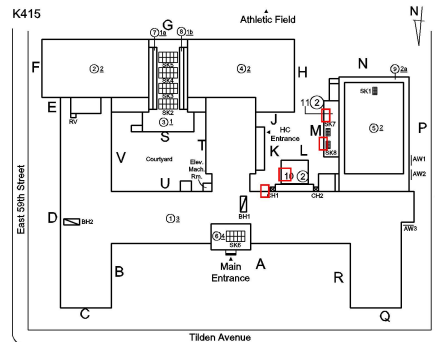
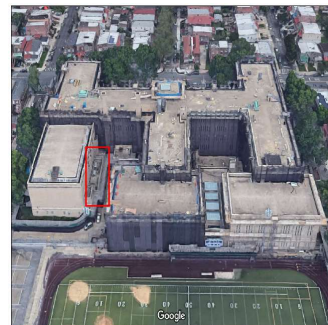
BRICK: MINOR CRACKS AND SPALLING

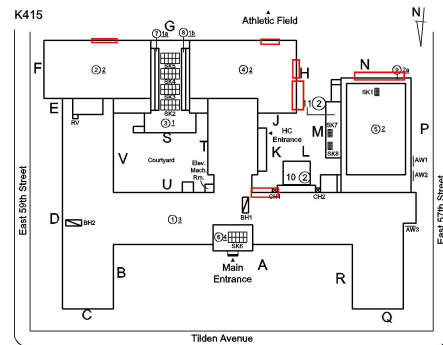
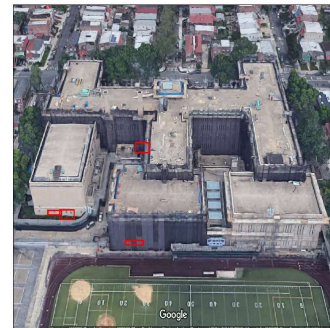
BRICK: DETERIORATED MASONRY SILLS - MINOR

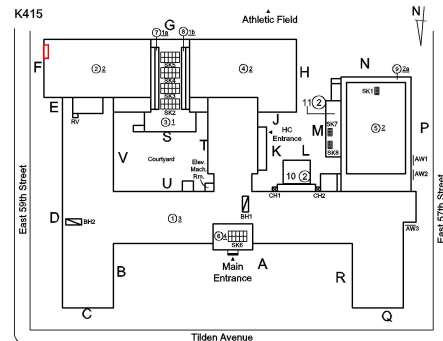
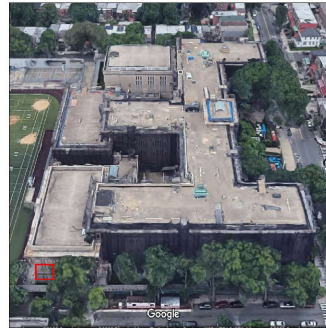
TERRA COTTA: CHIPPED/SPALLED/BROKEN PIECES - MINOR

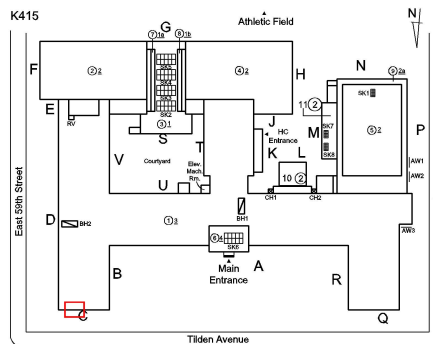
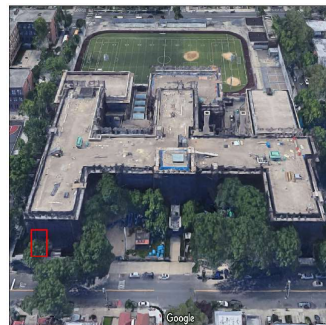
BRICK: MAJOR / THRU CRACKS

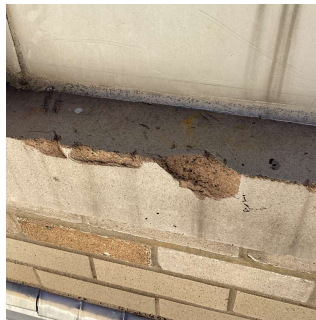
BH1
No violations recorded.

Is/Are the roof(s) suitable for Solar Panel installation?	No
Installation Year	2023
Source of Installation	Custodial Staff
Deficiency	No deficiencies recorded
ROOFING DRAINS	Inspected
Condition	1 - Good
Deficiency	No deficiencies recorded
Specialties	Inspected
BULKHEAD/PENTHOUSE	Inspected
Condition	2 - Between Good and Fair
Deficiency	BULKHEAD/PENTHOUSE WALLS/EXTERIOR: CRACKS/SPALLING - MINOR

10
S.F.
REPAIR
PRIORITY 3
LEVEL 2

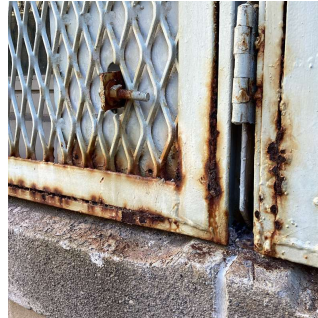
Facade K

RUST - MAJOR

60
S.F.
REPLACE
PRIORITY 4
LEVEL 2

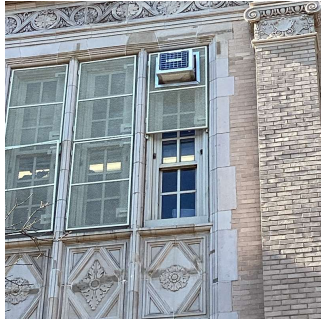
Question	Response
EXTERIOR	
WINDOWS	
EXTERIOR GUARDS	
Potential Action	REPLACE
Urgency of Action	PRIORITY 4
Purpose of Action	LEVEL 2
Deficiency Photo1

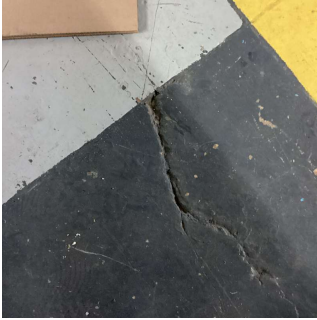
Violations	Boiler Room No violations recorded.
Deficiency	CONCRETE SLAB ON GRADE: THRU CRACKS
Deficiency Location/Instance	Boiler Room
Deficiency Quantity	40
Quantity Uom	S.F.
Potential Action	REPLACE
Urgency of Action	PRIORITY 4
Purpose of Action	LEVEL 5
Deficiency Photo1

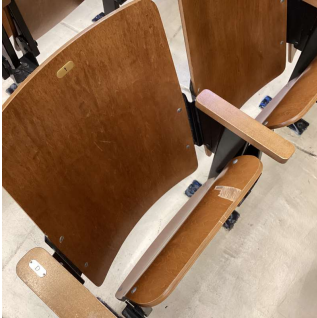
Question	Response
INTERIOR	
AUDITORIUM	
Fixed Seating	
Deficiency Location/Instance	Seats A/103, 104, B/101, D/1, T/1 and others
Deficiency Quantity	9
Quantity Uom	EACH
Potential Action	REPLACE
Urgency of Action	PRIORITY 3
Purpose of Action	LEVEL 2
Deficiency Photo1

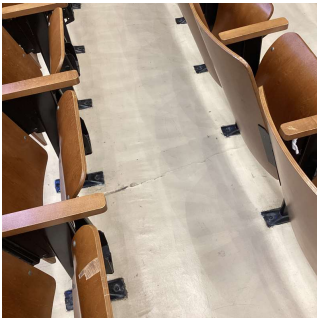
Violations	Seat D/1 No violations recorded.
Floor Finish	
Instance on 1st Floor (1297 Seats)	Inspected
Condition	2 - Between Good and Fair
Deficiency	CONCRETE: CRACKS
Deficiency Location/Instance	Near Seat D/3, 20, 2nd Floor Balcony
Deficiency Quantity	75
Quantity Uom	S.F.
Potential Action	REPLACE
Urgency of Action	PRIORITY 3
Purpose of Action	LEVEL 2
Deficiency Photo1

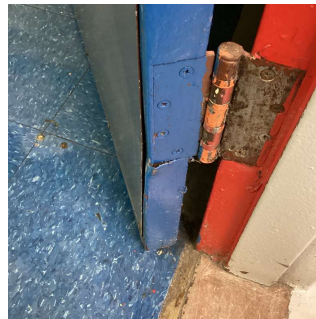
Instance on Basement	Inspected
Condition	3 - Fair
Deficiency	METAL: DETERIORATED DOOR
Deficiency Location/Instance	Main Entrance
Deficiency Quantity	1
Quantity Uom	EACH
Potential Action	MAINTENANCE
Urgency of Action	PRIORITY 3
Purpose of Action	LEVEL 2
Deficiency Photo1

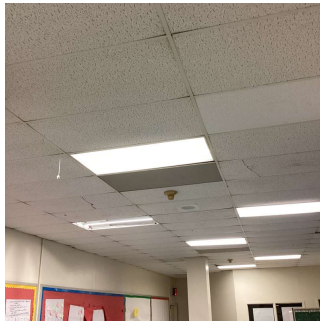
Near Stair A
Violations	No violations recorded.
Window Curtains/Shades/Blinds	
Instance on Basement	Does not Exist
CLASSROOMS/CORRIDORS/ADMIN SPACES	
Ceiling	Inspected
Condition	2 - Between Good and Fair
Deficiency	ACOUSTIC TILES: DAMAGED/MISSING
Deficiency Location/Instance	Room B30
Deficiency Quantity	20
Quantity Uom	S.F.
Potential Action	REPLACE
Urgency of Action	PRIORITY 3
Purpose of Action	LEVEL 2
Deficiency Photo1

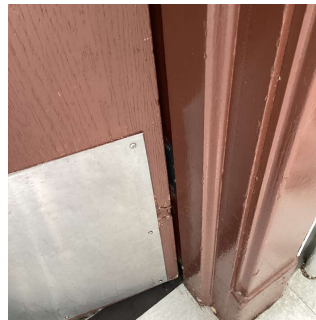
Room 350

WOOD: DETERIORATED DOOR

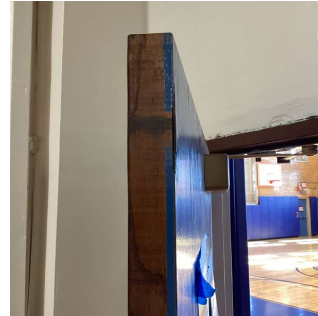
Main Entrance

WOOD: DETERIORATED DOOR

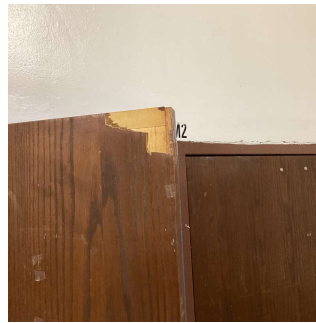
Main Entrance

WOOD: DETERIORATED DOOR

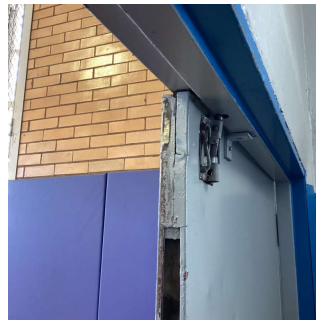
Storage Room

METAL: DETERIORATED DOOR

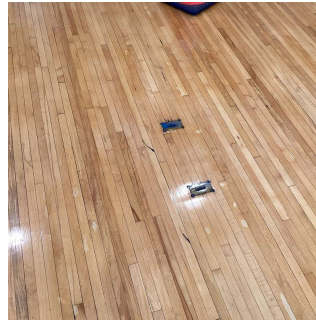
Deficiency	WOOD: DAMAGED/DETERIORATED
Deficiency Location/Instance	Center
Deficiency Quantity	20
Quantity Uom	S.F.
Potential Action	REPLACE
Urgency of Action	PRIORITY 3
Purpose of Action	LEVEL 2

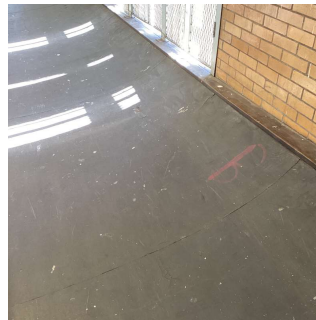
2nd Floor Running Track

SHEET VINYL: BROKEN/DETERIORATED

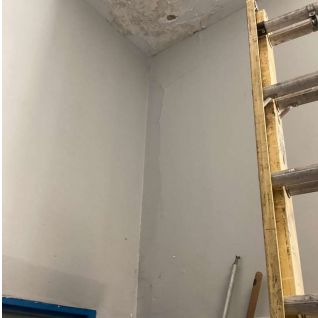
Question	Response
INTERIOR	
GYMNASIUM	
Stage	
Instance on 1st Floor - Gymnasium 1	Does not Exist
Instance on 1st Floor - Gymnasium 2	Does not Exist
Instance on 1st Floor - Gymnasium 3	Does not Exist
Walls	
Instance on 1st Floor - Gymnasium 3	Inspected
Condition	2 - Between Good and Fair
Deficiency	PLASTER: CRACKS/SPALLING
Deficiency Location/Instance	Storage Room
Deficiency Quantity	20
Quantity Uom	S.F.
Potential Action	REPLACE
Urgency of Action	PRIORITY 3
Purpose of Action	LEVEL 2
Deficiency Photo1

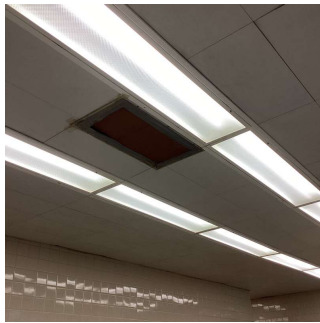
Question	Response
INTERIOR	
INTERIOR GUARDS	
Deficiency Photo1	 
Violations	Stair GH/3 No violations recorded.
KITCHEN	Inspected
Instance on Basement	Inspected
Ceiling	
Instance on Basement	Inspected
Condition	3 - Fair
Deficiency	METAL PAN: DAMAGED/MISSING
Deficiency Location/Instance	Near Sinks area, Near Walk-in Freezer
Deficiency Quantity	20
Quantity Uom	S.F.
Potential Action	REPLACE
Urgency of Action	PRIORITY 5
Purpose of Action	LEVEL 6
Deficiency Photo1	 
Violations	Near Sinks area No violations recorded.
Deficiency	METAL PAN: DAMAGED/MISSING
Deficiency Location/Instance	Serving area, near Office
Deficiency Quantity	20
Quantity Uom	S.F.
Potential Action	REPLACE
Urgency of Action	PRIORITY 3
Purpose of Action	LEVEL 2

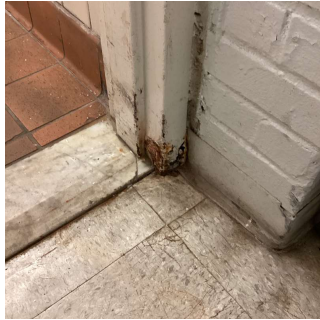
Violations	Serving area No violations recorded.
Door(s)	
Instance on Basement	Inspected
Condition	5 - Poor
Deficiency	METAL: DETERIORATED DOOR AND FRAME
Deficiency Location/Instance	Storage Room, Near Sinks area
Deficiency Quantity	2
Quantity Uom	EACH
Potential Action	MAINTENANCE
Urgency of Action	PRIORITY 3
Purpose of Action	LEVEL 2
Deficiency Photo1

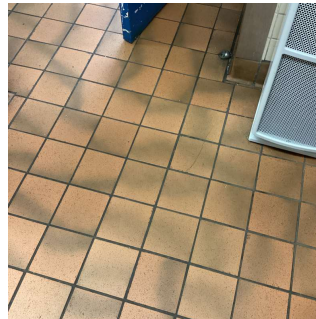
Deficiency QUARRY TILE: BROKEN/MISSING TILES

Deficiency Location/Instance Serving area

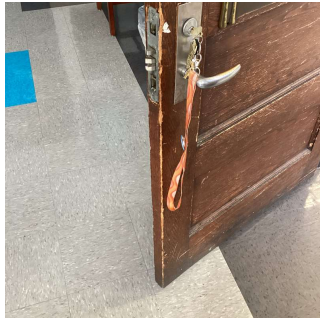
Question	Response
INTERIOR	
LIBRARY	Inspected
Instance on 3rd Floor	Inspected
Built-in Furnishing	
Instance on 3rd Floor	Inspected
Condition	2 - Between Good and Fair
Deficiency	No deficiencies recorded
Ceiling	
Instance on 3rd Floor	Inspected
Condition	2 - Between Good and Fair
Deficiency	No deficiencies recorded
Door(s)	
Instance on 3rd Floor	Inspected
Condition	5 - Poor
Deficiency	WOOD: DETERIORATED DOOR
Deficiency Location/Instance	Rooms 306B, 306C, Main Entrance
Deficiency Quantity	4
Quantity Uom	EACH
Potential Action	MAINTENANCE
Urgency of Action	PRIORITY 3
Purpose of Action	LEVEL 2
Deficiency Photo1

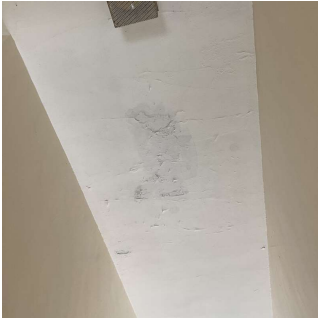
Deficiency	PLASTER: CRACKS/SPALLING
Deficiency Location/Instance	Stairs A/Basement, 2, B/2, C/2, F/3 and other
Deficiency Quantity	120
Quantity Uom	S.F.
Potential Action	REPLACE
Urgency of Action	PRIORITY 3
Purpose of Action	LEVEL 2
Deficiency Photo1

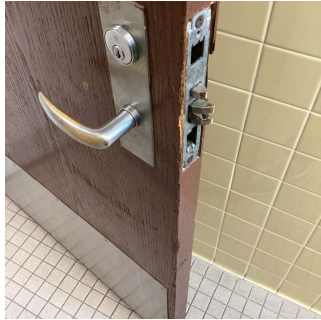
Question	Response
INTERIOR	
STAIRS/RAMPS: INTERIOR	Inspected
Walls	Inspected
Violations	Stair M/Basement No violations recorded.
TOILET ROOMS - STAFF	Inspected
Ceiling	Inspected
Condition	2 - Between Good and Fair
Deficiency	No deficiencies recorded
Door(s)	Inspected
Condition	5 - Poor
Deficiency	WOOD: DETERIORATED DOOR
Deficiency Location/Instance	Rooms 345A, 220A
Deficiency Quantity	2
Quantity Uom	EACH
Potential Action	MAINTENANCE
Urgency of Action	PRIORITY 3
Purpose of Action	LEVEL 2
Deficiency Photo1

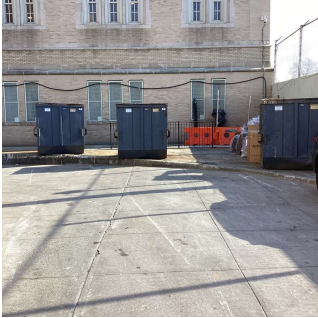
Question	Response
INTERIOR	
TOILET ROOMS - STUDENTS	
Walls	
Deficiency Photo1	 
Violations	Room 318B No violations recorded.
Deficiency	CERAMIC TILE: BROKEN/ MISSING
Deficiency Location/Instance	Rooms 318B, 244A, 245A, 107A
Deficiency Quantity	40
Quantity Uom	S.F.
Potential Action	REPLACE
Urgency of Action	PRIORITY 3
Purpose of Action	LEVEL 2
Deficiency Photo1	 
Violations	Room 318B No violations recorded.
LIFE SAFETY	Inspected
F.D. HOLDING AREA	Does not Exist
STEEL STAIRS	Does not Exist
SITE	Inspected
CONTAINERIZATION	Inspected
Condition	5 - Poor
Deficiency	FENCING MISSING
Deficiency Location/Instance	Near Athletic Field
Deficiency Quantity	600
Quantity Uom	S.F.
Potential Action	INSTALL NEW
Urgency of Action	PRIORITY 3
Purpose of Action	LEVEL 2
Deficiency Photo1	No photo recorded
Violations	No violations recorded.
Deficiency	CONTAINER DAMAGED
Deficiency Location/Instance	Near Athletic Field

Question	Response
SITE	
CONTAINERIZATION	
Deficiency Quantity	3
Quantity Uom	EACH
Potential Action	REPLACE
Urgency of Action	PRIORITY 3
Purpose of Action	LEVEL 2
Deficiency Photo1

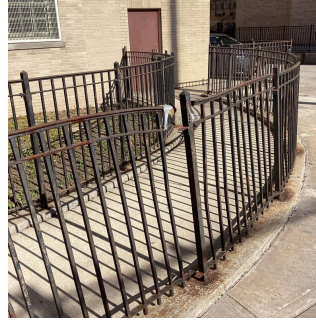
FENCES	Inspected
Condition	4 - Between Fair and Poor
Deficiency	WROUGHT IRON: DAMAGED/DETERIORATED
Deficiency Location/Instance	Near Exit 9
Deficiency Quantity	40
Quantity Uom	S.F.
Potential Action	REPLACE
Urgency of Action	PRIORITY 5
Purpose of Action	LEVEL 6

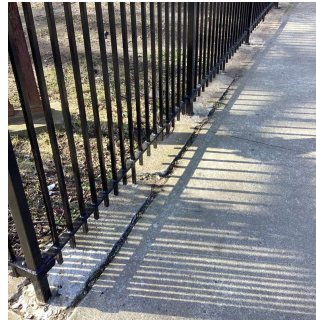
Tilden Avenue

CONCRETE CURB: DAMAGED/DETERIORATED

REPLACE

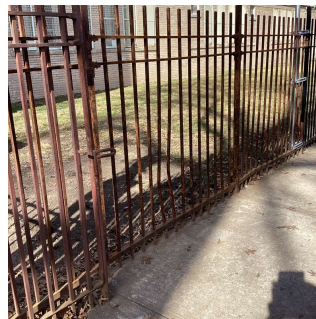
East 59th Street

WROUGHT IRON: DAMAGED/DETERIORATED

REPLACE

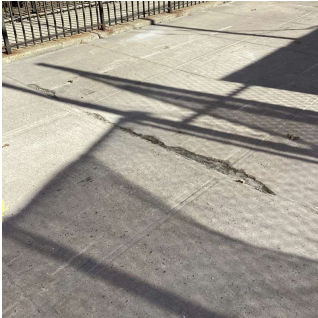
Question	Response
SITE	
IRRIGATION SYSTEM	Does not Exist
PAVING	Inspected
Student Non-Use	Inspected
Gravel Exists?	No
Asphalt	Does not Exist
Concrete	Inspected
Condition	4 - Between Fair and Poor
Deficiency	CRACKS - MAJOR
Deficiency Location/Instance	Driveway near Athletic Field, parking lot, East 57th Street
Deficiency Quantity	600
Quantity Uom	S.F.
Potential Action	REPLACE
Urgency of Action	PRIORITY 3
Purpose of Action	LEVEL 2
Deficiency Photo1

Driveway near Athletic Field
Violations	No violations recorded.
Pavers	Does not Exist
Student Use	Does not Exist
Site Sidewalks & Walkways	Inspected
Asphalt	Does not Exist
Concrete	Inspected
Condition	3 - Fair
Deficiency	CRACKS - MAJOR
Deficiency Location/Instance	Near Exit 6, near Athletic Field
Deficiency Quantity	275
Quantity Uom	S.F.
Potential Action	REPLACE
Urgency of Action	PRIORITY 3
Purpose of Action	LEVEL 2
Deficiency Photo1	 
	Near Exit 6

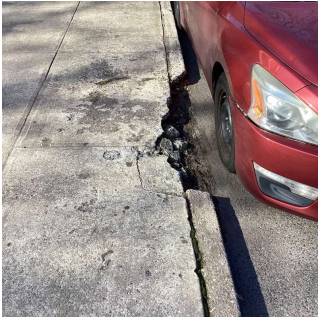
Question	Response
SITE	
PAVING	Inspected
Site Sidewalks & Walkways	Inspected
Concrete	Inspected
Violations	No violations recorded.
Pavers	Does not Exist
DOT Sidewalk	Inspected
Asphalt	Does not Exist
Concrete	Inspected
Condition	4 - Between Fair and Poor
Deficiency	DAMAGED CURBS
Deficiency Location/Instance	Tilden Avenue, East 59th Street, East 57th Street
Deficiency Quantity	160
Quantity Uom	L.F.
Potential Action	REPLACE
Urgency of Action	PRIORITY 3
Purpose of Action	LEVEL 2
Deficiency Photo1

Violations	Tilden Avenue No violations recorded.
Deficiency	DAMAGED/DETERIORATED/MISSING SECTIONS
Deficiency Location/Instance	Tilden Avenue, East 59th Street, East 57th Street
Deficiency Quantity	1,625
Quantity Uom	S.F.
Potential Action	REPLACE
Urgency of Action	PRIORITY 3
Purpose of Action	LEVEL 2
Deficiency Photo1

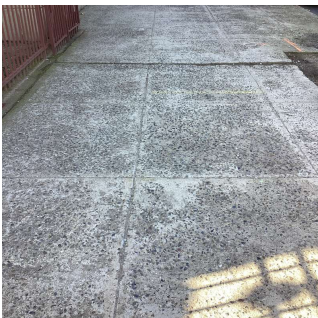
Violations	Tilden Avenue No violations recorded.
Deficiency	DAMAGED/DETERIORATED/MISSING SECTIONS
Deficiency Location/Instance	Tilden Avenue

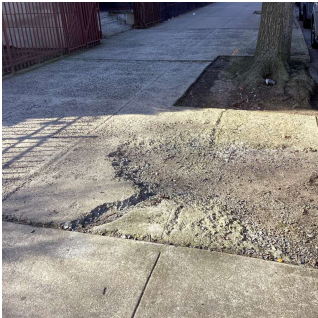
Question	Response
SITE	
PAVING	
DOT Sidewalk	Inspected
Concrete	Inspected
Quantity Uom	S.F.
Potential Action	REPLACE
Urgency of Action	PRIORITY 5
Purpose of Action	LEVEL 6
Deficiency Photo1

Violations	Tilden Avenue No violations recorded.
Deficiency	HEAVING
Deficiency Location/Instance	Tilden Avenue, East 59th Street, East 57th Street
Deficiency Quantity	400
Quantity Uom	S.F.
Potential Action	REPLACE
Urgency of Action	PRIORITY 3
Purpose of Action	LEVEL 2
Deficiency Photo1

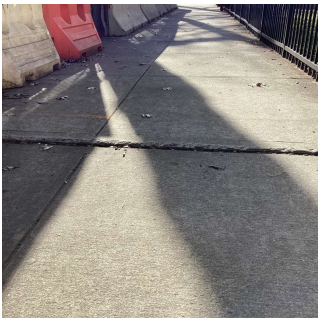
Violations	East 59th Street No violations recorded.
Pavers	Does not Exist
PLAYGROUNDS	Does not Exist
PLAYING SURFACE	Does not Exist
RETAINING WALLS	Inspected
Are there any Retaining Walls 6' OR higher facing public street/sidewalk?	No
Condition	3 - Fair
Deficiency	CAST IN PLACE CONCRETE: CRACKS/SPALLING - MAJOR
Deficiency Location/Instance	Near Exit 6
Deficiency Quantity	20
Quantity Uom	S.F.
Potential Action	REPLACE
Urgency of Action	PRIORITY 3

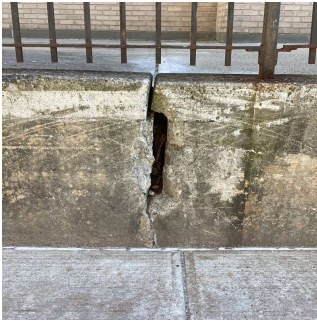
Violations	Near Exit 6 No violations recorded.
Deficiency	MASONRY UNIT: DETERIORATED CONTROL/EXPANSION JOINT
Deficiency Location/Instance	Near Exit 6
Deficiency Quantity	20
Quantity Uom	L.F.
Potential Action	REPLACE
Urgency of Action	PRIORITY 3
Purpose of Action	LEVEL 2
Deficiency Photo1

Violations	Near Exit 6 No violations recorded.
SEATING	Does not Exist
SITE WALLS (NOT RETAINING WALLS)	Does not Exist
STAIRS/RAMPS: EXTERIOR	Does not Exist
ARTWORK	Inspected
Instance	Interior - Room 327 - 21027
Instance ID	21027
Artwork exist at stated location?	No
Instance	Interior - Room 327 - 17015
Instance Photo	 
	Room 327
Instance ID	17015
Artwork exist at stated location?	Yes
