**NYC Department of Education**  
**Building Condition Assessment Survey 2023 - 2024**

Architectural Inspection

**K422**

**Asset:**        **SPRING CREEK EDUCATIONAL CAMPUS - BROOKLYN, 1065 ELTON STREET, New York, 11208**

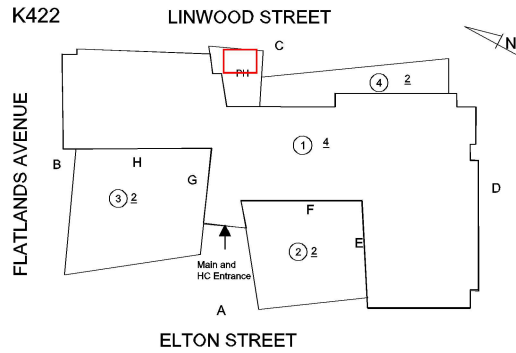
Roof Plan reference

Question	Response
<b>Architectural</b>	
<b>EXTERIOR</b>	Inspected
<b>AREAWAY</b>	Does not Exist
<b>AWNINGS AND CANOPIES</b>	Inspected
Condition	2 - Between Good and Fair
Deficiency	No deficiencies recorded
<b>CHIMNEY</b>	Inspected
Material Type(s)	Metal
Condition	3 - Fair
Deficiency	METAL: LOOSE OR MISSING SUPPORTS

**CHIMNEY**

2  
 EACH  
 REPAIR  
 PRIORITY 3  
 LEVEL 2

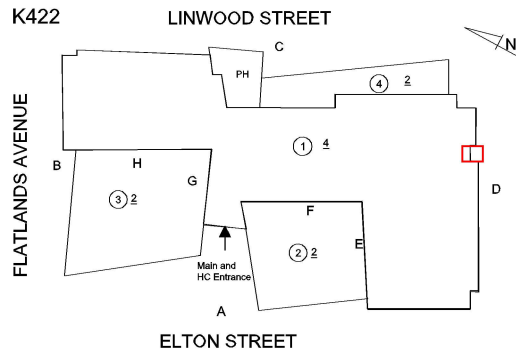
Roof Plan reference

METAL: DETERIORATED DOOR AND FRAME - MINOR DETERIORATION

2  
 EACH  
 MAINTENANCE  
 PRIORITY 3

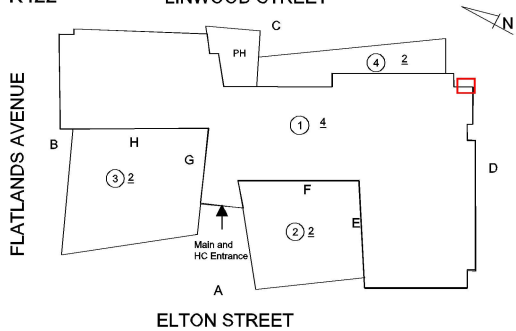
Violations	Facade D No violations recorded.
Deficiency	METAL: DETERIORATED DOOR - MINOR DETERIORATION
Roof Plan reference	K422 LINWOOD STREET FLATLANDS AVENUE ELTON STREET

Deficiency Quantity	1
Quantity Uom	EACH
Potential Action	MAINTENANCE
Urgency of Action	PRIORITY 3
Purpose of Action	LEVEL 2
Deficiency Photo1

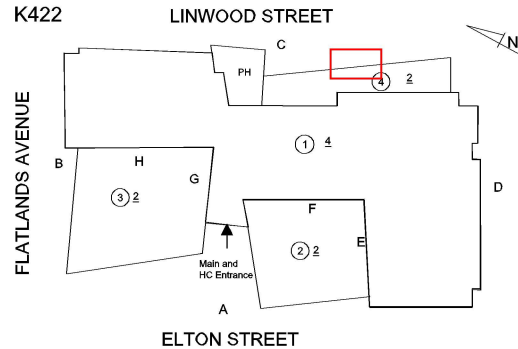
Roof Plan reference

CAST IN PLACE / PRE-CAST CONCRETE: MINOR  
CRACKS/SPALLING

Question	Response
<b>EXTERIOR</b>	
<b>EXTERIOR WALLS</b>	
Elevation	 
Deficiency Quantity	20
Quantity Uom	S.F.
Potential Action	REPAIR
Urgency of Action	PRIORITY 3
Purpose of Action	LEVEL 2
Deficiency Photo1	 
Violations	Facade C No violations recorded.
<b>EXTERIOR SOFFITS</b>	Inspected
Condition	2 - Between Good and Fair
Deficiency	No deficiencies recorded
<b>LOADING DOCK</b>	Does not Exist
<b>LOUVER</b>	Inspected
Condition	2 - Between Good and Fair
Deficiency	No deficiencies recorded
<b>PARAPETS</b>	Inspected
Material Type(s)	Concrete, Masonry, Metal
Replacement Quantity	12,000
Replacement Uom	C.F.
Instance on All Facades	Inspected
Instance Condition	3 - Fair
Instance Quantity	12,000
Instance Quantity Uom	C.F.
Deficiency	BRICK: MAJOR DETERIORATION/CRACKS

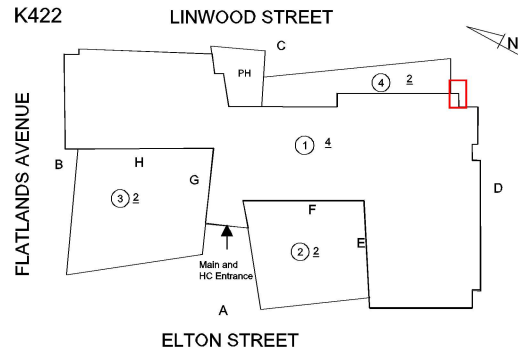
Roof Plan reference

**PARAPETS**

10  
S.F.  
REMOVE AND REBUILD  
PRIORITY 4  
LEVEL 2

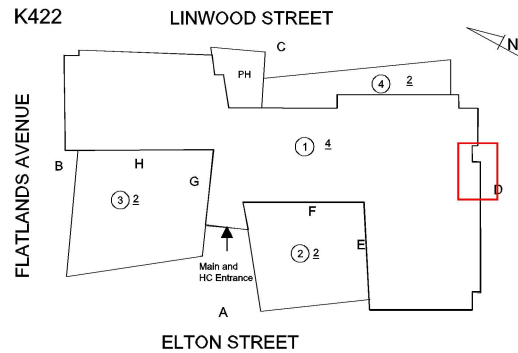
Roof Plan reference

**BRICK: EFFLORESCENCE**

40  
S.F.  
MAINTENANCE  
PRIORITY 1  
LEVEL 1

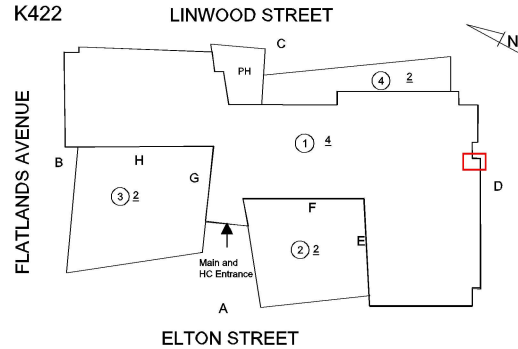
Roof Plan reference

BRICK: MINOR CRACKS, SPALLING

REPAIR

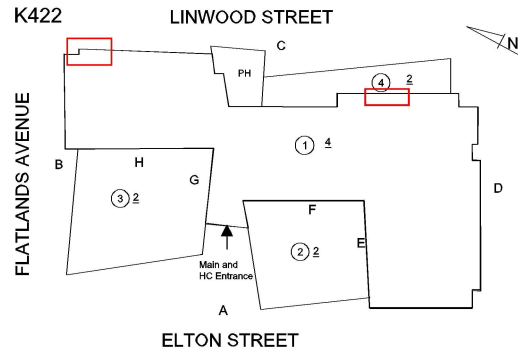
Roof Plan reference

CONCRETE: MINOR CRACKS, SPALLING

**PARAPETS**

30  
 S.F.  
 REPAIR  
 PRIORITY 3  
 LEVEL 2

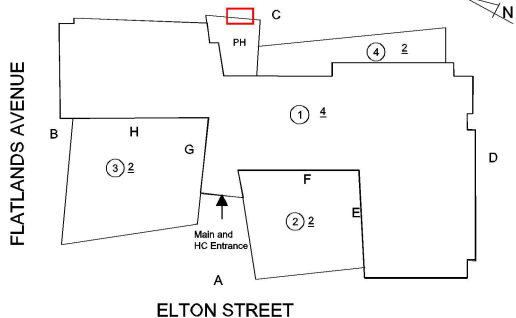
Question	Response
<b>EXTERIOR</b>	
<b>ROOF</b>	
<b>Roofing</b>	
<b>ROOFING</b>	
Instance Photo	 
	Roof 4
Instance Quantity	35,000
Instance Quantity Uom	S.F.
Does the roof have major mechanical equipment sitting on Dunnage Steel less than 18" above the Roofing?	No
Does this roof instance have a Sustainable Roof System?	No
Do solar panels exist on these roofs?	No
Is/Are the roof(s) suitable for Solar Panel installation?	Yes
Installation Year	2012
Source of Installation	Custodial Staff
Deficiency	IRMA: FLASHING: DETERIORATED JOINTS
Roof Plan reference	K422 LINWOOD STREET

Deficiency Quantity	10
Quantity Uom	L.F.
Potential Action	MAINTENANCE
Urgency of Action	PRIORITY 3
Purpose of Action	LEVEL 2
Deficiency Photo1	 
	Roof 1 PH
Violations	No violations recorded.
Deficiency	IRMA: FLASHING: BASE FLASHING DETERIORATED

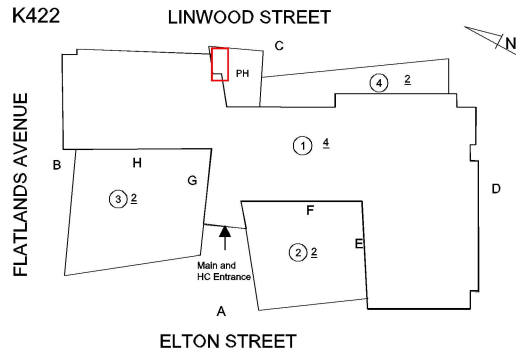
Roof Plan reference

**ROOFING**

30  
S.F.  
REPAIR  
PRIORITY 3  
LEVEL 2

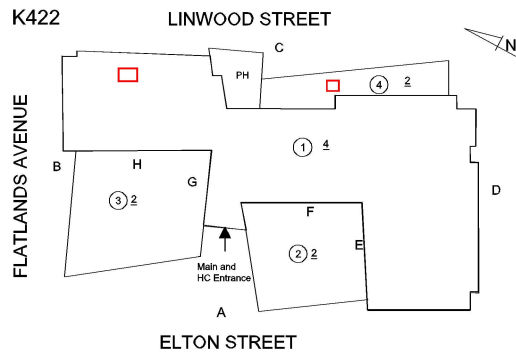
Roof Plan reference

DETERIORATED

2  
EACH  
REPLACE  
PRIORITY 4  
LEVEL 2

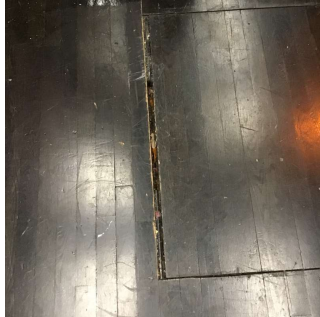
Question	Response
<b>INTERIOR</b>	
<b>AUDITORIUM</b>	
<b>Stage</b>	
<b>Stage</b>	
Deficiency Photo1

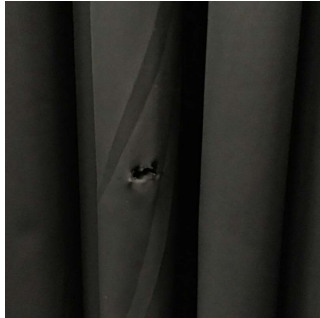
Right side
Violations	No violations recorded.
<b>Stage Curtain Rigging</b>	Inspected
Instance on 1st Floor (599 seats)	Inspected
Condition	2 - Between Good and Fair
Deficiency	No deficiencies recorded
<b>Stage Curtains</b>	Inspected
Instance on 1st Floor (599 seats)	Inspected
Condition	3 - Fair
Deficiency	WORN/DETERIORATED
Deficiency Location/Instance	Left side
Deficiency Quantity	100
Quantity Uom	S.F.
Potential Action	REPLACE
Urgency of Action	PRIORITY 3
Purpose of Action	LEVEL 2
Deficiency Photo1

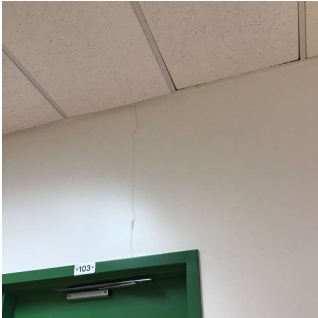
Question	Response
<b>INTERIOR</b>	
<b>CLASSROOMS/CORRIDORS/ADMIN SPACES</b>	
<b>Floor Finish</b>	Inspected
	Near cafeteria
Violations	No violations recorded.
<b>Walls</b>	Inspected
Condition	2 - Between Good and Fair
Deficiency	GYPSON BOARD: DETERIORATED
Deficiency Location/Instance	Corridor near Room 246,229,225,119,103, and others
Deficiency Quantity	100
Quantity Uom	S.F.
Potential Action	REPLACE
Urgency of Action	PRIORITY 3
Purpose of Action	LEVEL 2
Deficiency Photo1

Violations	Corridor near Room 103 No violations recorded.
Deficiency	CERAMIC TILE: BROKEN/ MISSING
Deficiency Location/Instance	Corridor near Room 243,220,103,B/4,A/1, and others
Deficiency Quantity	80
Quantity Uom	S.F.
Potential Action	REPLACE
Urgency of Action	PRIORITY 3
Purpose of Action	LEVEL 2
Deficiency Photo1

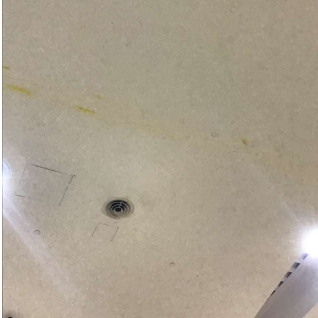
Question	Response
<b>INTERIOR</b>	
<b>GYMNASIUM</b>	
Instance on 1st Floor	Inspected
<b>Ceiling</b>	
Instance on 1st Floor	Inspected
Condition	2 - Between Good and Fair
Deficiency	GYPSUM BOARD: DAMAGED/DETERIORATED
Deficiency Location/Instance	Near Entrance
Deficiency Quantity	50
Quantity Uom	S.F.
Potential Action	REPLACE
Urgency of Action	PRIORITY 3
Purpose of Action	LEVEL 2
Deficiency Photo1

Near Entrance
Violations	No violations recorded.
<b>Door(s)</b>	
Instance on 1st Floor	Inspected
Condition	2 - Between Good and Fair
Deficiency	No deficiencies recorded
<b>Fixed Equipment</b>	
Instance on 1st Floor	Inspected
Condition	2 - Between Good and Fair
Deficiency	No deficiencies recorded
<b>Floor Finish</b>	
Instance on 1st Floor	Inspected
Condition	2 - Between Good and Fair
Deficiency	WOOD: DAMAGED/DETERIORATED
Deficiency Location/Instance	Near Windows, center
Deficiency Quantity	10
Quantity Uom	S.F.
Potential Action	REPLACE

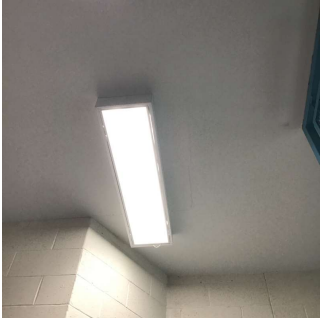
Violations	Center No violations recorded.
<b>Walls</b>	
Instance on 1st Floor - Visitors	Inspected
Condition	2 - Between Good and Fair
Deficiency	No deficiencies recorded
<b>STAIRS/RAMPS: INTERIOR</b>	
Do Letter Stair Signs Exist?	Inspected Yes
<b>Ceiling</b>	
Condition	Inspected 2 - Between Good and Fair
Deficiency	GYPSUM BOARD: DAMAGED/DETERIORATED
Deficiency Location/Instance	Stair B/4,C/4
Deficiency Quantity	20
Quantity Uom	S.F.
Potential Action	REPLACE
Urgency of Action	PRIORITY 3
Purpose of Action	LEVEL 2
Deficiency Photo1

Violations	Stair C/4 No violations recorded.
<b>Door(s)</b>	
Condition	Inspected 2 - Between Good and Fair
Deficiency	No deficiencies recorded
<b>Partition</b>	
Does not Exist	
<b>Railings</b>	
Inspected	
Condition	2 - Between Good and Fair

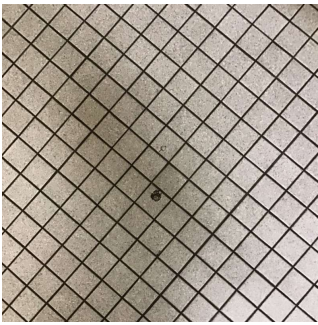
Question	Response
<b>INTERIOR</b>	
<b>TOILET ROOMS - STUDENTS</b>	
<b>Floor Finish</b>	
Deficiency Photo1

Violations	Room 324 No violations recorded.
<b>Stalls</b>	Inspected
Condition	2 - Between Good and Fair
Deficiency	No deficiencies recorded
<b>Walls</b>	Inspected
Condition	2 - Between Good and Fair
Deficiency	No deficiencies recorded
<b>LIFE SAFETY</b>	Inspected
<b>F.D. HOLDING AREA</b>	Does not Exist
<b>STEEL STAIRS</b>	Does not Exist
<b>SITE</b>	Inspected
<b>CONTAINERIZATION</b>	Does not Exist
<b>Drainage System for Asphalt</b>	Inspected
<b>Catch Basins/Manhole - Surrounded by asphalt</b>	Inspected
Condition	2 - Between Good and Fair
Deficiency	No deficiencies recorded
<b>Culverts - Asphalt Covering</b>	Does not Exist
<b>Drainage System for Concrete</b>	Inspected
<b>Catch Basins/Manhole - Surrounded by concrete</b>	Inspected
Condition	2 - Between Good and Fair
Deficiency	No deficiencies recorded
<b>Culverts - Concrete Covering</b>	Does not Exist
