NYC Department of Education
Building Condition Assessment Survey 2023 - 2024

Architectural Inspection

K426

Asset: MADISON AF - BROOKLYN, 3787 BEDFORD AVENUE, New York, 11229

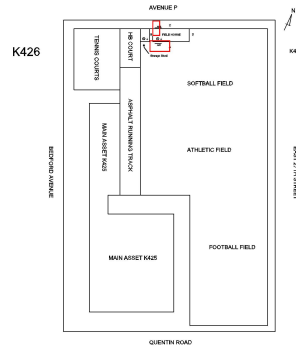
AREAWAY WALLS: CRACKS AND SPALLING

REPLACE

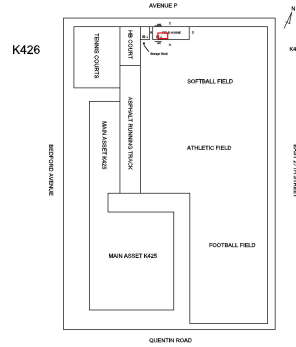
CHIMNEY

BRICK: MINOR CRACKS AND SPALLING

10
S.F.
RESTITCH
PRIORITY 3
LEVEL 2

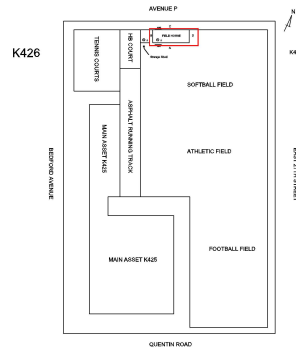
CAST STONE: DETERIORATED TRANSVERSE JOINTS

50
L.F.
MAINTENANCE
PRIORITY 3
LEVEL 2

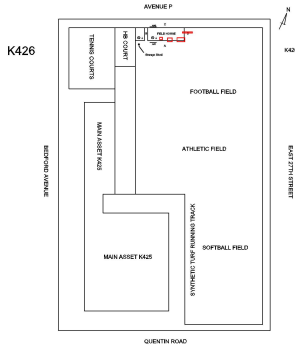
Violations	Roof 1 No violations recorded.
CORNICE	Inspected
Condition	2 - Between Good and Fair
Deficiency	No deficiencies recorded
DOORS	Inspected
DOORS AND FRAMES	Inspected
Condition	5 - Poor
Deficiency	METAL CLAD: DETERIORATED DOOR - MAJOR DETERIORATION
Roof Plan reference

Deficiency Quantity	4
Quantity Uom	EACH
Potential Action	REPLACE
Urgency of Action	PRIORITY 4
Purpose of Action	LEVEL 2
Deficiency Photo1

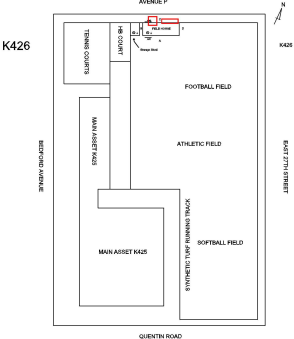
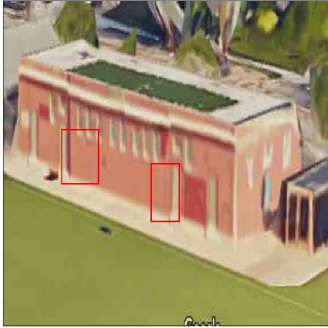
Question	Response
EXTERIOR	
DOORS	Inspected
LINTELS	Inspected
Condition	2 - Between Good and Fair
Deficiency	No deficiencies recorded
TRANSOM/SIDE LIGHT	Does not Exist
EXTERIOR WALLS	Inspected
Material Type(s)	Masonry
Replacement Quantity	4,000
Replacement Uom	S.F.
Instance on Fieldhouse	Inspected
Instance Condition	3 - Fair
Instance Quantity	2,500
Instance Quantity Uom	S.F.
Deficiency	BRICK: MAJOR / THRU CRACKS
Roof Plan reference

Deficiency Quantity	20
Quantity Uom	S.F.
Potential Action	REMOVE AND REBUILD
Urgency of Action	PRIORITY 4
Purpose of Action	LEVEL 2
Deficiency Photo1

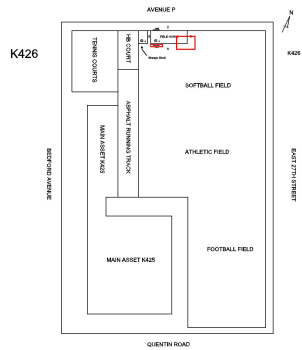
Question	Response
EXTERIOR	
PARAPETS	
Material Type(s)	Masonry
Replacement Quantity	1,000
Replacement Uom	C.F.
Instance on Fieldhouse Roof 1	Inspected
Instance Condition	3 - Fair
Instance Quantity	1,000
Instance Quantity Uom	C.F.
Deficiency	BRICK: EFFLORESCENCE
Roof Plan reference

Deficiency Quantity	80
Quantity Uom	S.F.
Potential Action	MAINTENANCE
Urgency of Action	PRIORITY 1
Purpose of Action	LEVEL 1
Deficiency Photo	No photo recorded
Violations	No violations recorded.
PLAZA DECK	Does not Exist
ROOF	Inspected
Roofing	Inspected
Replacement Quantity	3,200
Replacement Uom	S.F.
ROOF HATCH/SMOKE HATCH	Inspected
Condition	5 - Poor
Deficiency	DETERIORATED
Roof Plan reference

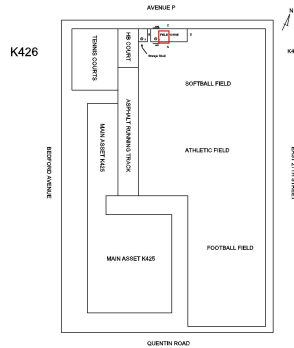
Roof 1 - 1st Floor - in West Office Room
No violations recorded.

Question	Response
EXTERIOR	
ROOF	
Roofing	
ROOFING	
Instance Photo	 
	Roof 1
Instance Quantity	2,400
Instance Quantity Uom	S.F.
Does the roof have major mechanical equipment sitting on Dunnage Steel less than 18" above the Roofing?	No
Does this roof instance have a Sustainable Roof System?	No
Do solar panels exist on these roofs?	No
Is/Are the roof(s) suitable for Solar Panel installation?	No
Installation Year	2002
Source of Installation	Custodial Staff
Deficiency	BUILT-UP: FLASHING: CAP FLASHING DAMAGED
Roof Plan reference	 
Deficiency Quantity	30
Quantity Uom	L.F.
Potential Action	REPLACE
Urgency of Action	PRIORITY 4
Purpose of Action	LEVEL 2
Deficiency Photo1	 
	Roof 1
Violations	No violations recorded.
Deficiency	BUILT-UP: ROOFING: MAJOR ACTIVE ROOF LEAKS IN INSTRUCTIONAL SPACE

100
S.F.
REPLACE ROOFING WITHOUT MAJOR EQUIPMENT
REMOVAL
PRIORITY 5
LEVEL 2

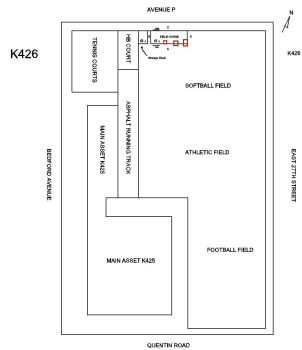
Question	Response
EXTERIOR	
ROOF	Inspected
Roofing	Inspected
ROOFING DRAINS	
Condition	2 - Between Good and Fair
Deficiency	No deficiencies recorded
Specialties	Does not Exist
STAIRS/RAMPS: EXTERIOR	Inspected
BUILDING CHEEK/FLANK WALLS	Does not Exist
RAILINGS	Does not Exist
STAIRS/RAMPS	Inspected
Condition	5 - Poor
Deficiency	STONE: CRACKS/SPALLING - MAJOR
Roof Plan reference

Deficiency Quantity	25
Quantity Uom	S.F.
Potential Action	REPLACE
Urgency of Action	PRIORITY 4
Purpose of Action	LEVEL 2
Deficiency Photo1

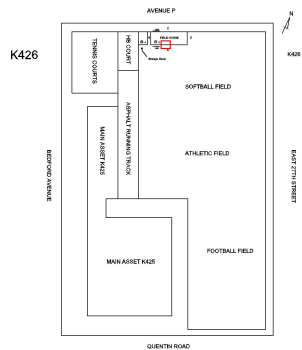
Deficiency	CONCRETE: CRACKS/SPALLING - MAJOR
Roof Plan reference

Question	Response
EXTERIOR	
STAIRS/RAMPS: EXTERIOR	Inspected
STAIRS/RAMPS	
Deficiency Quantity	10
Quantity Uom	S.F.
Potential Action	REPLACE
Urgency of Action	PRIORITY 4
Purpose of Action	LEVEL 2
Deficiency Photo1	 
Violations	Facade A No violations recorded.
WINDOWS	Inspected
Replacement Quantity	200
Replacement Uom	S.F.
EXTERIOR GUARDS	Inspected
Condition	2 - Between Good and Fair
Deficiency	No deficiencies recorded
LINTELS	Inspected
Condition	2 - Between Good and Fair
Deficiency	No deficiencies recorded
WINDOWS	Inspected
Material Type(s)	Aluminum
Instance on Aluminum - Double Hung: Fieldhouse	Inspected
Instance Condition	3 - Fair
Instance Quantity	200
Instance Quantity Uom	S.F.
Are these windows insulated	No
Installation Year	1995
Source of Installation	Custodial Staff
Deficiency	No deficiencies recorded
INTERIOR	Inspected
STRUCTURAL	Inspected
COLUMNS/BEAMS/BEARING WALLS	Inspected
Condition	2 - Between Good and Fair
Deficiency	No deficiencies recorded

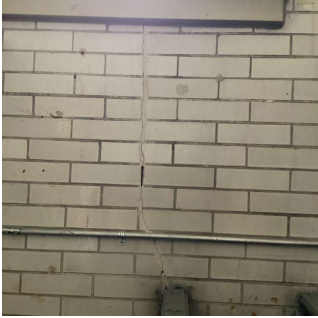
Question	Response
INTERIOR	
CLASSROOMS/CORRIDORS/ADMIN SPACES	
Door(s)	Inspected
Deficiency	No deficiencies recorded
Floor Finish	Inspected
Condition	2 - Between Good and Fair
Deficiency	No deficiencies recorded
Walls	Inspected
Condition	2 - Between Good and Fair
Deficiency	BRICK: CRACKS/SPALLING
Deficiency Location/Instance	Near Windows
Deficiency Quantity	10
Quantity Uom	S.F.
Potential Action	REPLACE
Urgency of Action	PRIORITY 3
Purpose of Action	LEVEL 2
Deficiency Photo1

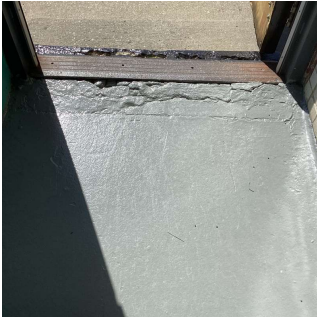
Condition	2 - Between Good and Fair
Deficiency	No deficiencies recorded
Door(s)	
Instance on 1st Floor - East (48 Lockers)	Not Required
Instance on 1st Floor - West (30 Lockers)	Not Required
Floor Finish	
Instance on 1st Floor - West (30 Lockers)	Inspected
Condition	2 - Between Good and Fair
Deficiency	CONCRETE: CRACKS
Deficiency Location/Instance	Near Main Entrance

Question	Response
INTERIOR	
LOCKER ROOM	
Floor Finish	
Deficiency Quantity	10
Quantity Uom	S.F.
Potential Action	REPLACE
Urgency of Action	PRIORITY 3
Purpose of Action	LEVEL 2
Deficiency Photo1

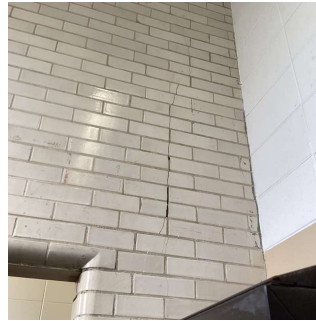
Near Entrance

Deficiency BRICK: CRACKS/SPALLING

Potential Action REPLACE

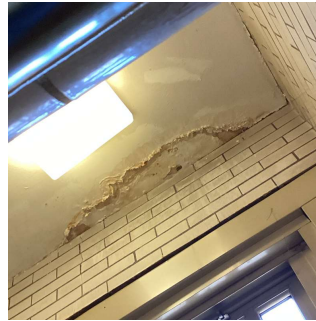
In West Office Room

PLASTER: CRACKS/SPALLING - ACTIVE LEAK

REPLACE

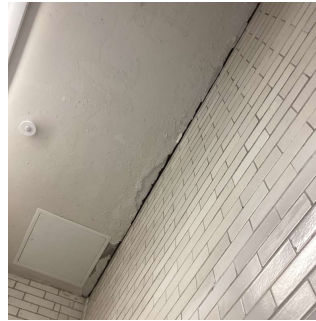
Violations	In East Office Room No violations recorded.
Stalls	Does not Exist
Walls	Inspected
Condition	2 - Between Good and Fair
Deficiency	No deficiencies recorded
TOILET ROOMS - STUDENTS	
Ceiling	Inspected
Condition	2 - Between Good and Fair
Deficiency	PLASTER: CRACKS/SPALLING
Deficiency Location/Instance	Girls Toilet Room
Deficiency Quantity	10
Quantity Uom	S.F.
Potential Action	REPLACE
Urgency of Action	PRIORITY 3
Purpose of Action	LEVEL 2

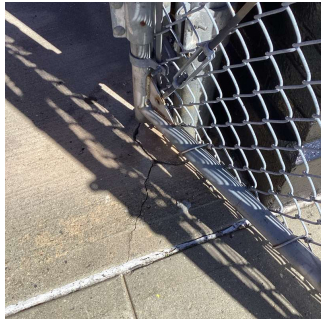
Near Boys Toilet Room
Violations	No violations recorded.
Pavers	Does not Exist
DOT Sidewalk	Inspected
Asphalt	Does not Exist
Concrete	Inspected
Condition	4 - Between Fair and Poor
Deficiency	HEAVING
Deficiency Location/Instance	Quentin Road, Bedford Avenue
Deficiency Quantity	175
Quantity Uom	S.F.

Question	Response
SITE	
IRRIGATION SYSTEM	Does not Exist
PAVING	Inspected
Student Non-Use	Does not Exist
Student Use	Inspected
Gravel Exists?	No
Asphalt	Does not Exist
Concrete	Inspected
Condition	2 - Between Good and Fair
Deficiency	No deficiencies recorded
Pavers	Does not Exist
Site Sidewalks & Walkways	Inspected
Asphalt	Does not Exist
Concrete	Inspected
Condition	3 - Fair
Deficiency	DAMAGED/DETERIORATED/MISSING SECTIONS
Deficiency Location/Instance	Near Boys Toilet Room, by Locker Room
Deficiency Quantity	175
Quantity Uom	S.F.
Potential Action	REPLACE
Urgency of Action	PRIORITY 3
Purpose of Action	LEVEL 2
Deficiency Photo1

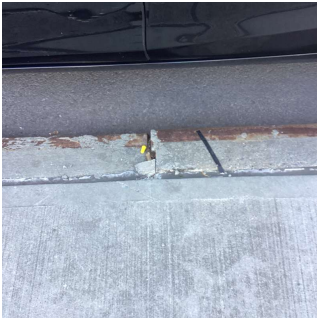
Question	Response
SITE	
PAVING	
DOT Sidewalk	
Concrete	
Violations	No violations recorded.
Deficiency	DAMAGED CURBS
Deficiency Location/Instance	Quentin Road, Bedford Avenue, Avenue P
Deficiency Quantity	180
Quantity Uom	L.F.
Potential Action	REPLACE
Urgency of Action	PRIORITY 3
Purpose of Action	LEVEL 2
Deficiency Photo1
