NYC Department of Education
Building Condition Assessment Survey 2023 - 2024

Architectural Inspection

Asset: BROOKLYN TECH AF - BROOKLYN, 490 CLERMONT AVENUE, New York, 11238

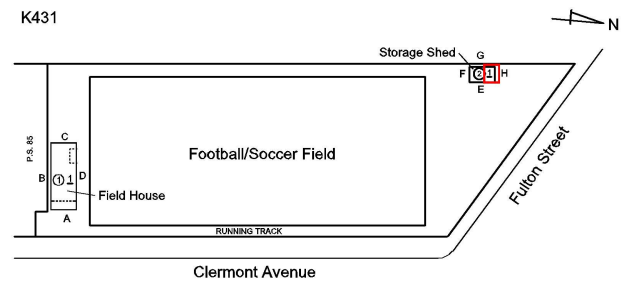
Question	Response
Architectural	
EXTERIOR	Inspected
AREAWAY	Does not Exist
AWNINGS AND CANOPIES	Does not Exist
CHIMNEY	Does not Exist
COPING	Does not Exist
CORNICE	Does not Exist
DOORS	Inspected
DOORS AND FRAMES	Inspected
Condition	3 - Fair
Deficiency	METAL: DETERIORATED DOOR AND FRAME - MINOR DETERIORATION
Roof Plan reference	K431
Deficiency Quantity	2
Quantity Uom	EACH
Potential Action	MAINTENANCE
Urgency of Action	PRIORITY 3
Purpose of Action	LEVEL 2

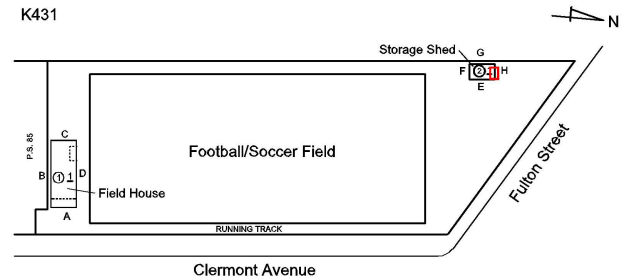
Instance on Facades E - H (Storage Shed)	Inspected
Instance Condition	3 - Fair
Instance Quantity	700
Instance Quantity Uom	S.F.
Deficiency	BRICK: MINOR CRACKS AND SPALLING
Roof Plan reference	K431

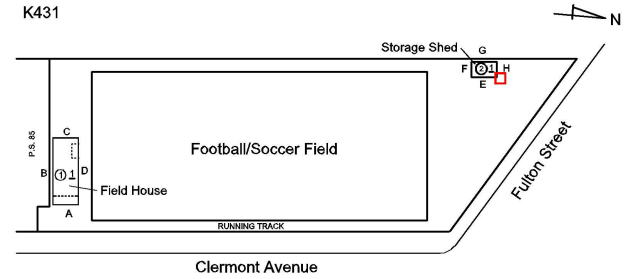
Deficiency

BRICK: MAJOR / THRU CRACKS

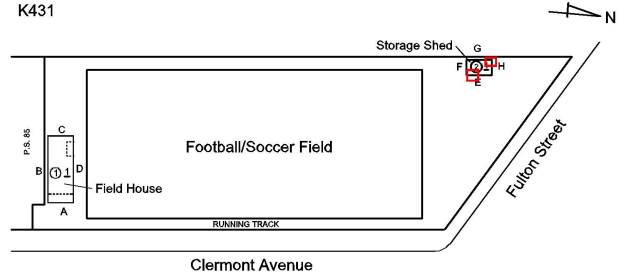
Roof 2
Instance Quantity	560
Instance Quantity Uom	S.F.
Does the roof have major mechanical equipment sitting on Dunnage Steel less than 18" above the Roofing?	No
Does this roof instance have a Sustainable Roof System?	Yes
Sustainable Roof Type	White Roof
Sustainable Roof Location (Roof Number)	Roof 2
Do solar panels exist on these roofs?	No
Is/Are the roof(s) suitable for Solar Panel installation?	No
Installation Year	2001
Source of Installation	Custodial Staff
Deficiency	METAL: FLASHING: DETERIORATED METAL FLASHING
Roof Plan reference	K431

Deficiency Quantity	10
Quantity Uom	L.F.
Potential Action	REMOVE AND REPLACE
Urgency of Action	PRIORITY 4
Purpose of Action	LEVEL 2
