NYC Department of Education
Building Condition Assessment Survey 2023 - 2024

Architectural Inspection

K441

Asset: 3K CENTER @ 274 ATLANTIC AVENUE - BROOKLYN, 274 ATLANTIC AVENUE, 11201

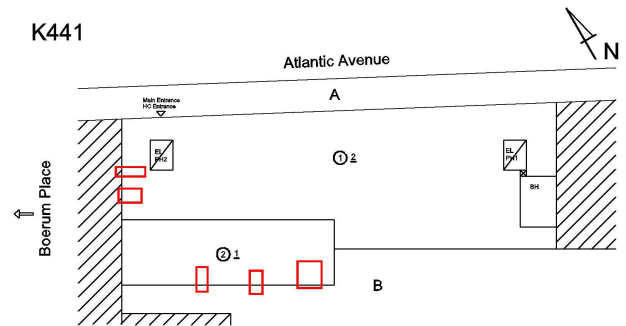
Question	Response
Architectural	
EXTERIOR	Inspected
AREAWAY	Does not Exist
AWNINGS AND CANOPIES	Does not Exist
CHIMNEY	Inspected
Material Type(s)	Metal
Condition	1 - Good
Deficiency	No deficiencies recorded
COPING	Inspected
Condition	2 - Between Good and Fair
Deficiency	METAL: DETERIORATED TRANSVERSE JOINTS
Roof Plan reference

10
 L.F.
 MAINTENANCE
 PRIORITY 3
 LEVEL 2

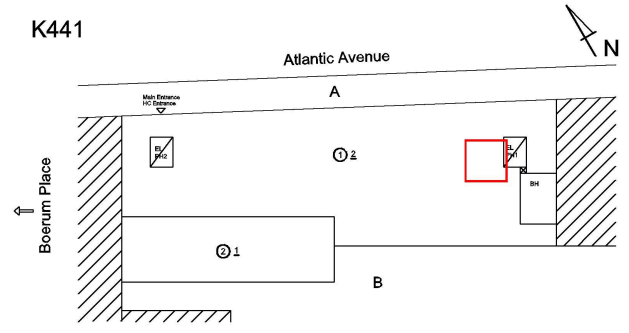
Question	Response
EXTERIOR	
PARAPETS	Inspected
Instance Quantity	1,000
Instance Quantity Uom	C.F.
Deficiency	No deficiencies recorded
PLAZA DECK	Does not Exist
ROOF	Inspected
Roofing	Inspected
Replacement Quantity	10,000
Replacement Uom	S.F.
ROOF HATCH/SMOKE HATCH	Does not Exist
LEADERS, GUTTERS, DOWNSPOUTS, SCUPPERS	Inspected
Condition	3 - Fair
Deficiency	DAMAGED/MISSING
Roof Plan reference

K441
10
L.F.
REPLACE
PRIORITY 4
LEVEL 2

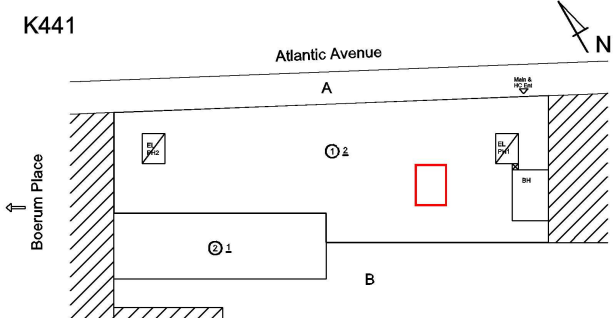
Question	Response
EXTERIOR	
ROOF	Inspected
Roofing	
ROOFING	
	Roof 1
Instance Quantity	10,000
Instance Quantity Uom	S.F.
Does the roof have major mechanical equipment sitting on Dunnage Steel less than 18" above the Roofing?	No
Does this roof instance have a Sustainable Roof System?	Yes
Sustainable Roof Type	White Roof
Sustainable Roof Location (Roof Number)	Roofs 1, 2
Do solar panels exist on these roofs?	No
Is/Are the roof(s) suitable for Solar Panel installation?	No
Installation Year	2018
Source of Installation	Custodial Staff
Deficiency	MODIFIED BITUMEN; ROOFING; MAJOR ACTIVE ROOF LEAKS IN NON-INSTRUCTIONAL SPACE
Roof Plan reference	<p>K441</p>

Deficiency Quantity	50
Quantity Uom	S.F.
Potential Action	REPLACE ROOFING WITHOUT MAJOR EQUIPMENT REMOVAL
Urgency of Action	PRIORITY 5
Purpose of Action	LEVEL 2
Deficiency Photo1

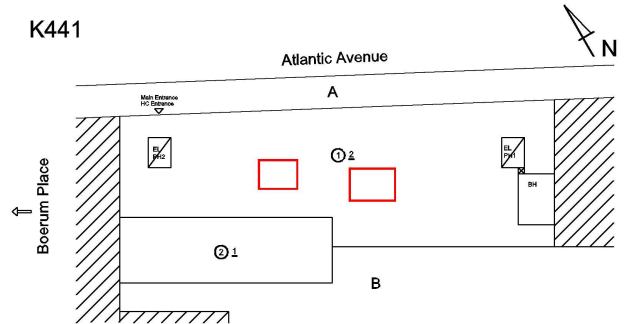
Condition	5 - Poor
Deficiency	DETERIORATED

4
 EACH
 REPLACE
 PRIORITY 4
 LEVEL 2

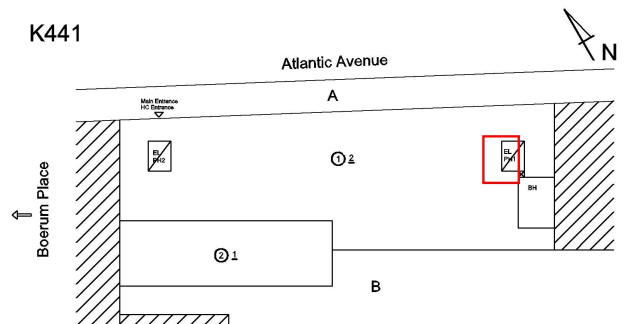
BULKHEAD/PENTHOUSE WALLS/EXTERIOR:
 CRACKS/SPALLING - MINOR

50
 S.F.
 REPAIR
 PRIORITY 3
 LEVEL 2
