NYC Department of Education
Building Condition Assessment Survey 2023 - 2024

Architectural Inspection

Asset: GRAND STREET CAMPUS (OLD E.D.HS)-K, 850 GRAND STREET, New York, 11225

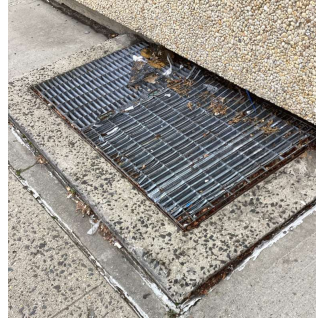
Question	Response
Architectural	
EXTERIOR	Inspected
AREAWAY	Inspected
Instance on AW1, AW2	Inspected
Instance Condition	3 - Fair
Instance Quantity	2
Instance Quantity Uom	EACH
Deficiency	AREAWAY WALLS: CRACKS AND SPALLING
Roof Plan reference	
Deficiency Quantity	10
Quantity Uom	S.F.
Potential Action	REPAIR
Urgency of Action	PRIORITY 3
Purpose of Action	LEVEL 2

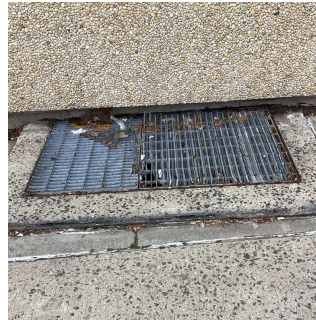
AW2

AREAWAY GRATINGS: MAJOR RUSTING AND / OR BROKEN SUPPORTS

REPLACE

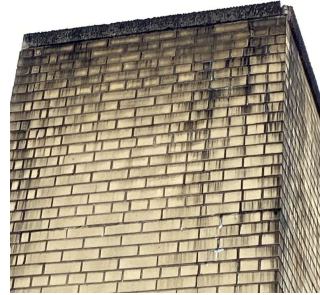
Chimney

BRICK: DETERIORATED CAP

20
L.F.
REPLACE
PRIORITY 3
LEVEL 2

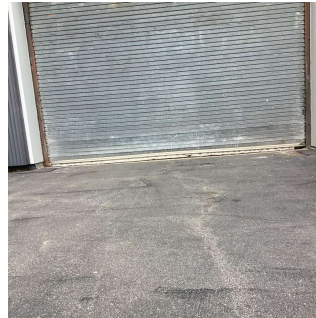
Facade N

ROLL-UP DOOR: DETERIORATED DOOR - MINOR DETERIORATION

120
S.F.
MAINTENANCE
PRIORITY 3

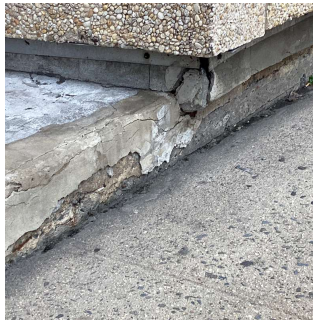
Facade R

CAST IN PLACE / PRE-CAST CONCRETE: MAJOR
CRACKS/SPALLING

REPLACE

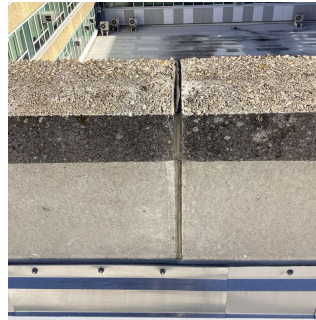
Roof 1 - Facade W

Violations	Facade C No violations recorded.
EXTERIOR SOFFITS	Inspected
Condition	2 - Between Good and Fair
Deficiency	No deficiencies recorded
LOADING DOCK	Does not Exist
LOUVER	Inspected
Condition	2 - Between Good and Fair
Deficiency	No deficiencies recorded
PARAPETS	Inspected
Material Type(s)	Concrete
Replacement Quantity	17,000
Replacement Uom	C.F.
Instance on All Facades	Inspected
Instance Condition	3 - Fair
Instance Quantity	17,000
Instance Quantity Uom	C.F.
Deficiency	CONCRETE: DETERIORATED CONTROL/EXPANSION JOINT
Roof Plan reference

Deficiency Quantity	100
Quantity Uom	L.F.
Potential Action	MAINTENANCE
Urgency of Action	PRIORITY 3
Purpose of Action	LEVEL 2

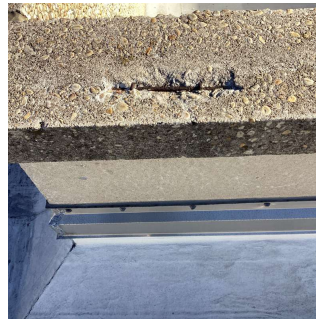
Roof 1 - Facade W

CONCRETE: MAJOR DETERIORATION/CRACKS

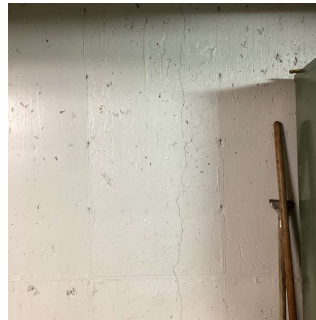
Basement Corridor to Boiler Room

CONCRETE: CRACKED/SPALLED/REINFORCEMENT EXPOSED

REPAIR

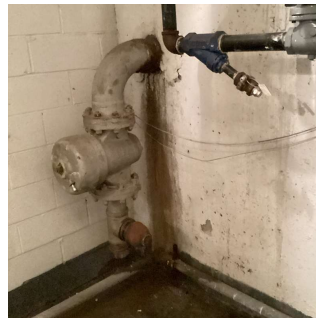
Room LM85

CONCRETE: WATER INFILTRATION IN NON- INSTRUCTIONAL SPACE

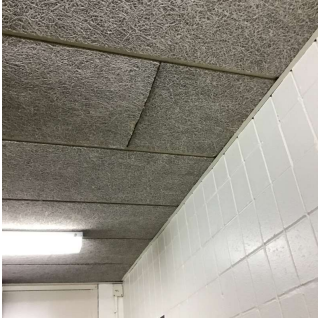
Question	Response
INTERIOR	
STRUCTURAL	
FOUNDATION WALLS	Inspected
Violations	No violations recorded.
ROOF STRUCTURE	Inspected
Condition	3 - Fair
Deficiency	CONCRETE COLUMNS AND BEAMS: CRACKED/SPALLED/REINFORCEMENT EXPOSED
Deficiency Location/Instance	Auditorium Fan Room, PH2
Deficiency Quantity	60
Quantity Uom	S.F.
Potential Action	REPAIR
Urgency of Action	PRIORITY 3
Purpose of Action	LEVEL 5
Deficiency Photo1	 
Violations	PH2 No violations recorded.
VAULTS-BUNKERS	Does not Exist
AUDITORIUM	Inspected
Instance on 2nd Floor (1000 seats) (14000 SF)	Inspected
Ceiling	
Instance on 2nd Floor (1000 seats) (14000 SF)	Inspected
Condition	2 - Between Good and Fair
Deficiency	TECTUM: DAMAGED/MISSING
Deficiency Location/Instance	Stage Left side Vestibule
Deficiency Quantity	20
Quantity Uom	S.F.
Potential Action	REPLACE
Urgency of Action	PRIORITY 3
Purpose of Action	LEVEL 2
Deficiency Photo1

Violations	Stage Left side Vestibule No violations recorded.

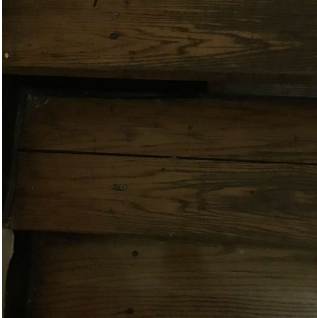
Question	Response
INTERIOR	
AUDITORIUM	
Stage	
Stage	
Deficiency Quantity	35
Quantity Uom	S.F.
Potential Action	REPLACE
Urgency of Action	PRIORITY 3
Purpose of Action	LEVEL 2
Deficiency Photo1

Right side
Violations	No violations recorded.
Deficiency	DAMAGED FASCIA
Deficiency Location/Instance	Right side
Deficiency Quantity	10
Quantity Uom	S.F.
Potential Action	REPLACE
Urgency of Action	PRIORITY 3
Purpose of Action	LEVEL 2
Deficiency Photo1

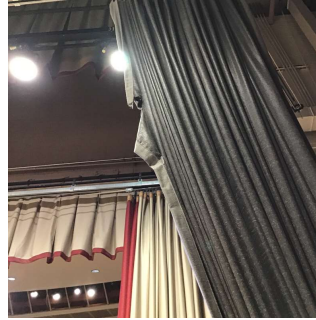
Right side
No violations recorded.

Urgency of Action
Purpose of Action
Deficiency Photo1

PRIORITY 3
LEVEL 2

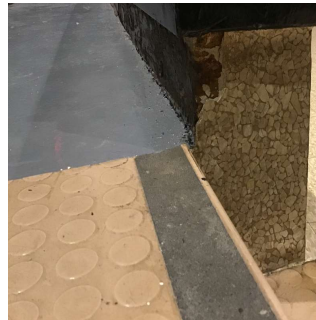
Near Seat AA/102
No violations recorded.

CERAMIC TILE: BROKEN/ MISSING
Near Seat AA/102
10
S.F.
REPLACE
PRIORITY 3
LEVEL 2

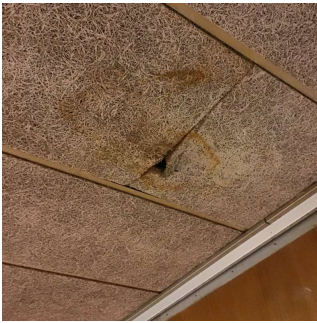
Question	Response
INTERIOR	
CAFETERIA	
Ceiling	
Deficiency Photo1

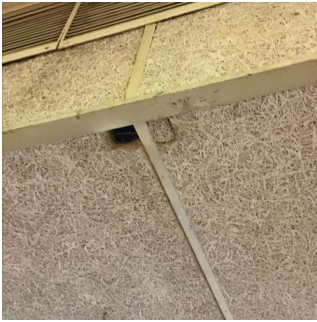
Violations	Near Sliding Folding Partition No violations recorded.
Instance on 1st Floor - Student B	Inspected
Condition	2 - Between Good and Fair
Deficiency	TECTUM: DAMAGED/MISSING
Deficiency Location/Instance	Near Entrance, Servery
Deficiency Quantity	25
Quantity Uom	S.F.
Potential Action	REPLACE
Urgency of Action	PRIORITY 3
Purpose of Action	LEVEL 2
Deficiency Photo1

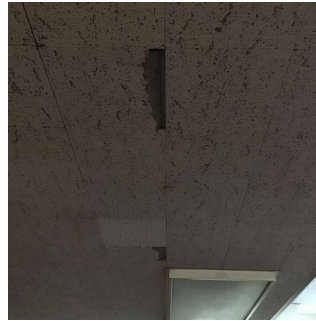
Near Windows

Violations	Near Entrance No violations recorded.
Instance on 1st Floor - Staff (1500 SF)	Inspected
Condition	2 - Between Good and Fair
Deficiency	ACOUSTIC TILES ON PLASTER: DAMAGED/MISSING
Deficiency Location/Instance	Near Entrance, windows, center
Deficiency Quantity	20
Quantity Uom	S.F.
Potential Action	REPLACE
Urgency of Action	PRIORITY 3
Purpose of Action	LEVEL 2

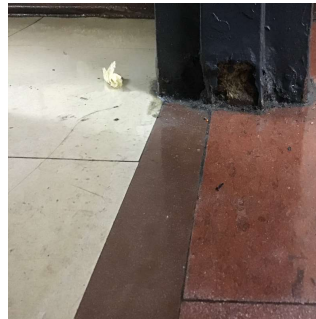
Instance on 1st Floor - Student A	Inspected
Condition	4 - Between Fair and Poor
Deficiency	METAL: DETERIORATED DOOR AND FRAME
Deficiency Location/Instance	Entrance
Deficiency Quantity	2
Quantity Uom	EACH
Potential Action	MAINTENANCE
Urgency of Action	PRIORITY 3
Purpose of Action	LEVEL 2
Deficiency Photo1

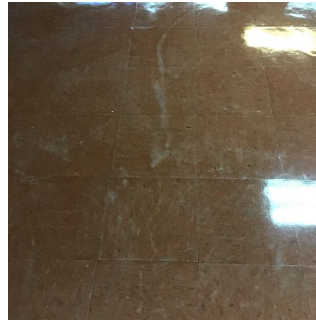
Near center

VINYL TILES: DETERIORATED SUBSTRATE

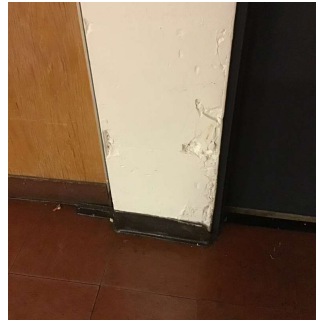
Near Sliding Folding Partition

Walls

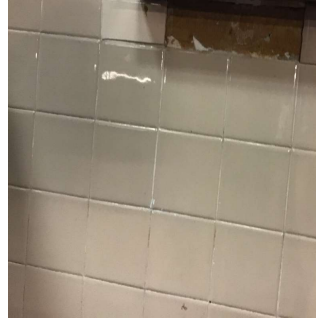
Near Servedy

CERAMIC TILE: BROKEN/ MISSING

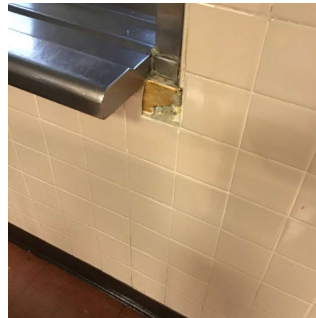
CERAMIC TILE: BROKEN/ MISSING

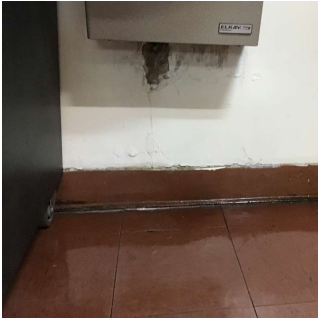
Question	Response
INTERIOR	
CAFETERIA	
Walls	
Violations	Near Servery No violations recorded.
Instance on 1st Floor - Staff (1500 SF)	Inspected
Condition	2 - Between Good and Fair
Deficiency	PLASTER: CRACKS/SPALLING
Deficiency Location/Instance	Near water fountain
Deficiency Quantity	10
Quantity Uom	S.F.
Potential Action	REPLACE
Urgency of Action	PRIORITY 3
Purpose of Action	LEVEL 2
Deficiency Photo1

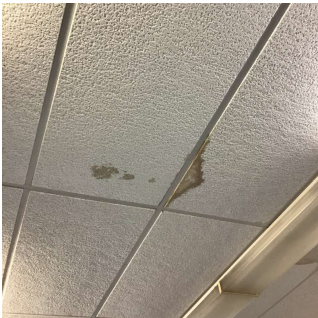
Violations	Near water fountain No violations recorded.
Window Curtains/Shades/Blinds	
Instance on 1st Floor - Staff (1500 SF)	Does not Exist
Instance on 1st Floor - Student A	Does not Exist
Instance on 1st Floor - Student B	Does not Exist
CLASSROOMS/CORRIDORS/ADMIN SPACES	
Condition	Inspected
Ceiling	Inspected
Condition	2 - Between Good and Fair
Deficiency	ACOUSTIC TILES: DAMAGED/MISSING
Deficiency Location/Instance	Room G181
Deficiency Quantity	10
Quantity Uom	S.F.
Potential Action	REPLACE
Urgency of Action	PRIORITY 3

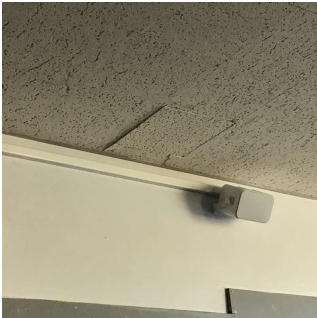
Question	Response
INTERIOR	
CLASSROOMS/CORRIDORS/ADMIN SPACES	
Ceiling	
Violations	No violations recorded.
Deficiency	ACOUSTIC TILES ON PLASTER: DAMAGED/MISSING
Deficiency Location/Instance	Room 437, 357,G283,G198,GGE
Deficiency Quantity	20
Quantity Uom	S.F.
Potential Action	REPLACE
Urgency of Action	PRIORITY 3
Purpose of Action	LEVEL 2
Deficiency Photo1

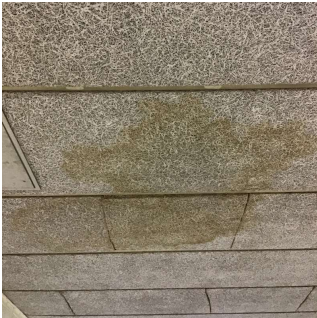
Violations	Room 437 No violations recorded.
Deficiency	TECTUM: DAMAGED/MISSING
Deficiency Location/Instance	Main Entrance Lobby, Corridor near Room 262,260B,257,210, and others
Deficiency Quantity	500
Quantity Uom	S.F.
Potential Action	REPLACE
Urgency of Action	PRIORITY 3
Purpose of Action	LEVEL 2
Deficiency Photo1

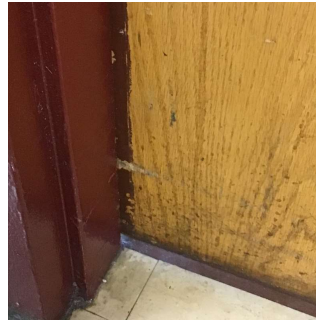
Room 405

Violations	Corridor near Room 257 No violations recorded.
Door(s)	Inspected
Condition	5 - Poor
Deficiency	WOOD: DETERIORATED DOOR
Deficiency Location/Instance	Room 462,460D,405,333,222, and others
Deficiency Quantity	40
Quantity Uom	EACH
Potential Action	MAINTENANCE

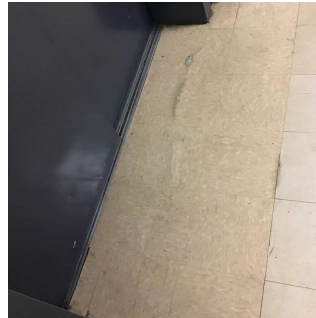
Corridor near Elevator B/1

VINYL TILES: DETERIORATED SUBSTRATE

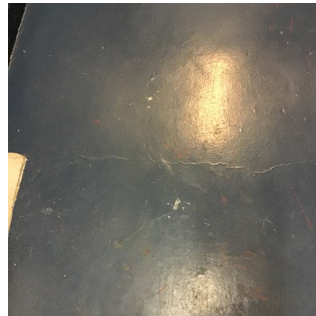
CONCRETE: CRACKS

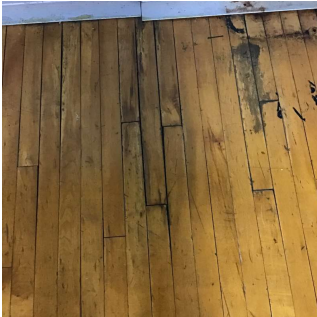
Question	Response
INTERIOR	
CLASSROOMS/CORRIDORS/ADMIN SPACES	
Floor Finish	
Violations	Exit 5 No violations recorded.
Deficiency	WOOD: DAMAGED/DETERIORATED
Deficiency Location/Instance	Room BGE
Deficiency Quantity	10
Quantity Uom	S.F.
Potential Action	REPLACE
Urgency of Action	PRIORITY 3
Purpose of Action	LEVEL 2
Deficiency Photo1

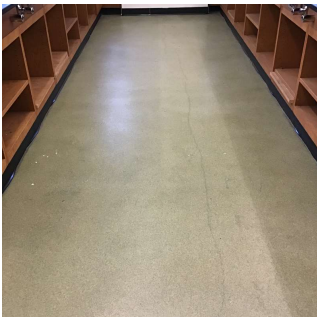
Violations	Room BGE No violations recorded.
Deficiency	EPOXY FLOORING: CRACKS/SPALLING
Deficiency Location/Instance	Room G283, G280A, G280
Deficiency Quantity	40
Quantity Uom	S.F.
Potential Action	REPLACE
Urgency of Action	PRIORITY 3
Purpose of Action	LEVEL 2
Deficiency Photo1

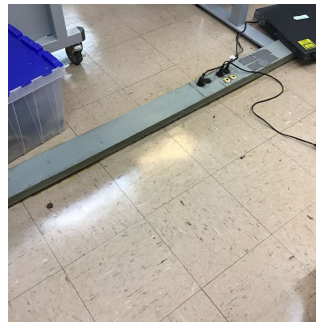
Room 462

Violations	Room G283 No violations recorded.
Deficiency	VINYL TILES: TRIPPING HAZARD - ELECTRICAL OUTLET
Deficiency Location/Instance	Room 462,330,G298,G297
Deficiency Quantity	40
Quantity Uom	S.F.
Potential Action	REMOVE
Urgency of Action	PRIORITY 5
Purpose of Action	LEVEL 6

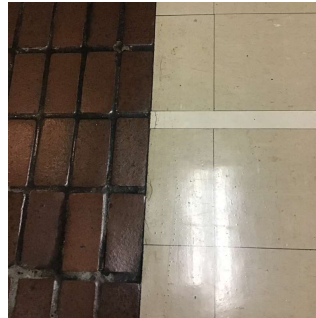
Corridor near Room 262

VINYL TILES: BROKEN/DETERIORATED/MISSING TILES

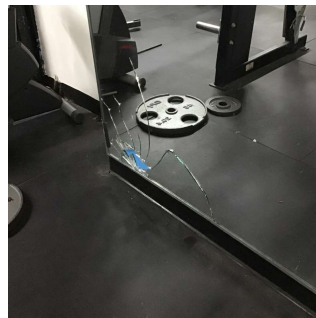
MIRRORS: BROKEN/DAMAGED

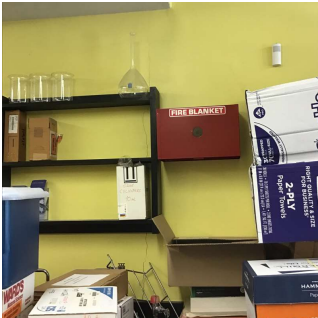
Question	Response
INTERIOR	
CLASSROOMS/CORRIDORS/ADMIN SPACES	
Walls	
Violations	Room G192 No violations recorded.
Deficiency	PLASTER: CRACKS/SPALLING
Deficiency Location/Instance	Room 455B, 450,G283,BGE, GGE, and others
Deficiency Quantity	100
Quantity Uom	S.F.
Potential Action	REPLACE
Urgency of Action	PRIORITY 3
Purpose of Action	LEVEL 2
Deficiency Photo1

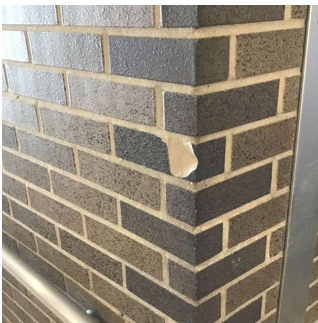
Violations	Room 455B No violations recorded.
Deficiency	BRICK: CRACKS/SPALLING
Deficiency Location/Instance	Main Entrance Lobby
Deficiency Quantity	10
Quantity Uom	S.F.
Potential Action	REPLACE
Urgency of Action	PRIORITY 3
Purpose of Action	LEVEL 2
Deficiency Photo1

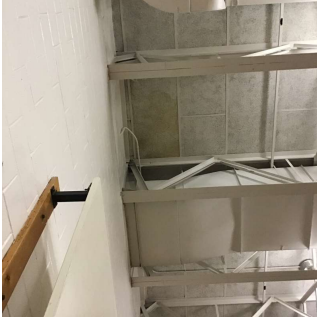
Question	Response
INTERIOR	
CLASSROOMS/CORRIDORS/ADMIN SPACES	
Specialties	
Classroom Locker(s)	
Urgency of Action	PRIORITY 3
Purpose of Action	LEVEL 2
Deficiency Photo1	 
	Corridor near Room 462
Violations	No violations recorded.
Fixed Seating	Does not Exist
GYMNASIUM	Inspected
Instance on 1st Floor - Gymnasium 1	Inspected
Instance on 1st Floor - Gymnasium 2	Inspected
Instance on 1st Floor - Gymnasium 3	Inspected
Instance on 1st Floor - Gymnasium 4	Inspected
Ceiling	
Instance on 1st Floor - Gymnasium 4	Inspected
Condition	2 - Between Good and Fair
Deficiency	ACOUSTIC TILES ON PLASTER: DAMAGED/MISSING
Deficiency Location/Instance	Near center
Deficiency Quantity	10
Quantity Uom	S.F.
Potential Action	REPLACE
Urgency of Action	PRIORITY 3
Purpose of Action	LEVEL 2
Deficiency Photo1	 
	Near center
Violations	No violations recorded.
Instance on 1st Floor - Gymnasium 2	Inspected
Condition	3 - Fair
Deficiency	TECTUM: DAMAGED/MISSING

Deficiency Location/Instance	Near Sliding Folding Partition
Deficiency Quantity	280

Question	Response
INTERIOR	
GYMNASIUM	
Ceiling	
Quantity Uom	S.F.
Potential Action	REPLACE
Urgency of Action	PRIORITY 3
Purpose of Action	LEVEL 2
Deficiency Photo1

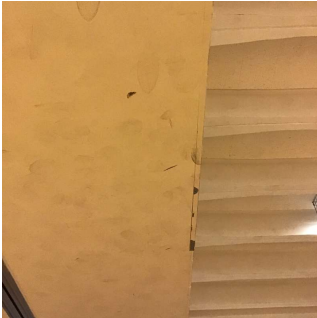
Violations	Near Sliding Folding Partition No violations recorded.
Instance on 1st Floor - Gymnasium 3	Inspected
Condition	2 - Between Good and Fair
Deficiency	GYPSUM BOARD: DAMAGED/DETERIORATED
Deficiency Location/Instance	Near center
Deficiency Quantity	10
Quantity Uom	S.F.
Potential Action	REPLACE
Urgency of Action	PRIORITY 3
Purpose of Action	LEVEL 2
Deficiency Photo1

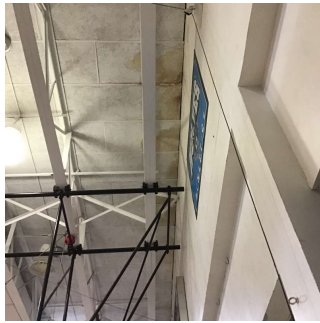
Violations	Near center No violations recorded.
Instance on 1st Floor - Gymnasium 1	Inspected
Condition	4 - Between Fair and Poor
Deficiency	TECTUM: DAMAGED/MISSING
Deficiency Location/Instance	Near Sliding Folding Partition
Deficiency Quantity	480
Quantity Uom	S.F.
Potential Action	REPLACE
Urgency of Action	PRIORITY 3
Purpose of Action	LEVEL 2

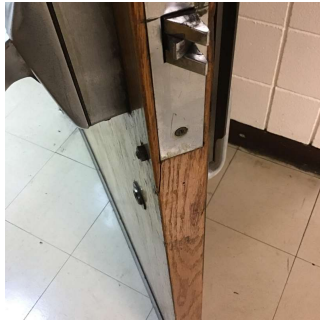
Violations	Near Sliding Folding Partition No violations recorded.
Door(s)	
Instance on 1st Floor - Gymnasium 4	Inspected
Condition	3 - Fair
Deficiency	WOOD: DETERIORATED DOOR
Deficiency Location/Instance	Entrance
Deficiency Quantity	1
Quantity Uom	EACH
Potential Action	MAINTENANCE
Urgency of Action	PRIORITY 3
Purpose of Action	LEVEL 2
Deficiency Photo1

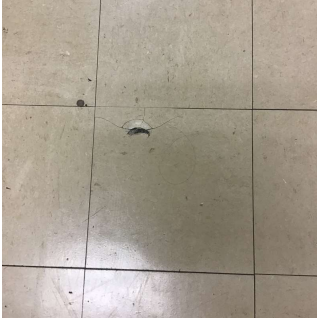
Question	Response
INTERIOR	
GYMNASIUM	
Floor Finish	
Condition	2 - Between Good and Fair
Deficiency	VINYL TILES: BROKEN/DETERIORATED/MISSING TILES
Deficiency Location/Instance	Near Entrance
Deficiency Quantity	10
Quantity Uom	S.F.
Potential Action	REPLACE
Urgency of Action	PRIORITY 3
Purpose of Action	LEVEL 2
Deficiency Photo1

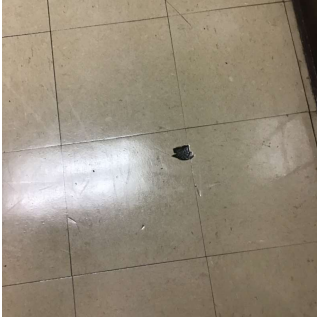
Near Entrance
Violations	No violations recorded.
Instance on 1st Floor - Gymnasium 4	Inspected
Condition	2 - Between Good and Fair
Deficiency	VINYL TILES: BROKEN/DETERIORATED/MISSING TILES
Deficiency Location/Instance	Near Entrance
Deficiency Quantity	10
Quantity Uom	S.F.
Potential Action	REPLACE
Urgency of Action	PRIORITY 3
Purpose of Action	LEVEL 2
Deficiency Photo1

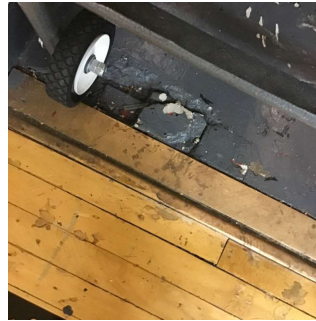
Near Entrance
Violations	No violations recorded.
Deficiency	CONCRETE: CRACKS
Deficiency Location/Instance	Near center
Deficiency Quantity	10
Quantity Uom	S.F.
Potential Action	REPLACE
Urgency of Action	PRIORITY 3
Purpose of Action	LEVEL 2

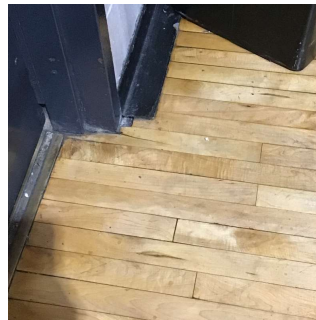
Near Entrance

WOOD: DAMAGED/DETERIORATED

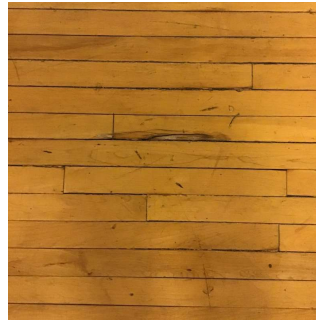
Near center

WOOD: DAMAGED/DETERIORATED

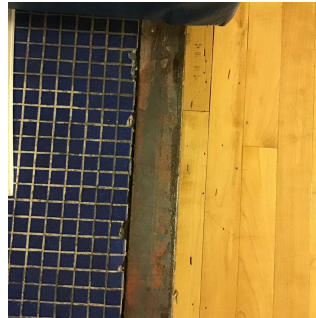
Near water fountain

CERAMIC TILE: BROKEN/MISSING TILES

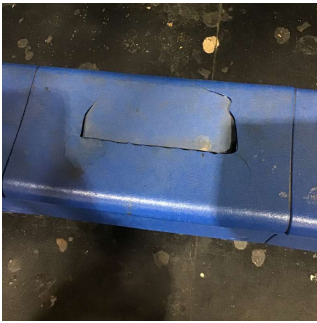
DAMAGED BLEACHERS

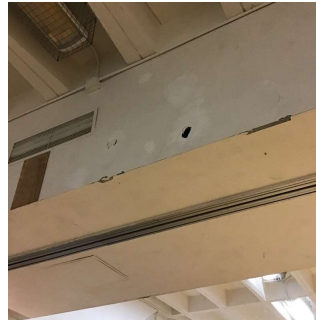
Condition	3 - Fair
Deficiency	GYPSUM BOARD: DETERIORATED
Deficiency Location/Instance	Near center
Deficiency Quantity	20
Quantity Uom	S.F.
Potential Action	REPLACE
Urgency of Action	PRIORITY 3
Purpose of Action	LEVEL 2

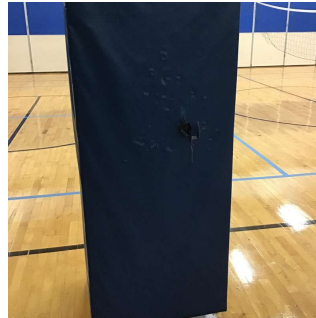
Near center

WALL PADDING: DETERIORATED

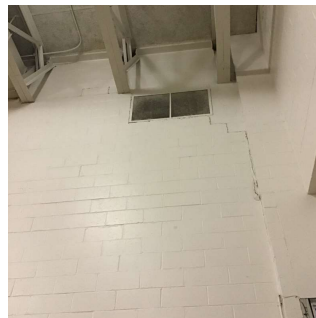
MASONRY: CRACKS/SPALLING

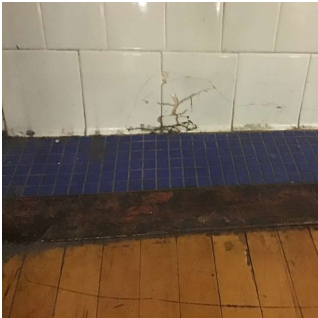
Question	Response
INTERIOR	
GYMNASIUM	
Walls	
Violations	Near Sliding Folding Partition No violations recorded.
Deficiency	CERAMIC TILE: BROKEN/ MISSING
Deficiency Location/Instance	Near water fountain
Deficiency Quantity	10
Quantity Uom	S.F.
Potential Action	REPLACE
Urgency of Action	PRIORITY 3
Purpose of Action	LEVEL 2
Deficiency Photo1

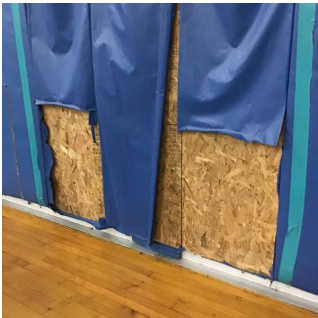
Violations	Near water fountain No violations recorded.
Deficiency	WALL PADDING: DETERIORATED
Deficiency Location/Instance	Near Entrance, center, Sliding Folding Partition
Deficiency Quantity	860
Quantity Uom	S.F.
Potential Action	REPLACE
Urgency of Action	PRIORITY 3
Purpose of Action	LEVEL 2
Deficiency Photo1

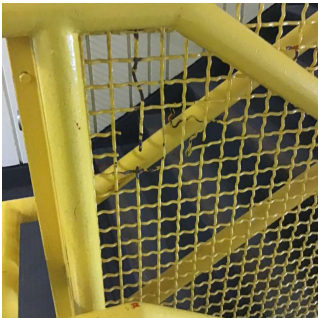
Question	Response
INTERIOR	
INTERIOR GUARDS	
Condition	2 - Between Good and Fair
Deficiency	DETERIORATED/TORN-OUT/MISSING
Deficiency Location/Instance	Stair D/2
Deficiency Quantity	10
Quantity Uom	S.F.
Potential Action	REPLACE
Urgency of Action	PRIORITY 3
Purpose of Action	LEVEL 2
Deficiency Photo1

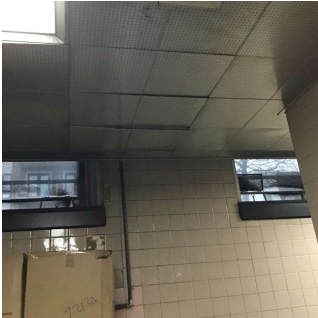
Violations	Stair D/2 No violations recorded.
KITCHEN	Inspected
Instance on 1st Floor (4500 SF)	Inspected
Ceiling	
Instance on 1st Floor (4500 SF)	Inspected
Condition	2 - Between Good and Fair
Deficiency	METAL PAN: DAMAGED/MISSING
Deficiency Location/Instance	Servery, Near center
Deficiency Quantity	10
Quantity Uom	S.F.
Potential Action	REPLACE
Urgency of Action	PRIORITY 3
Purpose of Action	LEVEL 2
Deficiency Photo1

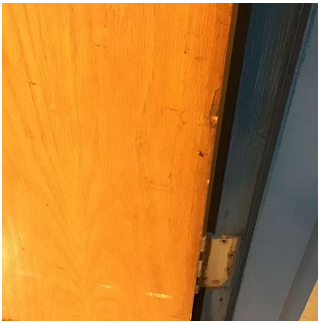
Question	Response
INTERIOR	
LIBRARY	Inspected
Door(s)	
Deficiency Photo1

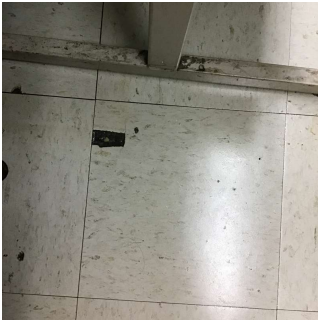
Entrance
Violations	No violations recorded.
Floor Finish	
Instance on Room 235 (3000 SF)	Inspected
Condition	2 - Between Good and Fair
Deficiency	VINYL TILES: BROKEN/DETERIORATED/MISSING TILES
Deficiency Location/Instance	Room 235D, 235E
Deficiency Quantity	15
Quantity Uom	S.F.
Potential Action	REPLACE
Urgency of Action	PRIORITY 3
Purpose of Action	LEVEL 2
Deficiency Photo1

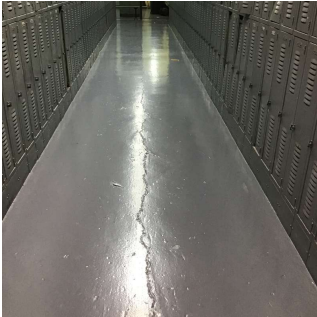
Deficiency	CONCRETE: CRACKS
Deficiency Location/Instance	Near locker 365, 371, 789,1639

Question	Response
INTERIOR	
LOCKER ROOM	
Floor Finish	
Deficiency Quantity	50
Quantity Uom	S.F.
Potential Action	REPLACE
Urgency of Action	PRIORITY 3
Purpose of Action	LEVEL 2
Deficiency Photo1

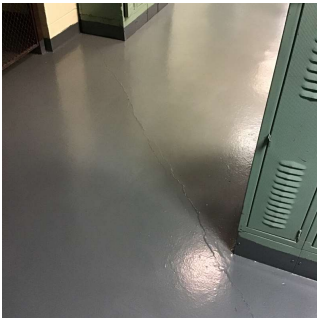
Near locker 1639
Violations	No violations recorded.
Instance on Basement - Girls (1914 Lockers)	Inspected
Condition	2 - Between Good and Fair
Deficiency	CONCRETE: CRACKS
Deficiency Location/Instance	Near locker 1425,1444,
Deficiency Quantity	20
Quantity Uom	S.F.
Potential Action	REPLACE
Urgency of Action	PRIORITY 3
Purpose of Action	LEVEL 2
Deficiency Photo1

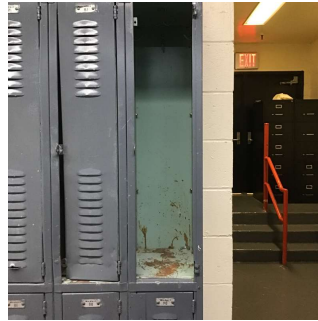
Locker 89

Near locker 1425
Violations	No violations recorded.
Locker Room Lockers	
Instance on Basement - Boys (1914 Lockers)	Inspected
Condition	3 - Fair
Deficiency	DAMAGED UNITS
Deficiency Location/Instance	Locker 9,12,41,78,89, and others
Deficiency Quantity	104
Quantity Uom	EACH
Potential Action	REPLACE
Urgency of Action	PRIORITY 3
Purpose of Action	LEVEL 2

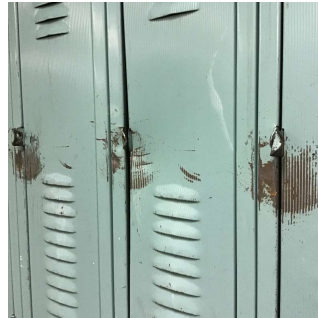
Locker 1753

DAMAGED UNITS

REPLACE

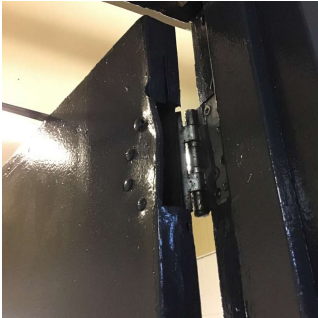
Question	Response
INTERIOR	
STAIRS/RAMPS: INTERIOR	
Ceiling	Inspected
Condition	2 - Between Good and Fair
Deficiency	No deficiencies recorded
Door(s)	Inspected
Condition	2 - Between Good and Fair
Deficiency	METAL: DETERIORATED DOOR
Deficiency Location/Instance	Stair E/1
Deficiency Quantity	1
Quantity Uom	EACH
Potential Action	MAINTENANCE
Urgency of Action	PRIORITY 3
Purpose of Action	LEVEL 2
Deficiency Photo1

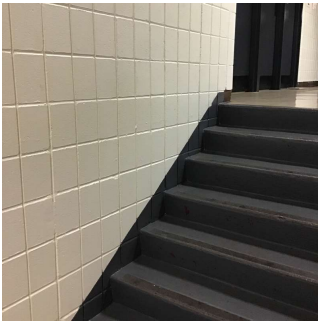
Violations	Stair E/1 No violations recorded.
Partition	Does not Exist
Railings	Inspected
Condition	3 - Fair
Deficiency	METAL: MISSING
Deficiency Location/Instance	Stair near exit 5
Deficiency Quantity	10
Quantity Uom	L.F.
Potential Action	REPLACE
Urgency of Action	PRIORITY 5
Purpose of Action	LEVEL 6
Deficiency Photo1

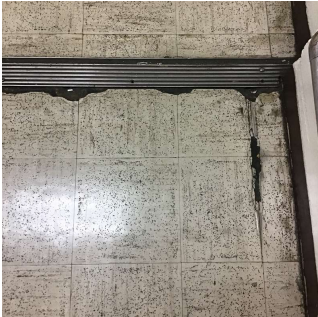
Ramp Near 198
Violations	No violations recorded.
Deficiency	CONCRETE: CRACKS/SPALLING - MAJOR
Deficiency Location/Instance	Stair B/3, F/1
Deficiency Quantity	20
Quantity Uom	S.F.
Potential Action	REPLACE
Urgency of Action	PRIORITY 3
Purpose of Action	LEVEL 2
Deficiency Photo1

Violations	Stair near exit 5 No violations recorded.
Stairs and Landings	Inspected
Condition	2 - Between Good and Fair
Deficiency	VINYL TILES: BROKEN/DETERIORATED/MISSING TILES
Deficiency Location/Instance	Ramp Near 198

Question	Response
INTERIOR	
STAIRS/RAMPS: INTERIOR	
Stairs and Landings	
Deficiency Quantity	10
Quantity Uom	S.F.
Potential Action	REPLACE
Urgency of Action	PRIORITY 3
Purpose of Action	LEVEL 2
Deficiency Photo1

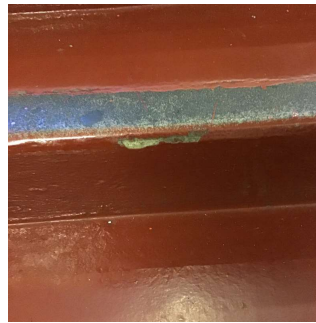
Stair B/3
Violations	No violations recorded.
Deficiency	CONCRETE: WORN-OUT TREAD/NOSINGS
Deficiency Location/Instance	Stair B/3, C/1,D/1
Deficiency Quantity	20
Quantity Uom	S.F.
Potential Action	REPLACE
Urgency of Action	PRIORITY 3
Purpose of Action	LEVEL 2

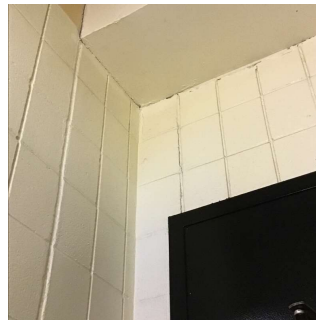
Stair B/3

MASONRY: CRACKS/SPALLING

REPLACE

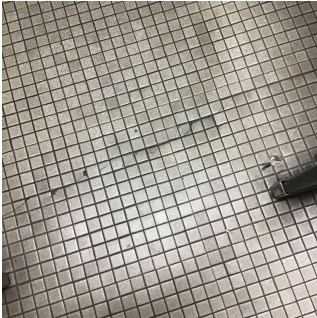
Question	Response
INTERIOR	
TOILET ROOMS - STAFF	
Door(s)	Inspected
	Room A261M
Violations	No violations recorded.
Floor Finish	Inspected
Condition	3 - Fair
Deficiency	CERAMIC TILE: BROKEN/MISSING TILES
Deficiency Location/Instance	Room 415T,261M,261T,215T,213G, and others
Deficiency Quantity	50
Quantity Uom	S.F.
Potential Action	REPLACE
Urgency of Action	PRIORITY 3
Purpose of Action	LEVEL 2
Deficiency Photo1

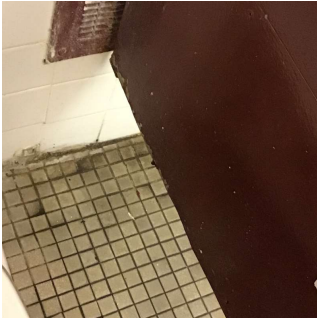
Room 261T
Violations	No violations recorded.
Stalls	Inspected
Condition	5 - Poor
Deficiency	RUST - MAJOR
Deficiency Location/Instance	Room 431T,229T,215T,213G,115G, and others
Deficiency Quantity	7
Quantity Uom	EACH
Potential Action	REPLACE
Urgency of Action	PRIORITY 3
Purpose of Action	LEVEL 2
Deficiency Photo1

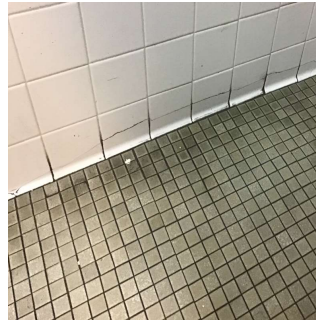
Room 329B

CERAMIC TILE: BROKEN/ MISSING

REPLACE

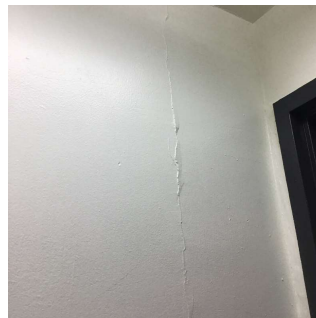
PLASTER: CRACKS/SPALLING

REPLACE

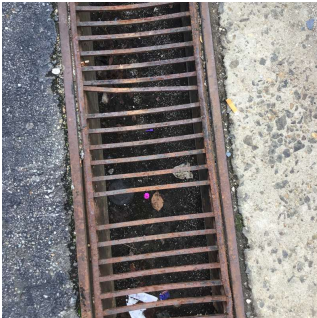
Question	Response
LIFE SAFETY	Inspected
F.D. HOLDING AREA	Inspected
Deficiency Photo1	 
Violations	Room 211 No violations recorded.
STEEL STAIRS	Does not Exist
SITE	Inspected
CONTAINERIZATION	Inspected
Condition	5 - Poor
Deficiency	FENCING MISSING
Deficiency Location/Instance	Near exit 5
Deficiency Quantity	1,200
Quantity Uom	S.F.
Potential Action	INSTALL NEW
Urgency of Action	PRIORITY 3
Purpose of Action	LEVEL 2
Deficiency Photo1	No photo recorded
Violations	No violations recorded.
Deficiency	CONTAINER DAMAGED
Deficiency Location/Instance	Near exit 5
Deficiency Quantity	6
Quantity Uom	EACH
Potential Action	REPLACE
Urgency of Action	PRIORITY 3
Purpose of Action	LEVEL 2
Deficiency Photo1	 
Violations	Near exit 5 No violations recorded.
Drainage System for Asphalt	Inspected
Catch Basins/Manhole - Surrounded by asphalt	Inspected
Condition	5 - Poor
Deficiency	DAMAGED COVER
Deficiency Location/Instance	Near exit 9, Exit 1, Exit 2

Question	Response
SITE	
Drainage System for Asphalt	
Catch Basins/Manhole - Surrounded by asphalt	
Deficiency Quantity	7
Quantity Uom	EACH
Potential Action	REPLACE
Urgency of Action	PRIORITY 3
Purpose of Action	LEVEL 2
Deficiency Photo1

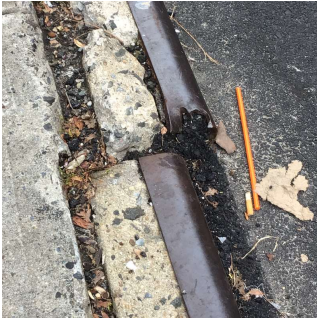
Violations	Near exit 4 No violations recorded.
Pavers	Does not Exist
DOT Sidewalk	Inspected
Asphalt	Does not Exist
Concrete	Inspected
Condition	4 - Between Fair and Poor
Deficiency	DAMAGED CURBS
Deficiency Location/Instance	Along Grand Street
Deficiency Quantity	10
Quantity Uom	L.F.
Potential Action	REPLACE
Urgency of Action	PRIORITY 5
Purpose of Action	LEVEL 6
Deficiency Photo1

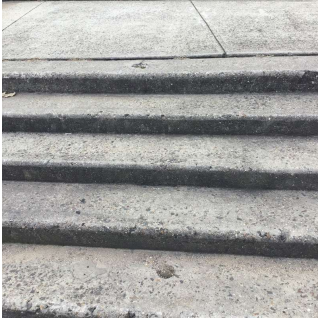
Question	Response
SITE	
PAVING	Inspected
DOT Sidewalk	
Concrete	Inspected
Violations	No violations recorded.
Pavers	Does not Exist
PLAYGROUNDS	Does not Exist
PLAYING SURFACE	Does not Exist
RETAINING WALLS	Does not Exist
SEATING	Does not Exist
SITE WALLS (NOT RETAINING WALLS)	Does not Exist
STAIRS/RAMPS: EXTERIOR	Inspected
Railings	Inspected
Condition	5 - Poor
Deficiency	MISSING
Deficiency Location/Instance	Near exit 9
Deficiency Quantity	30
Quantity Uom	L.F.
Potential Action	REPLACE
Urgency of Action	PRIORITY 5
Purpose of Action	LEVEL 6
Deficiency Photo1

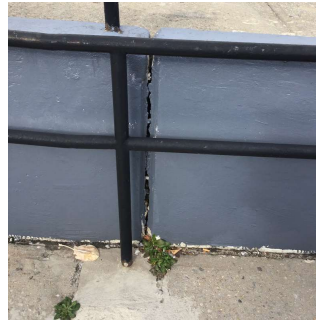
Near exit 10

Violations	Near exit 9 No violations recorded.
Site Cheek/flank Walls	Inspected
Condition	3 - Fair
Deficiency	CAST IN PLACE CONCRETE: DETERIORATED CONTROL/EXPANSION JOINT
Deficiency Location/Instance	Near exit 10, Parking Lot
Deficiency Quantity	15
Quantity Uom	L.F.
Potential Action	REPLACE
Urgency of Action	PRIORITY 3
Purpose of Action	LEVEL 2

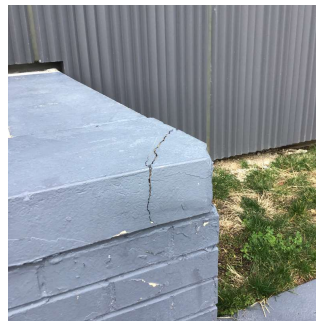
Near exit 9

BRICK: DETERIORATED COPING STONE

REPLACE

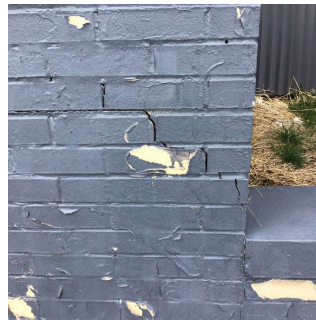
Near exit 9

BRICK: CRACKS/SPALLING - MAJOR

REPLACE

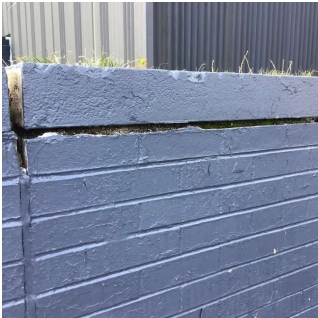
Question	Response
SITE	
STAIRS/RAMPS: EXTERIOR	
Site Cheek/flank Walls	
Violations	No violations recorded.
Deficiency	BRICK: DETERIORATED JOINT AT COPING STONE
Deficiency Location/Instance	Near exit 9, near Main Entrance, Along Grand Street
Deficiency Quantity	30
Quantity Uom	L.F.
Potential Action	MAINTENANCE
Urgency of Action	PRIORITY 3
Purpose of Action	LEVEL 2
Deficiency Photo1

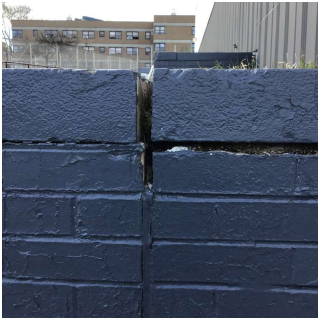
Violations	No violations recorded.
Deficiency	BRICK: DETERIORATED CONTROL/EXPANSION JOINT
Deficiency Location/Instance	Near exit 9, near Main Entrance, along Bushwick Avenue, Grand Street
Deficiency Quantity	40
Quantity Uom	L.F.
Potential Action	REPLACE
Urgency of Action	PRIORITY 3
Purpose of Action	LEVEL 2
Deficiency Photo1
