NYC Department of Education
Building Condition Assessment Survey 2023 - 2024

Architectural Inspection

K456

Asset: BOYS & GIRLS AF - BROOKLYN, 1700 FULTON STREET, New York, 11213

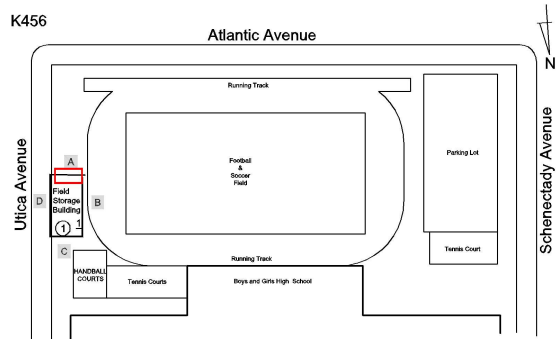
Roof Plan reference

Question	Response
Architectural	
EXTERIOR	Inspected
AREAWAY	Does not Exist
AWNINGS AND CANOPIES	Does not Exist
CHIMNEY	Does not Exist
COPING	Does not Exist
CORNICE	Does not Exist
DOORS	Inspected
DOORS AND FRAMES	Inspected
Condition	5 - Poor

Deficiency METAL: DETERIORATED DOOR AND FRAME - MAJOR DETERIORATION

2
EACH
REPLACE
PRIORITY 4
LEVEL 2

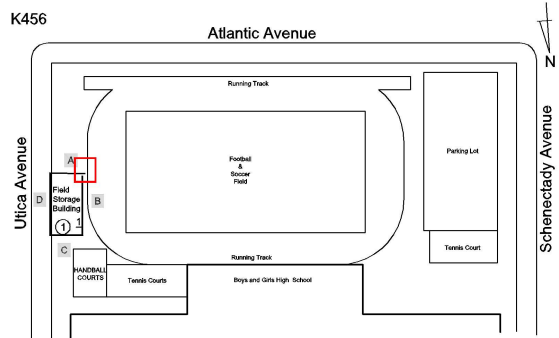
Roof Plan reference

LEADERS, GUTTERS, DOWNSPOUTS, SCUPPERS	Inspected
Condition	3 - Fair
Deficiency	DAMAGED/MISSING

LEADERS, GUTTERS, DOWNSPOUTS, SCUPPERS

10
L.F.
REPLACE
PRIORITY 4
LEVEL 2

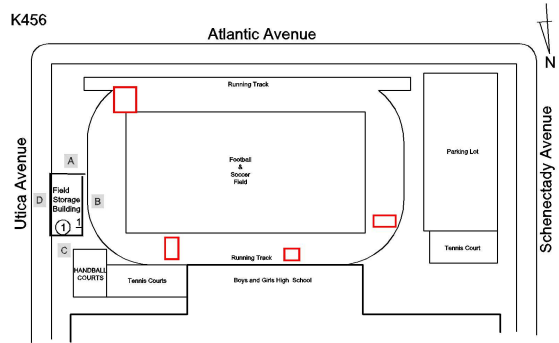
Roof Plan reference

Synthetic Turf Field exists?	Yes
Year of Installation	2014
Replacement Quantity	152,000
Replacement Uom	S.F.
Instance on Running Track	Inspected
Instance Condition	5 - Poor
Instance Quantity	15,000
Instance Quantity Uom	S.F.
Deficiency	ATHLETIC WEARING SURFACE: DAMAGED/DETERIORATED
Deficiency Location/Instance	Running Track - Various Locations

REPLACE

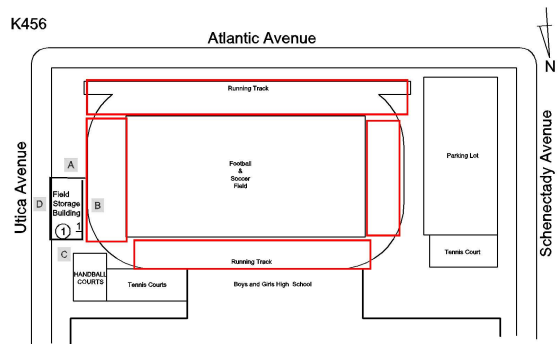
Roof Plan reference

ATHLETIC WEARING SURFACE: DAMAGED/DETERIORATED

Running Track

REPLACE

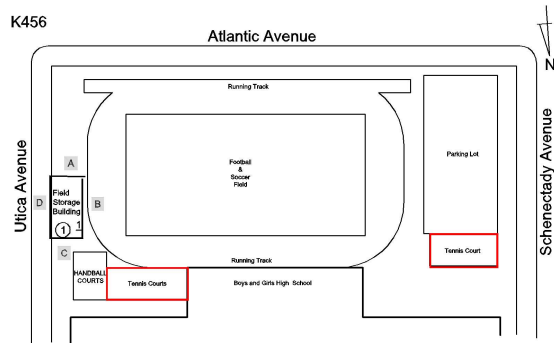
Roof Plan reference

ASPHALT: DAMAGED/DETERIORATED

REPLACE

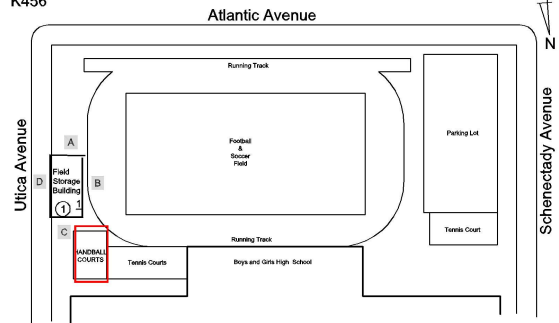
Roof Plan reference

ASPHALT: DAMAGED/DETERIORATED

REPLACE
