**NYC Department of Education**  
**Building Condition Assessment Survey 2023 - 2024**

Architectural Inspection

**K457**

**Asset: BOYS HS AF (OLD) - BROOKLYN, 708 MAPLE STREET, New York, 11216**

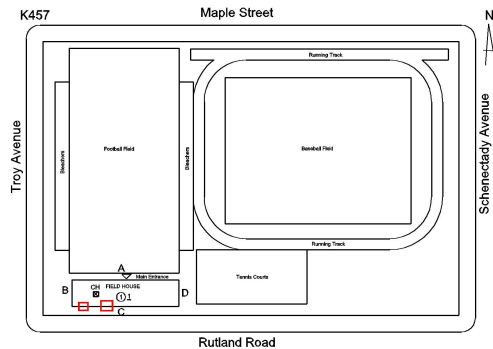
Violations	Roof 1 - CH No violations recorded.
<b>COPING</b>	Does not Exist
<b>CORNICE</b>	Does not Exist
<b>DOORS</b>	Inspected
<b>DOORS AND FRAMES</b>	Inspected
Condition	2 - Between Good and Fair
Deficiency	No deficiencies recorded
<b>DOOR HARDWARE</b>	Inspected
Condition	3 - Fair
Deficiency	No deficiencies recorded
<b>LINTELS</b>	Inspected
Condition	2 - Between Good and Fair
Deficiency	No deficiencies recorded
<b>TRANSOM/SIDE LIGHT</b>	Does not Exist
<b>EXTERIOR WALLS</b>	Inspected
Material Type(s)	Masonry, Concrete
Replacement Quantity	5,300
Replacement Uom	S.F.
Instance on All Facades	Inspected
Instance Condition	4 - Between Fair and Poor
Instance Quantity	5,300
Instance Quantity Uom	S.F.
Deficiency	<b>BRICK: DETERIORATED CONTROL/EXPANSION JOINTS</b>
Roof Plan reference

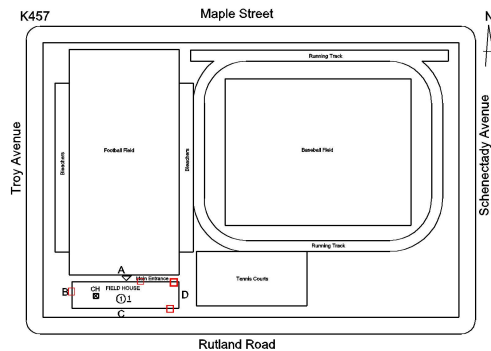
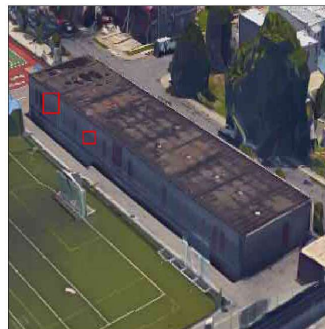
BRICK: MAJOR / THRU CRACKS

70

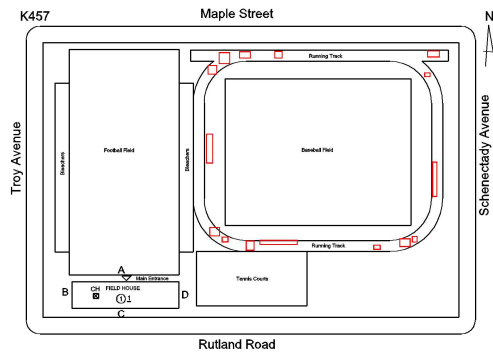
Instance on Football Field	Inspected
Instance Condition	1 - Good
Instance Quantity	68,000
Instance Quantity Uom	S.F.
Deficiency	No deficiencies recorded
Instance on Running Track	Inspected
Instance Condition	4 - Between Fair and Poor
Instance Quantity	44,000
Instance Quantity Uom	S.F.
Deficiency	ATHLETIC WEARING SURFACE: DAMAGED/DETERIORATED
Deficiency Location/Instance	Running Track
Roof Plan reference

1,000
