**NYC Department of Education**  
**Building Condition Assessment Survey 2023 - 2024**

Architectural Inspection

**K458**

**Asset:**        **BOYS HS (OLD) - K, 832 MARCY AVENUE, New York, 11216**

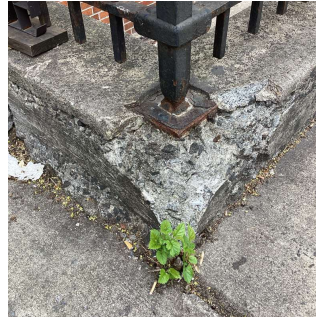
AW2

**AREAWAY WALLS: CRACKS AND SPALLING**

REPLACE

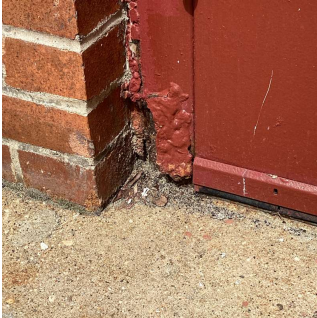
Violations	Facade F - Roof 8 No violations recorded.
<b>DOORS</b>	Inspected
<b>DOORS AND FRAMES</b>	Inspected
Condition	5 - Poor
Deficiency	METAL: DETERIORATED DOOR AND FRAME - MAJOR DETERIORATION
Roof Plan reference

Deficiency Quantity	6
Quantity Uom	EACH
Potential Action	REPLACE
Urgency of Action	PRIORITY 4
Purpose of Action	LEVEL 2
Deficiency Photo1

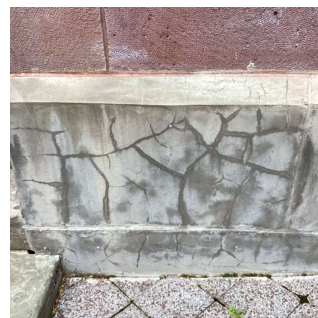
**CAST IN PLACE / PRE-CAST CONCRETE: MINOR  
CRACKS/SPALLING**

40  
S.F.  
REPAIR  
PRIORITY 3  
LEVEL 2

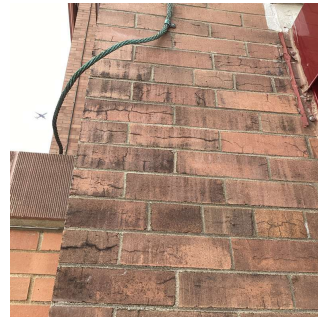
Facade G

**BRICK: MINOR CRACKS AND SPALLING**

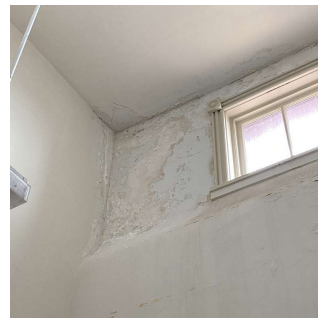
**BRICK: WATER INFILTRATION IN INSTRUCTIONAL SPACE**

600  
S.F.  
REPAIR  
PRIORITY 5  
LEVEL 2

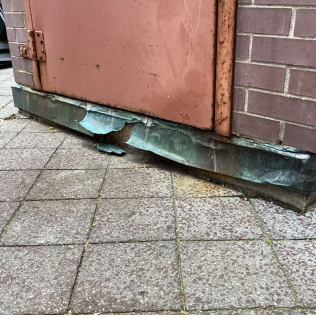
Deficiency Quantity	40
Quantity Uom	L.F.
Potential Action	REPLACE
Urgency of Action	PRIORITY 4
Purpose of Action	LEVEL 2
Deficiency Photo1

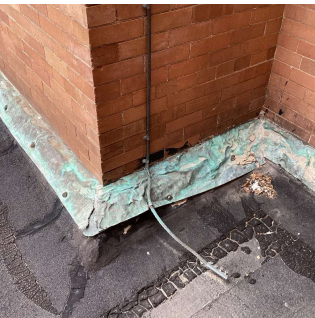
Instance on Modified Bitumen: Roof 9	Inspected
Instance Condition	3 - Fair

Deficiency Quantity	60
Quantity Uom	L.F.
Potential Action	REPLACE
Urgency of Action	PRIORITY 4
Purpose of Action	LEVEL 2
Deficiency Photo1

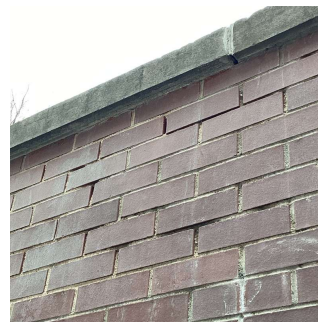
BH3  
No violations recorded.

40  
S.F.  
REPOINT  
PRIORITY 3  
LEVEL 2

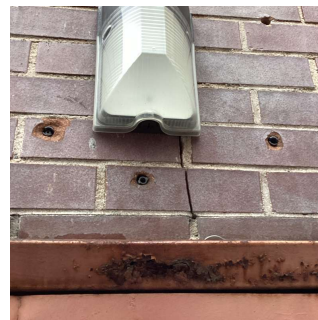
Plaza Deck - BH3

40  
S.F.  
REPLACE  
PRIORITY 4  
LEVEL 2

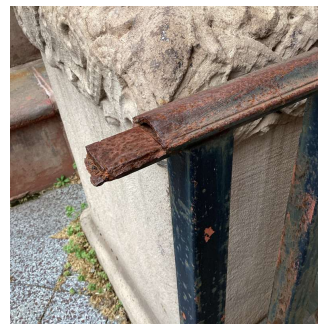
Facade C

10  
L.F.  
REPLACE  
PRIORITY 5  
LEVEL 6

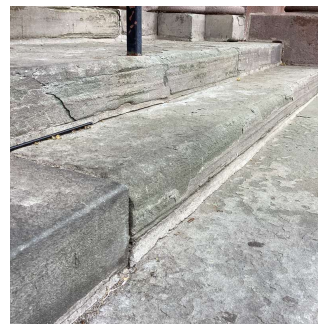
Facade K  
No violations recorded.

30  
S.F.  
REPLACE  
PRIORITY 4  
LEVEL 2

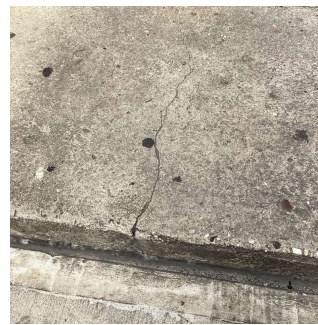
Facade G

10  
S.F.  
REPAIR  
PRIORITY 3  
LEVEL 2

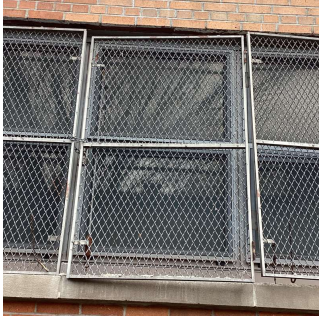
Question	Response
<b>EXTERIOR</b>	
<b>WINDOWS</b>	
<b>EXTERIOR GUARDS</b>	
Elevation	 
Deficiency Quantity	30
Quantity Uom	S.F.
Potential Action	REPLACE
Urgency of Action	PRIORITY 4
Purpose of Action	LEVEL 2
Deficiency Photo1

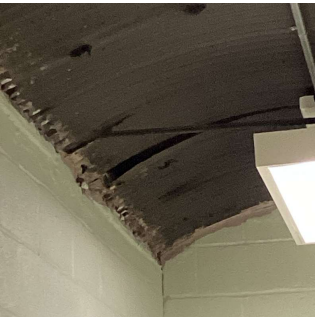
Boiler Room No violations recorded.
<b>FLOOR STRUCTURE</b>	
Condition Deficiency Deficiency Location/Instance Deficiency Quantity Quantity Uom Potential Action Urgency of Action Purpose of Action Deficiency Photo1       Violations	Inspected 3 - Fair CINDER CONCRETE ARCH: METAL PAN DETERIORATED, SPALLED Basement - Lift Vestibule, Stair W/Cellar 20 S.F. REPAIR PRIORITY 4 LEVEL 5

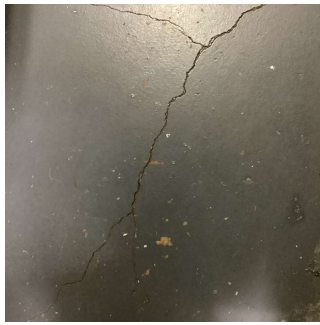
Question	Response
<b>INTERIOR</b>	
<b>STRUCTURAL</b>	
<b>FLOOR STRUCTURE</b>	Inspected
Deficiency Photo1

Room C9
Violations	No violations recorded.
<b>FOUNDATION WALLS</b>	Inspected
Material Type(s)	Masonry
Condition	4 - Between Fair and Poor
Deficiency	BRICK: CRACKED/SPALLED
Deficiency Location/Instance	Electrical Panel Room C6A, Fan Room, Switchboard Room C11
Deficiency Quantity	40
Quantity Uom	S.F.
Potential Action	RESTITCH
Urgency of Action	PRIORITY 4
Purpose of Action	LEVEL 5
Deficiency Photo1	 
	Electrical Panel Room C6A
Violations	No violations recorded.
Deficiency	BRICK: WATER INFILTRATION IN INSTRUCTIONAL SPACE
Deficiency Location/Instance	Cellar - Room C3, Basement - Lift Vestibule
Deficiency Quantity	200
Quantity Uom	S.F.
Potential Action	INSTALL WATERPROOFING
Urgency of Action	PRIORITY 5
Purpose of Action	LEVEL 5

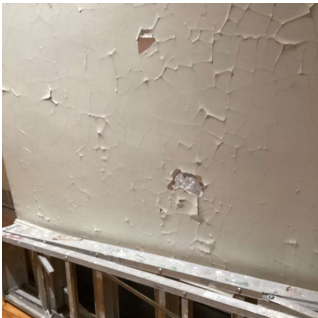
Question	Response
<b>INTERIOR</b>	
<b>AUDITORIUM</b>	
<b>Stage</b>	
<b>Stage</b>	Inspected
Instance on 1st Floor (996 Seats)	Inspected
Condition	2 - Between Good and Fair
Deficiency	DAMAGED FLOOR
Deficiency Location/Instance	Center
Deficiency Quantity	10
Quantity Uom	S.F.
Potential Action	REPLACE
Urgency of Action	PRIORITY 3
Purpose of Action	LEVEL 2
Deficiency Photo1	 
Violations	Center No violations recorded.
<b>Stage Curtain Rigging</b>	Does not Exist
Instance on 1st Floor (996 Seats)	Does not Exist
<b>Stage Curtains</b>	Does not Exist
Instance on 1st Floor (996 Seats)	Does not Exist
<b>Walls</b>	
Instance on 1st Floor (996 Seats)	Inspected
Condition	2 - Between Good and Fair
Deficiency	PLASTER: CRACKS/SPALLING
Deficiency Location/Instance	Balcony
Deficiency Quantity	15
Quantity Uom	S.F.
Potential Action	REPLACE
Urgency of Action	PRIORITY 3
Purpose of Action	LEVEL 2
Deficiency Photo1

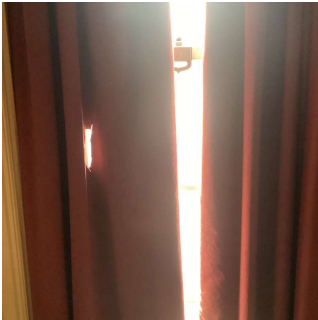
Question	Response
<b>INTERIOR</b>	
<b>AUDITORIUM</b>	
<b>Window Curtains/Shades/Blinds</b>	
Instance on 1st Floor (996 Seats)	Inspected
Condition	3 - Fair
Deficiency	WORN/DAMAGED CURTAINS
Deficiency Location/Instance	Rear Center
Deficiency Quantity	50
Quantity Uom	S.F.
Potential Action	MAINTENANCE
Urgency of Action	PRIORITY 3
Purpose of Action	LEVEL 2
Deficiency Photo1

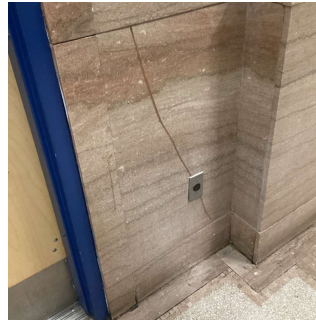
Room 102
Violations	No violations recorded.
<b>Floor Finish</b>	Inspected
Condition	2 - Between Good and Fair
Deficiency	STONE: BROKEN/MISSING TILES
Deficiency Location/Instance	Corridor near Room 117
Deficiency Quantity	15
Quantity Uom	S.F.
Potential Action	REPLACE
Urgency of Action	PRIORITY 3
Purpose of Action	LEVEL 2

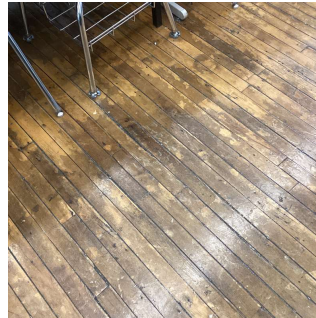
Room 210

**WOOD: DAMAGED/DETERIORATED**

REPLACE

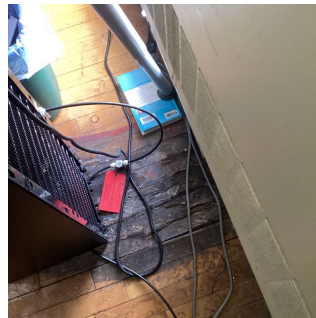
Room 402A

**WOOD: DETERIORATED SUBSTRATE**

REPLACE

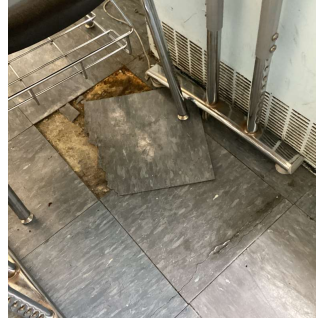
Room 416

Deficiency	VINYL TILES: BROKEN/DETERIORATED/MISSING TILES
Deficiency Location/Instance	Rooms 416, 310
Deficiency Quantity	20
Quantity Uom	S.F.
Potential Action	REPLACE
Urgency of Action	PRIORITY 3
Purpose of Action	LEVEL 2
Deficiency Photo1

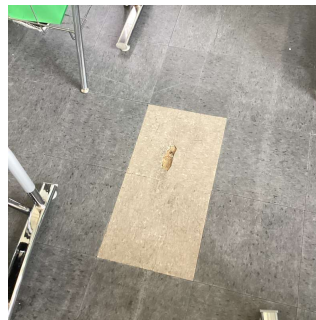
Room 421

Deficiency	VINYL TILES: DETERIORATED SUBSTRATE
Deficiency Location/Instance	Rooms 421, 416, Corridor near room 408, 406, 403 and others
Deficiency Quantity	1,300
Quantity Uom	S.F.
Potential Action	REPLACE
Urgency of Action	PRIORITY 3
Purpose of Action	LEVEL 2
Deficiency Photo1

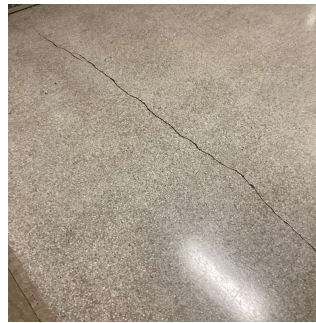
Corridor near room 120

Deficiency	TERRAZZO: CRACKS
Deficiency Location/Instance	Corridor near rooms 115, 116, 120, 123, 125 and others
Deficiency Quantity	125
Quantity Uom	S.F.
Potential Action	REPLACE
Urgency of Action	PRIORITY 3
Purpose of Action	LEVEL 2

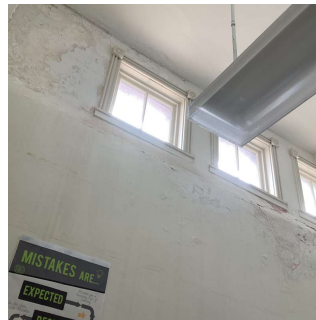
Room 402

PLASTER: CRACKS/SPALLING - ACTIVE LEAK

REPLACE

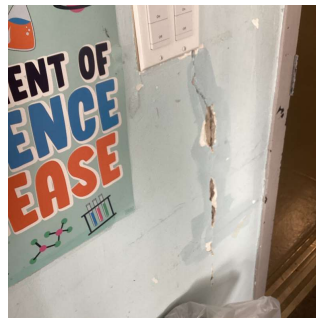
PLASTER: CRACKS/SPALLING

REPLACE

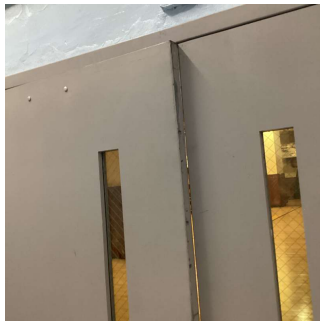
Question	Response
<b>INTERIOR</b>	
<b>CLASSROOMS/CORRIDORS/ADMIN SPACES</b>	
<b>Walls</b>	Inspected
	Room 421
Violations	No violations recorded.
<b>Specialties</b>	Inspected
<b>Classroom Locker(s)</b>	Inspected
Condition	2 - Between Good and Fair
Deficiency	No deficiencies recorded
<b>Fixed Seating</b>	Does not Exist
<b>GYMNASIUM</b>	Inspected
Instance on Cellar	Inspected
<b>Ceiling</b>	
Instance on Cellar	Inspected
Condition	2 - Between Good and Fair
Deficiency	No deficiencies recorded
<b>Door(s)</b>	
Instance on Cellar	Inspected
Condition	3 - Fair
Deficiency	METAL: DETERIORATED DOOR
Deficiency Location/Instance	Entrance
Deficiency Quantity	1
Quantity Uom	EACH
Potential Action	MAINTENANCE
Urgency of Action	PRIORITY 3
Purpose of Action	LEVEL 2
Deficiency Photo1

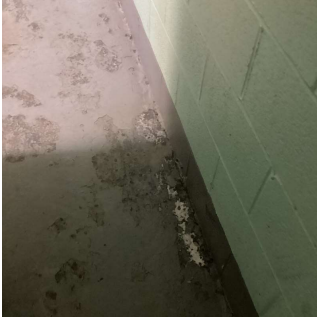
Question	Response
<b>INTERIOR</b>	
<b>LOCKER ROOM</b>	
<b>Door(s)</b>	
Deficiency	No deficiencies recorded
Instance on Cellar - Girls (406 Lockers)	Inspected
Condition	2 - Between Good and Fair
Deficiency	No deficiencies recorded
<b>Floor Finish</b>	
Instance on Cellar - Boys (428 Lockers)	Inspected
Condition	2 - Between Good and Fair
Deficiency	CONCRETE: CRACKS
Deficiency Location/Instance	Right Side
Deficiency Quantity	10
Quantity Uom	S.F.
Potential Action	REPLACE
Urgency of Action	PRIORITY 3
Purpose of Action	LEVEL 2
Deficiency Photo1

Right Side
Violations	No violations recorded.
Instance on Cellar - Girls (406 Lockers)	Inspected
Condition	3 - Fair
Deficiency	CONCRETE: CRACKS
Deficiency Location/Instance	Left Side
Deficiency Quantity	60
Quantity Uom	S.F.
Potential Action	REPLACE
Urgency of Action	PRIORITY 3
Purpose of Action	LEVEL 2
Deficiency Photo1

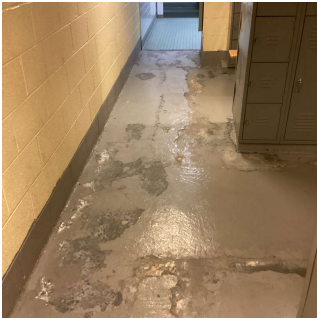
Left Side
Violations	No violations recorded.
<b>Locker Room Lockers</b>

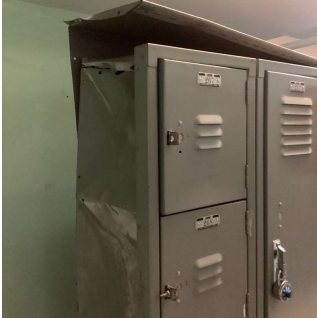
Question	Response
<b>INTERIOR</b>	
<b>LOCKER ROOM</b>	
<b>Locker Room Lockers</b>	
Condition	3 - Fair
Deficiency	DAMAGED UNITS
Deficiency Location/Instance	Lockers 267, 268, 269, 270, 271 and others
Deficiency Quantity	14
Quantity Uom	EACH
Potential Action	REPLACE
Urgency of Action	PRIORITY 3
Purpose of Action	LEVEL 2
Deficiency Photo1

Locker 267	
Violations	No violations recorded.
<b>Walls</b>	
Instance on Cellar - Boys (428 Lockers)	Inspected
Condition	2 - Between Good and Fair
Deficiency	PLASTER: CRACKS/SPALLING
Deficiency Location/Instance	Left Side
Deficiency Quantity	10
Quantity Uom	S.F.
Potential Action	REPLACE
Urgency of Action	PRIORITY 3
Purpose of Action	LEVEL 2
Deficiency Photo1

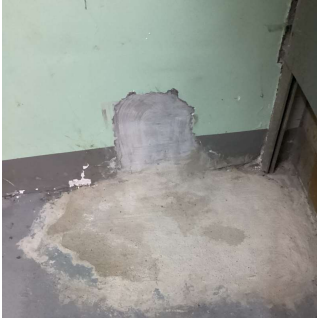
Left Side	
Violations	No violations recorded.
Instance on Cellar - Girls (406 Lockers)	Inspected
Condition	2 - Between Good and Fair
Deficiency	PLASTER: CRACKS/SPALLING
Deficiency Location/Instance	Column, Right Side
Deficiency Quantity	20

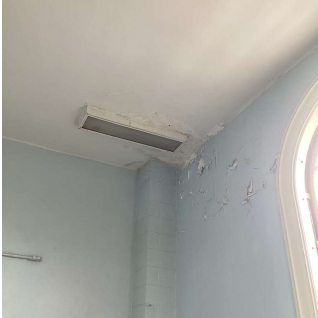
Question	Response
<b>INTERIOR</b>	
<b>SCIENCE LAB</b>	
<b>Fixed Equipment</b>	
Condition	2 - Between Good and Fair
Deficiency	No deficiencies recorded
Instance on Room 320	Inspected
Condition	2 - Between Good and Fair
Deficiency	No deficiencies recorded
<b>SCIENCE PREP ROOM</b>	
Instance on Room 220B	Inaccessible
<b>SHOWER ROOM</b>	
Instance on Cellar - Boys	Inaccessible
Instance on Cellar - Girls	Inaccessible
<b>STAIRS/RAMPS: INTERIOR</b>	
Do Letter Stair Signs Exist?	Yes
<b>Ceiling</b>	Inspected
Condition	2 - Between Good and Fair
Deficiency	PLASTER: CRACKS/SPALLING - ACTIVE LEAK
Deficiency Location/Instance	Stair F/2
Deficiency Quantity	25
Quantity Uom	S.F.
Potential Action	REPLACE
Urgency of Action	PRIORITY 5
Purpose of Action	LEVEL 2
Deficiency Photo1

Violations	Stair F/2 No violations recorded.
<b>Door(s)</b>	
Condition	Inspected
Deficiency	2 - Between Good and Fair
Deficiency	No deficiencies recorded
<b>Partition</b>

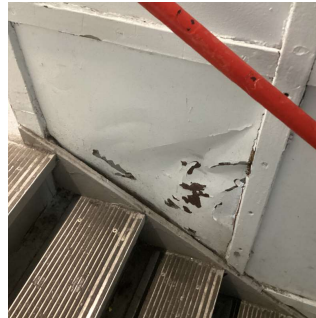
Stair G/2

METAL PANEL: DAMAGED/DETERIORATED

REPLACE

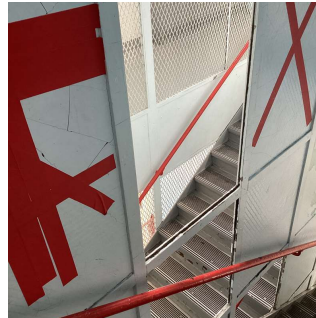
Stair G/5

GLASS PANEL: DAMAGED/DETERIORATED

REPLACE

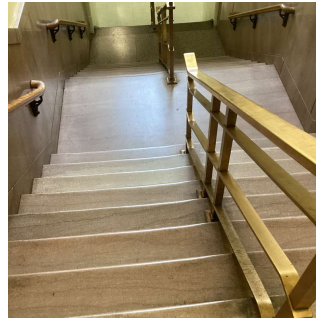
Stair K/Basement

STONE: WORN-OUT TREAD/NOSINGS

REPLACE

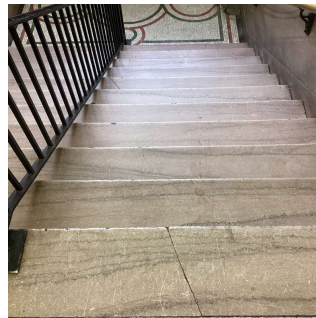
Stair H/Basement

STONE: BROKEN/MISSING

REPLACE

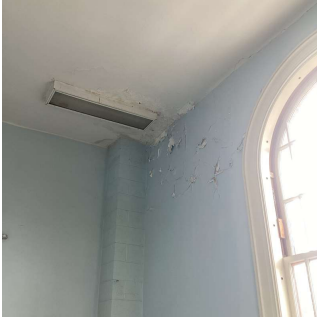
Question	Response
<b>INTERIOR</b>	
<b>STAIRS/RAMPS: INTERIOR</b>	
<b>Walls</b>	Inspected
Condition	2 - Between Good and Fair
Deficiency	PLASTER: CRACKS/SPALLING - ACTIVE LEAK
Deficiency Location/Instance	Stair F/2
Deficiency Quantity	30
Quantity Uom	S.F.
Potential Action	REPLACE
Urgency of Action	PRIORITY 5
Purpose of Action	LEVEL 2
Deficiency Photo1

Violations	Stair F/2 No violations recorded.
Deficiency	CERAMIC TILE: BROKEN/ MISSING
Deficiency Location/Instance	Stair G/4, D/Basement
Deficiency Quantity	20
Quantity Uom	S.F.
Potential Action	REPLACE
Urgency of Action	PRIORITY 3
Purpose of Action	LEVEL 2
Deficiency Photo1

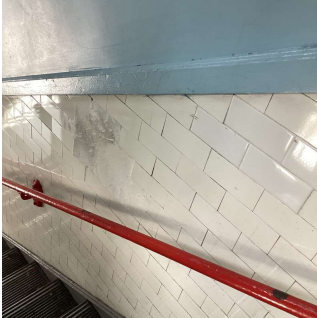
Violations	Stair G/4 No violations recorded.
Deficiency	STONE: CRACKS/SPALLING
Deficiency Location/Instance	Stair K/Basement
Deficiency Quantity	25
Quantity Uom	S.F.
Potential Action	REPLACE
Urgency of Action	PRIORITY 3
Purpose of Action	LEVEL 2

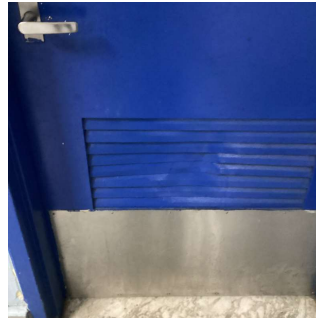
Room 215

METAL: DAMAGED LOUVER

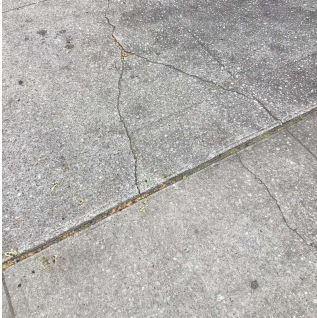
Question	Response
<b>SITE</b>	
<b>PAVING</b>	
<b>DOT Sidewalk</b>	
<b>Concrete</b>	
Deficiency	DAMAGED/DETERIORATED/MISSING SECTIONS
Deficiency Location/Instance	Marcy Avenue, Putnam Avenue, Madison Avenue
Deficiency Quantity	1,200
Quantity Uom	S.F.
Potential Action	REPLACE
Urgency of Action	PRIORITY 3
Purpose of Action	LEVEL 2
Deficiency Photo1

Violations	<p align="center">Marcy Avenue</p> <p align="center">No violations recorded.</p>
<b>Pavers</b>	Does not Exist
<b>PLAYGROUNDS</b>	Inspected
Instance on Near Madison Street	Inspected
<b>Benches</b>	
Instance on Near Madison Street	Does not Exist
<b>Fence</b>	
Instance on Near Madison Street	Does not Exist
<b>Pavement</b>	
Instance on Near Madison Street	Does not Exist
<b>Play Equipment</b>	
Instance on Near Madison Street	Inspected
Condition	2 - Between Good and Fair
Deficiency	No deficiencies recorded
<b>Safety Surfacing</b>	
Instance on Near Madison Street	Inspected

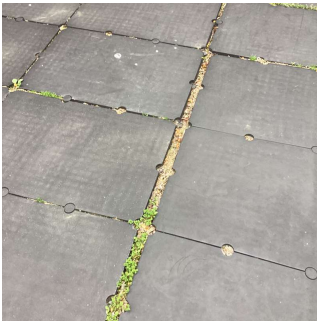
Condition	2 - Between Good and Fair
Deficiency	DETERIORATED/MISSING
Deficiency Location/Instance	Center
Deficiency Quantity	15
Quantity Uom	S.F.
Potential Action	REPLACE
Urgency of Action	PRIORITY 3
Purpose of Action	LEVEL 2

Question	Response
<b>SITE</b>	
<b>PLAYGROUNDS</b>	
<b>Safety Surfacing</b>	
Deficiency Photo1

Violations	Center No violations recorded.
<b>Unpaved Area</b>	
Instance on Near Madison Street	Does not Exist
<b>PLAYING SURFACE</b>	Does not Exist
<b>RETAINING WALLS</b>	
Are there any Retaining Walls 6' OR higher facing public street/sidewalk?	Inspected No
Condition	3 - Fair
Deficiency	CAST IN PLACE CONCRETE: CRACKS/SPALLING - MAJOR
Deficiency Location/Instance	Putnam Avenue Courtyard
Deficiency Quantity	15
Quantity Uom	S.F.
Potential Action	REPLACE
Urgency of Action	PRIORITY 4
Purpose of Action	LEVEL 4
Deficiency Photo1

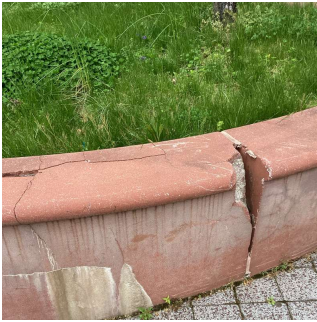
Violations	Putnam Avenue Courtyard 35671675N
Deficiency	CAST IN PLACE CONCRETE: CRACKS/SPALLING - MAJOR
Deficiency Location/Instance	Playground
Deficiency Quantity	10
Quantity Uom	S.F.
Potential Action	REPLACE
Urgency of Action	PRIORITY 3
Purpose of Action	LEVEL 2
