**NYC Department of Education
Building Condition Assessment Survey 2023 - 2024**

Architectural Inspection

K462

Asset: 3K CENTER @ 4822 NEW UTRECHT AVENUE - BROOKLYN, 4822 NEW UTRECHT AVENUE, 11219

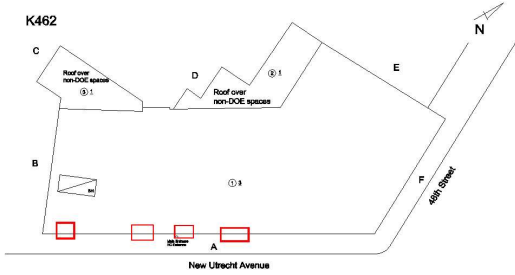
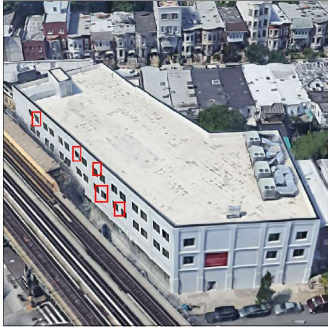
Question	Response
EXTERIOR	
WINDOWS	
WINDOWS	
Roof Plan reference

Question	Response
EXTERIOR	
WINDOWS	
WINDOWS	
Instance Quantity Uom	S.F.
Are these windows insulated	Yes
Installation Year	2016
Source of Installation	Custodial Staff
Deficiency	ALUMINUM - OTHER: AIR/WATER INFILTRATION, DETERIORATED JOINTS WITH DAMAGED CAULKING
Roof Plan reference	 
Elevation	 
Deficiency Quantity	150
Quantity Uom	L.F.
Potential Action	MAINTENANCE
Urgency of Action	PRIORITY 3
Purpose of Action	LEVEL 2
Deficiency Photo1	 
Violations	Facade A - Room 219 (Facade A - Room 219A similar) No violations recorded.
Deficiency	ALUMINUM - OTHER: BROKEN PANE

Deficiency Quantity	150
Quantity Uom	S.F.
Potential Action	MAINTENANCE
Urgency of Action	PRIORITY 3
Purpose of Action	LEVEL 2
Deficiency Photo1
