NYC Department of Education
Building Condition Assessment Survey 2023 - 2024

Architectural Inspection

Asset: **I.S. 187 - BROOKLYN, 1171 65 STREET, New York, 11219**

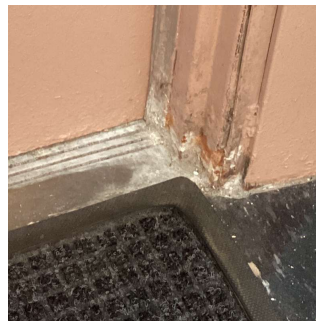
Facade B - Exit 2/3

METAL: DETERIORATED DOOR AND FRAME - MINOR DETERIORATION

3
 EACH
 MAINTENANCE
 PRIORITY 3
 LEVEL 2

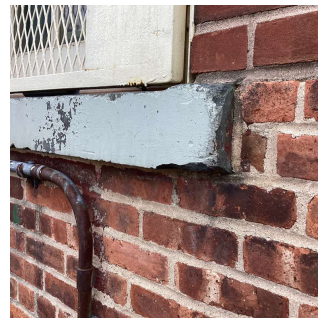
Facade G - Near Exit 9

BRICK: DETERIORATED MASONRY SILLS - MAJOR

REMOVE AND REPLACE

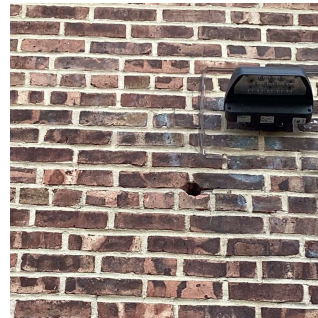
Facade B - Near Exit 2/3

BRICK: MAJOR / THRU CRACKS
