NYC Department of Education
Building Condition Assessment Survey 2023 - 2024

Architectural Inspection

K491

Asset: PRE-K CENTER @ 2165 71ST STREET - BROOKLYN, 2165 71ST STREET, New York, 11204

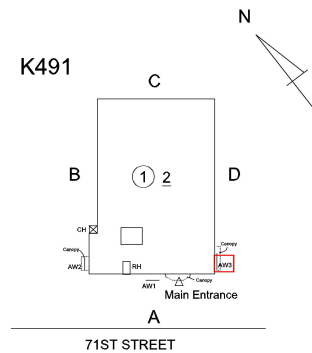
Question	Response
Architectural	
EXTERIOR	Inspected
AREAWAY	Inspected
Instance on AW1-AW3	Inspected
Instance Condition	3 - Fair
Instance Quantity	3
Instance Quantity Uom	EACH
Deficiency	AREAWAY DRAINS: DETERIORATED
Roof Plan reference

Deficiency Quantity	1
Quantity Uom	EACH
Potential Action	REPLACE
Urgency of Action	PRIORITY 4
Purpose of Action	LEVEL 2

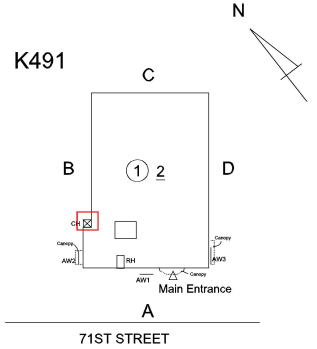
AW3
Violations	No violations recorded.
AWNINGS AND CANOPIES	
Condition	Inspected
Deficiency	2 - Between Good and Fair
	No deficiencies recorded
CHIMNEY	
Material Type(s)	Inspected
Condition	Masonry
Deficiency	3 - Fair
Roof Plan reference	BRICK: DETERIORATED JOINTS

<p align="center">K491</p> <p align="center">71ST STREET</p>
Deficiency Quantity	30
Quantity Uom	S.F.
Potential Action	REPOINT
Urgency of Action	PRIORITY 3
Purpose of Action	LEVEL 2
Deficiency Photo1

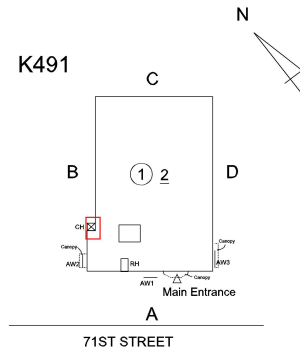
Roof 1
Violations	No violations recorded.
Deficiency	BRICK: DETERIORATED CAP

10
L.F.
REPLACE
PRIORITY 3
LEVEL 2

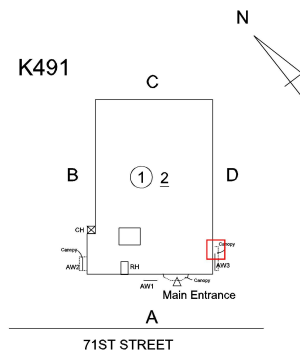
METAL: DETERIORATED DOOR AND FRAME - MINOR DETERIORATION

1
EACH
MAINTENANCE
PRIORITY 3

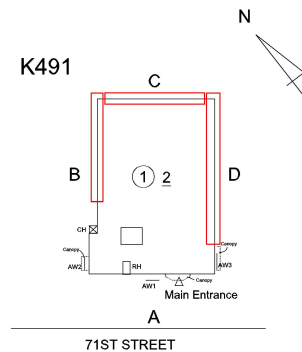
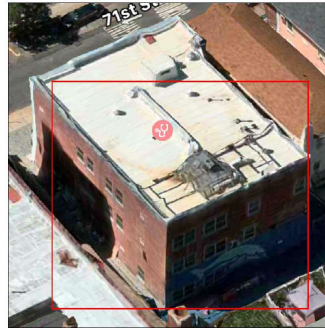
BRICK: DETERIORATED JOINTS

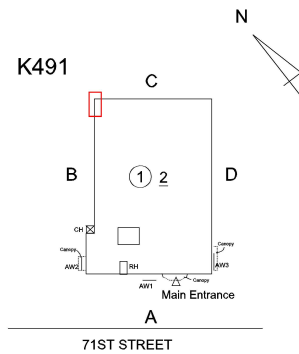
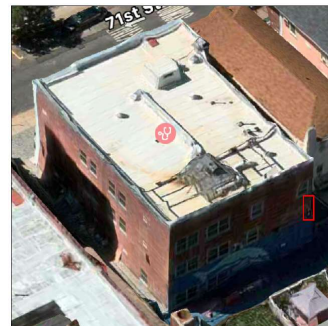
BRICK: CRACKS/DISPLACED/SPALLED BRICK AT BUILDING CORNERS

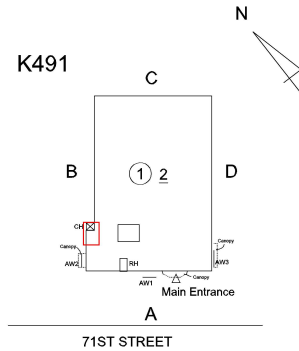
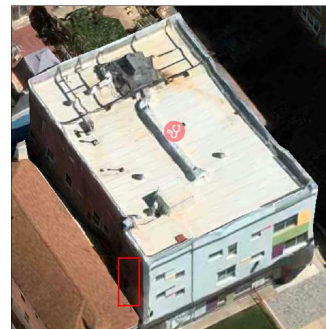
BRICK: MINOR CRACKS AND SPALLING

40
S.F.
RESTITCH
PRIORITY 3
LEVEL 2

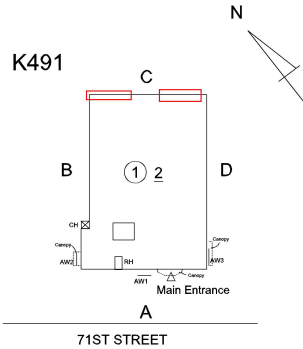
Question	Response
EXTERIOR	
EXTERIOR WALLS	Inspected
	Facade B
Violations	No violations recorded.
EXTERIOR SOFFITS	Does not Exist
LOADING DOCK	Does not Exist
LOUVER	Inspected
Condition	2 - Between Good and Fair
Deficiency	No deficiencies recorded
PARAPETS	Inspected
Material Type(s)	Concrete, Masonry
Replacement Quantity	1,000
Replacement Uom	C.F.
Instance on Roof 1	Inspected
Instance Condition	3 - Fair
Instance Quantity	1,000
Instance Quantity Uom	C.F.
Deficiency	CONCRETE MASONRY UNITS: DETERIORATED JOINTS
Roof Plan reference

Deficiency Quantity	60
Quantity Uom	S.F.
Potential Action	REPOINT
Urgency of Action	PRIORITY 3
Purpose of Action	LEVEL 2
Deficiency Photo1

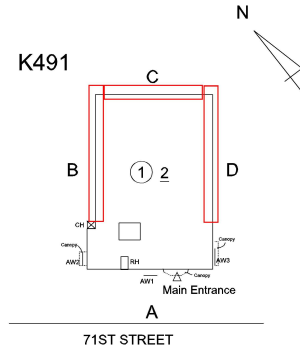
Violations	Roof 1 Facade C No violations recorded.
Deficiency	BRICK: DETERIORATED JOINTS

150
 S.F.
 REPOINT
 PRIORITY 3
 LEVEL 2

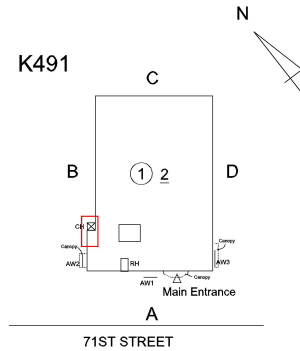
CONCRETE: MINOR CRACKS, SPALLING

30
 S.F.
 REPAIR
 PRIORITY 3
 LEVEL 2

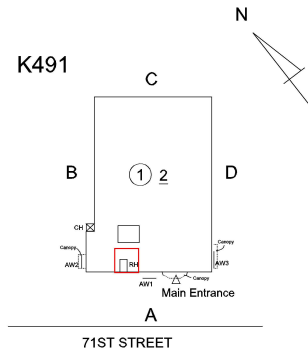
Violations	Roof 1 No violations recorded.
PLAZA DECK	Does not Exist
ROOF	Inspected
Roofing	Inspected
Replacement Quantity	4,000
Replacement Uom	S.F.
ROOF HATCH/SMOKE HATCH	Inspected
Condition	5 - Poor
Deficiency	DETERIORATED
Roof Plan reference

Deficiency Quantity	1
Quantity Uom	EACH
Potential Action	REPLACE
Urgency of Action	PRIORITY 4
Purpose of Action	LEVEL 2
Deficiency Photo1

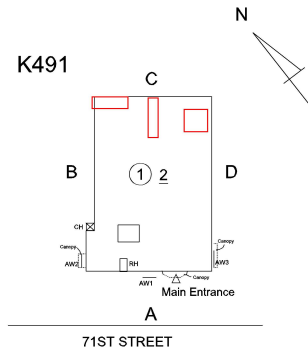
Principal Name	Danielle Bennett
Organization	District 20 Pre-K Center - Brooklyn
Did you meet with this Principal?	No
Did this Principal provide feedback?	Yes
Summary of Principal's Feedback	Site Coordinator Jenna Martin provided the following comment on behalf of the principal: active leaks into Room 206 need to be repaired.

Roof 1
Instance Quantity	4,000
Instance Quantity Uom	S.F.
Does the roof have major mechanical equipment sitting on Dunnage Steel less than 18" above the Roofing?	No
Does this roof instance have a Sustainable Roof System?	Yes
Sustainable Roof Type	White Roof
Sustainable Roof Location (Roof Number)	Roof 1
Do solar panels exist on these roofs?	No
Is/Are the roof(s) suitable for Solar Panel installation?	No
Installation Year	2015
Source of Installation	Custodial Staff
Deficiency	MODIFIED BITUMEN: ROOFING: MAJOR ACTIVE ROOF LEAKS IN INSTRUCTIONAL SPACE
Roof Plan reference

Deficiency Quantity	300
Quantity Uom	S.F.
Potential Action	REPLACE ROOFING WITHOUT MAJOR EQUIPMENT REMOVAL

Urgency of Action	PRIORITY 5
Purpose of Action	LEVEL 2

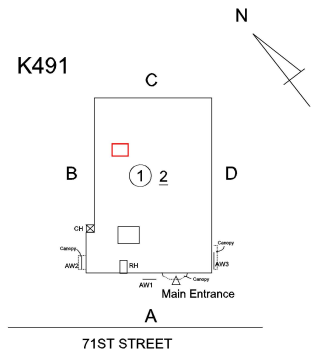
Roof 1 - Stair B/2 shown, Room 206, Corridor near Room 206 similar
Violations	No violations recorded.
Deficiency	MODIFIED BITUMEN: ROOFING: MAJOR ACTIVE ROOF LEAKS IN NON-INSTRUCTIONAL SPACE
Roof Plan reference

Deficiency Quantity	50
Quantity Uom	S.F.
Potential Action	REPLACE ROOFING WITHOUT MAJOR EQUIPMENT REMOVAL
Urgency of Action	PRIORITY 5
Purpose of Action	LEVEL 2
Deficiency Photo1
