NYC Department of Education
Building Condition Assessment Survey 2023 - 2024

Architectural Inspection

Asset: CANARSIE HS - K, 1600 ROCKAWAY PKWY, New York, 11236

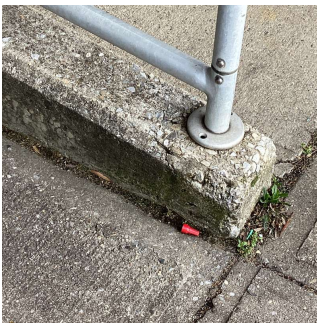
Question	Response
EXTERIOR	
STAIRS/RAMPS: EXTERIOR	
BUILDING CHEEK/FLANK WALLS	
Deficiency Photo1

Violations	Facade J - Toilet Room Entrances No violations recorded.
RAILINGS	Inspected
Condition	2 - Between Good and Fair
Deficiency	No deficiencies recorded
STAIRS/RAMPS	Inspected
Condition	5 - Poor
Deficiency	CONCRETE: CRACKS/SPALLING - MAJOR
Roof Plan reference

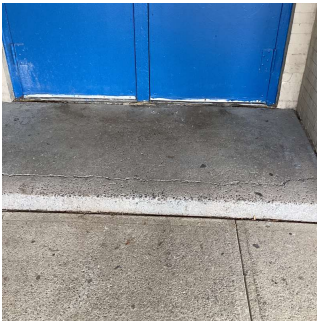
Deficiency Quantity	30
Quantity Uom	S.F.
Potential Action	REPLACE
Urgency of Action	PRIORITY 4
Purpose of Action	LEVEL 2
Deficiency Photo1

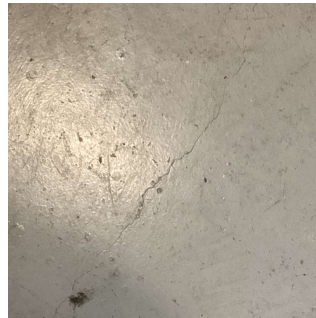
3rd Floor - Room 340
 No violations recorded.

Deficiency	CONCRETE: CRACKS/SPALLED/REINFORCEMENT EXPOSED
Deficiency Location/Instance	3rd Floor - Room 340
Deficiency Quantity	10
Quantity Uom	S.F.
Potential Action	REPAIR
Urgency of Action	PRIORITY 3
Purpose of Action	LEVEL 5
Deficiency Photo1

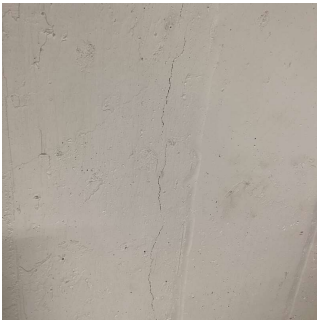
Violations	Basement - Room B06 No violations recorded.
FOUNDATION WALLS	
Material Type(s)	Inspected Concrete, Masonry
Condition	2 - Between Good and Fair
Deficiency	CONCRETE: CRACKED/SPALLED/REINFORCEMENT EXPOSED
Deficiency Location/Instance	Sub-Basement - Boiler Room
Deficiency Quantity	20
Quantity Uom	S.F.
Potential Action	REPAIR
Urgency of Action	PRIORITY 3
Purpose of Action	LEVEL 5
Deficiency Photo1

Violations	Sub-Basement - Boiler Room No violations recorded.
ROOF STRUCTURE	
Condition	Inspected 2 - Between Good and Fair
Deficiency	No deficiencies recorded
VAULTS-BUNKERS	
Foundation Walls	
Condition	Inspected 2 - Between Good and Fair
Deficiency	No deficiencies recorded
Slab Structure	
Condition	Inspected 2 - Between Good and Fair
Deficiency	No deficiencies recorded
Vault/Ash Hoist Doors and Framing	
Condition	Inspected 1 - Good
Deficiency	No deficiencies recorded

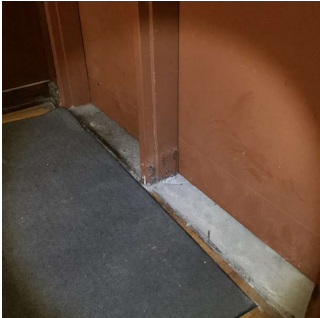
Violations	Near Stage Right No violations recorded.
Door(s)	
Instance on 1st Floor (1000 Seats)	Inspected
Condition	5 - Poor
Deficiency	METAL: DETERIORATED DOOR AND FRAME
Deficiency Location/Instance	Exit Vestibule at Stage Left, Corridor Exit at Stage Right
Deficiency Quantity	4
Quantity Uom	EACH
Potential Action	MAINTENANCE
Urgency of Action	PRIORITY 3
Purpose of Action	LEVEL 2
Deficiency Photo1

Violations	Exit Vestibule at Stage Left No violations recorded.
Fixed H/C Lift	
Instance on 1st Floor (1000 Seats)	Does not Exist

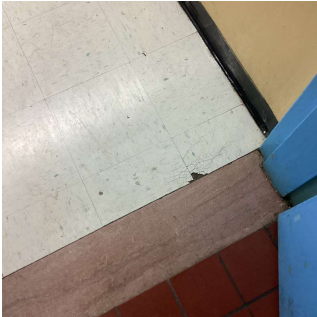
Left Side
Violations	No violations recorded.
Instance on 1st Floor Students Small (1000 SF)	Inspected
Condition	2 - Between Good and Fair
Deficiency	VINYL TILES: BROKEN/DETERIORATED/MISSING TILES
Deficiency Location/Instance	Near Entrance to Kitchen
Deficiency Quantity	10
Quantity Uom	S.F.
Potential Action	REPLACE
Urgency of Action	PRIORITY 3
Purpose of Action	LEVEL 2
Deficiency Photo1

Near Entrance to Kitchen
Violations	No violations recorded.
Sliding-folding Partition	
Instance on 1st Floor Students Large	Does not Exist
Instance on 1st Floor Students Small (1000 SF)	Does not Exist
Stage	
Instance on 1st Floor Students Large	Does not Exist
Instance on 1st Floor Students Small (1000 SF)	Does not Exist
Walls	
Instance on 1st Floor Students Large	Inspected

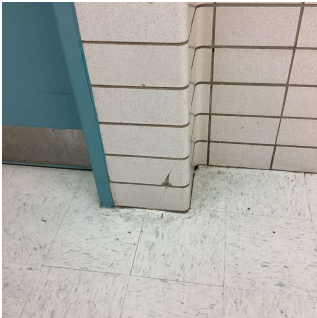
Violations	Right Side No violations recorded.
Deficiency	GLAZED BLOCK: CRACKS/SPALLING
Deficiency Location/Instance	Left Side, Columns at Center, Near Rear Entrance
Deficiency Quantity	30
Quantity Uom	S.F.
Potential Action	REPLACE
Urgency of Action	PRIORITY 3
Purpose of Action	LEVEL 2
Deficiency Photo1

Violations	Left Side No violations recorded.
Window Curtains/Shades/Blinds	
Instance on 1st Floor Students Large	Does not Exist
Instance on 1st Floor Students Small (1000 SF)	Does not Exist
CLASSROOMS/CORRIDORS/ADMIN SPACES	
Ceiling	Inspected
Condition	2 - Between Good and Fair
Deficiency	ACOUSTIC TILES ON PLASTER: DAMAGED/MISSING
Deficiency Location/Instance	Corridor near Rooms 252, 260A
Deficiency Quantity	25
Quantity Uom	S.F.
Potential Action	REPLACE

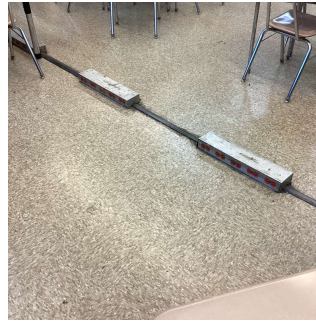
Room 305

Floor Finish

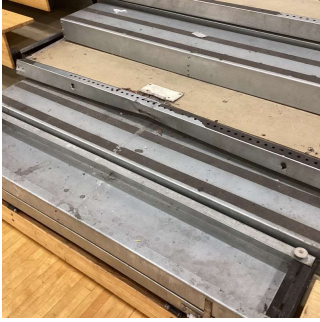
Question	Response
INTERIOR	
GYMNASIUM	
Seating	
Condition	5 - Poor
Deficiency	INOPERABLE BLEACHERS
Deficiency Location/Instance	Right Side
Deficiency Quantity	720
Quantity Uom	S.F.
Potential Action	REPLACE
Urgency of Action	PRIORITY 3
Purpose of Action	LEVEL 2
Deficiency Photo1	No photo recorded
Violations	No violations recorded.
Deficiency	DAMAGED BLEACHERS
Deficiency Location/Instance	Right Side
Deficiency Quantity	25
Quantity Uom	S.F.
Potential Action	REPLACE
Urgency of Action	PRIORITY 3
Purpose of Action	LEVEL 2
Deficiency Photo1

Violations	Right Side No violations recorded.
Sliding-folding Partition	
Instance on 1st Floor	Inspected
Condition	2 - Between Good and Fair
Deficiency	No deficiencies recorded
Stage	
Instance on 1st Floor	Does not Exist
Walls	
Instance on 1st Floor	Inspected
Condition	2 - Between Good and Fair
Deficiency	MASONRY: CRACKS/SPALLING
Deficiency Location/Instance	Right Side
Deficiency Quantity	20

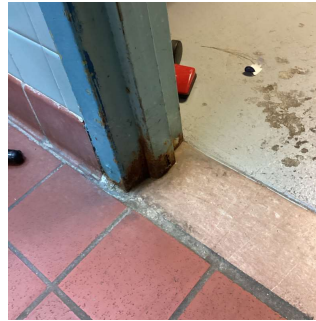
Storage Room Adjacent to Locker Room
No violations recorded.

Door(s)

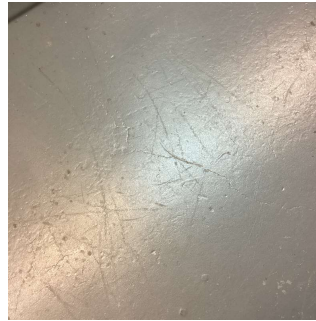
Storage Room

Floor Finish

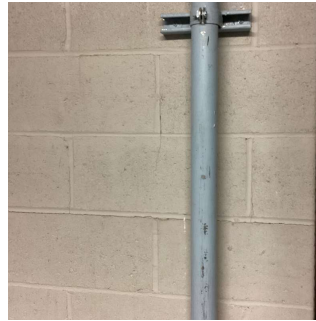
Storage Room Adjacent to Locker Room
No violations recorded.

Walls

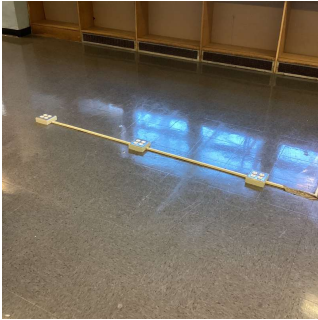
Instance on Room 209	Inspected
Condition	2 - Between Good and Fair
Deficiency	VINYL TILES: TRIPPING HAZARD - ELECTRICAL OUTLET
Deficiency Location/Instance	Left Side, Right Side
Deficiency Quantity	20
Quantity Uom	S.F.
Potential Action	REMOVE
Urgency of Action	PRIORITY 5
Purpose of Action	LEVEL 6
Deficiency Photo1

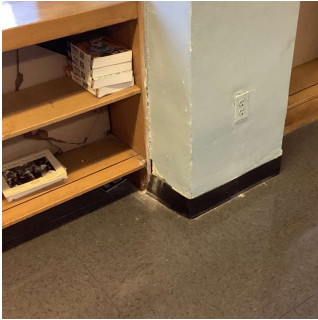
Instance on Room 209	Inspected
Condition	2 - Between Good and Fair
Deficiency	PLASTER: CRACKS/SPALLING
Deficiency Location/Instance	Left Side
Deficiency Quantity	10
Quantity Uom	S.F.
Potential Action	REPLACE
Urgency of Action	PRIORITY 3
Purpose of Action	LEVEL 2
Deficiency Photo1

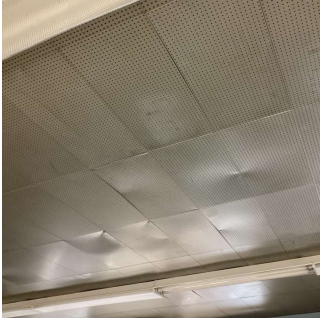
Center	
--------	--

Condition	2 - Between Good and Fair
-----------	---------------------------

Deficiency	METAL PAN: DAMAGED/MISSING
------------	----------------------------

Deficiency Location/Instance	Center
------------------------------	--------

Deficiency Quantity	10
---------------------	----

Potential Action	REPLACE
------------------	---------

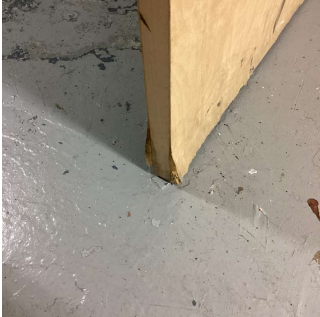
Exit Vestibule to Exterior	
----------------------------	--

Condition	4 - Between Fair and Poor
-----------	---------------------------

Deficiency	WOOD: DETERIORATED DOOR
------------	-------------------------

Deficiency Location/Instance	Exit Vestibule to Exterior
------------------------------	----------------------------

Deficiency Quantity	2
---------------------	---

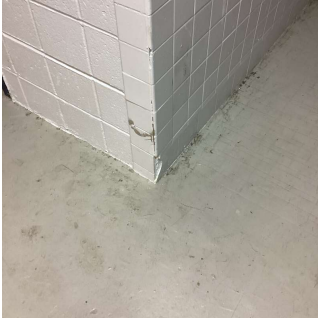
Locker 189	
Violations	No violations recorded.
Walls	
Instance on Basement - Boys (394 Lockers)	Inspected
Condition	2 - Between Good and Fair
Deficiency	CERAMIC TILE: BROKEN/ MISSING
Deficiency Location/Instance	Near Locker 121
Deficiency Quantity	10
Quantity Uom	S.F.
Potential Action	REPLACE
Urgency of Action	PRIORITY 3
Purpose of Action	LEVEL 2
Deficiency Photo1

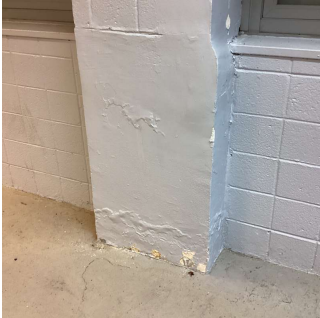
Question	Response
INTERIOR	
LOCKER ROOM	
Walls	
Deficiency	PLASTER: CRACKS/SPALLING
Deficiency Location/Instance	Right Side
Deficiency Quantity	30
Quantity Uom	S.F.
Potential Action	REPLACE
Urgency of Action	PRIORITY 3
Purpose of Action	LEVEL 2
Deficiency Photo1

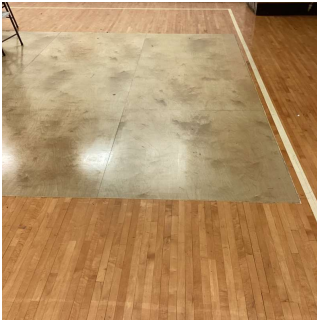
Violations	Near Exit No violations recorded.
Deficiency	WOOD: DAMAGED/DETERIORATED
Deficiency Location/Instance	Center
Deficiency Quantity	120
Quantity Uom	S.F.
Potential Action	REPLACE
Urgency of Action	PRIORITY 4
Purpose of Action	LEVEL 4
Deficiency Photo1

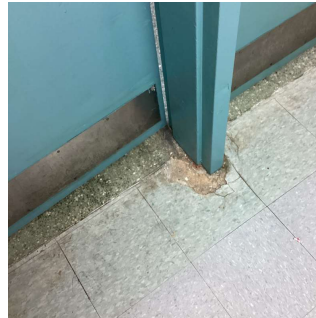
Stair F/1

VINYL TILES: DETERIORATED SUBSTRATE

REPLACE

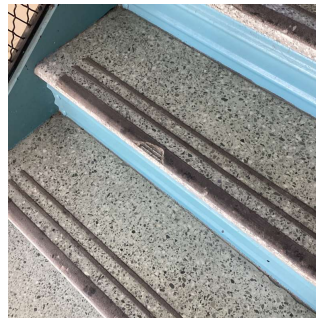
Stair B/Bulkhead

TERRAZZO: CRACKS

REPLACE

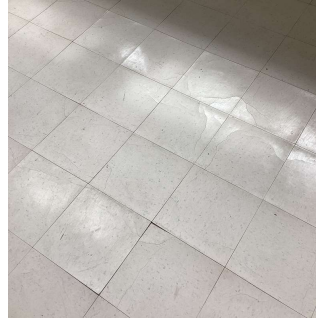
Stair A/2

Deficiency	VINYL TILES: BROKEN/DETERIORATED/MISSING TILES
Deficiency Location/Instance	Stairs A/2, B/1,Bulkhead, C/2, D/3, Near Boys Locker Room
Deficiency Quantity	145
Quantity Uom	S.F.
Potential Action	REPLACE
Urgency of Action	PRIORITY 3
Purpose of Action	LEVEL 2
Deficiency Photo1

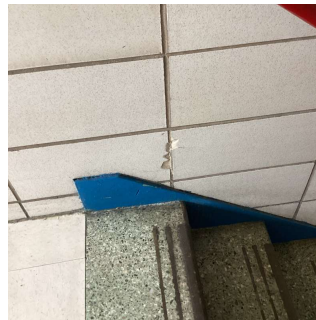
Condition	2 - Between Good and Fair
Deficiency	GLAZED BLOCK: CRACKS/SPALLING
Deficiency Location/Instance	Stair A/2
Deficiency Quantity	10
Quantity Uom	S.F.
Potential Action	REPLACE
Urgency of Action	PRIORITY 3
Purpose of Action	LEVEL 2
Deficiency Photo1

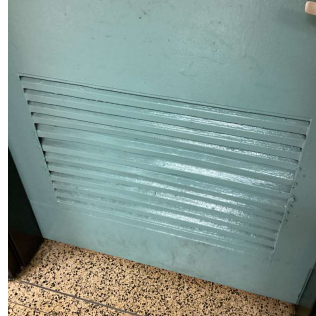
Room 182

METAL: DAMAGED LOUVER

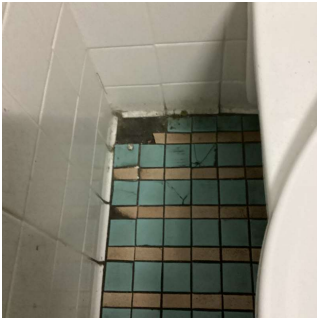
Question	Response
INTERIOR	
TOILET ROOMS - STAFF	
Floor Finish	
Violations	Room 186 No violations recorded.
Deficiency	CERAMIC TILE: BROKEN/MISSING TILES
Deficiency Location/Instance	Rooms 229, 329
Deficiency Quantity	20
Quantity Uom	S.F.
Potential Action	REPLACE
Urgency of Action	PRIORITY 3
Purpose of Action	LEVEL 2
Deficiency Photo1

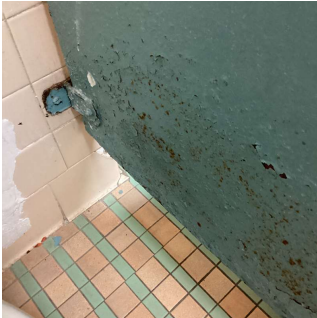
Violations	Room 329 No violations recorded.
Stalls	Inspected
Condition	5 - Poor
Deficiency	RUST - MAJOR
Deficiency Location/Instance	Kitchen, Rooms 186, 229, 325, In Room 201
Deficiency Quantity	5
Quantity Uom	EACH
Potential Action	REPLACE
Urgency of Action	PRIORITY 3
Purpose of Action	LEVEL 2
Deficiency Photo1

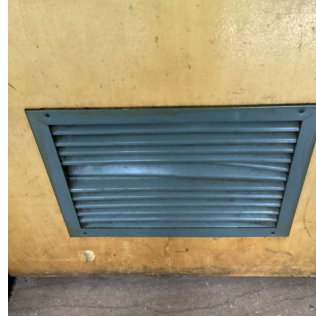
Room 161

WOOD: DAMAGED LOUVER

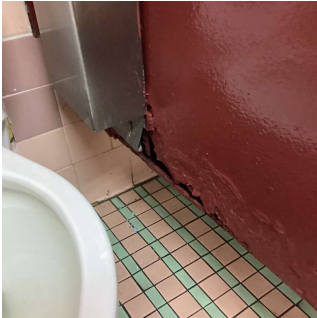
Question	Response
INTERIOR	
TOILET ROOMS - STUDENTS	
Floor Finish	Inspected
	Room 312
Violations	No violations recorded.
Stalls	Inspected
Condition	5 - Poor
Deficiency	RUST - MAJOR
Deficiency Location/Instance	Rooms 170, 172, 312
Deficiency Quantity	9
Quantity Uom	EACH
Potential Action	REPLACE
Urgency of Action	PRIORITY 3
Purpose of Action	LEVEL 2
Deficiency Photo1

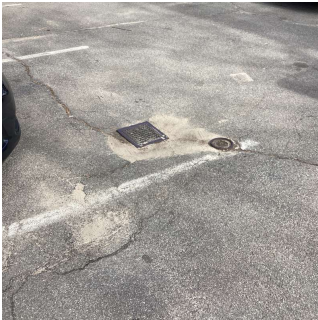
Question	Response
SITE	
Drainage System for Asphalt	Inspected
Catch Basins/Manhole - Surrounded by asphalt	Inspected
Condition	2 - Between Good and Fair
Deficiency	No deficiencies recorded
Culverts - Asphalt Covering	Does not Exist
Drainage System for Concrete	Inspected
Catch Basins/Manhole - Surrounded by concrete	Inspected
Condition	2 - Between Good and Fair
Deficiency	No deficiencies recorded
Culverts - Concrete Covering	Does not Exist
Drainage System for Soil	Inspected
Catch Basins/Manhole - Surrounded by Soil	Inspected
Condition	2 - Between Good and Fair
Deficiency	No deficiencies recorded
Culverts - Soil Covering	Does not Exist
DRINKING FOUNTAINS	Does not Exist
FENCES	Inaccessible
IRRIGATION SYSTEM	Does not Exist
PAVING	Inspected
Student Non-Use	Inspected
Gravel Exists?	No
Asphalt	Inspected
Condition	4 - Between Fair and Poor
Deficiency	LOCALIZED SINK AREA
Deficiency Location/Instance	Parking Lot on East 95th Street, Driveway on Rockaway Parkway

Deficiency Quantity	50
Quantity Uom	S.F.
Potential Action	REPAIR
Urgency of Action	PRIORITY 3
Purpose of Action	LEVEL 2
Deficiency Photo1

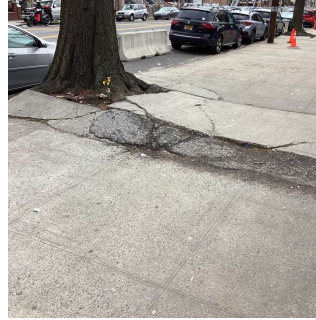
Rockaway Parkway
79518

Near Athletic Field Entrance
Violations	No violations recorded.
Pavers	Does not Exist
DOT Sidewalk	Inspected
Asphalt	Does not Exist
Concrete	Inspected
Condition	4 - Between Fair and Poor
Deficiency	HEAVING
Deficiency Location/Instance	Rockaway Parkway
Deficiency Quantity	1,000
Quantity Uom	S.F.
Potential Action	REPLACE

PRIORITY 5
LEVEL 6

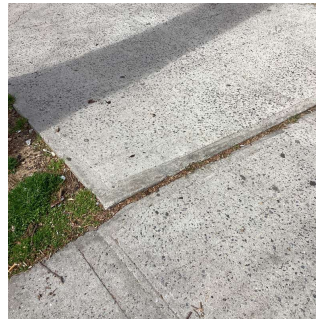
Avenue K
79518

HEAVING
Avenue K
150
S.F.
REPLACE
PRIORITY 4
LEVEL 4

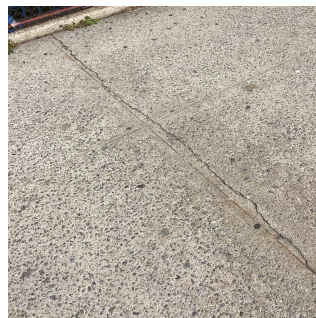
DAMAGED/DETERIORATED/MISSING SECTIONS
Avenue K, East 95th Street, Rockaway Parkway
2,850
S.F.
REPLACE
PRIORITY 4
LEVEL 4

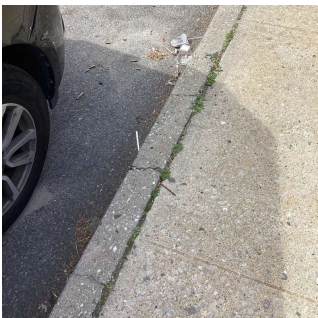
Question	Response
SITE	
PAVING	
DOT Sidewalk	
Concrete	
Violations	Avenue K 79518
Deficiency	DAMAGED CURBS
Deficiency Location/Instance	Avenue K, East 95th Street, Rockaway Parkway
Deficiency Quantity	295
Quantity Uom	L.F.
Potential Action	REPLACE
Urgency of Action	PRIORITY 4
Purpose of Action	LEVEL 4
Deficiency Photo1

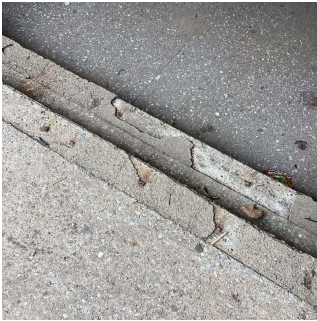
Question	Response
SITE	
STAIRS/RAMPS: EXTERIOR	
Stairs/ramps	
Deficiency Photo1

Violations	Avenue K 79518
Pavers	Does not Exist
PLAYGROUNDS	Does not Exist
PLAYING SURFACE	Does not Exist
RETAINING WALLS	Does not Exist
SEATING	Does not Exist
SITE WALLS (NOT RETAINING WALLS)	Does not Exist
STAIRS/RAMPS: EXTERIOR	Inspected
Railings	Inspected
Condition	2 - Between Good and Fair
Deficiency	No deficiencies recorded
Site Cheek/flank Walls	Inspected
Condition	2 - Between Good and Fair
Deficiency	No deficiencies recorded
Stairs/ramps	Inspected
Condition	2 - Between Good and Fair
Deficiency	CAST IN PLACE CONCRETE: CRACKS/SPALLING - MAJOR
Deficiency Location/Instance	Rockaway Parkway
Deficiency Quantity	20

Quantity Uom	S.F.
Potential Action	REPLACE
Urgency of Action	PRIORITY 3
Purpose of Action	LEVEL 2
