**NYC Department of Education**  
**Building Condition Assessment Survey 2023 - 2024**

Architectural Inspection

**Asset: SOUTH SHORE AF - BROOKLYN, 6565 FLATLANDS AVENUE, New York, 11236**

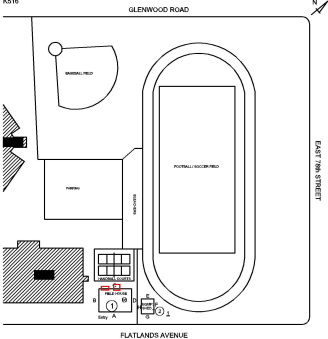
Question	Response
<b>Architectural</b>	
<b>EXTERIOR</b>	Inspected
<b>AREAWAY</b>	Does not Exist
<b>AWNINGS AND CANOPIES</b>	Does not Exist
<b>CHIMNEY</b>	Inspected
Material Type(s)	Metal
Condition	2 - Between Good and Fair
Deficiency	No deficiencies recorded
<b>COPING</b>	Inspected
Condition	3 - Fair
Deficiency	<b>CAST STONE: CRACKED/BROKEN PIECES</b>
Roof Plan reference

Deficiency Quantity	20
Quantity Uom	L.F.
Potential Action	REPLACE-IN-KIND
Urgency of Action	PRIORITY 4
Purpose of Action	LEVEL 2

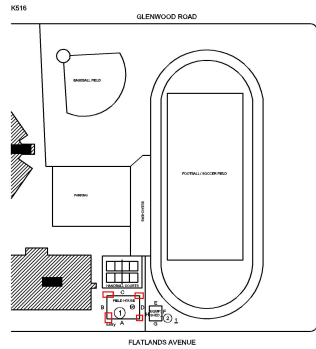
**CAST STONE: DETERIORATED TRANSVERSE JOINTS**

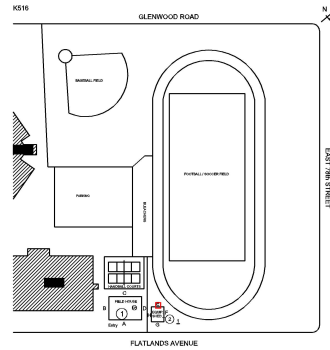
METAL: DETERIORATED DOOR - MINOR DETERIORATION

1  
EACH  
MAINTENANCE  
PRIORITY 3  
LEVEL 2

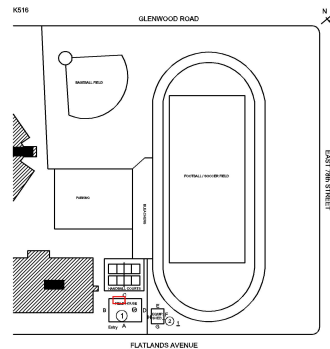
**ROLL-UP DOOR: DETERIORATED DOOR - MAJOR DETERIORATION**

300  
S.F.  
REPLACE  
PRIORITY 4  
LEVEL 2

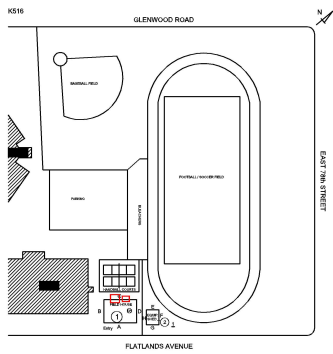
Question	Response
<b>EXTERIOR</b>	
<b>DOORS</b>	
<b>DOORS AND FRAMES</b>	
Deficiency Photo1	 
Violations	Facade C No violations recorded.
Deficiency	<b>METAL: DETERIORATED DOOR - MAJOR DETERIORATION</b>
Roof Plan reference

Deficiency Quantity	2
Quantity Uom	EACH
Potential Action	REPLACE
Urgency of Action	PRIORITY 4
Purpose of Action	LEVEL 2
Deficiency Photo1

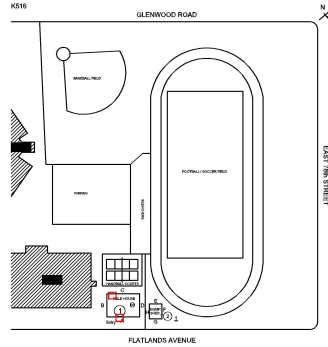
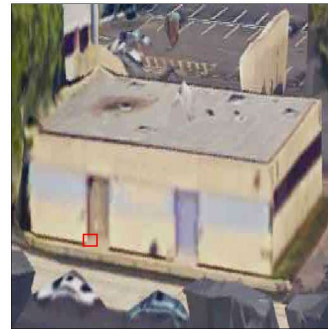
Question	Response
<b>EXTERIOR</b>	
<b>EXTERIOR WALLS</b>	Inspected
Material Type(s)	Masonry, Steel
Replacement Quantity	4,000
Replacement Uom	S.F.
Instance on All Facades	Inspected
Instance Condition	5 - Poor
Instance Quantity	4,000
Instance Quantity Uom	S.F.
Deficiency	STUCCO CEMENT SURFACE: CRACKS, SPALLING
Roof Plan reference	 
Elevation	 
Deficiency Quantity	20
Quantity Uom	S.F.
Potential Action	REPLACE
Urgency of Action	PRIORITY 4
Purpose of Action	LEVEL 2
Deficiency Photo1	 
Violations	Facade F No violations recorded.
Deficiency	BRICK: MINOR CRACKS AND SPALLING

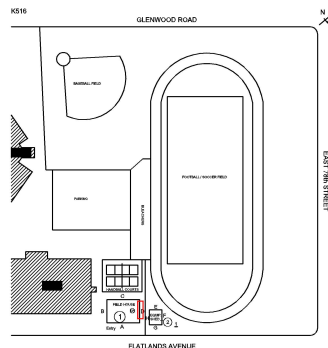
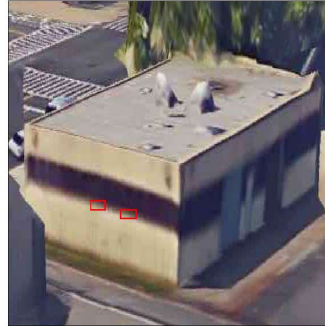
**METAL PANEL: DAMAGED TRIM**

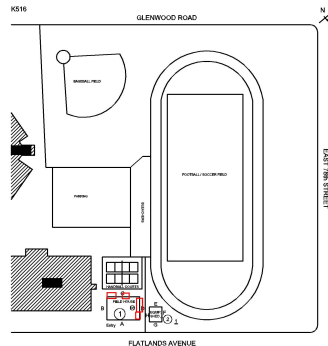
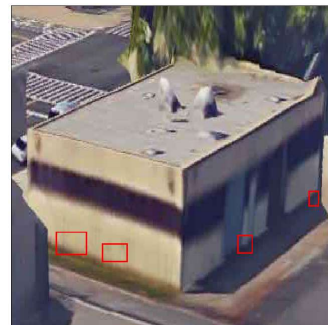
**BRICK: MAJOR / THRU CRACKS**

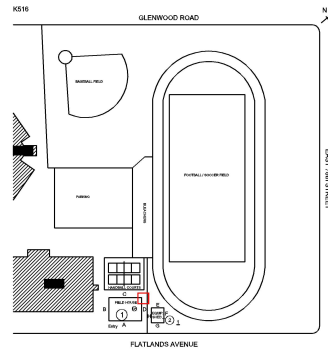
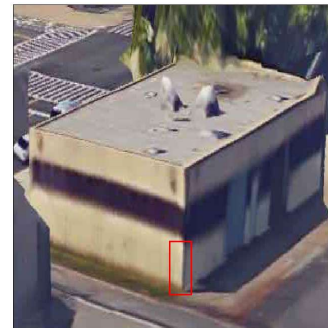
**BRICK: CRACKS/DISPLACED/SPALLED BRICK AT BUILDING CORNERS**

35  
S.F.  
REMOVE AND REBUILD  
PRIORITY 4  
LEVEL 2

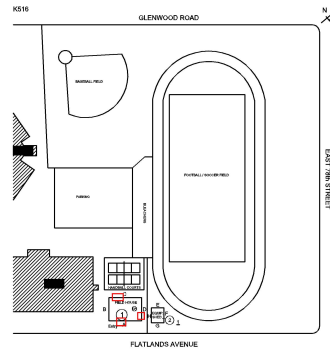
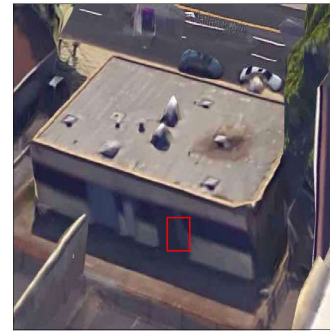
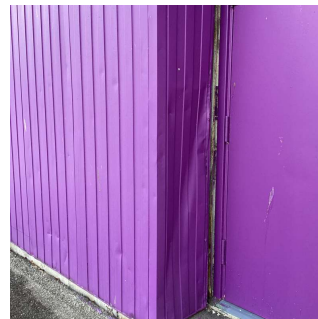
Facade C

**METAL PANEL: SEVERE DENTS**

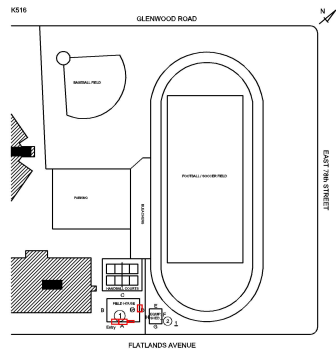
Question	Response
<b>EXTERIOR</b>	
<b>PARAPETS</b>	
Instance on Roof 1	Inspected
Instance Condition	3 - Fair
Instance Quantity	800
Instance Quantity Uom	C.F.
Deficiency	<b>BRICK: DETERIORATED JOINTS</b>
Roof Plan reference

Deficiency Quantity	30
Quantity Uom	S.F.
Potential Action	REPOINT
Urgency of Action	PRIORITY 3
Purpose of Action	LEVEL 2
Deficiency Photo1

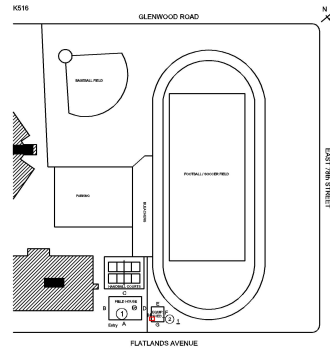
Violations	Roof 1 No violations recorded.
<b>PLAZA DECK</b>	Does not Exist
<b>ROOF</b>	Inspected
<b>Roofing</b>	Inspected
Replacement Quantity	4,200
Replacement Uom	S.F.
<b>ROOF HATCH/SMOKE HATCH</b>	Does not Exist
<b>LEADERS, GUTTERS, DOWNSPOUTS, SCUPPERS</b>	Inspected
Condition	3 - Fair
Deficiency	LOOSE

1  
EACH  
MAINTENANCE  
PRIORITY 3  
LEVEL 2

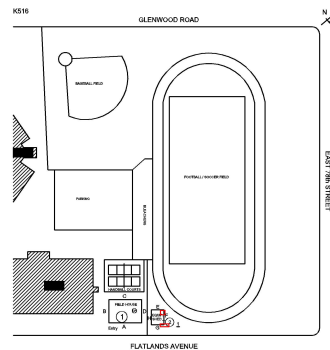
**DAMAGED/MISSING**

25  
L.F.  
REPLACE  
PRIORITY 4  
LEVEL 2

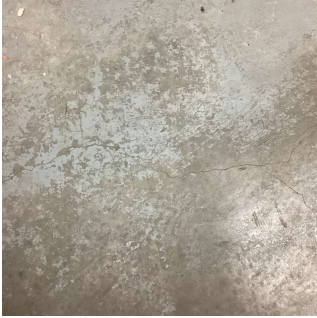
Question	Response
<b>EXTERIOR</b>	
<b>ROOF</b>	
<b>Roofing</b>	
<b>ROOFING</b>	Inspected
Source of Installation	Custodial Staff
Deficiency	No deficiencies recorded
<b>ROOFING DRAINS</b>	Inspected
Condition	2 - Between Good and Fair
Deficiency	No deficiencies recorded
<b>Specialties</b>	Does not Exist
<b>STAIRS/RAMPS: EXTERIOR</b>	Does not Exist
<b>WINDOWS</b>	Does not Exist
<b>INTERIOR</b>	Inspected
<b>STRUCTURAL</b>	Inspected
<b>COLUMNS/BEAMS/BEARING WALLS</b>	Inspected
Condition	2 - Between Good and Fair
Deficiency	No deficiencies recorded
<b>FLOOR STRUCTURE</b>	Inspected
Condition	3 - Fair
Deficiency	CONCRETE SLAB ON GRADE: THRU CRACKS
Deficiency Location/Instance	1st Floor
Deficiency Quantity	70
Quantity Uom	S.F.
Potential Action	REPAIR
Urgency of Action	PRIORITY 3
Purpose of Action	LEVEL 5
Deficiency Photo1

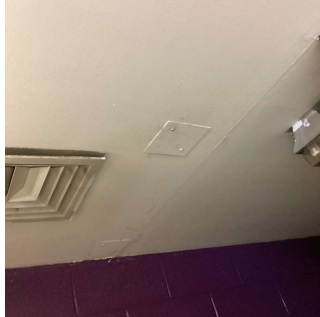
Violations	Center No violations recorded.
Instance on 1st Floor- Visitors (85 Lockers)	Inspected
Condition	2 - Between Good and Fair
Deficiency	GYPSUM BOARD: DAMAGED/DETERIORATED
Deficiency Location/Instance	Rear
Deficiency Quantity	10
Quantity Uom	S.F.
Potential Action	REPLACE
Urgency of Action	PRIORITY 3

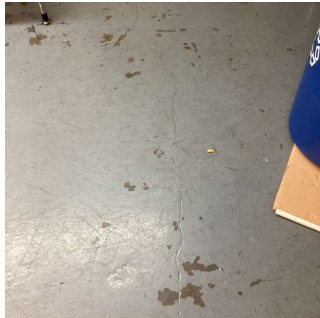
Rear
Violations	No violations recorded.
<b>Door(s)</b>	
Instance on 1st Floor- West (41 Lockers)	Inspected
Condition	2 - Between Good and Fair
Deficiency	No deficiencies recorded
Instance on 1st Floor- East (52 Lockers)	Inspected
Condition	2 - Between Good and Fair
Deficiency	No deficiencies recorded
Instance on 1st Floor- Visitors (85 Lockers)	Inspected
Condition	2 - Between Good and Fair
Deficiency	No deficiencies recorded
<b>Floor Finish</b>	
Instance on 1st Floor- East (52 Lockers)	Inspected
Condition	2 - Between Good and Fair
Deficiency	CONCRETE: CRACKS
Deficiency Location/Instance	Center
Deficiency Quantity	20
Quantity Uom	S.F.
Potential Action	REPLACE
Urgency of Action	PRIORITY 3
Purpose of Action	LEVEL 2
Deficiency Photo1

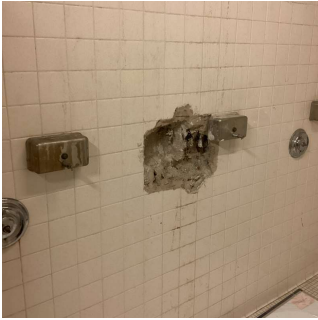
Question	Response
<b>INTERIOR</b>	
<b>SHOWER ROOM</b>	
<b>Walls</b>	
Instance on 1st Floor- East	Inspected
Condition	4 - Between Fair and Poor
Deficiency	PLASTER: CRACKS/SPALLING
Deficiency Location/Instance	Center
Deficiency Quantity	20
Quantity Uom	S.F.
Potential Action	REPLACE
Urgency of Action	PRIORITY 3
Purpose of Action	LEVEL 2
Deficiency Photo1	 
Violations	Center No violations recorded.
Deficiency	CERAMIC TILE: BROKEN/ MISSING
Deficiency Location/Instance	Center
Deficiency Quantity	20
Quantity Uom	S.F.
Potential Action	REPLACE
Urgency of Action	PRIORITY 3
Purpose of Action	LEVEL 2
Deficiency Photo1

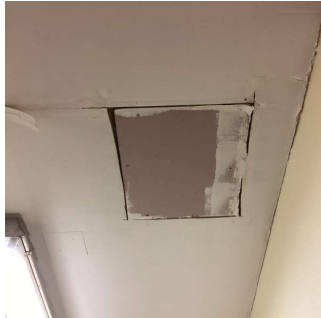
Question	Response
<b>INTERIOR</b>	
<b>TOILET ROOMS - STAFF</b>	
<b>Floor Finish</b>	Inspected
Condition	2 - Between Good and Fair
Deficiency	No deficiencies recorded
<b>Stalls</b>	Does not Exist
<b>Walls</b>	Inspected
Condition	2 - Between Good and Fair
Deficiency	No deficiencies recorded
<b>TOILET ROOMS - STUDENTS</b>	
<b>Ceiling</b>	Inspected
Condition	2 - Between Good and Fair
Deficiency	GYPSUM BOARD: DAMAGED/DETERIORATED
Deficiency Location/Instance	Visitors Restroom
Deficiency Quantity	10
Quantity Uom	S.F.
Potential Action	REPLACE
Urgency of Action	PRIORITY 3
Purpose of Action	LEVEL 2
Deficiency Photo1

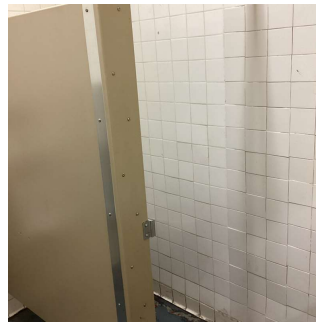
Violations	Visitors Restroom No violations recorded.
<b>Door(s)</b>	Does not Exist
<b>Floor Finish</b>	Inspected
Condition	2 - Between Good and Fair
Deficiency	No deficiencies recorded
<b>Stalls</b>	Inspected
Condition	4 - Between Fair and Poor
Deficiency	BROKEN/MISSING
Deficiency Location/Instance	East
Deficiency Quantity	1

Quantity Uom	EACH
Potential Action	REPLACE
Urgency of Action	PRIORITY 3
Purpose of Action	LEVEL 2

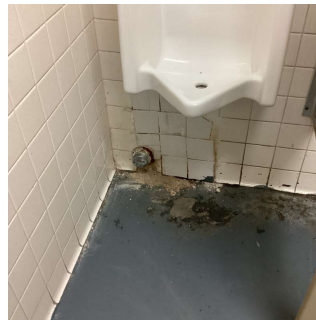
East Locker Room

CERAMIC TILE: BROKEN/ MISSING

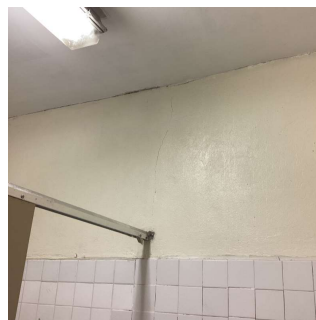
PLASTER: CRACKS/SPALLING

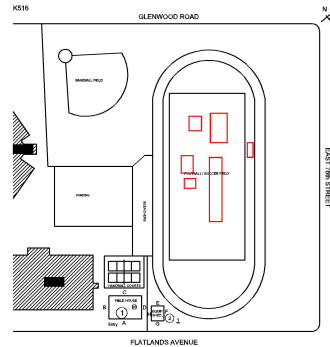
Football Field

ARTIFICIAL TURF: DAMAGED/WORN OUT

1,000

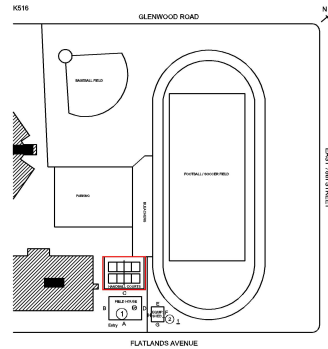
Handball Courts

**ASPHALT: DAMAGED/DETERIORATED**

5,000

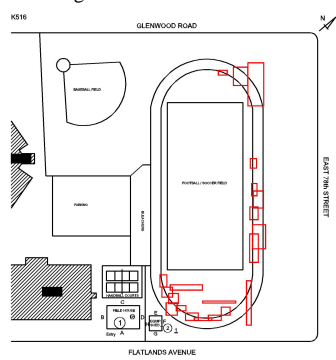
**ATHLETIC WEARING SURFACE: DAMAGED/DETERIORATED**

Question	Response
<b>ATHLETIC FIELDS</b>	
<b>PLAYING SURFACE</b>	
Deficiency Location/Instance	Running Track
Roof Plan reference

Deficiency Quantity	1,800
Quantity Uom	S.F.
Potential Action	REPLACE
Urgency of Action	PRIORITY 4
Purpose of Action	LEVEL 2
Deficiency Photo1

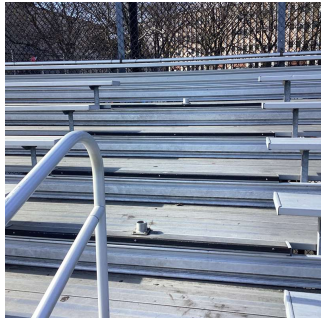
<b>Deficiency</b>	3 - Fair
<b>Deficiency Location/Instance</b>	MISSING RAILINGS
<b>Deficiency Quantity</b>	Right Side, Center 10

Question	Response
<b>ATHLETIC FIELDS</b>	
<b>SEATING</b>	
<b>Bleachers</b>	
<b>Metal/Wood/Plastic</b>	
Quantity Uom	L.F.
Potential Action	REPLACE
Urgency of Action	PRIORITY 5
Purpose of Action	LEVEL 6
Deficiency Photo1

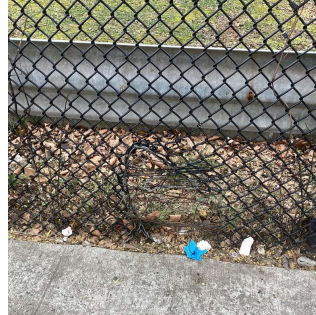
Deficiency Quantity	1
Quantity Uom	EACH
Potential Action	MAINTENANCE
Urgency of Action	PRIORITY 3
Purpose of Action	LEVEL 2
Deficiency Photo1	No photo recorded
Violations	No violations recorded.
<b>FENCES</b>	Inspected
Condition	4 - Between Fair and Poor
Deficiency	CHAIN LINK: DAMAGED/DETERIORATED
Deficiency Location/Instance	Glenwood Road
Deficiency Quantity	50
Quantity Uom	S.F.

REPLACE  
PRIORITY 3  
LEVEL 2

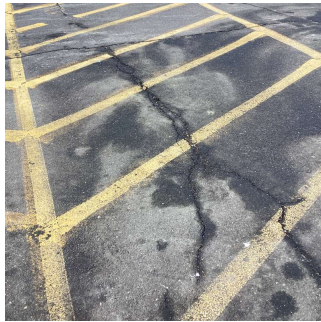
Question	Response
<b>SITE</b>	
<b>FENCES</b>	Inspected
	Near Handball Court
Violations	No violations recorded.
<b>IRRIGATION SYSTEM</b>	Does not Exist
<b>PAVING</b>	Inspected
<b>Student Non-Use</b>	Inspected
Gravel Exists?	No
<b>Asphalt</b>	Inspected
Condition	4 - Between Fair and Poor
Deficiency	CRACKS - MAJOR
Deficiency Location/Instance	Parking Lot
Deficiency Quantity	2,000
Quantity Uom	S.F.
Potential Action	REPLACE
Urgency of Action	PRIORITY 3
Purpose of Action	LEVEL 2
Deficiency Photo1

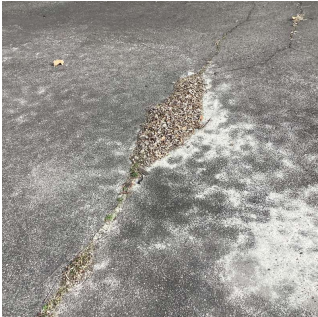
Parking Lot
Violations	No violations recorded.
<b>Concrete</b>	Does not Exist
<b>Pavers</b>	Does not Exist
<b>Student Use</b>	Inspected
Gravel Exists?	No
<b>Asphalt</b>	Inspected
Condition	3 - Fair
Deficiency	CRACKS - MAJOR
Deficiency Location/Instance	Batting Cage Area on Flatlands Avenue
Deficiency Quantity	150
Quantity Uom	S.F.
Potential Action	REPLACE
Urgency of Action	PRIORITY 3
Purpose of Action	LEVEL 2

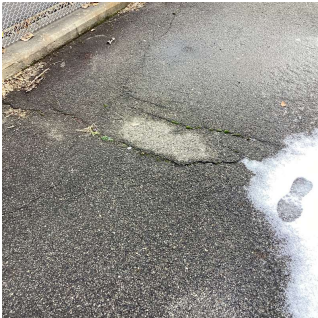
Batting Cage Area on Flatlands Avenue
Violations	No violations recorded.
<b>Concrete</b>	Inspected
Condition	2 - Between Good and Fair
Deficiency	No deficiencies recorded
<b>Pavers</b>	Does not Exist
<b>Site Sidewalks &amp; Walkways</b>	Inspected
<b>Asphalt</b>	Inspected
Condition	3 - Fair
Deficiency	CRACKS - MAJOR
Deficiency Location/Instance	Near Field House
Deficiency Quantity	300
Quantity Uom	S.F.
Potential Action	REPLACE
Urgency of Action	PRIORITY 3
Purpose of Action	LEVEL 2
Deficiency Photo1

Near Field House
Violations	No violations recorded.
Deficiency	CRACKS - MAJOR
Deficiency Location/Instance	Near Field House
Deficiency Quantity	50
Quantity Uom	S.F.
Potential Action	REPLACE
Urgency of Action	PRIORITY 5
Purpose of Action	LEVEL 6

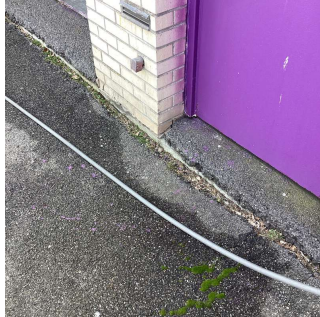
Question	Response
<b>SITE</b>	
<b>PAVING</b>	
<b>Site Sidewalks &amp; Walkways</b>	
<b>Asphalt</b>	
Deficiency Photo1

Violations	Near Field House No violations recorded.
<b>Concrete</b>	
Condition	Inspected 3 - Fair
Deficiency	CRACKS - MAJOR
Deficiency Location/Instance	Near Field House
Deficiency Quantity	150
Quantity Uom	S.F.
Potential Action	REPLACE
Urgency of Action	PRIORITY 3
Purpose of Action	LEVEL 2
Deficiency Photo1

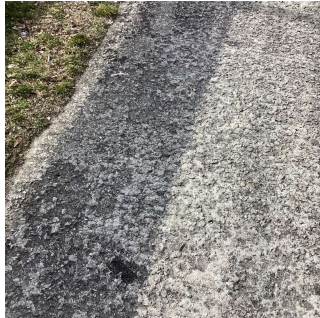
Violations	Near Field House No violations recorded.
Deficiency	HEAVING
Deficiency Location/Instance	Near Field House
Deficiency Quantity	50
Quantity Uom	S.F.
Potential Action	REPLACE
Urgency of Action	PRIORITY 3
Purpose of Action	LEVEL 2
