NYC Department of Education
Building Condition Assessment Survey 2023 - 2024

Architectural Inspection

K520

Asset: PACIFIC ALT HS - K, 112 SCHERMERHORN STREET, New York, 11201

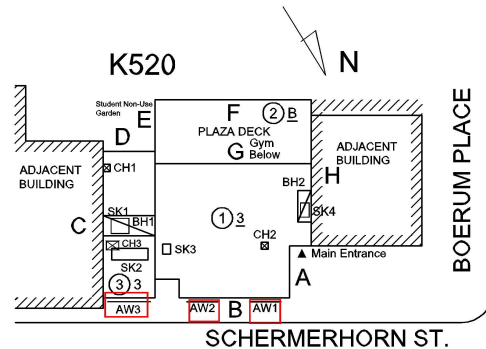
Question	Response
Architectural	
EXTERIOR	Inspected
AREAWAY	Inspected
Instance on AW1-AW3	Inspected
Instance Condition	4 - Between Fair and Poor
Instance Quantity	3
Instance Quantity Uom	EACH
Deficiency	AREAWAY WALLS: CRACKS AND SPALLING
Roof Plan reference

Deficiency Quantity	50
Quantity Uom	S.F.

REPLACE
PRIORITY 4
LEVEL 2

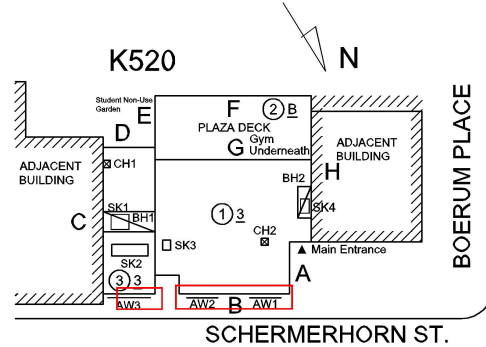
AREAWAY WALLS: DETERIORATED COPING STONE

50
S.F.
REPLACE
PRIORITY 4
LEVEL 2

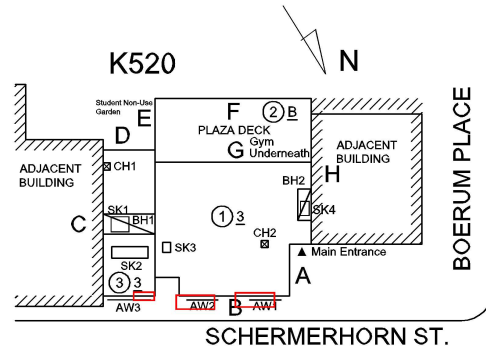
AREAWAY WALLS: DETERIORATED JOINTS

100
S.F.
REPAIR
PRIORITY 4
LEVEL 2

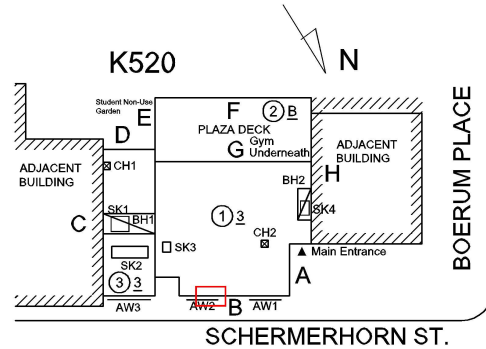
AREAWAY SLAB: CRACKS AND SPALLING

25
S.F.
REPLACE
PRIORITY 4
LEVEL 2

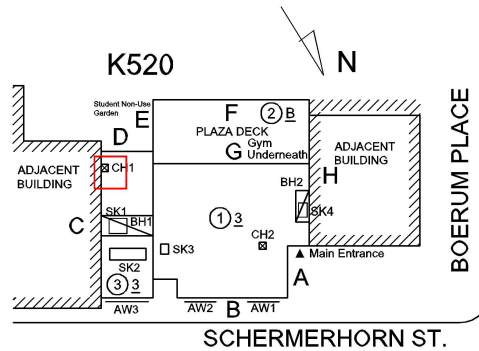
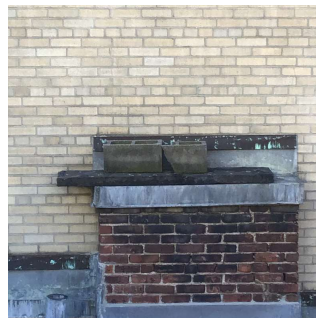
Chimney
No violations recorded.

BRICK: DETERIORATED CAP

10
L.F.
REPLACE
PRIORITY 3
LEVEL 2

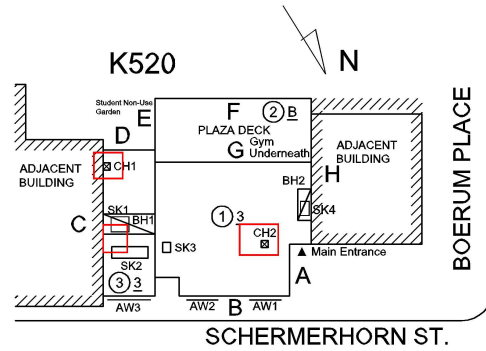
CHIMNEY

BRICK: DETERIORATED JOINTS

60
 S.F.
 REPOINT
 PRIORITY 3
 LEVEL 2

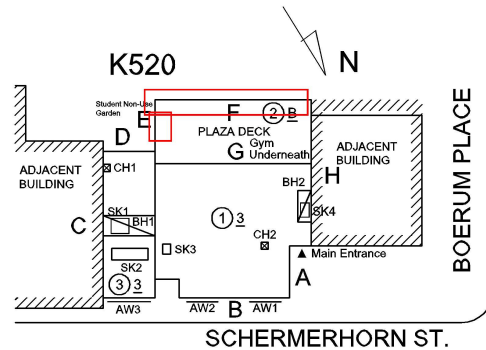
METAL: DETERIORATED TRANSVERSE JOINTS

50
 L.F.
 MAINTENANCE
 PRIORITY 3
 LEVEL 2

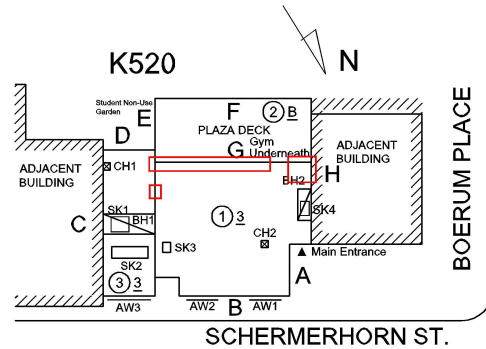
CAST STONE: DETERIORATED TRANSVERSE JOINTS

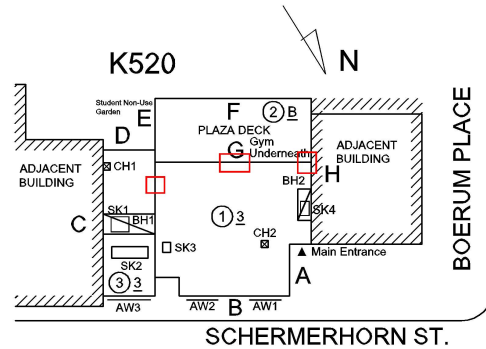
COPING

CAST STONE: CRACKED/BROKEN PIECES

10
 L.F.
 REPLACE-IN-KIND
 PRIORITY 4
 LEVEL 2

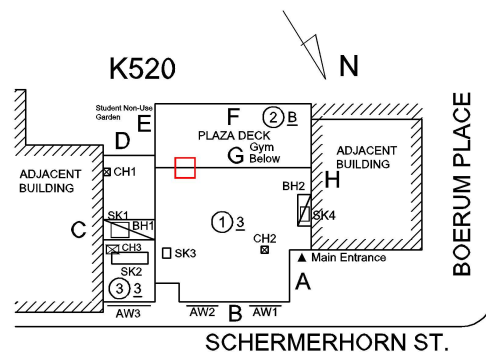
WOOD: DETERIORATED DOOR AND FRAME - MAJOR DETERIORATION

1
 EACH
 REPLACE
 PRIORITY 4
 LEVEL 2

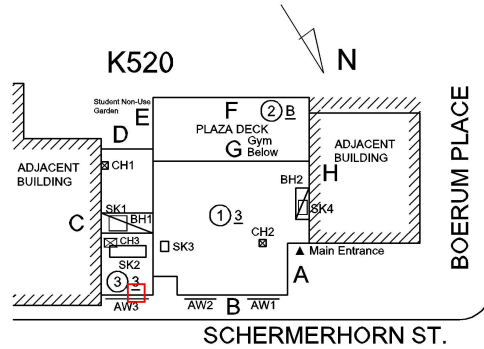
METAL: DETERIORATED DOOR AND FRAME - MINOR DETERIORATION

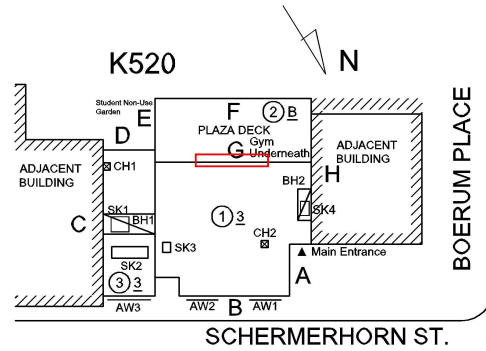
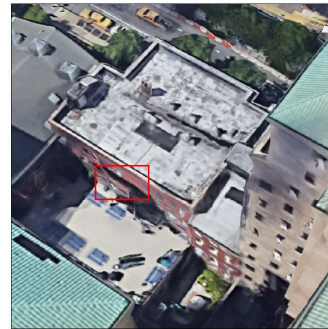
Question	Response
EXTERIOR	
DOORS	
DOORS AND FRAMES	
Roof Plan reference	
Deficiency Quantity	4
Quantity Uom	EACH
Potential Action	MAINTENANCE
Urgency of Action	PRIORITY 3
Purpose of Action	LEVEL 2
Deficiency Photo1	
	Facade G
Violations	No violations recorded.
DOOR HARDWARE	Inspected
Condition	2 - Between Good and Fair
Deficiency	No deficiencies recorded
LINTELS	Inspected
Condition	2 - Between Good and Fair
Deficiency	No deficiencies recorded
TRANSOM/SIDE LIGHT	Inspected
Condition	2 - Between Good and Fair
Deficiency	No deficiencies recorded
EXTERIOR WALLS	Inspected
Material Type(s)	Masonry
Replacement Quantity	8,000
Replacement Uom	S.F.
Instance on All Facades	Inspected
Instance Condition	3 - Fair
Instance Quantity	8,000
Instance Quantity Uom	S.F.
Deficiency	BRICK: DETERIORATED JOINTS

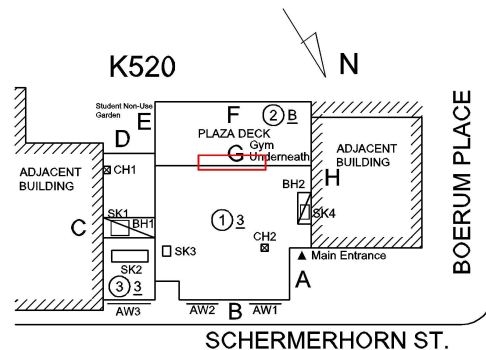
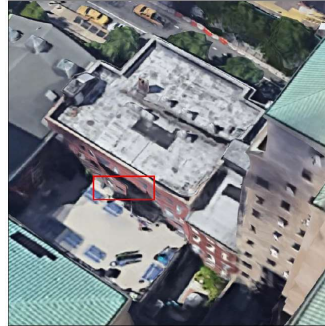
BRICK: DETERIORATED MASONRY SILLS - MAJOR

REMOVE AND REPLACE

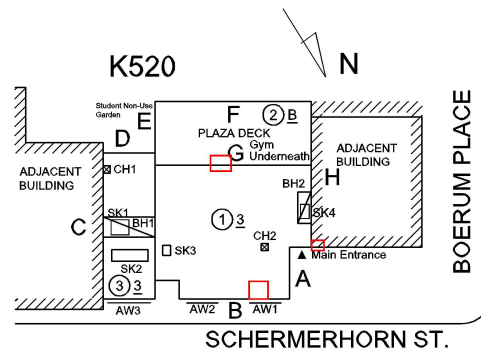
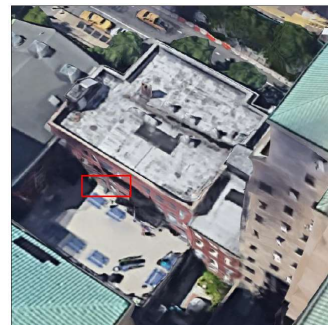
BRICK: MINOR CRACKS AND SPALLING

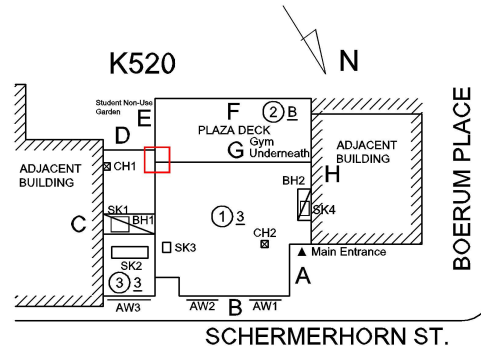
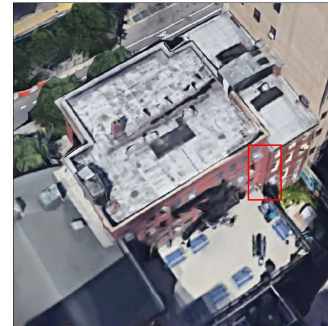
BRICK: MAJOR / THRU CRACKS

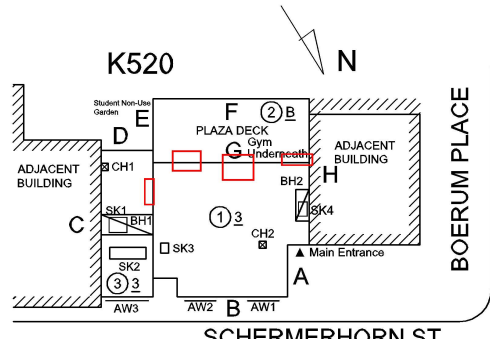
Question	Response
EXTERIOR	
EXTERIOR WALLS	Inspected
Violations	No violations recorded.
EXTERIOR SOFFITS	Inspected
Condition	2 - Between Good and Fair
Deficiency	No deficiencies recorded
LOADING DOCK	Does not Exist
LOUVER	Inspected
Condition	2 - Between Good and Fair
Deficiency	No deficiencies recorded
PARAPETS	Inspected
Material Type(s)	Masonry
Replacement Quantity	2,000
Replacement Uom	C.F.
Instance on All Roofs	Inspected
Instance Condition	3 - Fair
Instance Quantity	2,000
Instance Quantity Uom	C.F.
Deficiency	BRICK: DETERIORATED JOINTS
Roof Plan reference

Deficiency Quantity	100
Quantity Uom	S.F.
Potential Action	REPOINT
Urgency of Action	PRIORITY 3
Purpose of Action	LEVEL 2
Deficiency Photo1

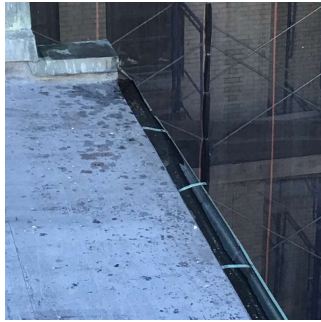
Gutter - Facade D
 No violations recorded.

Question	Response
EXTERIOR	
PLAZA DECK	Inspected
Installation Year	2018
Source of Installation	Custodial Staff
Deficiency	No deficiencies recorded
ROOF	Inspected
Roofing	Inspected
Replacement Quantity	9,300
Replacement Uom	S.F.
ROOF HATCH/SMOKE HATCH	Does not Exist
LEADERS, GUTTERS, DOWNSPOUTS, SCUPPERS	Inspected
Condition	3 - Fair
Deficiency	LOOSE
Roof Plan reference	
Deficiency Quantity	1
Quantity Uom	EACH
Potential Action	MAINTENANCE
Urgency of Action	PRIORITY 3
Purpose of Action	LEVEL 2
Deficiency Photo1

1
 EACH
 MAINTENANCE
 PRIORITY 3
 LEVEL 2

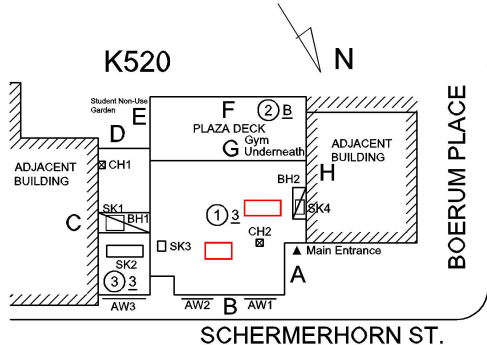
Roof 1
Instance Quantity	9,300
Instance Quantity Uom	S.F.
Does the roof have major mechanical equipment sitting on Dunnage Steel less than 18" above the Roofing?	No
Does this roof instance have a Sustainable Roof System?	No
Do solar panels exist on these roofs?	No
Is/Are the roof(s) suitable for Solar Panel installation?	No
Installation Year	2000
Source of Installation	Custodial Staff
Deficiency	MODIFIED BITUMEN: ROOFING: DELAMINATION
Roof Plan reference

Deficiency Quantity	20
Quantity Uom	S.F.
Potential Action	REPLACE ROOFING WITHOUT MAJOR EQUIPMENT REMOVAL
Urgency of Action	PRIORITY 4
Purpose of Action	LEVEL 2
Deficiency Photo1

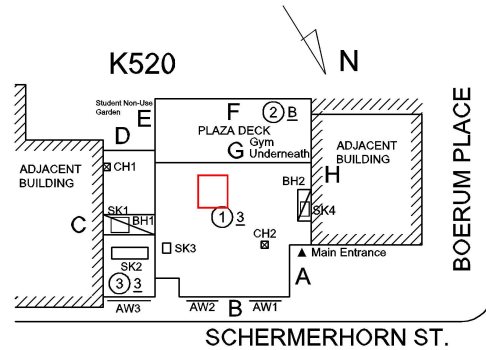
Roof 1 - Room 332
 No violations recorded.

Roof 1
Violations	No violations recorded.
Deficiency	MODIFIED BITUMEN: ROOFING: MAJOR ACTIVE ROOF LEAKS IN INSTRUCTIONAL SPACE

100
 S.F.
 REPLACE ROOFING WITHOUT MAJOR EQUIPMENT
 REMOVAL
 PRIORITY 5
 LEVEL 2

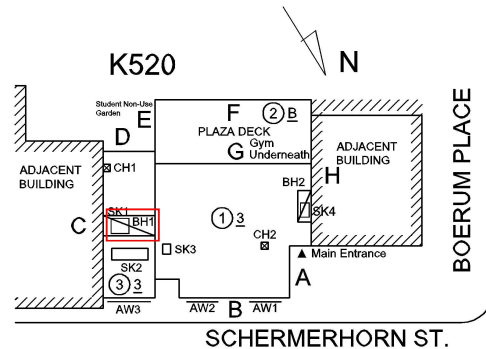
BULKHEAD/PENTHOUSE WALLS/INTERIOR: PLASTER
 CRACKS/SPALLING

80
 S.F.

Question	Response
EXTERIOR	
ROOF	
Specialties	
BULKHEAD/PENTHOUSE	
Potential Action	REPLACE
Urgency of Action	PRIORITY 3
Purpose of Action	LEVEL 2
Deficiency Photo1

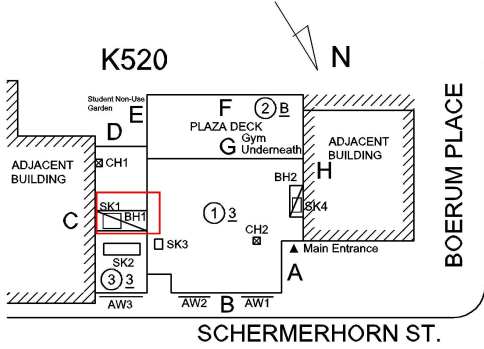
Violations	Bulkhead 1 No violations recorded.
Deficiency	BULKHEAD/PENTHOUSE WALLS/EXTERIOR: CRACKS/SPALLING - MINOR
Roof Plan reference

Deficiency Quantity	100
Quantity Uom	S.F.
Potential Action	REPAIR
Urgency of Action	PRIORITY 3
Purpose of Action	LEVEL 2
Deficiency Photo1

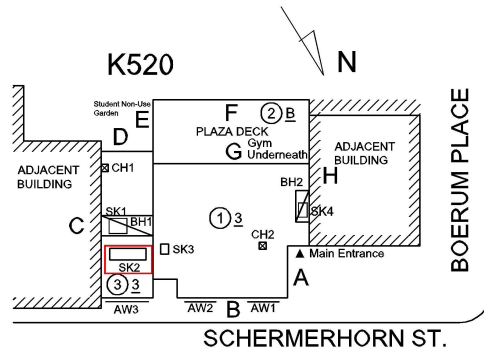
Skylight 2
No violations recorded.

Material Type(s)	Glass
Condition	3 - Fair
Deficiency	DAMAGED GUARDS
Roof Plan reference

75
S.F.
MAINTENANCE
PRIORITY 3
LEVEL 2

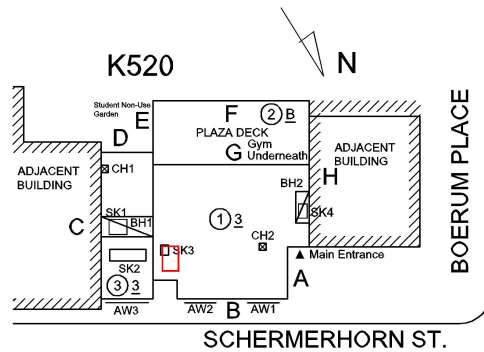
Deficiency	BROKEN GLASS
Roof Plan reference

10
S.F.
MAINTENANCE
PRIORITY 3
LEVEL 2

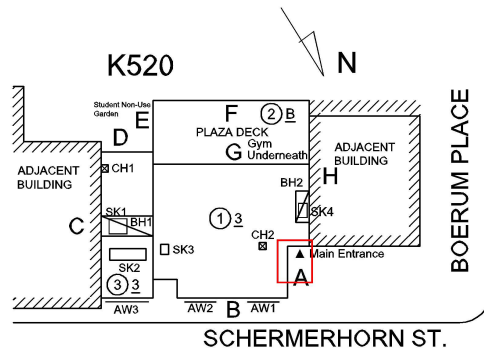
Inspected
 5 - Poor
 CONCRETE: WORN-OUT TREAD/RISER/NOSING

60
 S.F.
 REPLACE
 PRIORITY 4
 LEVEL 2

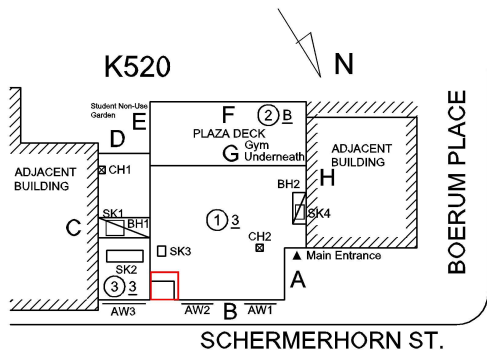
Violations	Main Entrance No violations recorded.
Deficiency	CONCRETE: CRACKS/SPALLING - MINOR
Roof Plan reference

Deficiency Quantity	10
Quantity Uom	S.F.
Potential Action	REPAIR
Urgency of Action	PRIORITY 3
Purpose of Action	LEVEL 2
Deficiency Photo1

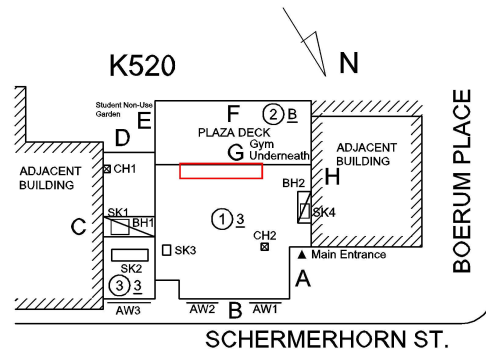
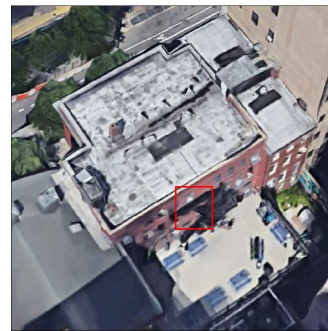
Facade G
No violations recorded.

Violations	Facade A No violations recorded.
WINDOWS	
Replacement Quantity	Inspected
Replacement Uom	3,000
EXTERIOR GUARDS	
Condition	S.F.
Deficiency	Inspected
Deficiency	2 - Between Good and Fair
Deficiency	No deficiencies recorded
LINTELS	
Condition	Inspected
Deficiency	2 - Between Good and Fair
Deficiency	STONE: CHIPPED/SPALLED/BROKEN PIECES

20
S.F.
REPAIR
PRIORITY 3
LEVEL 2

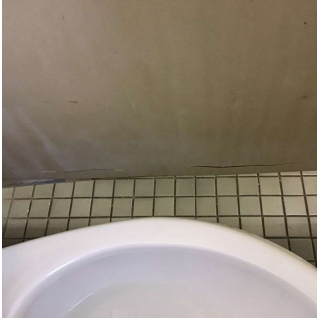
Question	Response
INTERIOR	
TOILET ROOMS - STUDENTS	
Stalls	
Quantity Uom	EACH
Potential Action	REPLACE
Urgency of Action	PRIORITY 3
Purpose of Action	LEVEL 2
Deficiency Photo1

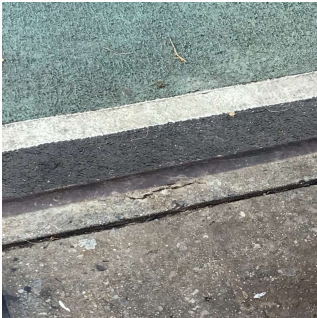
Question	Response
SITE	
PAVING	
DOT Sidewalk	
Concrete	
Violations	No violations recorded.
Deficiency	DAMAGED CURBS
Deficiency Location/Instance	Along Schermerhorn Street
Deficiency Quantity	40
Quantity Uom	L.F.
Potential Action	REPLACE
Urgency of Action	PRIORITY 3
Purpose of Action	LEVEL 2
Deficiency Photo1

Violations	Along Schermerhorn Street No violations recorded.
Pavers	Does not Exist
PLAYGROUNDS	Does not Exist
PLAYING SURFACE	Does not Exist
RETAINING WALLS	Does not Exist
SEATING	Does not Exist
SITE WALLS (NOT RETAINING WALLS)	Does not Exist
STAIRS/RAMPS: EXTERIOR	Does not Exist
ARTWORK	Does not Exist
