**NYC Department of Education**  
**Building Condition Assessment Survey 2023 - 2024**

Architectural Inspection

**K521**

**Asset:** PS 160 ANNEX - BROOKLYN, 1057 52ND STREET, New York, 11219

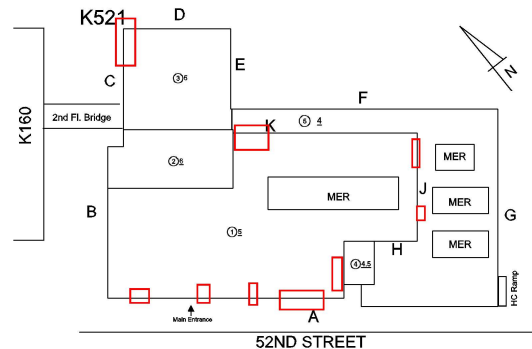
Deficiency CAST STONE: DETERIORATED TRANSVERSE JOINTS  
Roof Plan reference

Question	Response
<b>Architectural</b>	
<b>EXTERIOR</b>	Inspected
<b>AREAWAY</b>	Does not Exist
<b>AWNINGS AND CANOPIES</b>	Does not Exist
<b>CHIMNEY</b>	Inspected
Material Type(s)	Masonry
Condition	2 - Between Good and Fair
Deficiency	No deficiencies recorded
<b>COPING</b>	Inspected
Condition	3 - Fair

Deficiency Quantity 50  
 Quantity Uom L.F.  
 Potential Action MAINTENANCE  
 Urgency of Action PRIORITY 3  
 Purpose of Action LEVEL 2

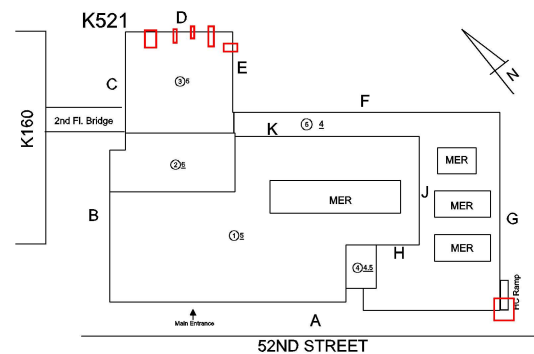
Roof Plan reference

CAST IN PLACE / PRE-CAST CONCRETE: DETERIORATED CONTROL/EXPANSION JOINTS

Deficiency Quantity	60
Quantity Uom	L.F.
Potential Action	MAINTENANCE
Urgency of Action	PRIORITY 3
Purpose of Action	LEVEL 2
Deficiency Photo1	 
Violations	Facade G No violations recorded.
<b>EXTERIOR SOFFITS</b>	Inspected
Condition	2 - Between Good and Fair
Deficiency	No deficiencies recorded
<b>LOADING DOCK</b>	Does not Exist
<b>LOUVER</b>	Inspected
Condition	2 - Between Good and Fair
Deficiency	No deficiencies recorded
<b>PARAPETS</b>	Inspected
Material Type(s)	Concrete
Replacement Quantity	5,000
Replacement Uom	C.F.
Instance on All Facades	Inspected
Instance Condition	3 - Fair
Instance Quantity	5,000
Instance Quantity Uom	C.F.
Deficiency	CONCRETE: DETERIORATED CONTROL/EXPANSION JOINT

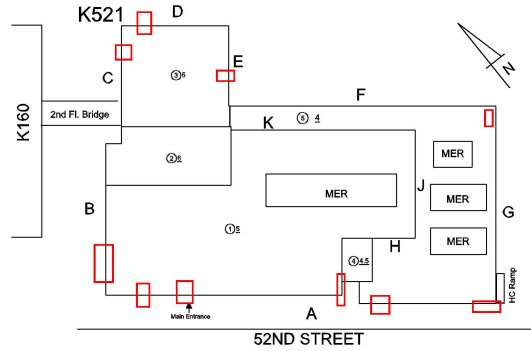
Roof Plan reference

**PARAPETS**

50  
L.F.  
MAINTENANCE  
PRIORITY 3  
LEVEL 2

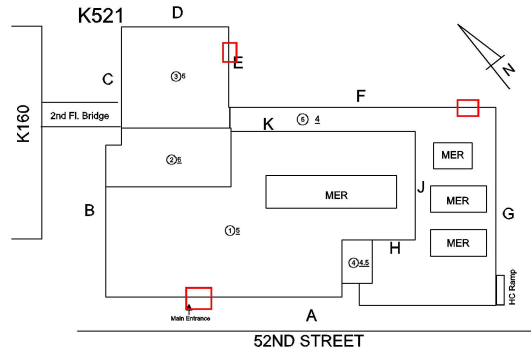
Roof Plan reference

**CONCRETE: MAJOR DETERIORATION/CRACKS**

30  
S.F.  
REMOVE AND REBUILD  
PRIORITY 4  
LEVEL 2

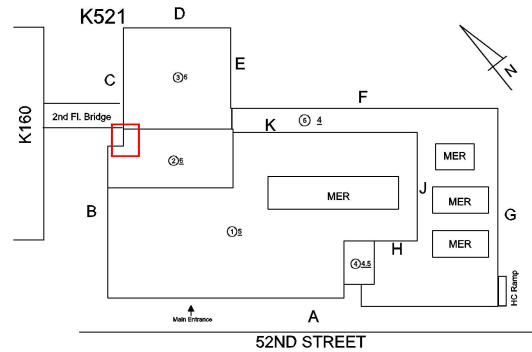
Roof Plan reference

Do solar panels exist on these roofs?	No
Is/Are the roof(s) suitable for Solar Panel installation?	No
Installation Year	2012
Source of Installation	Custodial Staff
Deficiency	IRMA: FLASHING: DRIP EDGE/GRAVEL STOP DAMAGED

10  
L.F.  
REPLACE  
PRIORITY 5  
LEVEL 6

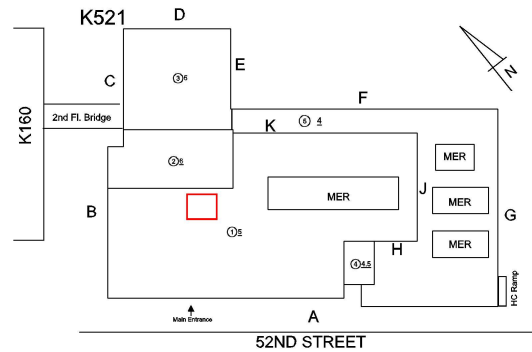
Roof Plan reference

IRMA: ROOFING: DETERIORATED PAVERS WITH INTEGRAL INSULATION

10  
S.F.  
REPLACE  
PRIORITY 4  
LEVEL 2

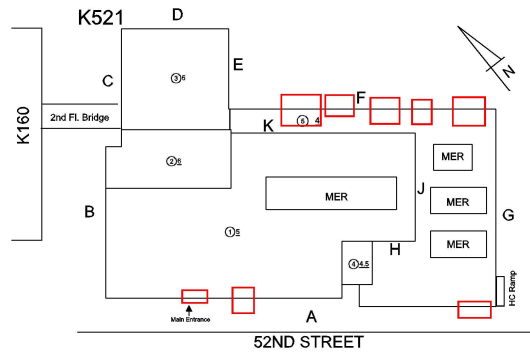
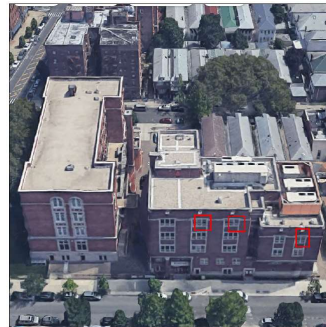
Roof Plan reference

Deficiency ALUMINUM - OTHER: AIR/WATER INFILTRATION

Deficiency Quantity	800
Quantity Uom	L.F.
Potential Action	REPLACE TRIM, SILLS OR WEATHERSTRIPPING
Urgency of Action	PRIORITY 5
Purpose of Action	LEVEL 2
