NYC Department of Education
Building Condition Assessment Survey 2023 - 2024

Architectural Inspection

Asset: P.S. 216 ANNEX - BROOKLYN, 2421 WEST STREET, New York, 11223

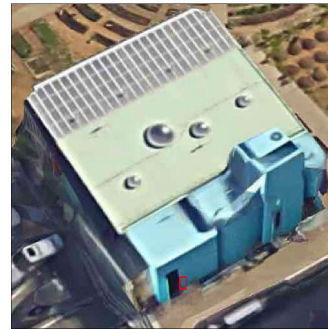
Elevation

Question	Response
Architectural	
EXTERIOR	Inspected
AREAWAY	Does not Exist
AWNINGS AND CANOPIES	Does not Exist
CHIMNEY	Does not Exist
COPING	Inspected
Condition	2 - Between Good and Fair
Deficiency	No deficiencies recorded
CORNICE	Does not Exist
DOORS	Inspected
DOORS AND FRAMES	Inspected
Condition	2 - Between Good and Fair
Deficiency	No deficiencies recorded
DOOR HARDWARE	Inspected
Condition	3 - Fair
Deficiency	No deficiencies recorded
LINTELS	Inspected
Condition	2 - Between Good and Fair
Deficiency	No deficiencies recorded
TRANSOM/SIDE LIGHT	Does not Exist
EXTERIOR WALLS	Inspected
Material Type(s)	Masonry, Wood
Replacement Quantity	2,500
Replacement Uom	S.F.
Instance on All Facades	Inspected
Instance Condition	3 - Fair
Instance Quantity	2,500
Instance Quantity Uom	S.F.
Deficiency	STUCCO CEMENT SURFACE: CRACKS, SPALLING

Deficiency Quantity
Quantity Uom
Potential Action
Urgency of Action
Purpose of Action
Deficiency Photo

10
S.F.
REPLACE
PRIORITY 4
LEVEL 2
