**NYC Department of Education**  
**Building Condition Assessment Survey 2023 - 2024**

Architectural Inspection

**Asset: LEON GOLDSTEIN HS - BROOKLYN, 1830 SHORE BOULEVARD, New York, 11235**

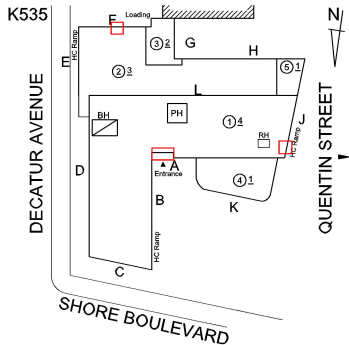
Violations	Roof 1 - Facade D No violations recorded.
<b>CORNICE</b>	Does not Exist
<b>DOORS</b>	Inspected
<b>DOORS AND FRAMES</b>	Inspected
Condition	5 - Poor
Deficiency	METAL: DETERIORATED DOOR AND FRAME - MAJOR DETERIORATION
Roof Plan reference

Deficiency Quantity	8
Quantity Uom	EACH
Potential Action	REPLACE
Urgency of Action	PRIORITY 4
Purpose of Action	LEVEL 2
Deficiency Photo1

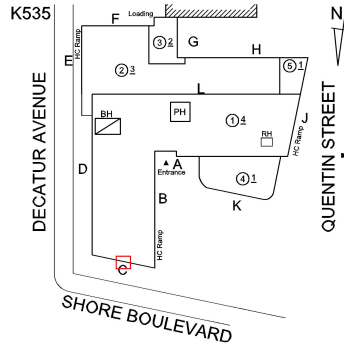
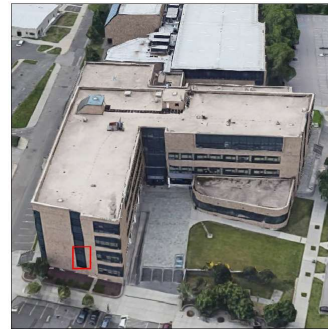
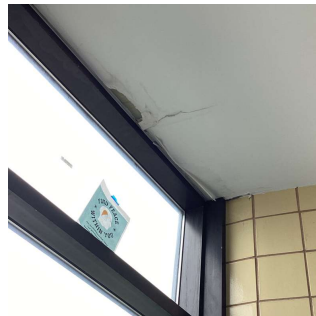
METAL/GLASS CURT WALL: WATER INFILTRATION IN INSTRUCTIONAL SPACE

REPAIR

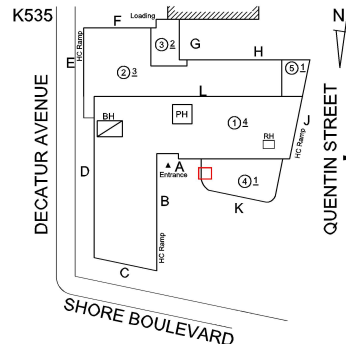
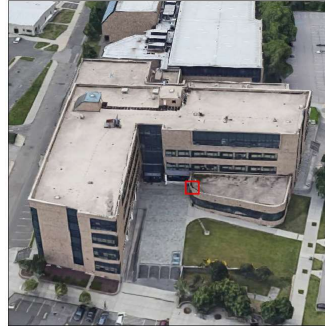
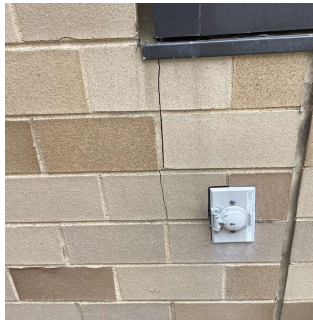
Facade A

BRICK: MINOR CRACKS AND SPALLING

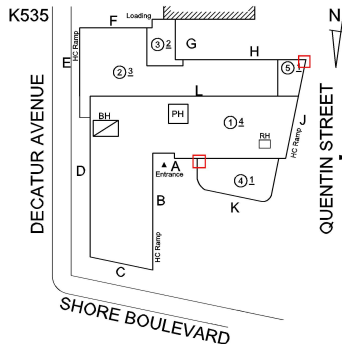
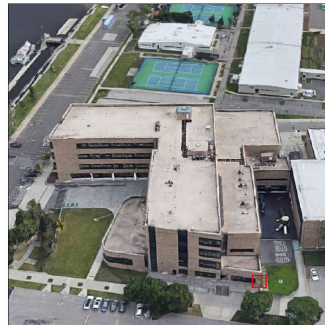
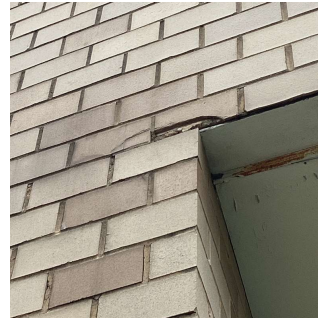
Facade J

BRICK: MAJOR / THRU CRACKS

PRIORITY 4  
LEVEL 2

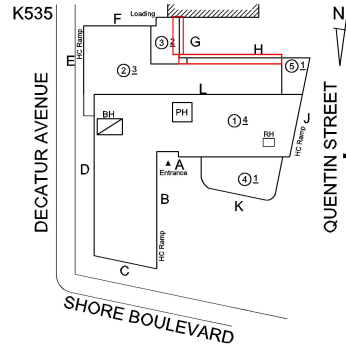
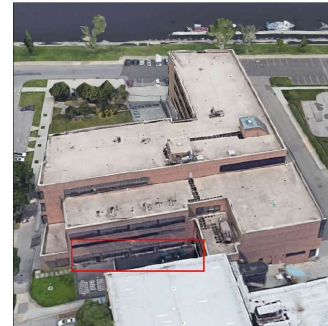
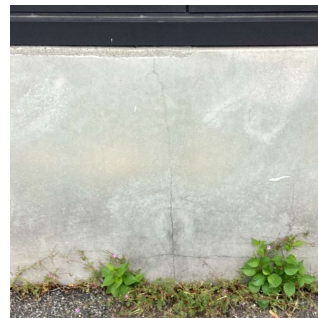
CAST IN PLACE / PRE-CAST CONCRETE: MINOR  
CRACKS/SPALLING

100  
S.F.  
REPAIR  
PRIORITY 3  
LEVEL 2

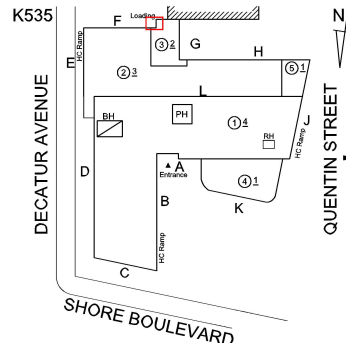
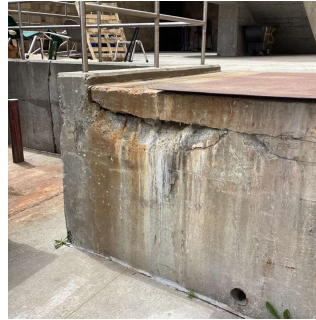
Facade F  
 No violations recorded.

CHEEK WALL/CRACKS, SPALLING - MAJOR

Deficiency Quantity	30
Quantity Uom	S.F.
Potential Action	REPLACE
Urgency of Action	PRIORITY 4
Purpose of Action	LEVEL 2
Deficiency Photo1

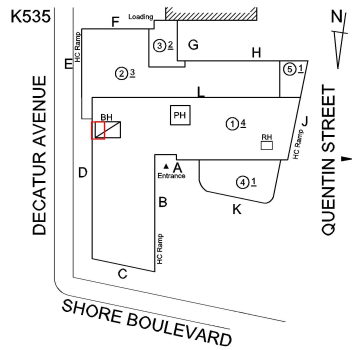
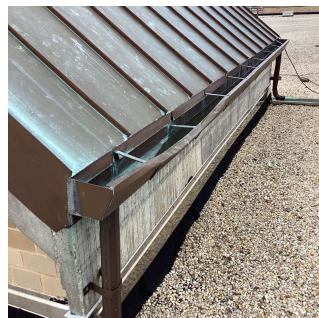
Violations	Roof 1 - BH No violations recorded.
<b>ROOF BARRIER/FENCE</b>	Inspected
Condition	2 - Between Good and Fair
Deficiency	No deficiencies recorded
<b>ROOF CAGE</b>	Does not Exist
<b>ROOFING</b>	Inspected
Instance on Built-Up: All Roofs	Inspected
Instance Condition	3 - Fair
Instance Photo

Violations	BH No violations recorded.
<b>LEADERS, GUTTERS, DOWNSPOUTS, SCUPPERS</b>	Inspected
Condition	3 - Fair
Deficiency	DAMAGED/MISSING

Deficiency Quantity	10
Quantity Uom	L.F.
Potential Action	REPLACE
Urgency of Action	PRIORITY 4
Purpose of Action	LEVEL 2
Deficiency Photo1

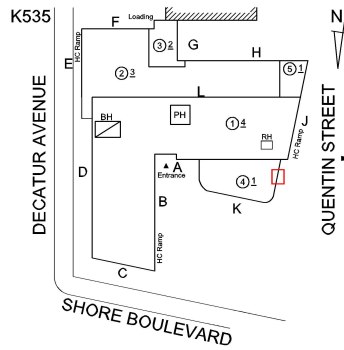
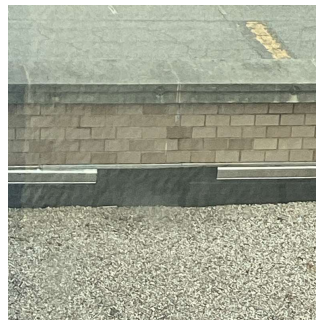
Roof 4 - Facade J

Installation Year	2002
Source of Installation	Custodial Staff
Deficiency	BUILT-UP: FLASHING: CAP FLASHING MISSING
Roof Plan reference	K535

Deficiency Quantity	10
Quantity Uom	L.F.
Potential Action	INSTALL NEW
Urgency of Action	PRIORITY 4
Purpose of Action	LEVEL 2
Deficiency Photo1

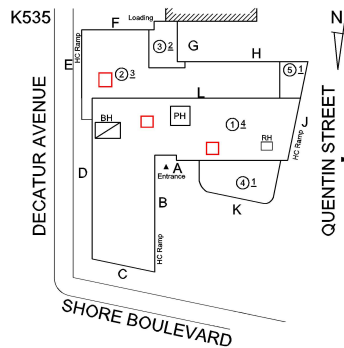
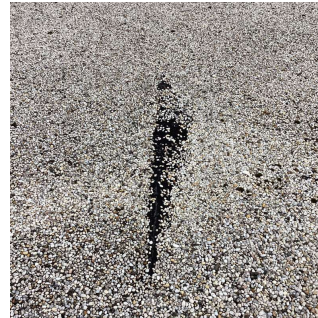
Roof 1

Deficiency	BUILT-UP: ROOFING: DELAMINATION
Roof Plan reference	K535

Deficiency Quantity	60
Quantity Uom	S.F.
Potential Action	REPLACE ROOFING WITHOUT MAJOR EQUIPMENT REMOVAL
Urgency of Action	PRIORITY 4
Purpose of Action	LEVEL 2

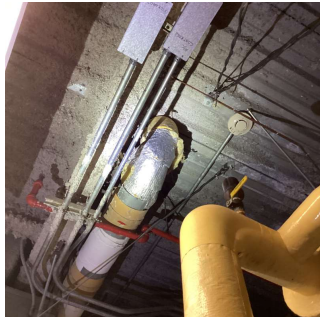
Question	Response
<b>EXTERIOR</b>	
<b>ROOF</b>	
<b>Roofing</b>	
<b>ROOFING</b>	
Deficiency Photo1

Violations	Roof 1 - Mechanical Equipment Room 423 No violations recorded.
<b>ROOFING DRAINS</b>	Inspected
Condition	3 - Fair
Deficiency	DETERIORATED
Roof Plan reference

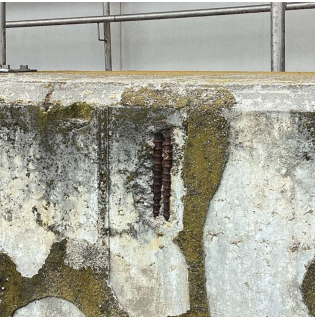
Facade E - HC Ramp
Violations	No violations recorded.
Deficiency	CAST IN PLACE CONCRETE: CRACKS/SPALLING - MINOR
Roof Plan reference

Question	Response
<b>EXTERIOR</b>	
<b>ROOF</b>	
<b>Specialties</b>	
<b>DUNNAGE STEEL</b>	Inspected
Condition	2 - Between Good and Fair
Deficiency	No deficiencies recorded
<b>SKYLIGHT/ROOF VENT</b>	Does not Exist
<b>ROOF/GRAVITY TANK</b>	Does not Exist
<b>STAIRS/RAMPS: EXTERIOR</b>	Inspected
<b>BUILDING CHEEK/FLANK WALLS</b>	Inspected
Condition	4 - Between Fair and Poor
Deficiency	CAST IN PLACE CONCRETE: CRACKS/SPALLING - MAJOR
Roof Plan reference

Deficiency Quantity	20
Quantity Uom	S.F.
Potential Action	REPLACE
Urgency of Action	PRIORITY 4
Purpose of Action	LEVEL 2
Deficiency Photo1

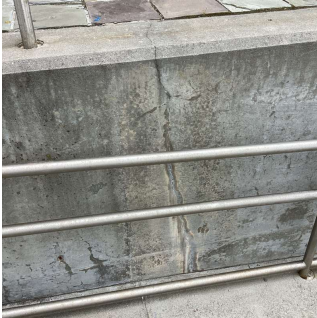
Violations	Facade J - HC Ramp No violations recorded.
Deficiency	CAST IN PLACE CONCRETE: DETERIORATED CONTROL/EXPANSION JOINT
Roof Plan reference	K535

Deficiency Quantity	100

Question	Response
<b>EXTERIOR</b>	
<b>STAIRS/RAMPS: EXTERIOR</b>	
<b>BUILDING CHEEK/FLANK WALLS</b>	
Quantity Uom	S.F.
Potential Action	REPAIR
Urgency of Action	PRIORITY 3
Purpose of Action	LEVEL 2
Deficiency Photo1

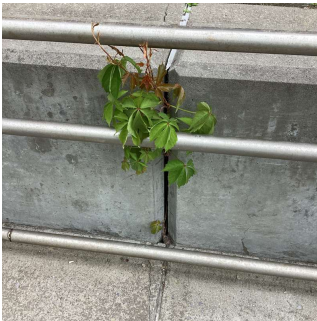
Violations	Facade J - HC Ramp No violations recorded.
<b>RAILINGS</b>	
Condition	Inspected
Deficiency	2 - Between Good and Fair
<b>STAIRS/RAMPS</b>	
Condition	Inspected
	5 - Poor

Deficiency Quantity	20
Quantity Uom	L.F.
Potential Action	REPLACE
Urgency of Action	PRIORITY 3
Purpose of Action	LEVEL 2
Deficiency Photo1

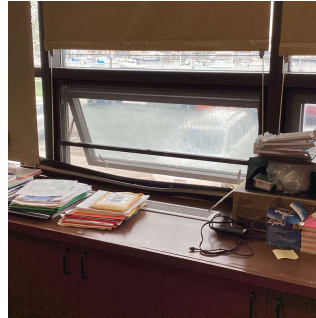
Facade C - Room 100  
No violations recorded.

ALUMINUM - OTHER: AIR/WATER INFILTRATION, DETERIORATED JOINTS WITH DAMAGED CAULKING

900  
L.F.  
MAINTENANCE  
PRIORITY 3  
LEVEL 2

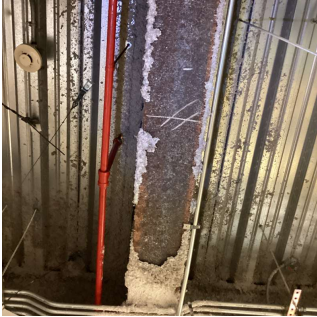
Question	Response
<b>INTERIOR</b>	
<b>STRUCTURAL</b>	
<b>COLUMNS/BEAMS/BEARING WALLS</b>	
Violations	Facade E No violations recorded.
Deficiency	STEEL COLUMNS/BEAMS: DETERIORATED/MISSING SPRAY-ON FIREPROOFING
Deficiency Location/Instance	Acid Waste Room 163, Mechanical Equipment Room 169
Deficiency Quantity	20
Quantity Uom	S.F.
Potential Action	REPLACE
Urgency of Action	PRIORITY 3
Purpose of Action	LEVEL 5
Deficiency Photo1

Violations	Mechanical Equipment Room 169 No violations recorded.
<b>FLOOR STRUCTURE</b>	
Condition	Inspected 3 - Fair
Deficiency	METAL DECK AND CONCRETE: DETERIORATED
Deficiency Location/Instance	Mechanical Equipment Rooms 231, 423
Deficiency Quantity	400
Quantity Uom	S.F.
Potential Action	REPAIR
Urgency of Action	PRIORITY 3
Purpose of Action	LEVEL 5
Deficiency Photo1

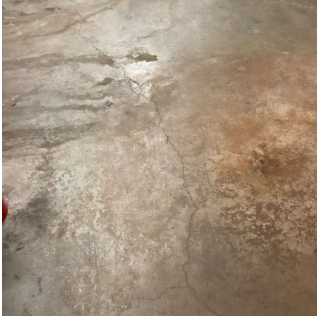
Violations	Mechanical Equipment Room 423 No violations recorded.
Deficiency	CONCRETE SLAB ON GRADE: THRU CRACKS
Deficiency Location/Instance	Mechanical Equipment Room 169

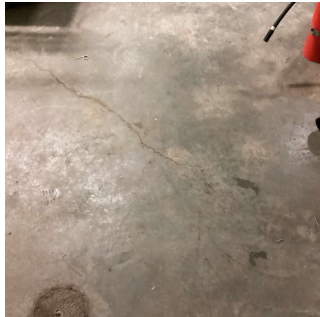
Deficiency Quantity	50
Quantity Uom	S.F.
Potential Action	REPAIR
Urgency of Action	PRIORITY 3

Mechanical Equipment Room 169
Violations	No violations recorded.
<b>FOUNDATION WALLS</b>	
Material Type(s)	Inspected Concrete
Condition	2 - Between Good and Fair
Deficiency	No deficiencies recorded
<b>ROOF STRUCTURE</b>	
Condition	Inspected 2 - Between Good and Fair
Deficiency	No deficiencies recorded
<b>VAULTS-BUNKERS</b>	
	Does not Exist
<b>AUDITORIUM</b>	
	Does not Exist
<b>CAFETERIA</b>	
Instance on 1st Floor	Inspected Inspected
<b>Ceiling</b>	
Instance on 1st Floor	Inspected
Condition	2 - Between Good and Fair
Deficiency	GYPSUM BOARD: DAMAGED/DETERIORATED
Deficiency Location/Instance	Near Windows
Deficiency Quantity	20
Quantity Uom	S.F.
Potential Action	REPLACE
Urgency of Action	PRIORITY 3
Purpose of Action	LEVEL 2
Deficiency Photo1

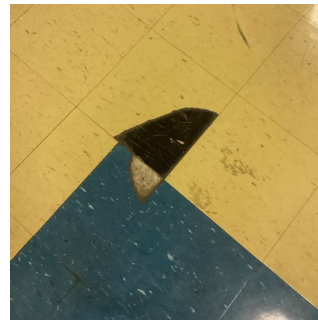
Corridor near Elevator/4

VINYL TILES: BROKEN/DETERIORATED/MISSING TILES

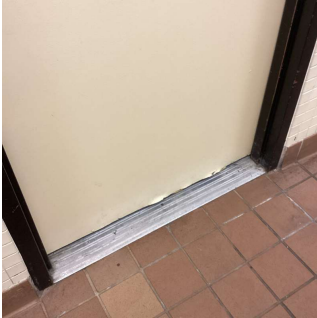
Question	Response
<b>INTERIOR</b>	
<b>KITCHEN</b>	
<b>Door(s)</b>	
Instance on 1st Floor	Inspected
Condition	3 - Fair
Deficiency	METAL: DETERIORATED DOOR
Deficiency Location/Instance	Servery
Deficiency Quantity	1
Quantity Uom	EACH
Potential Action	MAINTENANCE
Urgency of Action	PRIORITY 3
Purpose of Action	LEVEL 2
Deficiency Photo1

Violations	Servery No violations recorded.
<b>Floor Finish</b>	
Instance on 1st Floor	Inspected
Condition	2 - Between Good and Fair
Deficiency	QUARRY TILE: BROKEN/MISSING TILES
Deficiency Location/Instance	Preparation Area
Deficiency Quantity	10
Quantity Uom	S.F.
Potential Action	REPLACE
Urgency of Action	PRIORITY 3
Purpose of Action	LEVEL 2
Deficiency Photo1

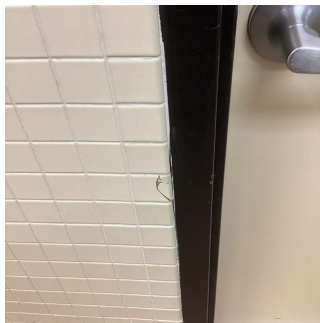
Deficiency	CERAMIC TILE: BROKEN/ MISSING
Deficiency Location/Instance	Servery
Deficiency Quantity	10
Quantity Uom	S.F.
Potential Action	REPLACE
Urgency of Action	PRIORITY 3
Purpose of Action	LEVEL 2

Violations	<p>Servery</p> <p>No violations recorded.</p>
<b>LIBRARY</b>	
Instance on Room 107	Inspected
<b>Built-in Furnishing</b>	Inspected
Instance on Room 107	Inspected
Condition	2 - Between Good and Fair
Deficiency	No deficiencies recorded
<b>Ceiling</b>	
Instance on Room 107	Inspected
Condition	5 - Poor
Deficiency	ACOUSTIC TILES: DAMAGED/MISSING
Deficiency Location/Instance	Room 107C
Deficiency Quantity	10
Quantity Uom	S.F.
Potential Action	REPLACE
Urgency of Action	PRIORITY 3
Purpose of Action	LEVEL 2
Deficiency Photo1

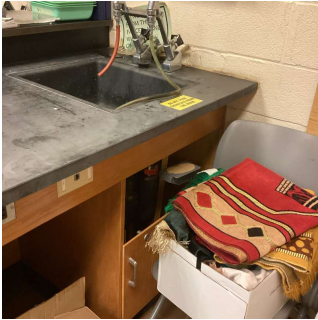
Question	Response
<b>INTERIOR</b>	
<b>SCIENCE LAB</b>	Inspected
<b>Fixed Equipment</b>	
Violations	Room 352 No violations recorded.
<b>SCIENCE PREP ROOM</b>	Inspected
Instance on Room 341	Inspected
Alternative use	No
<b>Fixed Equipment</b>	
Instance on Room 341	Inspected
Condition	3 - Fair
Deficiency	CABINETS: MISSING/DAMAGED
Deficiency Location/Instance	Room 341
Deficiency Quantity	10
Quantity Uom	L.F.
Potential Action	REPLACE
Urgency of Action	PRIORITY 3
Purpose of Action	LEVEL 2
Deficiency Photo1

Violations	Room 341 No violations recorded.
<b>SHOWER ROOM</b>	Inspected
Instance on 2nd Floor - Boys	Inaccessible
Instance on 2nd Floor - Girls	Inaccessible
<b>STAIRS/RAMPS: INTERIOR</b>	Inspected
Do Letter Stair Signs Exist?	Yes
<b>Ceiling</b>	Inspected
Condition	2 - Between Good and Fair
Deficiency	GYPSUM BOARD: DAMAGED/DETERIORATED
Deficiency Location/Instance	Stairs B/1, C/1
Deficiency Quantity	20
Quantity Uom	S.F.

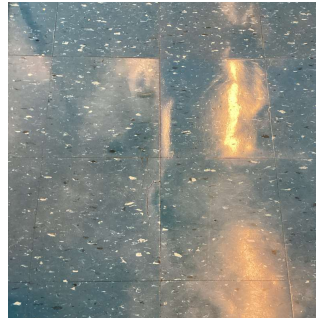
Stair B/1

VINYL TILES: DETERIORATED SUBSTRATE

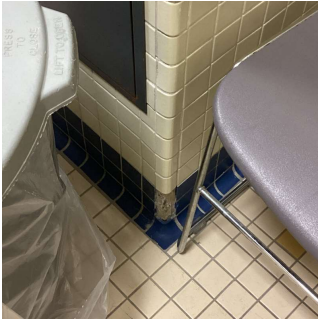
Question	Response
<b>INTERIOR</b>	
<b>TOILET ROOMS - STAFF</b>	Inspected
<b>Stalls</b>	Inspected
Condition	2 - Between Good and Fair
Deficiency	No deficiencies recorded
<b>Walls</b>	Inspected
Condition	2 - Between Good and Fair
Deficiency	CERAMIC TILE: BROKEN/ MISSING
Deficiency Location/Instance	Rooms 133G, 133H
Deficiency Quantity	20
Quantity Uom	S.F.
Potential Action	REPLACE
Urgency of Action	PRIORITY 3
Purpose of Action	LEVEL 2
Deficiency Photo1

Room 133H	
Violations	No violations recorded.
<b>TOILET ROOMS - STUDENTS</b>	Inspected
<b>Ceiling</b>	Inspected
Condition	2 - Between Good and Fair
Deficiency	GYPSUM BOARD: DAMAGED/DETERIORATED
Deficiency Location/Instance	Rooms 413, 313
Deficiency Quantity	20
Quantity Uom	S.F.
Potential Action	REPLACE
Urgency of Action	PRIORITY 3
Purpose of Action	LEVEL 2
Deficiency Photo1

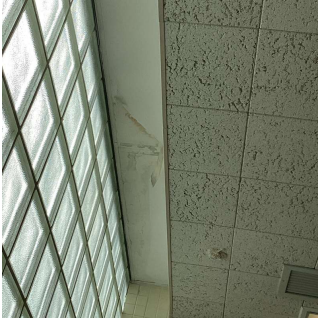
Room 413	
Violations	No violations recorded.
Deficiency	ACOUSTIC TILES ON PLASTER: DAMAGED/MISSING

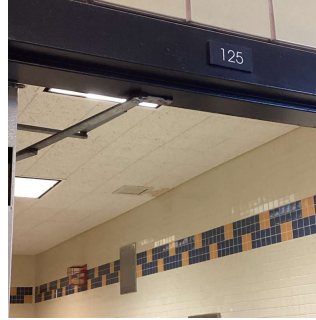
Deficiency Location/Instance	Room 125
Deficiency Quantity	10
Quantity Uom	S.F.

Potential Action	REPLACE
Urgency of Action	PRIORITY 3
Purpose of Action	LEVEL 2
Deficiency Photo1

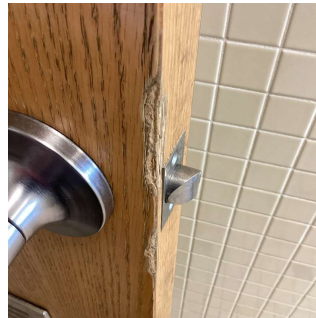
Room 319

Condition	5 - Poor
-----------	----------

Deficiency	WOOD: DETERIORATED DOOR
Deficiency Location/Instance	Rooms 319, 313
Deficiency Quantity	2
Quantity Uom	EACH
Potential Action	MAINTENANCE
Urgency of Action	PRIORITY 3
Purpose of Action	LEVEL 2
Deficiency Photo1

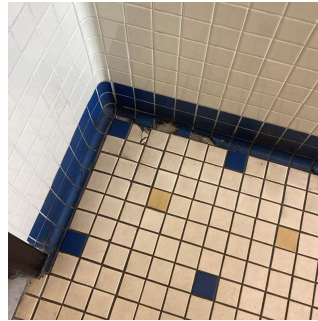
Room 313

Deficiency	CERAMIC TILE: BROKEN/MISSING TILES
Deficiency Location/Instance	Rooms 313, 213
Deficiency Quantity	20
Quantity Uom	S.F.
Potential Action	REPLACE
Urgency of Action	PRIORITY 3
Purpose of Action	LEVEL 2

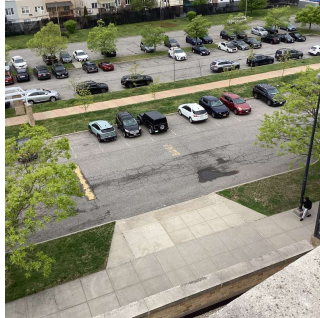
<b>IRRIGATION SYSTEM</b>	Does not Exist
<b>PAVING</b>	Inspected
<b>Student Non-Use</b>	Inspected
Gravel Exists?	No
<b>Asphalt</b>	Inspected
Condition	4 - Between Fair and Poor
Deficiency	CRACKS - MAJOR
Deficiency Location/Instance	Quentin Street, Decatur Avenue
Deficiency Quantity	3,500
Quantity Uom	S.F.
Potential Action	REPLACE
Urgency of Action	PRIORITY 3
Purpose of Action	LEVEL 2

Violations	Quentin Street No violations recorded.
<b>Concrete</b>	Inspected
Condition	3 - Fair
Deficiency	DAMAGED/DETERIORATED/MISSING SECTIONS
Deficiency Location/Instance	Decatur Avenue
Deficiency Quantity	100
Quantity Uom	S.F.
Potential Action	REPLACE
Urgency of Action	PRIORITY 3
Purpose of Action	LEVEL 2
Deficiency Photo1

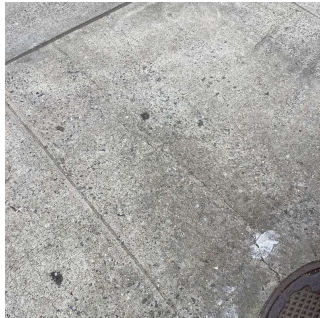
Violations	Decatur Avenue No violations recorded.
<b>Pavers</b>	Does not Exist
<b>Student Use</b>	Does not Exist
<b>Site Sidewalks &amp; Walkways</b>	Inspected
<b>Asphalt</b>	Does not Exist
<b>Concrete</b>	Inspected
Condition	4 - Between Fair and Poor
Deficiency	HEAVING
Deficiency Location/Instance	Shore Avenue
Deficiency Quantity	50
Quantity Uom	S.F.
Potential Action	REPLACE
Urgency of Action	PRIORITY 5
Purpose of Action	LEVEL 6

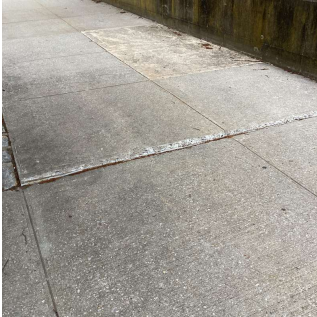
Violations	Shore Avenue No violations recorded.
Deficiency	LOCALIZED SINK AREA
Deficiency Location/Instance	Shore Avenue
Deficiency Quantity	25
Quantity Uom	S.F.
Potential Action	REPAIR
Urgency of Action	PRIORITY 3
Purpose of Action	LEVEL 2
Deficiency Photo1

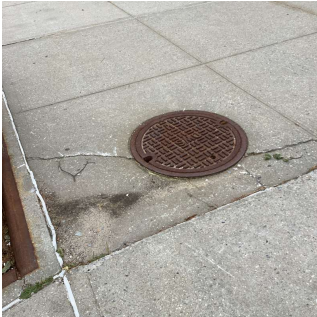
Violations	Shore Avenue No violations recorded.
Deficiency	DAMAGED CURBS
Deficiency Location/Instance	Shore Avenue, Decatur Avenue
Deficiency Quantity	60
Quantity Uom	L.F.
Potential Action	REPLACE
Urgency of Action	PRIORITY 3
Purpose of Action	LEVEL 2
Deficiency Photo1

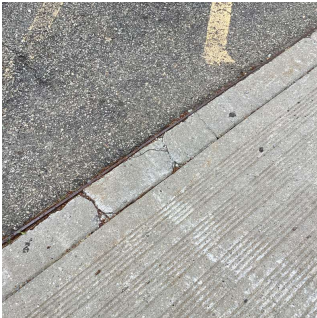
Violations	Shore Avenue

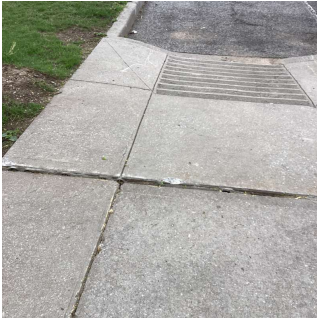
Question	Response
<b>SITE</b>	
<b>PAVING</b>	
<b>Site Sidewalks &amp; Walkways</b>	
<b>Concrete</b>	
Violations	No violations recorded.
Deficiency	HEAVING
Deficiency Location/Instance	Quentin Street
Deficiency Quantity	50
Quantity Uom	S.F.
Potential Action	REPLACE
Urgency of Action	PRIORITY 3
Purpose of Action	LEVEL 2
Deficiency Photo1

Violations	Quentin Street No violations recorded.
Deficiency	DAMAGED/DETERIORATED/MISSING SECTIONS
Deficiency Location/Instance	Shore Avenue, Quentin Street, near Containerization, Decatur Avenue
Deficiency Quantity	475
Quantity Uom	S.F.
Potential Action	REPLACE
Urgency of Action	PRIORITY 3
Purpose of Action	LEVEL 2
Deficiency Photo1

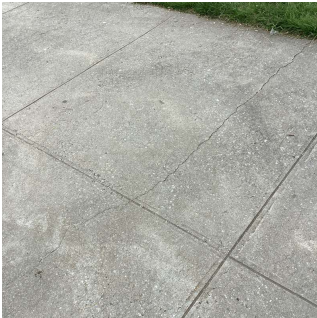
Violations	Quentin Street No violations recorded.
<b>Pavers</b>	
Condition	Inspected 3 - Fair
Deficiency	HEAVING
Deficiency Location/Instance	Shore Avenue, Near Main Entrance
Deficiency Quantity	40
Quantity Uom	S.F.
Potential Action	REPLACE
Urgency of Action	PRIORITY 5
