NYC Department of Education
Building Condition Assessment Survey 2023 - 2024

Architectural Inspection

Asset: JOHN DEWEY HS - K, 50 AVENUE X, New York, 11223

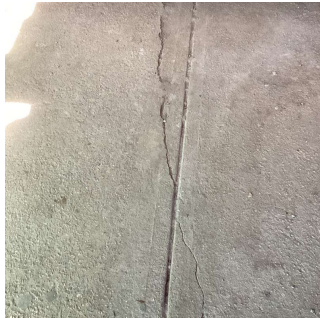
Question	Response
EXTERIOR	
STAIRS/RAMPS: EXTERIOR	
STAIRS/RAMPS	
Purpose of Action	LEVEL 2
Deficiency Photo1

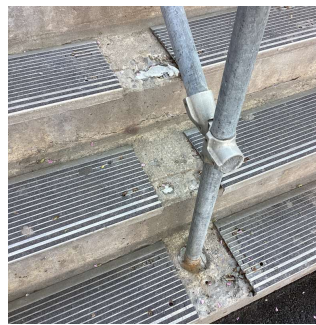
Facade P

STAIRS/RAMPS

30
 S.F.
 REPLACE
 PRIORITY 4
 LEVEL 2

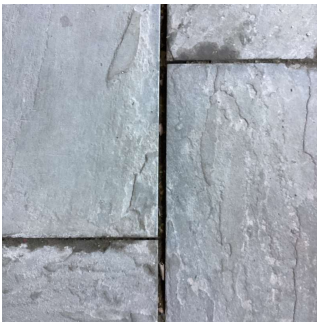
STONE: DETERIORATED JOINTS

20
 L.F.
 REPOINT
 PRIORITY 4
 LEVEL 2

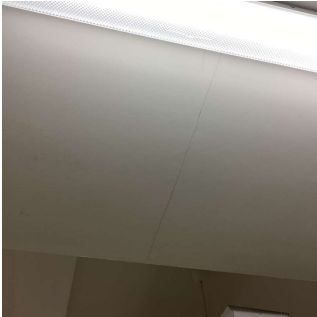
Deficiency	GYPSUM BOARD: DAMAGED/DETERIORATED
Deficiency Location/Instance	Corridor near Room 367

Question	Response
INTERIOR	
CLASSROOMS/CORRIDORS/ADMIN SPACES	
Ceiling	
Deficiency Quantity	10
Quantity Uom	S.F.
Potential Action	REPLACE
Urgency of Action	PRIORITY 3
Purpose of Action	LEVEL 2
Deficiency Photo1

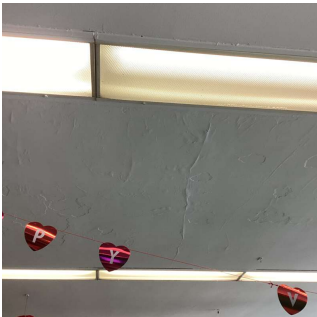
Corridor near Room 367
Violations	No violations recorded.
Deficiency	PLASTER: CRACKS/SPALLING
Deficiency Location/Instance	Room 226
Deficiency Quantity	10
Quantity Uom	S.F.
Potential Action	REPLACE
Urgency of Action	PRIORITY 3
Purpose of Action	LEVEL 2
Deficiency Photo1

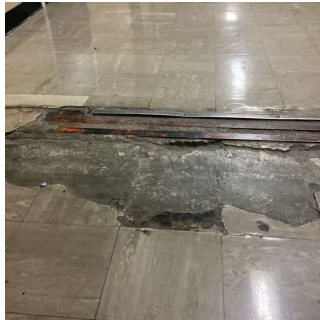
Question	Response
INTERIOR	
CLASSROOMS/CORRIDORS/ADMIN SPACES	
Door(s)	Inspected
	Room 205
Violations	No violations recorded.
Floor Finish	Inspected
Condition	2 - Between Good and Fair
Deficiency	VINYL TILES: DETERIORATED SUBSTRATE
Deficiency Location/Instance	Rooms 120, 122, 246, Corridor near Rooms 126, 129, 200, 221, 268, 321, 368B, 380, Vestibule Exit 7
Deficiency Quantity	220
Quantity Uom	S.F.
Potential Action	REPLACE
Urgency of Action	PRIORITY 5
Purpose of Action	LEVEL 6
Deficiency Photo1

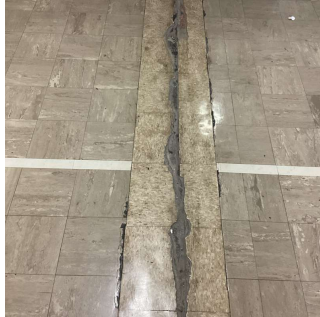
Question	Response
INTERIOR	
CLASSROOMS/CORRIDORS/ADMIN SPACES	
Floor Finish	Inspected
Purpose of Action	LEVEL 4
Deficiency Photo1

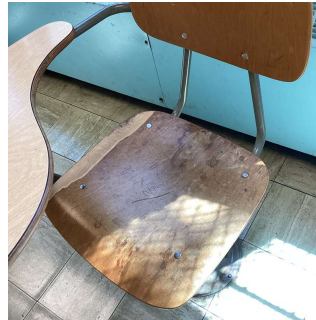
Room A1

Fixed Seating

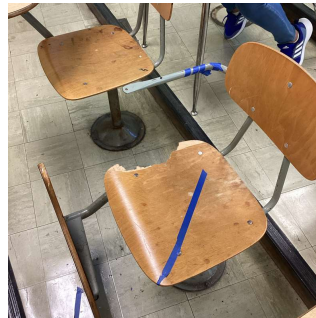
Room A1

DAMAGED/BROKEN/INOPERABLE

REPLACE

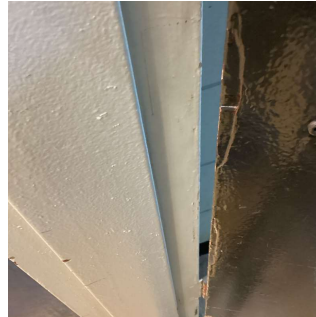
Entrance G/17

Instance on 1st Floor - G15/G17	Inspected
Condition	5 - Poor
Deficiency	WOOD: DETERIORATED DOOR
Deficiency Location/Instance	Entrances G/15, G/17, Storage Rooms
Deficiency Quantity	6
Quantity Uom	EACH
Potential Action	MAINTENANCE
Urgency of Action	PRIORITY 3
Purpose of Action	LEVEL 2
Deficiency Photo1

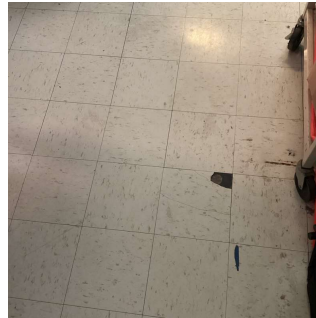
Violations	Drinking Fountain Area No violations recorded.
Instance on 1st Floor - G15/G17	Inspected
Condition	2 - Between Good and Fair
Deficiency	VINYL TILES: BROKEN/DETERIORATED/MISSING TILES
Deficiency Location/Instance	Room G/7
Deficiency Quantity	50

Quantity Uom	S.F.
Potential Action	REPLACE
Urgency of Action	PRIORITY 3

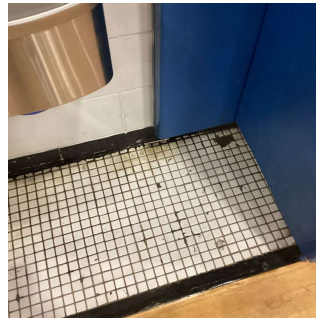
Drinking Fountain area

CERAMIC TILE: BROKEN/MISSING TILES

REPLACE

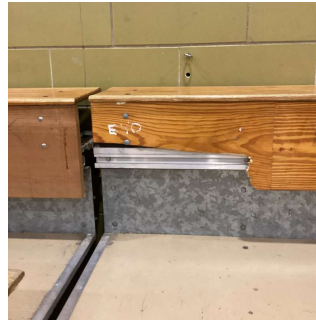
Near Entrance G/15

DAMAGED BLEACHERS

REPLACE

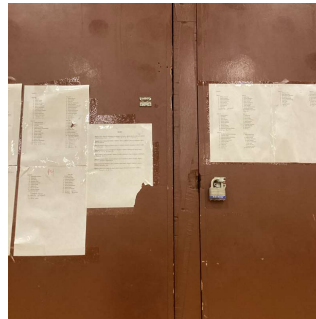
Instance on 1st Floor - G15/G17	Inspected
Condition	4 - Between Fair and Poor
Deficiency	MOVABLE PANELS: DAMAGED
Deficiency Location/Instance	Near center
Deficiency Quantity	960
Quantity Uom	S.F.
Potential Action	REPLACE
Urgency of Action	PRIORITY 3
Purpose of Action	LEVEL 2
Deficiency Photo1

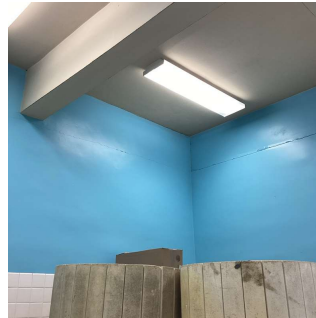
Room G7

PLASTER: CRACKS/SPALLING

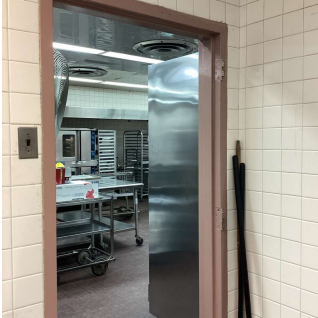
Room 150A
Violations	No violations recorded.
Door(s)	
Instance on 1st Floor	Inspected
Condition	5 - Poor
Deficiency	METAL: MISSING DOOR

Question	Response
INTERIOR	
KITCHEN	
Door(s)	
Deficiency Location/Instance	Near Sink Room
Deficiency Quantity	1
Quantity Uom	EACH
Potential Action	MAINTENANCE
Urgency of Action	PRIORITY 3
Purpose of Action	LEVEL 2
Deficiency Photo1

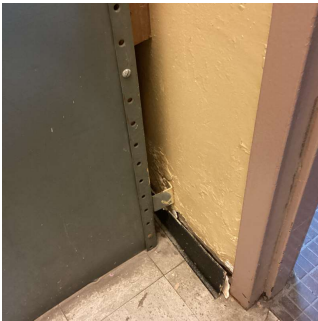
Question	Response
INTERIOR	
KITCHEN	
Walls	
Deficiency Photo1

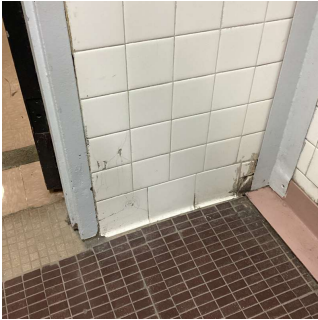
Violations	Room 150G No violations recorded.
Deficiency	CERAMIC TILE: BROKEN/ MISSING
Deficiency Location/Instance	Serving Area, Corridor near Corridor near Room 150I
Deficiency Quantity	20
Quantity Uom	S.F.
Potential Action	REPLACE
Urgency of Action	PRIORITY 3
Purpose of Action	LEVEL 2
Deficiency Photo1

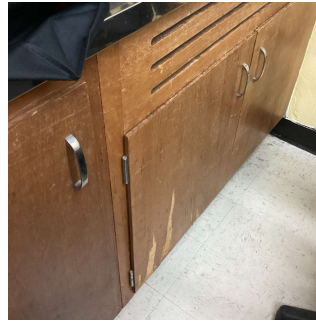
Violations	Corridor near Corridor near Room 150I No violations recorded.
LIBRARY	Inspected
Instance on Room 119	Inspected
Built-in Furnishing	
Instance on Room 119	Inspected
Condition	2 - Between Good and Fair
Deficiency	SINK/STORAGE CABINET - DAMAGED/DETERIORATED
Deficiency Location/Instance	Storage Room
Deficiency Quantity	10
Quantity Uom	L.F.
Potential Action	REPLACE
Urgency of Action	PRIORITY 3
Purpose of Action	LEVEL 2

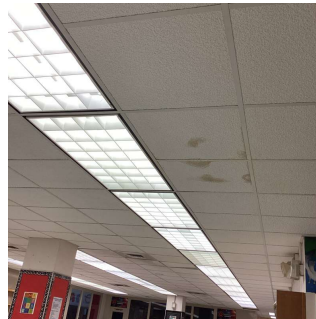
Near center

Instance on Room 119	Inspected
Condition	3 - Fair
Deficiency	ACOUSTIC TILES: DAMAGED/MISSING
Deficiency Location/Instance	Near Entrance, center
Deficiency Quantity	50
Quantity Uom	S.F.
Potential Action	REPLACE
Urgency of Action	PRIORITY 3
Purpose of Action	LEVEL 2
Deficiency Photo1

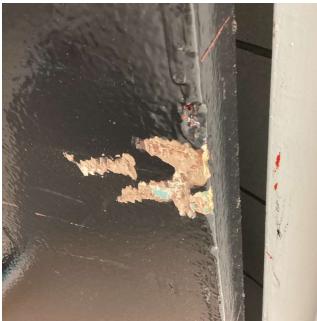
Instance on Room 119	Inspected
Condition	5 - Poor
Deficiency	WOOD: DETERIORATED DOOR
Deficiency Location/Instance	Entrances, Near Librarian Desk, Storage Room
Deficiency Quantity	3
Quantity Uom	EACH
Potential Action	MAINTENANCE
Urgency of Action	PRIORITY 3
Purpose of Action	LEVEL 2

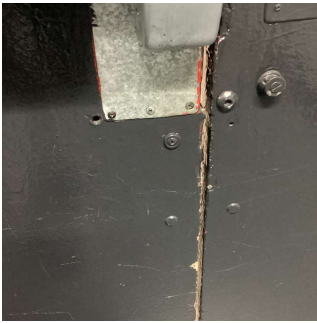
Question	Response
INTERIOR	
LOCKER ROOM	
Ceiling	
Deficiency Location/Instance	Near Room G11, Center, Exit 12
Deficiency Quantity	30
Quantity Uom	S.F.
Potential Action	REPLACE
Urgency of Action	PRIORITY 3
Purpose of Action	LEVEL 2
Deficiency Photo1	 
Violations	Near Room G11 No violations recorded.
Instance on 1st Floor - Girls (1586 Lockers)	Inspected
Condition	2 - Between Good and Fair
Deficiency	PLASTER: CRACKS/SPALLING
Deficiency Location/Instance	Near center, Entrance
Deficiency Quantity	30
Quantity Uom	S.F.
Potential Action	REPLACE
Urgency of Action	PRIORITY 3
Purpose of Action	LEVEL 2
Deficiency Photo1	 
Violations	Near center No violations recorded.
Door(s)	
Instance on 1st Floor - Boys (1550 Lockers)	Inspected
Condition	4 - Between Fair and Poor
Deficiency	WOOD: DETERIORATED DOOR
Deficiency Location/Instance	Entrance
Deficiency Quantity	2
Quantity Uom	EACH
Potential Action	MAINTENANCE
Urgency of Action	PRIORITY 3

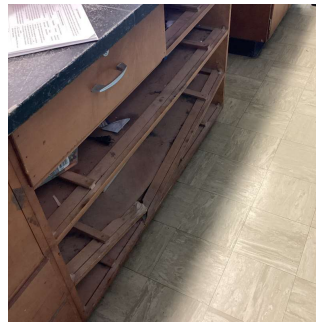
Condition	3 - Fair
Deficiency	CABINETS: MISSING/DAMAGED
Deficiency Location/Instance	Room 233
Deficiency Quantity	10
Quantity Uom	L.F.
Potential Action	REPLACE
Urgency of Action	PRIORITY 3
Purpose of Action	LEVEL 2

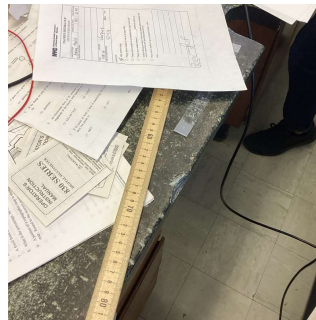
Room 353

DEMO TABLE: DAMAGED/DETERIORATED

REPLACE

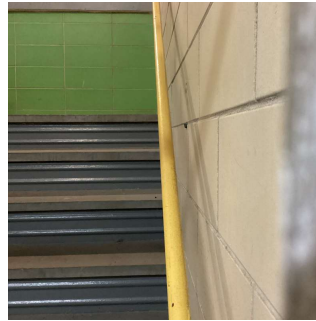
Question	Response
INTERIOR	
STAIRS/RAMPS: INTERIOR	
Ceiling	
Deficiency Location/Instance	Stairs A/Vestibule, D/Vestibule, 2, E/Vestibule, F/Vestibule, and others
Deficiency Quantity	150
Quantity Uom	S.F.
Potential Action	REPLACE
Urgency of Action	PRIORITY 3
Purpose of Action	LEVEL 2
Deficiency Photo1	 
	Stair E/Vestibule
Violations	No violations recorded.
Door(s)	Inspected
Condition	5 - Poor
Deficiency	METAL: DETERIORATED DOOR
Deficiency Location/Instance	Stairs D/1, 2, E/2, F/1, 2, and others
Deficiency Quantity	25
Quantity Uom	EACH
Potential Action	MAINTENANCE
Urgency of Action	PRIORITY 3
Purpose of Action	LEVEL 2
Deficiency Photo1	 
	Stair E/3
Violations	No violations recorded.
Partition	Does not Exist
Railings	Inspected
Condition	3 - Fair
Deficiency	METAL: BROKEN BRACKET
Deficiency Location/Instance	Stair E/Bulkhead
Deficiency Quantity	1
Quantity Uom	EACH
Potential Action	REPLACE
Urgency of Action	PRIORITY 3
Purpose of Action	LEVEL 2

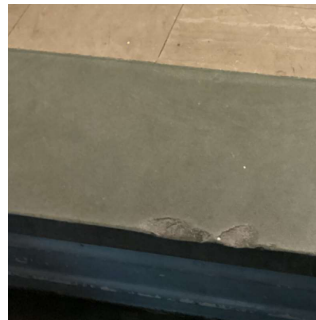
Stair B/2

STONE: BROKEN/MISSING

REPLACE

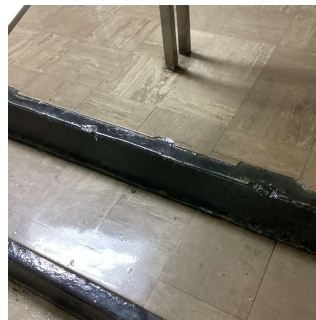
CONCRETE: CRACKS/SPALLING - MAJOR

REPLACE

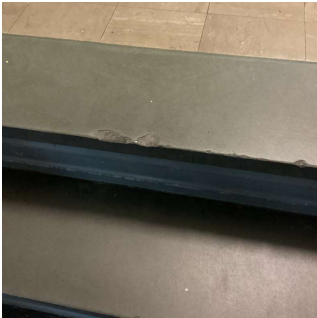
Question	Response
INTERIOR	
STAIRS/RAMPS: INTERIOR	
Stairs and Landings	
Violations	Corridors near Room A8 No violations recorded.
Deficiency	STONE: BROKEN/MISSING
Deficiency Location/Instance	Stairs A/Vestibule, 1, E/1, F/1
Deficiency Quantity	50
Quantity Uom	S.F.
Potential Action	REPLACE
Urgency of Action	PRIORITY 3
Purpose of Action	LEVEL 2
Deficiency Photo1

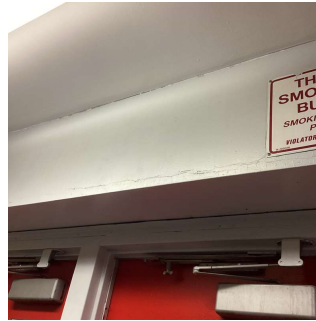
Stair B/Vestibule

Violations	Stair E/2 No violations recorded.
Walls	Inspected
Condition	2 - Between Good and Fair
Deficiency	PLASTER: CRACKS/SPALLING
Deficiency Location/Instance	Stair B/Vestibule, 3, C/Vestibule
Deficiency Quantity	30
Quantity Uom	S.F.
Potential Action	REPLACE

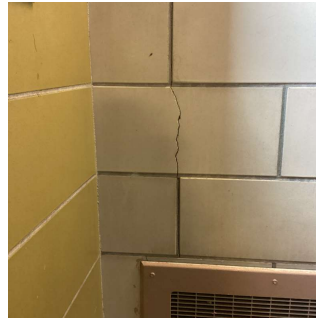
Stair C/2

GLAZED BLOCK: CRACKS/SPALLING

REPLACE

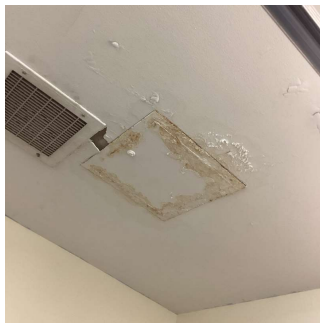
Question	Response
INTERIOR	
TOILET ROOMS - STAFF	
Ceiling	Inspected
Deficiency Photo1

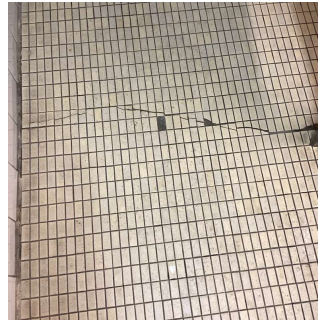
Room 2SMT

Violations	Room 1SFT No violations recorded.
Floor Finish	Inspected
Condition	4 - Between Fair and Poor
Deficiency	CERAMIC TILE: BROKEN/MISSING TILES
Deficiency Location/Instance	Rooms 1SFT, 2NFT, 2SFT, 2SMT, 3SFT, and others
Deficiency Quantity	70
Quantity Uom	S.F.
Potential Action	REPLACE
Urgency of Action	PRIORITY 3
Purpose of Action	LEVEL 2

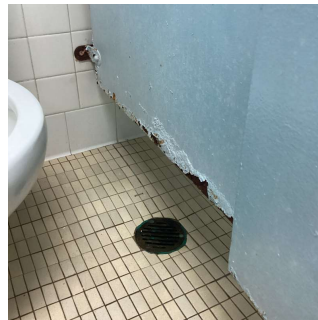
Room 150J

RUST - MAJOR

REPLACE

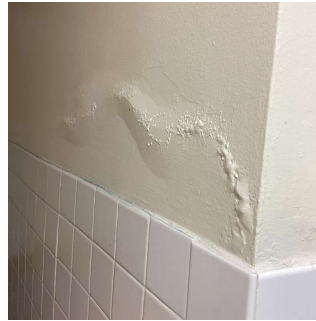
Room 2SMT

PLASTER: CRACKS/SPALLING

REPLACE

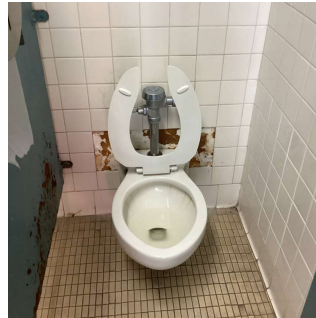
Room G7

CERAMIC TILE: BROKEN/ MISSING

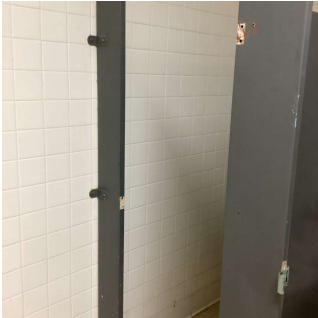
Question	Response
INTERIOR	
TOILET ROOMS - STUDENTS	
Floor Finish	Inspected
	Room 3SG
Violations	No violations recorded.
Stalls	Inspected
Condition	4 - Between Fair and Poor
Deficiency	BROKEN/MISSING
Deficiency Location/Instance	Rooms 1EB, 3NG
Deficiency Quantity	3
Quantity Uom	EACH
Potential Action	REPLACE
Urgency of Action	PRIORITY 3
Purpose of Action	LEVEL 2
Deficiency Photo1

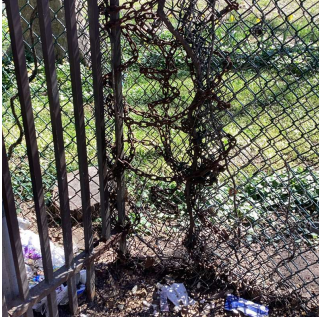
Question	Response
SITE	
FENCES	
Deficiency	CHAIN LINK: DAMAGED/DETERIORATED
Deficiency Location/Instance	Stillwell Avenue, Parking Lot areas
Deficiency Quantity	1,100
Quantity Uom	S.F.
Potential Action	REPLACE
Urgency of Action	PRIORITY 3
Purpose of Action	LEVEL 2
Deficiency Photo1

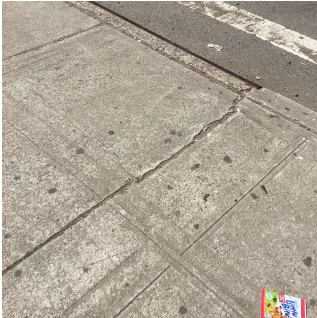
Violations	Stillwell Avenue No violations recorded.
Deficiency	DAMAGED/DETERIORATED/MISSING SECTIONS
Deficiency Location/Instance	Stillwell Avenue
Deficiency Quantity	1,125
Quantity Uom	S.F.
Potential Action	REPLACE
Urgency of Action	PRIORITY 3
Purpose of Action	LEVEL 2
Deficiency Photo1
