NYC Department of Education
Building Condition Assessment Survey 2023 - 2024

Architectural Inspection

K554

Asset: ALL CITY LEADERSHIP SECONDARY SCHOOL - BROOKLYN, 321 PALMETTO STREET, New York, 11237

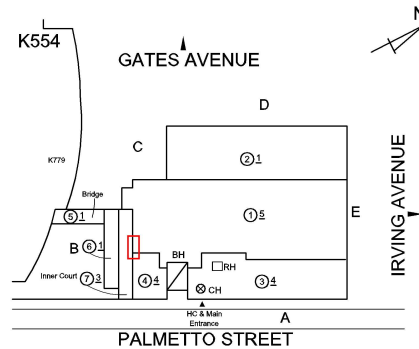
Roof Plan reference

CAST STONE: CRACKED/BROKEN PIECES

REPLACE-IN-KIND

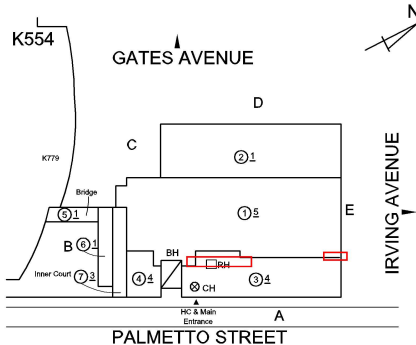
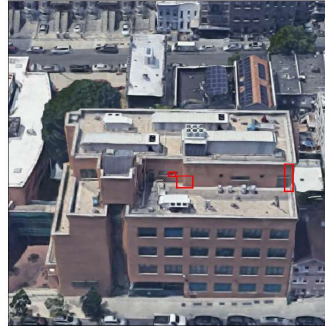
Violations	Roof 1 No violations recorded.
CORNICE	Does not Exist
DOORS	Inspected
DOORS AND FRAMES	Inspected
Condition	2 - Between Good and Fair
Deficiency	No deficiencies recorded
DOOR HARDWARE	Inspected
Condition	2 - Between Good and Fair
Deficiency	No deficiencies recorded
LINTELS	Inspected
Condition	2 - Between Good and Fair
Deficiency	No deficiencies recorded
TRANSOM/SIDE LIGHT	Inspected
Condition	2 - Between Good and Fair
Deficiency	No deficiencies recorded
EXTERIOR WALLS	Inspected
Material Type(s)	Masonry
Replacement Quantity	50,000
Replacement Uom	S.F.
Instance on All Facades	Inspected
Instance Condition	2 - Between Good and Fair
Instance Quantity	50,000
Instance Quantity Uom	S.F.
Deficiency	BRICK: MINOR CRACKS AND SPALLING
Roof Plan reference

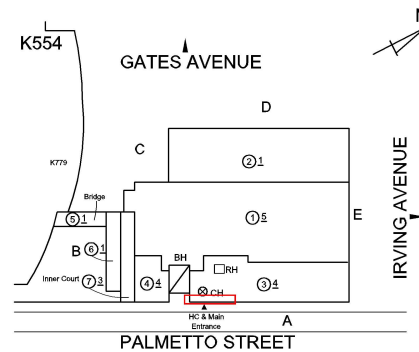
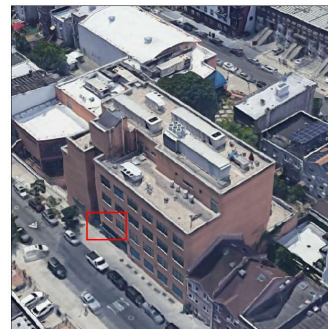
Roof Plan reference

STUCCO/PLASTER: MINOR CRACKS/SPALLING

Quantity Uom	S.F.
Potential Action	REPAIR
Urgency of Action	PRIORITY 3
Purpose of Action	LEVEL 2
Deficiency Photo1

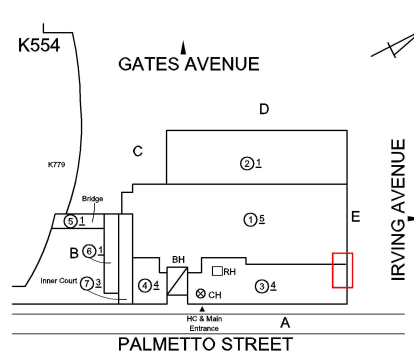
Roof Plan reference

Deficiency	CONCRETE: MINOR CRACKS, SPALLING
------------	----------------------------------

Deficiency Quantity	40
Quantity Uom	S.F.
Potential Action	REPAIR
Urgency of Action	PRIORITY 3
Purpose of Action	LEVEL 2

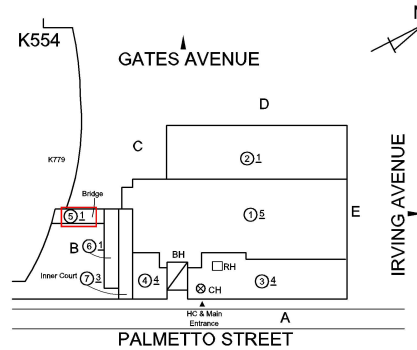
Roof Plan reference

Is/Are the roof(s) suitable for Solar Panel installation?	No
Installation Year	2013
Source of Installation	Custodial Staff
Deficiency	IRMA: ROOFING: MAJOR ACTIVE ROOF LEAKS IN INSTRUCTIONAL SPACE

100
S.F.
REPLACE ROOFING WITHOUT MAJOR EQUIPMENT
REMOVAL
PRIORITY 5
LEVEL 2

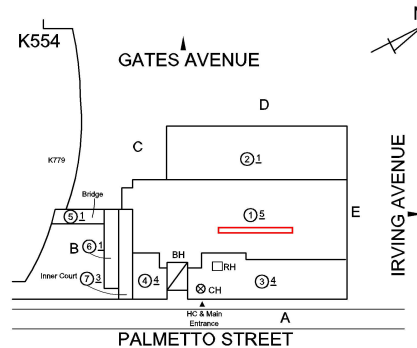
Roof Plan reference

IRMA: FLASHING: BASE FLASHING DETERIORATED

30
S.F.
REPLACE
PRIORITY 4
LEVEL 2

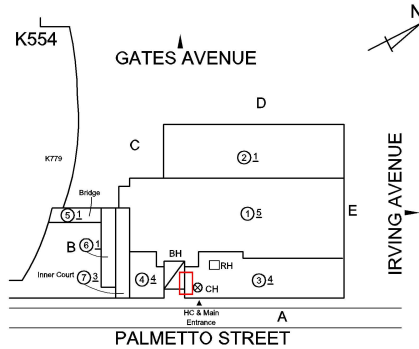
Roof 1 RTU1
Violations	No violations recorded.
ROOFING DRAINS	Inspected
Condition	2 - Between Good and Fair
Deficiency	No deficiencies recorded
Specialties	Inspected
BULKHEAD/PENTHOUSE	Inspected
Condition	3 - Fair
Deficiency	BULKHEAD/PENTHOUSE WALLS/EXTERIOR: CRACKS/SPALLING - MINOR
Roof Plan reference

Deficiency Quantity	20
Quantity Uom	S.F.
Potential Action	REPAIR
Urgency of Action	PRIORITY 3
Purpose of Action	LEVEL 2
Deficiency Photo1

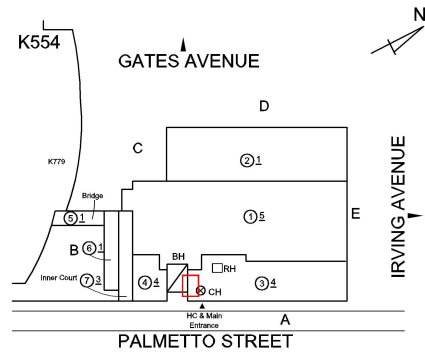
Roof 1 BH
Violations	No violations recorded.
Deficiency	BULKHEAD/PENTHOUSE WALLS/EXTERIOR: EFFLORESCENCE

Question	Response
EXTERIOR	
ROOF	
Specialties	
BULKHEAD/PENTHOUSE	
Roof Plan reference	
Deficiency Quantity	30
Quantity Uom	S.F.
Potential Action	MAINTENANCE
Urgency of Action	PRIORITY 1
Purpose of Action	LEVEL 1
Deficiency Photo1

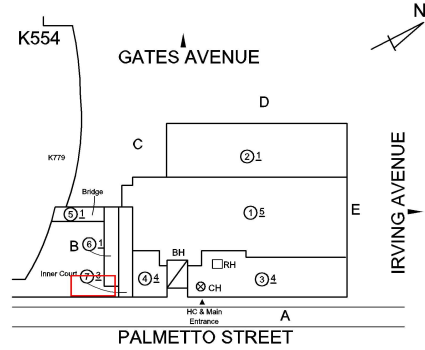
Question	Response
EXTERIOR	
STAIRS/RAMPS: EXTERIOR	
STAIRS/RAMPS	
Rooftop reference

Violations	No violations recorded.
CUPOLA/ SPIRES/ TOWERS	Does not Exist
DORMER	Does not Exist
DUNNAGE STEEL	Does not Exist
SKYLIGHT/ROOF VENT	Does not Exist
ROOF/GRAVITY TANK	Does not Exist
STAIRS/RAMPS: EXTERIOR	Inspected
BUILDING CHEEK/FLANK WALLS	Inspected
Condition	2 - Between Good and Fair
Deficiency	No deficiencies recorded
RAILINGS	Inspected
Condition	2 - Between Good and Fair
Deficiency	No deficiencies recorded
STAIRS/RAMPS	Inspected
Condition	3 - Fair
Deficiency	CONCRETE: CRACKS/SPALLING - MINOR

Deficiency Quantity	30
Quantity Uom	S.F.
Potential Action	REPAIR
Urgency of Action	PRIORITY 3
Purpose of Action	LEVEL 2
Deficiency Photo1

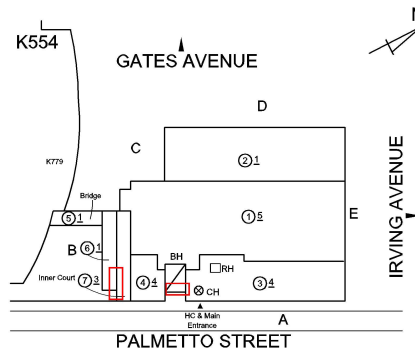
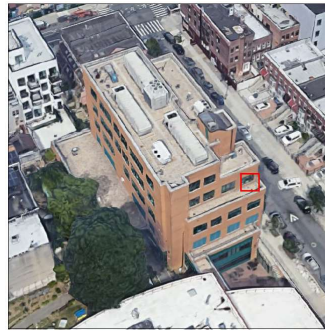
Roof Plan reference

Violations	Facade A No violations recorded.
WINDOWS	Inspected
Replacement Quantity	4,000
Replacement Uom	S.F.
EXTERIOR GUARDS	Inspected
Condition	2 - Between Good and Fair
Deficiency	No deficiencies recorded
LINTELS	Inspected
Condition	2 - Between Good and Fair
Deficiency	No deficiencies recorded
WINDOWS	Inspected
Material Type(s)	Aluminum
Instance on Aluminum - Other: All Facades except Facade E	Inspected
Instance Condition	3 - Fair
Instance Quantity	4,000
Instance Quantity Uom	S.F.
Are these windows insulated	Yes
Installation Year	2013
Source of Installation	Custodial Staff
Deficiency	ALUMINUM - OTHER: AIR/WATER INFILTRATION

REPLACE TRIM, SILLS OR WEATHERSTRIPPING

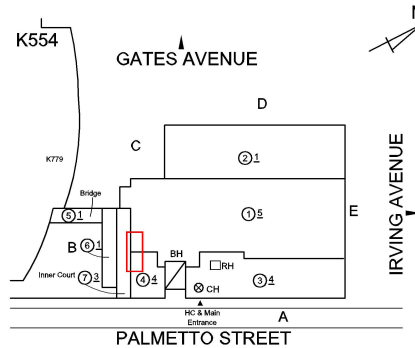
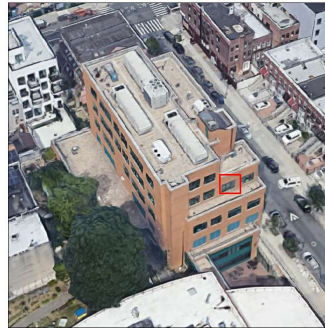
Roof Plan reference

ALUMINUM - OTHER: BROKEN PANE
