NYC Department of Education
Building Condition Assessment Survey 2023 - 2024

Architectural Inspection

Asset: **SUNSET PARK HS - BROOKLYN, 153 35TH STREET, New York, 11232**

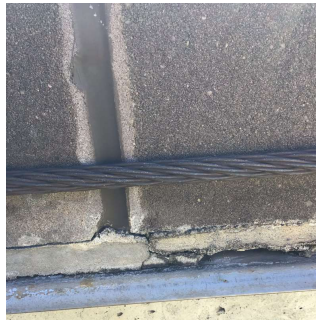
Roof 1

Question	Response
Architectural	
EXTERIOR	Inspected
AREAWAY	Does not Exist
AWNINGS AND CANOPIES	Inspected
Condition	2 - Between Good and Fair
Deficiency	No deficiencies recorded
CHIMNEY	Does not Exist
COPING	Inspected
Condition	3 - Fair
Deficiency	CAST STONE: DETERIORATED BED JOINT

COPING

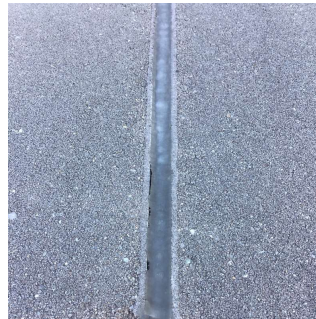
Roof 1

CAST STONE: DETERIORATED TRANSVERSE JOINTS

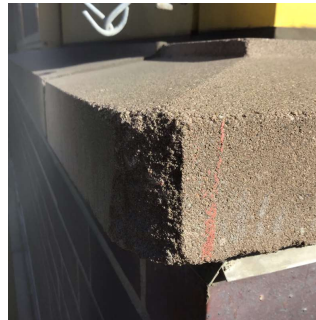
Facade A

BRICK: DETERIORATED MASONRY SILLS - MINOR

REPAIR

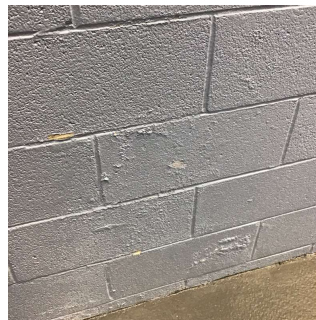
Facade E - Stair C/5

Deficiency BRICK: WATER INFILTRATION IN INSTRUCTIONAL SPACE

100
S.F.
REPAIR
PRIORITY 5
LEVEL 2

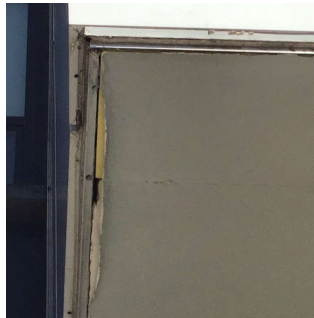
Facade A

Deficiency STUCCO/PLASTER: MAJOR CRACKS/SPALLING

REPLACE

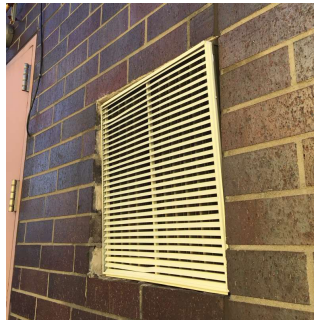
BROKEN/ DENTED BLADES

20
S.F.
REPLACE
PRIORITY 4
LEVEL 2

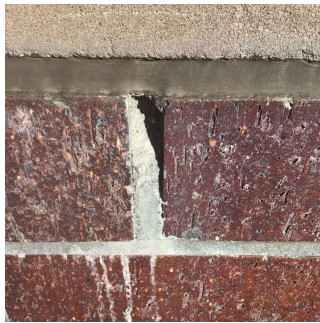
BRICK: DETERIORATED JOINTS

10
 S.F.
 REPOINT
 PRIORITY 4
 LEVEL 2

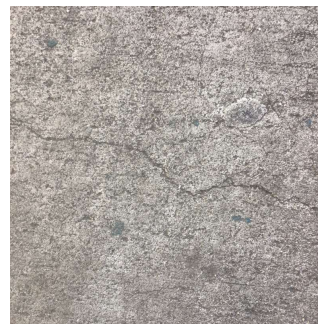
Violations	Facade A No violations recorded.
RAILINGS	Inspected
Condition	2 - Between Good and Fair
Deficiency	No deficiencies recorded
STAIRS/RAMPS	Inspected
Condition	5 - Poor
Deficiency	CONCRETE: CRACKS/SPALLING - MINOR

10
S.F.
REPAIR
PRIORITY 3
LEVEL 2

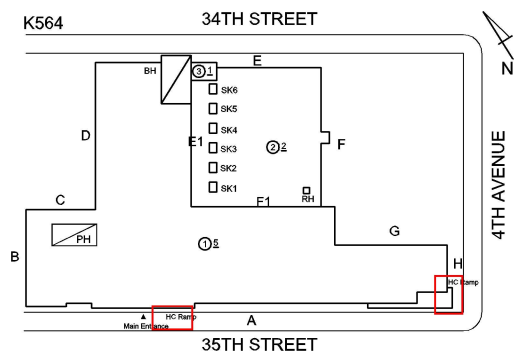
Roof Plan reference

CONCRETE: CRACKS/SPALLING - MAJOR

30
S.F.
REPLACE
PRIORITY 4
LEVEL 2

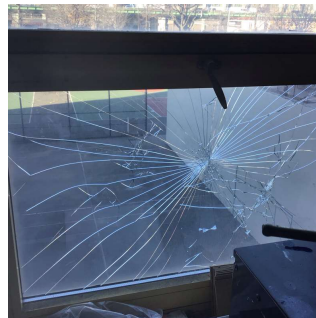
Deficiency ALUMINUM - OTHER: BROKEN PANE

Facade A - Rooms 211, 403
Facade C - Room 216
Facade D - Rooms 216A, 218 (Shown)
Facade H - Corridor near Stair B/2
Facade E1 - Room 329

210
S.F.
MAINTENANCE
PRIORITY 3
LEVEL 2

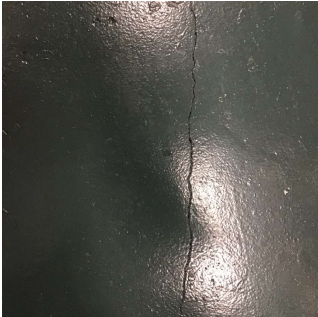
Violations	PH No violations recorded.
Deficiency	CONCRETE SLAB ON GRADE: THRU CRACKS
Deficiency Location/Instance	Basement - Main Sprinkler Valve Room, B25, Ejector Pump Room

Basement - Main Sprinkler Valve Room
Violations	No violations recorded.
FOUNDATION WALLS	
	Inspected
Material Type(s)	Concrete
Condition	2 - Between Good and Fair
Deficiency	CONCRETE: CRACKED/SPALLED/REINFORCEMENT EXPOSED
Deficiency Location/Instance	Basement - Switchgear Room
Deficiency Quantity	10
Quantity Uom	S.F.
Potential Action	REPAIR
Urgency of Action	PRIORITY 3
Purpose of Action	LEVEL 5
Deficiency Photo1	 
	Basement - Switchgear Room
Violations	No violations recorded.
ROOF STRUCTURE	
	Inspected
Condition	3 - Fair
Deficiency	STEEL COLUMNS/BEAMS: DETERIORATED/MISSING SPRAY-ON FIREPROOFING
Deficiency Location/Instance	PH
Deficiency Quantity	10
Quantity Uom	S.F.
Potential Action	REPLACE
Urgency of Action	PRIORITY 4
Purpose of Action	LEVEL 5

Deficiency Quantity	40
Quantity Uom	S.F.
Potential Action	REPLACE
Urgency of Action	PRIORITY 4

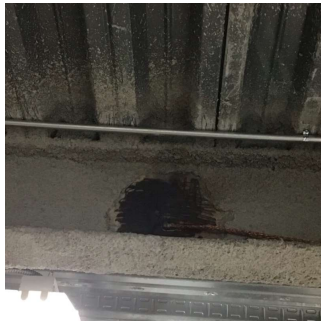
Question	Response
INTERIOR	
STRUCTURAL	
ROOF STRUCTURE	
Deficiency Photo1

Violations	PH No violations recorded.
VAULTS-BUNKERS	Does not Exist
AUDITORIUM	Inspected
Instance on 1st Floor (625 Seats)	Inspected
Ceiling	
Instance on 1st Floor (625 Seats)	Inspected
Condition	2 - Between Good and Fair
Deficiency	ACOUSTIC TILES: DAMAGED/MISSING
Deficiency Location/Instance	Room B22C
Deficiency Quantity	20
Quantity Uom	S.F.
Potential Action	REPLACE
Urgency of Action	PRIORITY 3
Purpose of Action	LEVEL 2
Deficiency Photo1

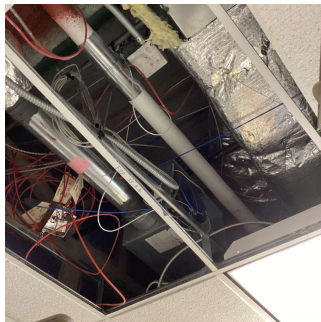
Violations	Room B22C No violations recorded.
Deficiency	GYPSUM BOARD: DAMAGED/DETERIORATED
Deficiency Location/Instance	Right and Left Side near Stage, Near Main Entrance
Deficiency Quantity	50
Quantity Uom	S.F.
Potential Action	REPLACE
Urgency of Action	PRIORITY 3
Purpose of Action	LEVEL 2

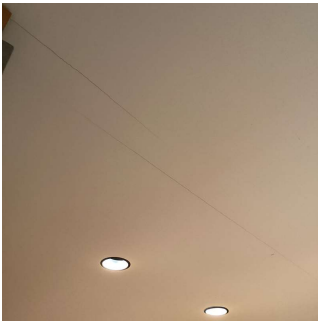
Violations	Near Main Entrance No violations recorded.
Door(s)	
Instance on 1st Floor (625 Seats)	Inspected
Condition	5 - Poor
Deficiency	WOOD: DETERIORATED DOOR
Deficiency Location/Instance	Main Entrance
Deficiency Quantity	4
Quantity Uom	EACH
Potential Action	MAINTENANCE
Urgency of Action	PRIORITY 3
Purpose of Action	LEVEL 2
Deficiency Photo1

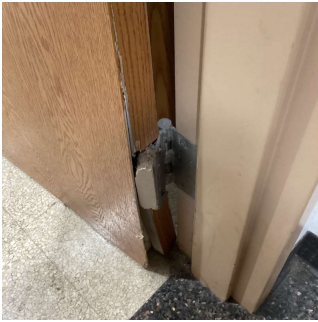
Violations	Left Side Main Entrance No violations recorded.
Fixed H/C Lift	
Instance on 1st Floor (625 Seats)	Inspected
Condition	2 - Between Good and Fair
Deficiency	No deficiencies recorded
Fixed Seating	
Instance on 1st Floor (625 Seats)	Inspected
Condition	2 - Between Good and Fair
Deficiency	DAMAGED/BROKEN/INOPERABLE
Deficiency Location/Instance	Seats A/3, 5, O/115, P/108, 109 and others
Deficiency Quantity	9
Quantity Uom	EACH
Potential Action	REPLACE
Urgency of Action	PRIORITY 3
Purpose of Action	LEVEL 2

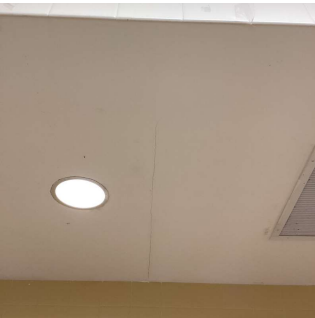
Left Side No violations recorded.
Deficiency Deficiency Location/Instance Deficiency Quantity Quantity Uom Potential Action Urgency of Action Purpose of Action Deficiency Photo1 Violations	GYPSUM BOARD: DAMAGED/DETERIORATED Near Drinking Fountain, by Right Side Entrance, Left Side 50 S.F. REPLACE PRIORITY 3 LEVEL 2

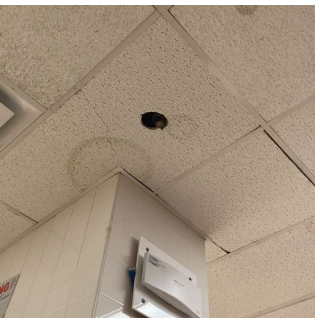
Left Side No violations recorded.
Deficiency Deficiency Location/Instance Deficiency Quantity Quantity Uom Potential Action Urgency of Action Purpose of Action Deficiency Photo1 Violations	ACOUSTIC TILES: DAMAGED/MISSING By Servedy, Near Column, close to Main Entrance, Center 50 S.F. REPLACE PRIORITY 3 LEVEL 2

Near Column No violations recorded.

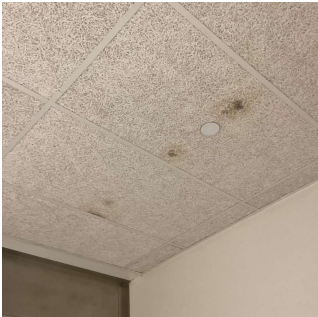
Corridor near Room 526
Violations	No violations recorded.
Deficiency	TECTUM: DAMAGED/MISSING
Deficiency Location/Instance	Corridor near Kitchen
Deficiency Quantity	20
Quantity Uom	S.F.
Potential Action	REPLACE
Urgency of Action	PRIORITY 3
Purpose of Action	LEVEL 2
Deficiency Photo1

Corridor near Kitchen
Violations	No violations recorded.
Deficiency	GYPSUM BOARD: DAMAGED/DETERIORATED
Deficiency Location/Instance	Corridor near Stair A/1, by Auditorium, next to Main Entrance, close to Rooms 105, 522 and others
Deficiency Quantity	280
Quantity Uom	S.F.
Potential Action	REPLACE
Urgency of Action	PRIORITY 3

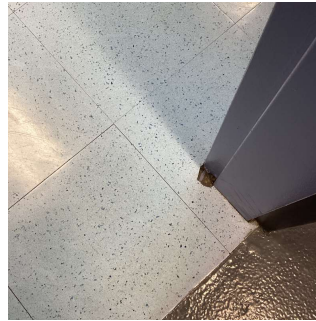
Violations	Room 528 No violations recorded.
Floor Finish	Inspected
Condition	2 - Between Good and Fair
Deficiency	VINYL TILES: BROKEN/DETERIORATED/MISSING TILES
Deficiency Location/Instance	Corridor near Stair C/5
Deficiency Quantity	10
Quantity Uom	S.F.
Potential Action	REPLACE
Urgency of Action	PRIORITY 3
Purpose of Action	LEVEL 2

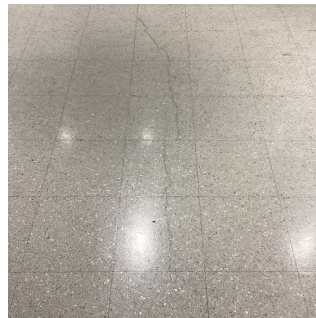
Main Entrance Lobby

VINYL TILES: DETERIORATED SUBSTRATE

REPLACE

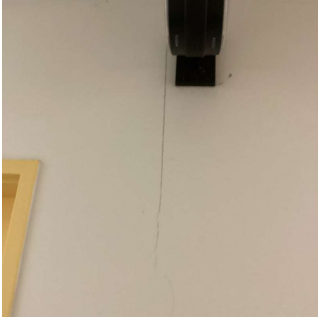
Question	Response
INTERIOR	
CLASSROOMS/CORRIDORS/ADMIN SPACES	
Floor Finish	Inspected
Violations	No violations recorded.
Walls	Inspected
Condition	2 - Between Good and Fair
Deficiency	CERAMIC TILE: BROKEN/ MISSING
Deficiency Location/Instance	Corridor near Drinking Fountain - Basement, by Students Cafeteria, next to Stair B/1, close to Rooms B20, 521 and others
Deficiency Quantity	100
Quantity Uom	S.F.
Potential Action	REPLACE
Urgency of Action	PRIORITY 3
Purpose of Action	LEVEL 2
Deficiency Photo1	 
Violations	Corridor near Drinking Fountain - Basement No violations recorded.
Deficiency	GYPSUM BOARD: DETERIORATED
Deficiency Location/Instance	Corridor near Rooms B20, B21, B14, by Students Cafeteria, next to Stair B/1 and others
Deficiency Quantity	360
Quantity Uom	S.F.
Potential Action	REPLACE
Urgency of Action	PRIORITY 3
Purpose of Action	LEVEL 2
Deficiency Photo1

Violations	Corridor near Room B21 No violations recorded.

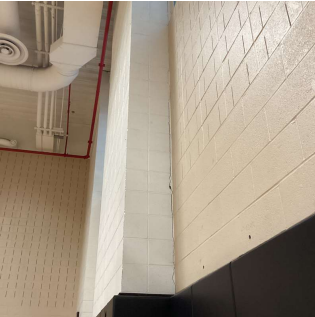
Violations	Near Room 113D No violations recorded.
Deficiency	MASONRY: CRACKS/SPALLING
Deficiency Location/Instance	Right and Left Side
Deficiency Quantity	60
Quantity Uom	S.F.
Potential Action	REPLACE
Urgency of Action	PRIORITY 3
Purpose of Action	LEVEL 2
Deficiency Photo1

Violations	Left Side No violations recorded.
Deficiency	WALL PADDING: DETERIORATED
Deficiency Location/Instance	Near Bleachers, Rear Wall
Deficiency Quantity	100
Quantity Uom	S.F.
Potential Action	REPLACE
Urgency of Action	PRIORITY 3
Purpose of Action	LEVEL 2
Deficiency Photo1

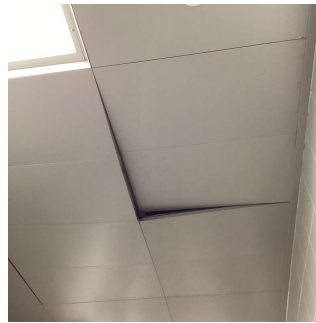
Near Room B37H

Violations	Students Servery No violations recorded.
Deficiency	METAL PAN: DAMAGED/MISSING
Deficiency Location/Instance	Near Room B37H, Staff Servery
Deficiency Quantity	20
Quantity Uom	S.F.
Potential Action	REPLACE

Urgency of Action	PRIORITY 3
Purpose of Action	LEVEL 2

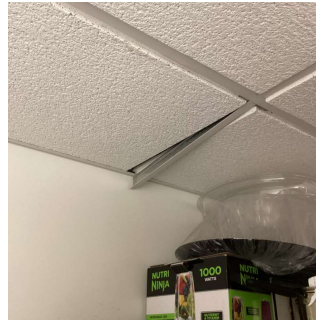
Room B371

ACOUSTIC TILES: DAMAGED/MISSING

REPLACE

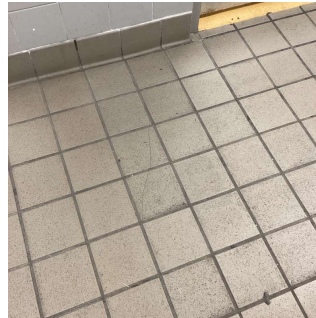
Servery Area

Deficiency	QUARRY TILE: BROKEN/MISSING TILES
Deficiency Location/Instance	Servery Area, near Sink
Deficiency Quantity	20
Quantity Uom	S.F.
Potential Action	REPLACE
Urgency of Action	PRIORITY 3
Purpose of Action	LEVEL 2
Deficiency Photo1

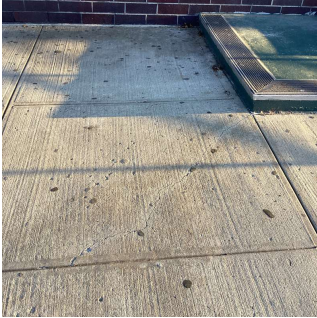
Question	Response
SITE	
PAVING	
Site Sidewalks & Walkways	
Concrete	
Condition	3 - Fair
Deficiency	DAMAGED/DETERIORATED/MISSING SECTIONS
Deficiency Location/Instance	35th Street, near Park, 4th Avenue
Deficiency Quantity	275
Quantity Uom	S.F.
Potential Action	REPLACE
Urgency of Action	PRIORITY 3
Purpose of Action	LEVEL 2
Deficiency Photo1

Violations	35th Street No violations recorded.
Pavers	Does not Exist
DOT Sidewalk	Inspected
Asphalt	Does not Exist
Concrete	Inspected
Condition	3 - Fair
Deficiency	DAMAGED/DETERIORATED/MISSING SECTIONS
Deficiency Location/Instance	35th Street, 4th Avenue
Deficiency Quantity	450
Quantity Uom	S.F.
Potential Action	REPLACE
Urgency of Action	PRIORITY 3
Purpose of Action	LEVEL 2
Deficiency Photo1

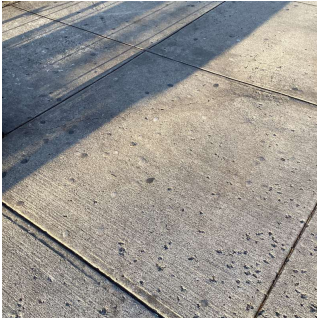
Violations	35th Street No violations recorded.
Deficiency	DAMAGED CURBS
Deficiency Location/Instance	35th Street
Deficiency Quantity	30
Quantity Uom	L.F.
