NYC Department of Education
Building Condition Assessment Survey 2023 - 2024

Architectural Inspection

Asset: AUTOMOTIVE TRADES VOC HS - K, 50 BEDFORD AVENUE, New York, 11222

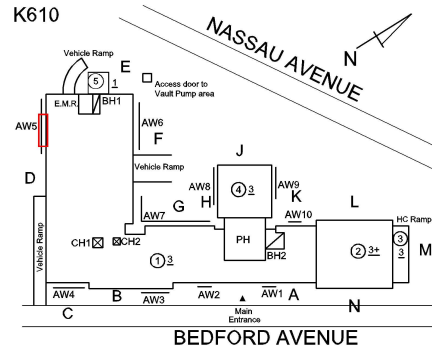
| Deficiency | AREAWAY STAIRS: DETERIORATED TREADS/RISERS/NOSINGS |

REPAIR

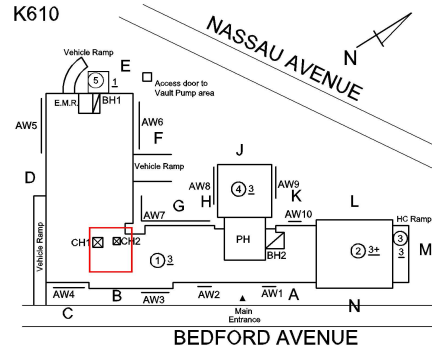
BRICK: DETERIORATED JOINTS

REPOINT
PRIORITY 3
LEVEL 2

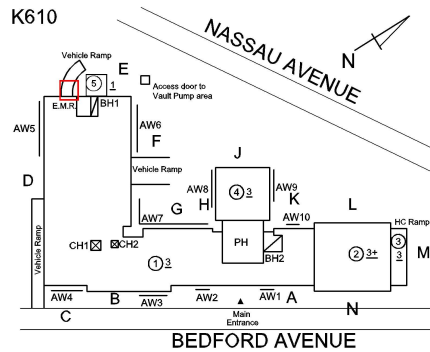
ROLL-UP DOOR: DETERIORATED DOOR AND FRAME - MINOR DETERIORATION

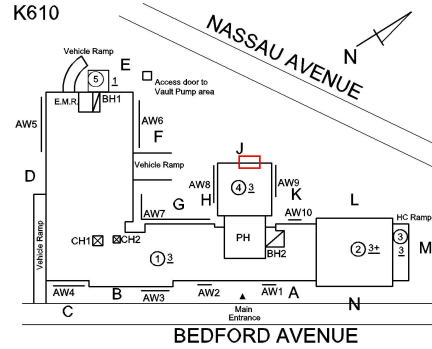
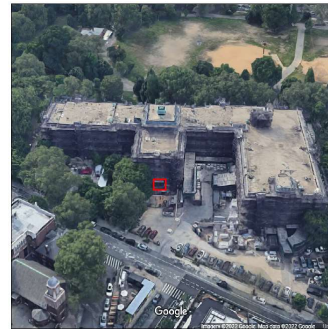
| Question | Response |
|---|--|
| Deficiency | STONE: CHIPPED/SPALLED/BROKEN PIECES - MAJOR |

REPLACE

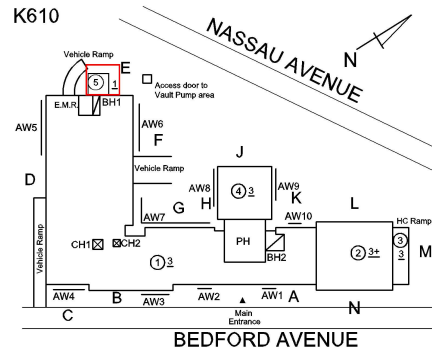
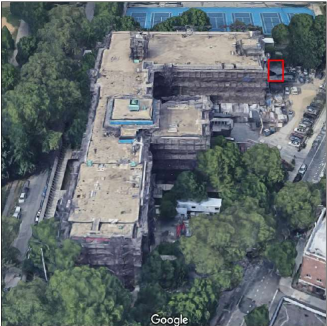
STUCCO CEMENT SURFACE: CRACKS, SPALLING

| Question | Response |
|---|---|
| Potential Action | REPLACE |

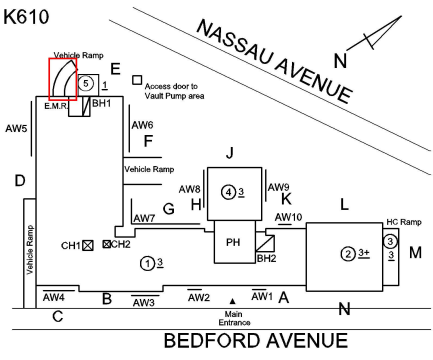
| Question | Response |
|---|---|
| Roof Plan reference | K610 |

| Question | Response |
|---|---|
| Deficiency | CAST IN PLACE CONCRETE: CRACKS/SPALLING - MAJOR |

| Question | Response |
|---|---|
| Potential Action | REPLACE |

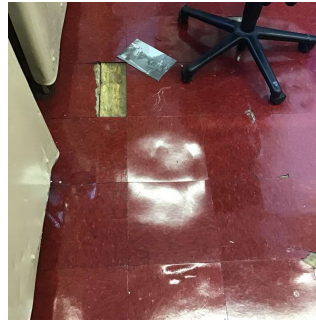
Room 334

| Priority Condition Exist Last Year? | Priority Category | Condition Description | Component Affected | Location Description | Person(s) Notified | Person(s) Title | PhotoImage |
|---|---|--|---|---|---|---|---|
| Yes | Tripping Hazard | Severely damaged vinyl tile floor and subfloor is a potential tripping hazard. | INTERIOR CLASSROOMS /CORRIDORS/ ADMIN SPACES Floor Finish | Rooms 213, 334, 360 | Charles Towns | Fireman | |

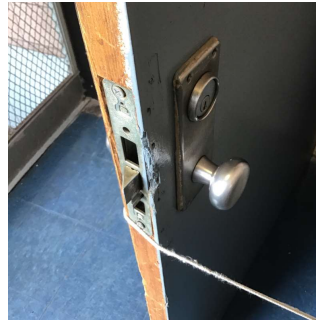
Entrance

WOOD: DETERIORATED DOOR

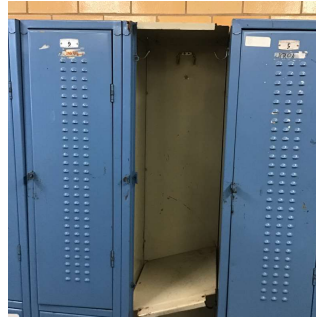
Locker 7

| Deficiency | DAMAGED UNITS |
| Deficiency Location/Instance | Lockers 7, 9, 15, 16 |

| Potential Action | REPLACE |

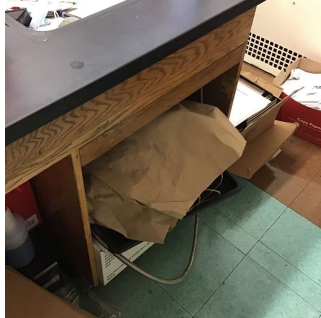
| Question | Response |
|---|--|
| | Room 360 |

| Question | Response |
|---|--|
| Deficiency | CABINETRY: MISSING/DAMAGED |

| Question | Response |
|---|--|
| Deficiency Location/Instance | Room 360 |

| Question | Response |
|---|--|
| Potential Action | REPLACE |

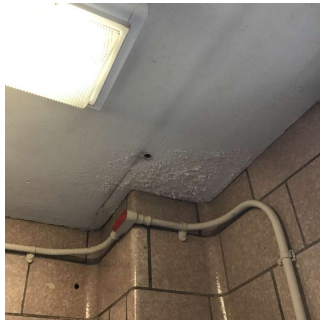
| Question | Response |
|---|--|
| | Stair G/3 |

| Question | Response |
|---|--|
| Deficiency | PLASTER: CRACKS/SPALLING |
| Deficiency Location/Instance | Stair G/3 |

| Question | Response |
|---|--|
| Potential Action | REPLACE |

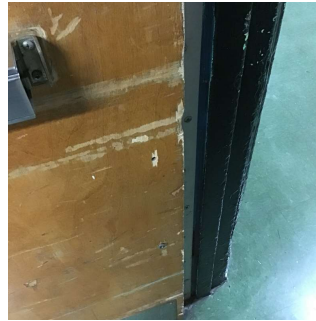
Stair B/Basement

| Question | Response |
|---|--|
| Deficiency | WOOD: DETERIORATED DOOR |
| Deficiency Location/Instance | Stairs B/Basement, G/1 |

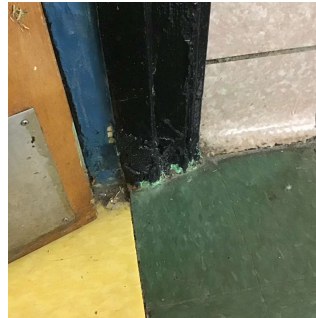
Stair C/Basement

METAL: DETERIORATED DOOR AND FRAME

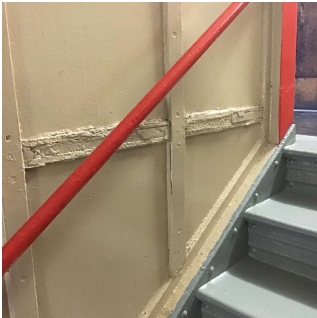
| Question | Response |
|---|--|
| Deficiency | METAL FRAME: DAMAGED/DETERIORATED |
| Deficiency Location/Instance | Stair C/1,2 |

| Question | Response |
|---|--|
| Potential Action | REPLACE |

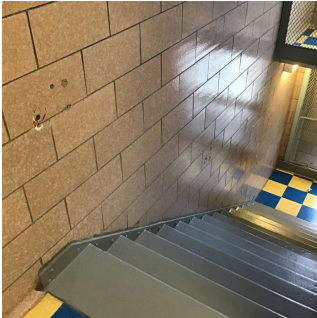
| Question | Response |
|---|--|
| Deficiency | METAL: MISSING |
| Deficiency Location/Instance | Stair C/3, Corridor near Room 202 |

| Question | Response |
|---|--|
| Potential Action | REPLACE |

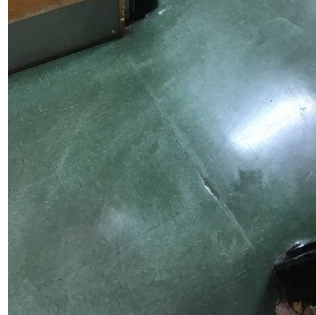
| Question | Response |
|---|--|
| Deficiency | VINYL TILES: DETERIORATED SUBSTRATE |
| Deficiency Location/Instance | Stair B/Basement |

| Question | Response |
|---|--|
| Potential Action | REPLACE |

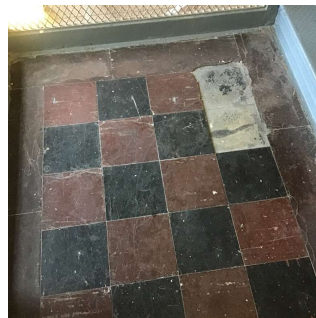
VINYL TILES: BROKEN/DETERIORATED/MISSING TILES
Stairs A/1, D/Bulkhead, G/2
50
S.F.
REPLACE
PRIORITY 3
LEVEL 2

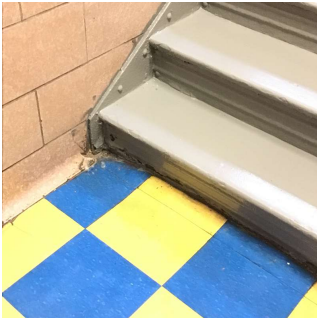
| Question | Response |
|---|--|
| Deficiency | METAL: RUST - MAJOR |
| Deficiency Location/Instance | Stair C/Basement |

| Question | Response |
|---|--|
| Potential Action | REPLACE |

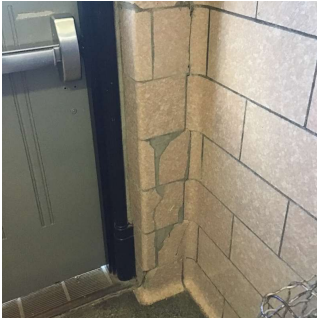
| Question | Response |
|---|--|
| Deficiency | GLAZED BLOCK: CRACKS/SPALLING |
| Deficiency Location/Instance | Stairs A/1,3, C/1 Vestibule |

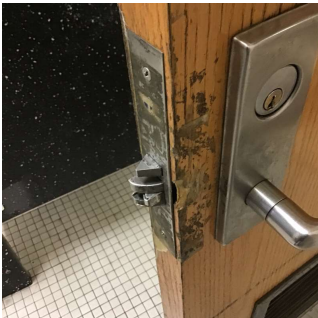
| Question | Response |
|---|--|
| Deficiency | WOOD: DETERIORATED DOOR |
